**Re: 2021 Leaf-on and Leaf-off Maintenance Inspections  
Former DuPont Waynesboro Site AOC 4  
Waynesboro, Virginia  
EPA ID# VAD003114832**

## Memorandum

Subject 2021 Leaf-on Maintenance Inspection  
Former DuPont Waynesboro Site, Area of Concern 4

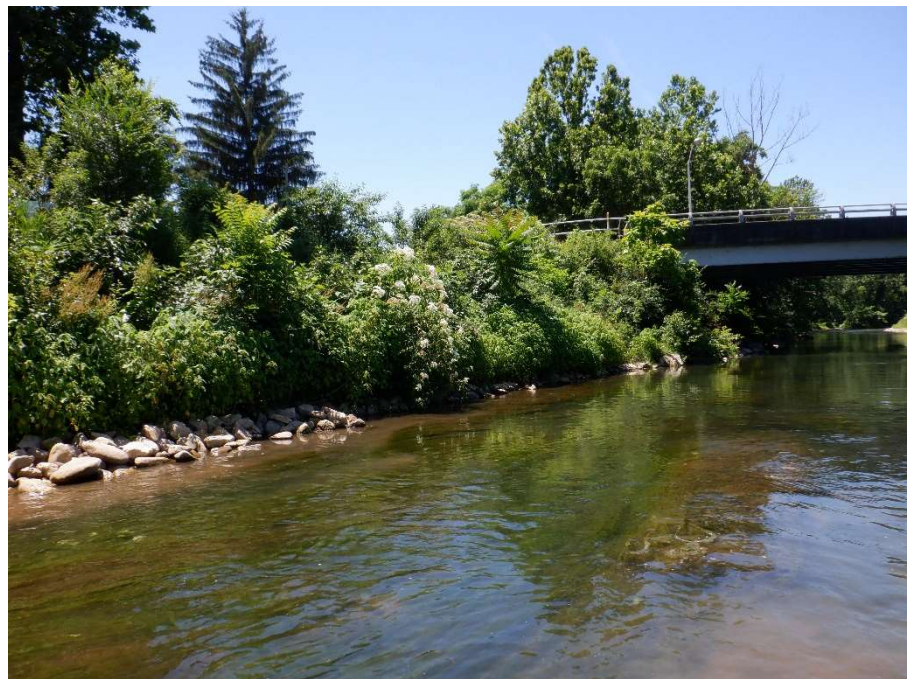
**Description:**  
~ 50 degree bank angle;  
upstream view of location;  
slope hydroseeded Spring  
2020; native herbaceous  
vegetation adjacent to water;  
Live stakes 30% established;  
No at-risk trees present;  
improvised weir that was  
previously present has been  
removed; scour at rock toe.

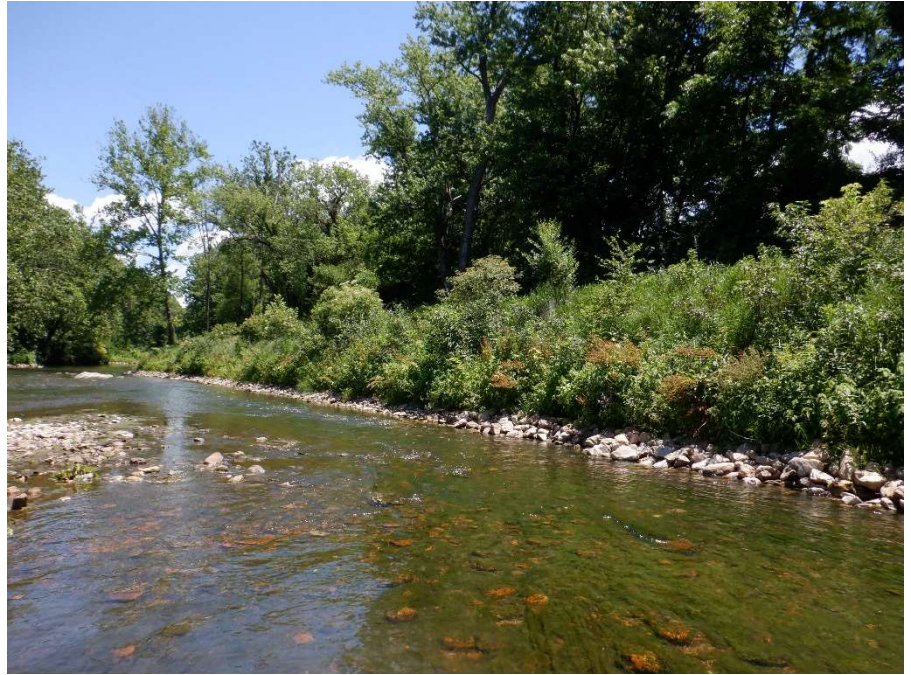
**Location:**  
00+150'

**Description:**  
~ 50 degree bank angle;  
native herbaceous vegetation  
adjacent to water; live stakes  
60% established; elderberry  
~30% cover, dogwood ~30%  
cover, sycamore, elm,  
jewelweed, willows; no at-  
risk trees present; no erosion  
control fabric or geocell  
exposed; sand deposition at  
toe of bank.

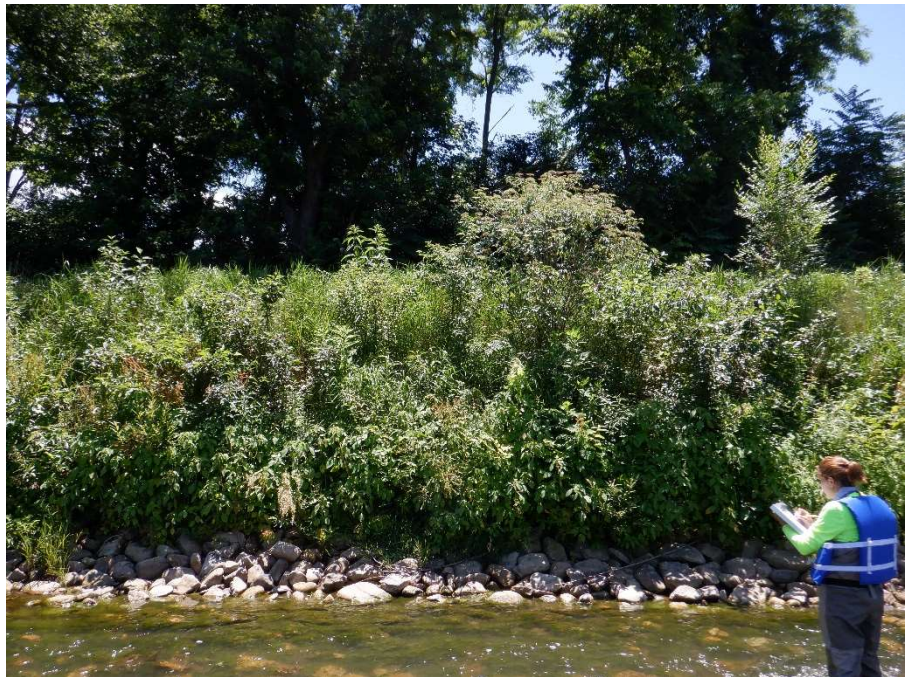
**Location:**  
00+200'

**Description:**  
~ 50 degree bank angle;  
native herbaceous vegetation  
established; live stakes 70%  
established-dogwoods and  
willows; elderberry ~60%  
cover, jewelweed and  
willows ~10% cover,  
intermixed grasses, and  
dogwoods; no at-risk trees  
present; no erosion control  
fabric or geocell exposed;  
sand deposition at toe of  
bank.

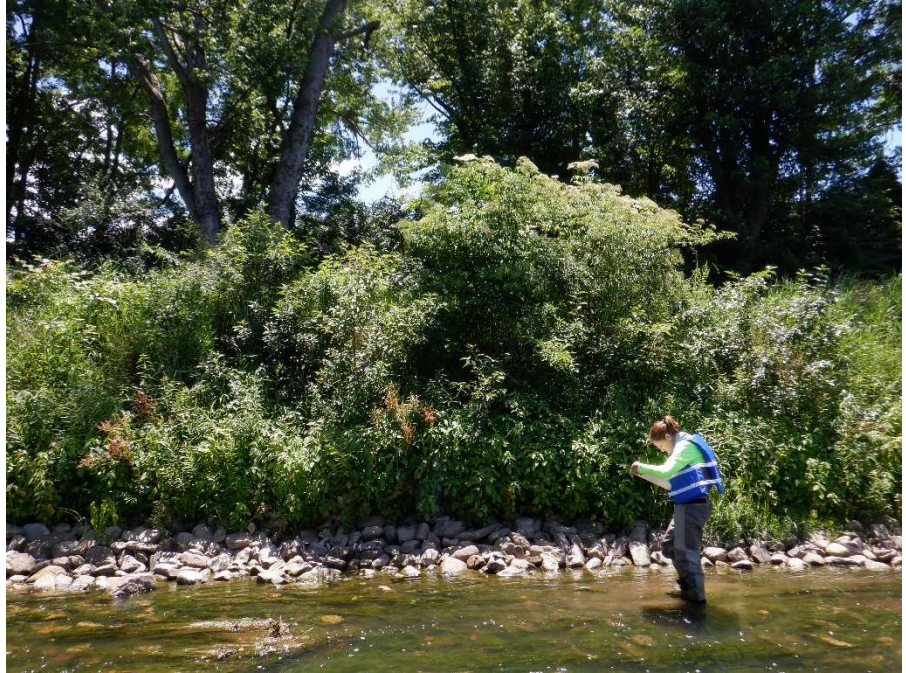
**Location:**  
00+250'

**Description:**  
~ 50 degree bank angle;  
native herbaceous vegetation  
established; live stakes 60%  
established; sycamore  
sapling at top of slope,  
grasses ~70% cover, willows,  
elderberry ~20% cover,  
jewelweed and dogwood  
~25% cover; no at-risk trees  
present; no erosion control  
fabric or geocell exposed; no  
exposed soil; sand deposition  
at toe of bank.

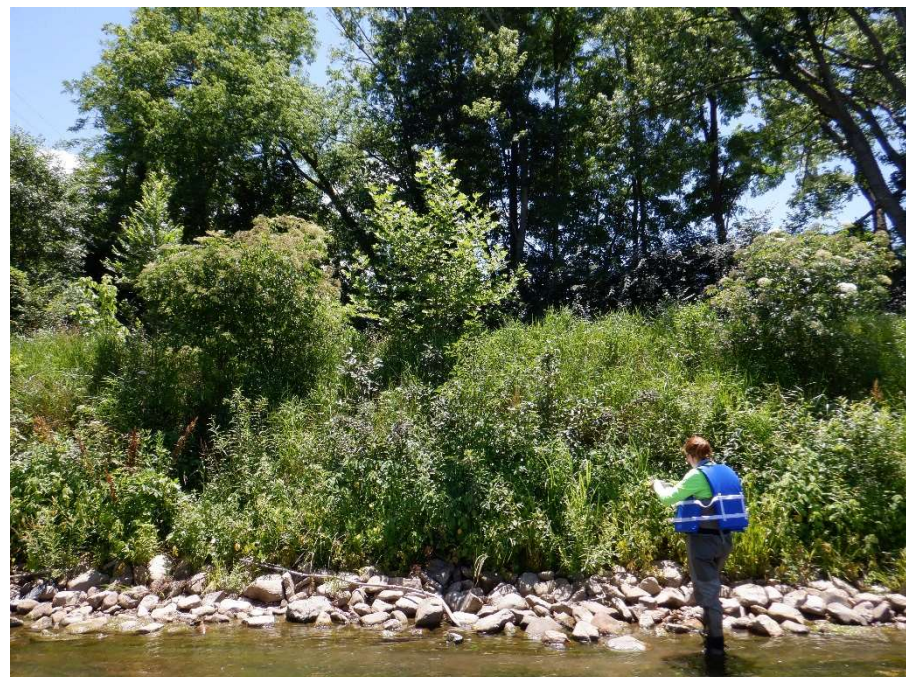
**Location:**  
00+300'

**Description:**  
~ 40 degree bank angle;  
native herbaceous vegetation  
established; live stakes 50%  
established; trampled grasses  
from improvised path on  
upstream portion of slope;  
no at-risk trees present; rock  
toe intact, outfall and  
drainage features intact;  
sand and gravel deposition at  
toe of bank.

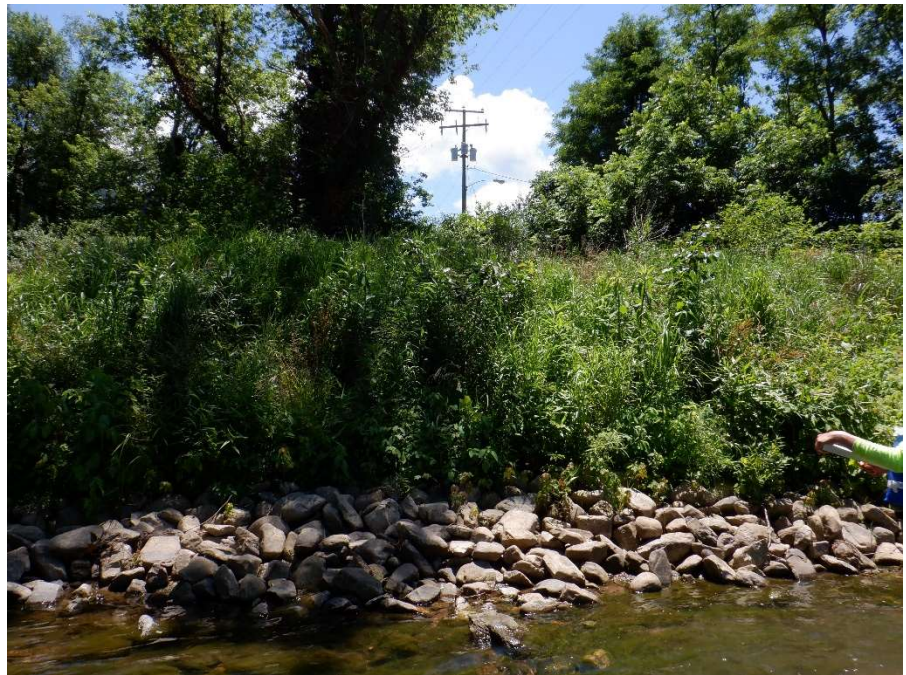
**Location:**  
00+400'

**Description:**  
~ 50 degree bank angle;  
native vegetation  
established; large patches of  
invasive knotweed present  
on both sides of the outfall;  
sycamore, maples-saplings at  
toe, mostly grasses ~80%  
cover, willows; no at-risk  
trees present; no erosion  
control fabric or geocell  
exposed; sand deposition at  
toe of bank.

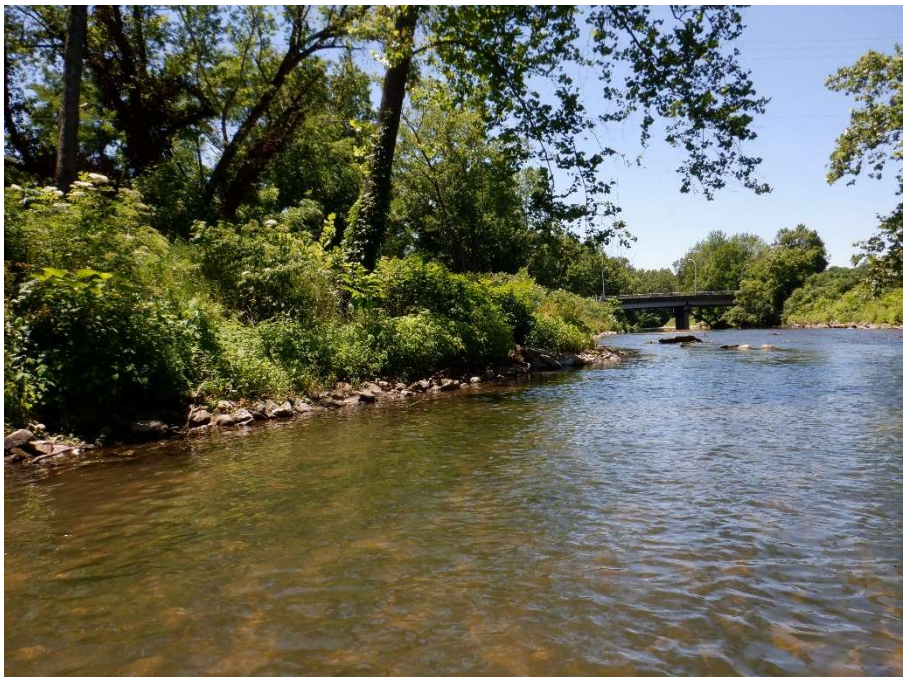
**Location:**  
00+500'

**Description:**  
~ 40 degree bank angle; bank completely covered in native vegetation; live stakes 50% established; dead sycamore with crack in trunk at top of slope; elderberry ~5% cover; no at-risk trees present; no erosion control fabric exposed; no geocell exposed; sand deposition at toe of bank.

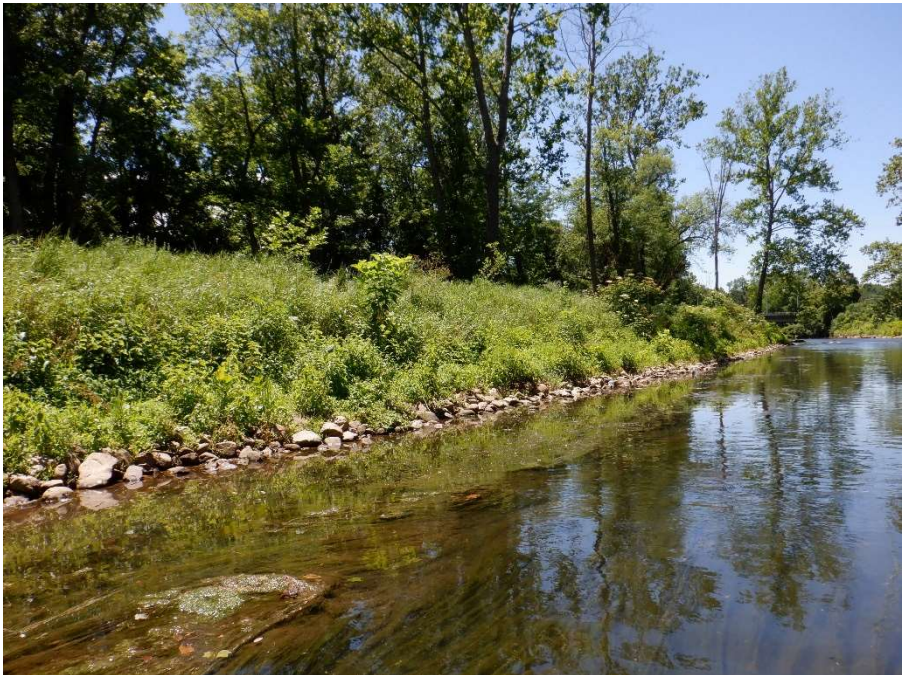
<p><b>Location:</b> 00+750'</p> <hr/> <p><b>Photo Number:</b>      <b>Date:</b> 27                              6/23/2021</p> <hr/> <p><b>Direction Photo Taken:</b> Southeast</p> <hr/> <p><b>Description:</b> ~ 30 degree bank angle; bank completely covered in native vegetation; live stakes 50% established; trampled vegetation from walking path to river; grasses are dominant, along with nightshade and nettles, 5 large sycamores on bank, red maples at toe of slope; no at-risk trees present in remediated area; no erosion control fabric exposed; no geocell exposed; improvised access path observed.</p>

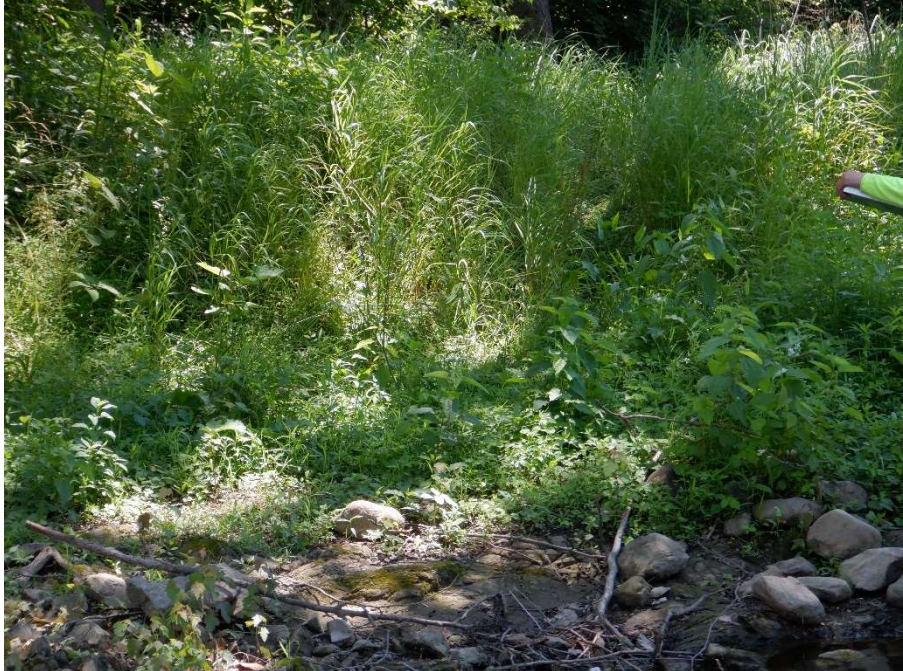
**Location:**  
00+1250'

**Description:**  
~ 20 degree bank angle; exposed roots just upstream of remediated bank; large patches of invasive knotweed present by riprap edge upstream (~85% cover), jewelweed ~15% cover, increased pedestrian access and a new rope swing chair hanging from box elder over water; scour under box elder tree and upstream of remediated section.

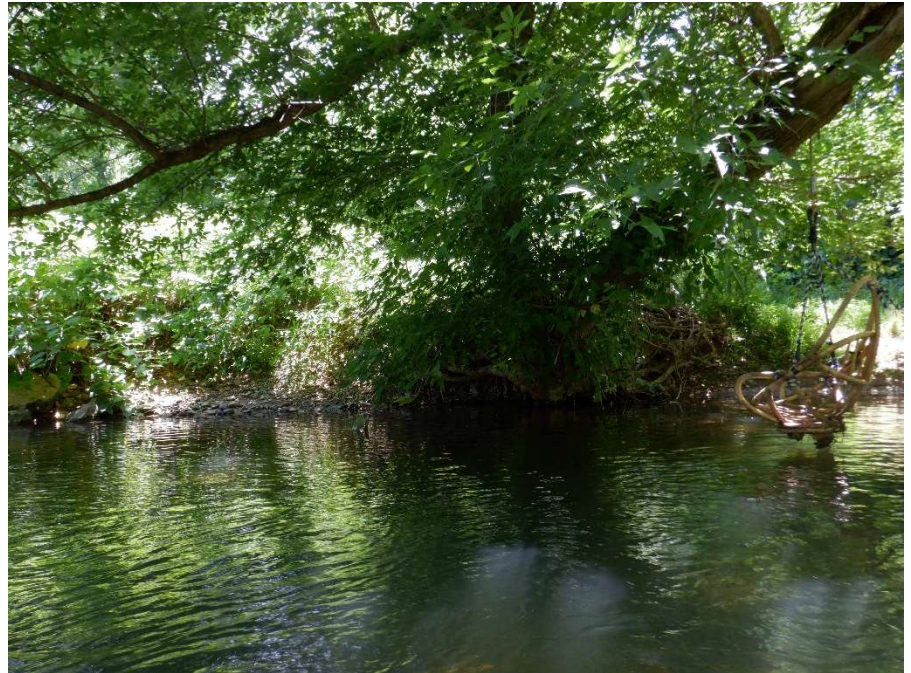
**Location:**  
00+1250'

**Description:**  
~ 20 degree bank angle; downstream view of location; exposed roots just upstream of remediated bank; one large box elder tree just upstream of remediated bank; entirely rip rap portion of bank; remediation downstream; scour under box elder tree and upstream of remediated section.

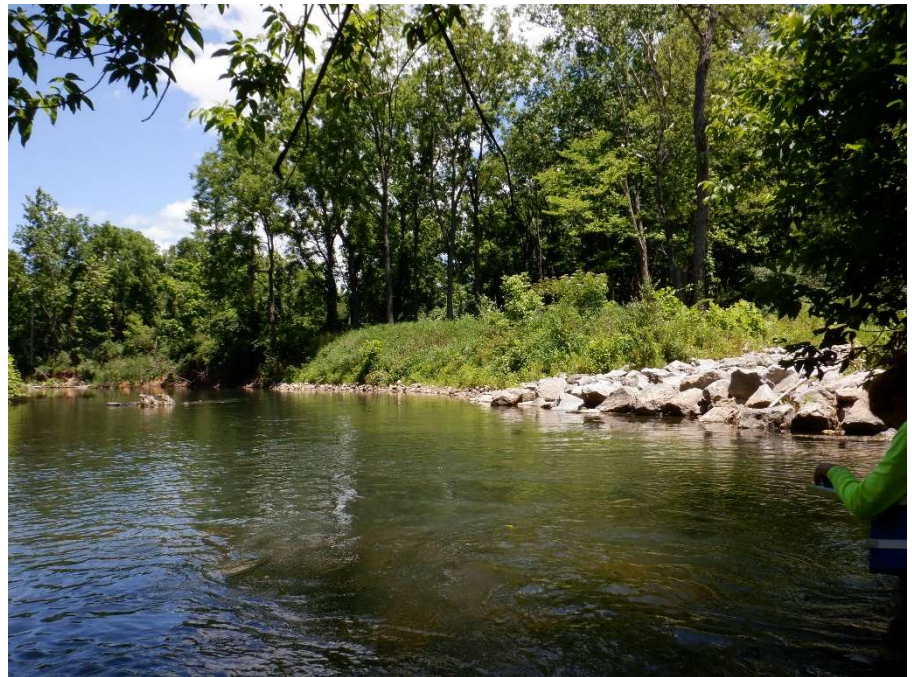
**Location:**  
00+1300'

**Description:**  
~ 20 degree bank angle; no exposed roots; invasive Japanese knotweed present ~80% cover, jewelweed at 20% cover, also present are willows, elderberry, and sycamore saplings; no at-risk trees present; entirely rip rap portion of bank; sediment deposition by rock toe.

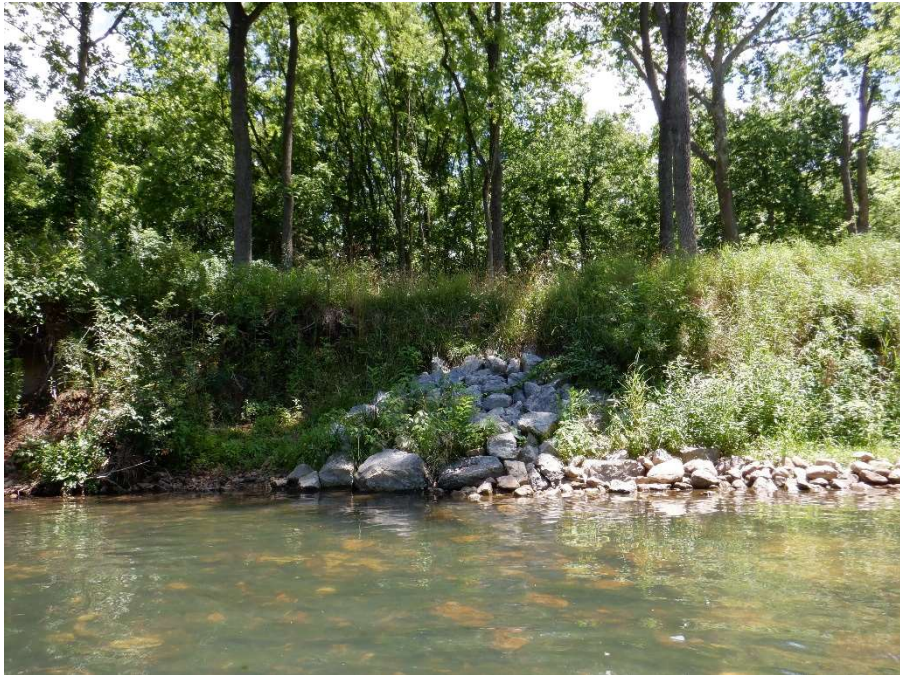
<p><b>Location:</b> 00+1450'</p> <hr/> <p><b>Photo Number:</b>      <b>Date:</b> 37                              6/23/2021</p> <hr/> <p><b>Direction Photo Taken:</b> Southeast</p> <hr/> <p><b>Description:</b> ~ 80 degree bank angle; native herbaceous vegetation establishing; live stakes 50% established; no at-risk trees present; erosion control fabric 40% exposed ; no geocell exposed; Rip rap fortified bank abutment intact; slight scour at rock toe; erosion observed downstream of station.</p>

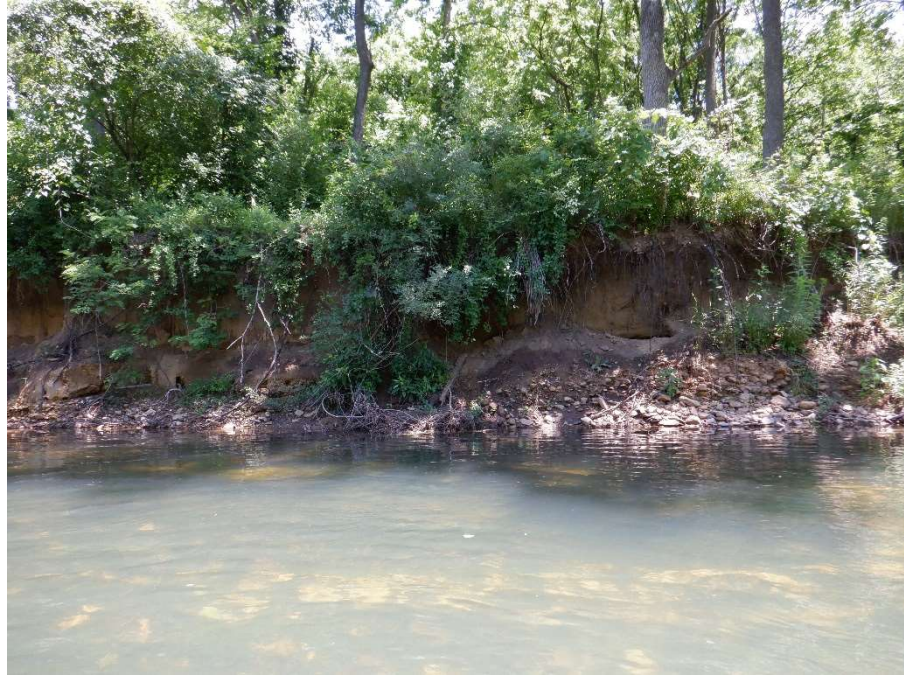
<p><b>Location:</b> 00+1500'</p> <hr/> <p><b>Photo Title:</b>              <b>Date:</b> 38                              6/23/2021</p> <hr/> <p><b>Direction Photo Taken:</b> Southeast</p> <hr/> <p><b>Description:</b> ~ 90 degree bank angle; severe root exposure downstream of remediated bank; erosion is too severe for vegetation to establish around rock toe; vegetation established at top of slope is dominated by mature black walnuts, sycamores, honeysuckle bush, no knotweed present; high density of at risk trees downstream of remediated bank; no fabric or geocell installed; downstream of remediation; heavy erosion present downstream of remediated BMA.</p>

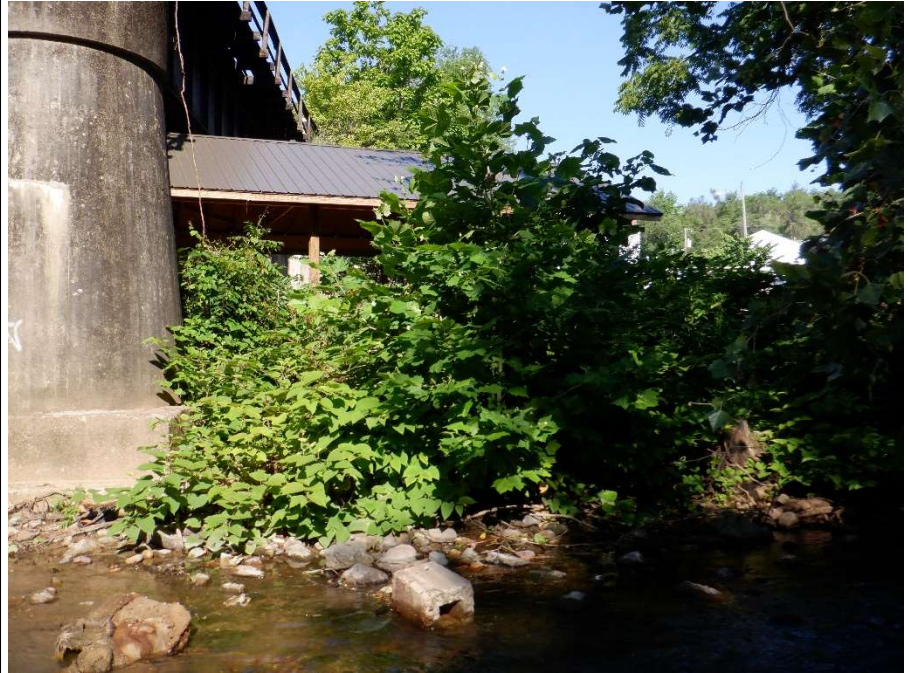
**Description:**  
~ 30 degree bank angle; minimal vegetation; exposed roots along bank; access pathways present; no at-risk trees present; upstream of remediation; minimal scour present. Invasive knotweed covers ~30% of the bank.

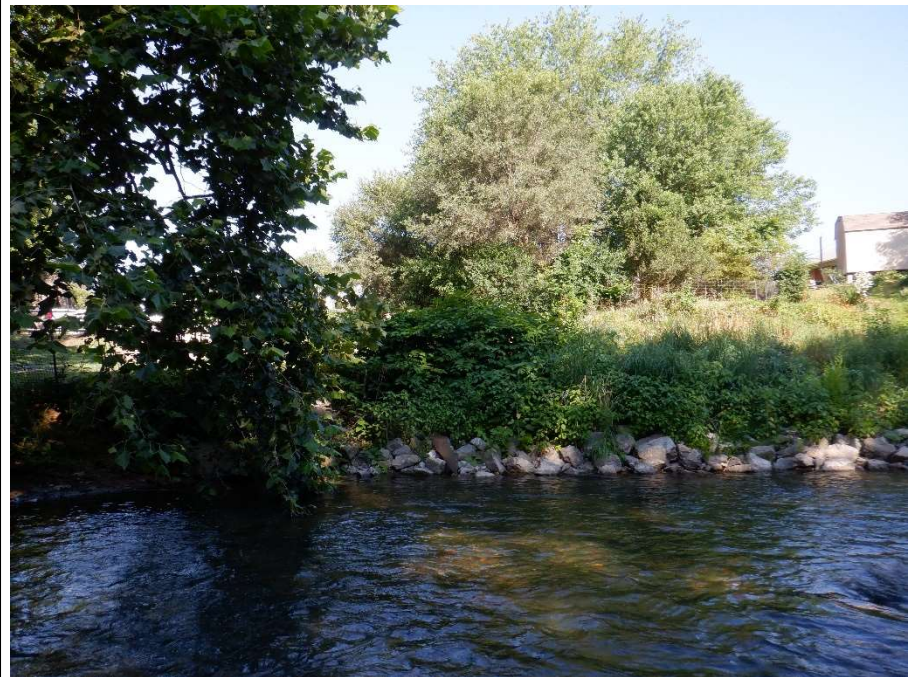
**Description:**  
~ 30 degree bank angle; Significant vegetation established; Live stakes and plantings 30% established; invasive knotweed ~5% cover; no trees adjacent to edge of water; No geocell or erosion fabric exposed; culvert just upstream of remediation; Evidence of sediment deposition.

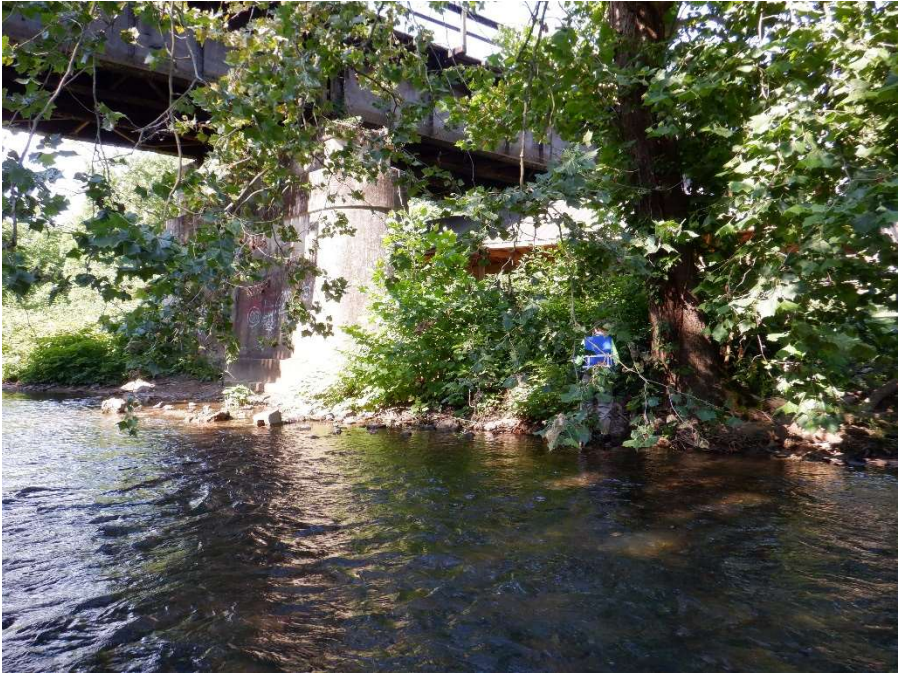
<p><b>Location:</b> 00+00'</p> <hr/> <p><b>Photo Number:</b>      <b>Date:</b> 3                              6/23/2021</p> <hr/> <p><b>Direction Photo Taken:</b> Southwest</p> <hr/> <p><b>Description:</b> ~ 30 degree bank angle; Significant vegetation established; Live stakes and plantings 30% established; invasive knotweed ~5% cover; no trees adjacent to edge of water; No geocell or erosion fabric exposed; culvert just upstream of remediation; Evidence of sediment deposition.</p>

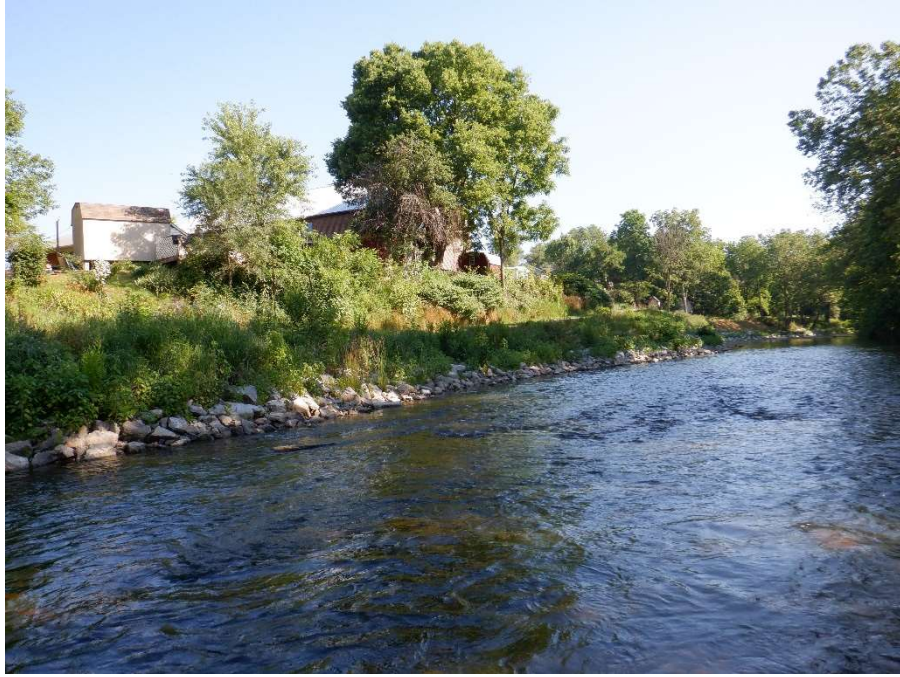
<p><b>Location:</b> 00+00'</p> <hr/> <p><b>Photo Title:</b>              <b>Date:</b> 4                              6/23/2021</p> <hr/> <p><b>Direction Photo Taken:</b> North</p> <hr/> <p><b>Description:</b> ~ 30 degree bank angle; Significant vegetation established; Live stakes and plantings 30% established; invasive knotweed ~5% cover; no trees adjacent to edge of water; No geocell or erosion fabric exposed; culvert just upstream of remediation; Evidence of sediment deposition.</p>

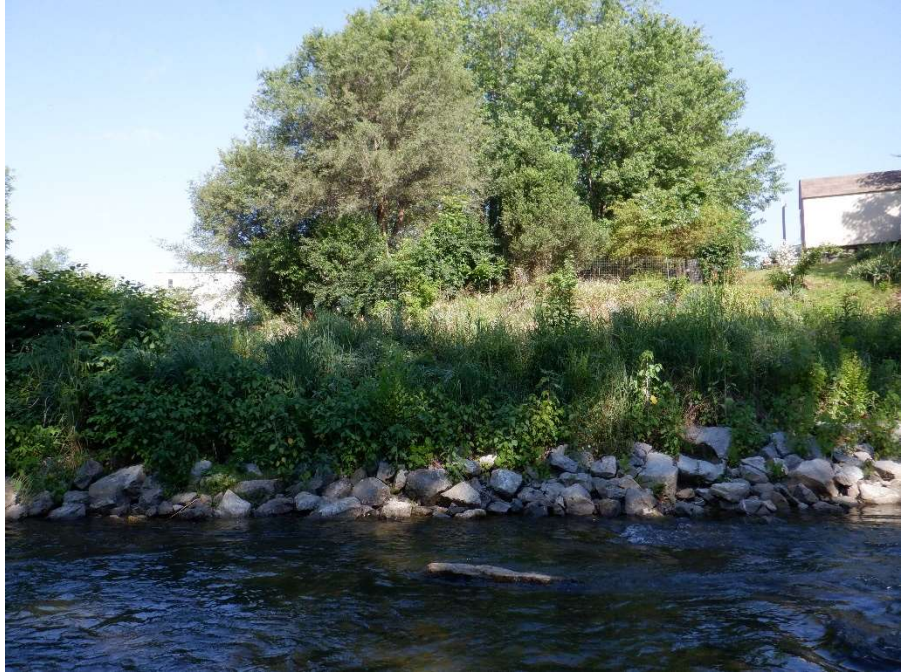
<p><b>Location:</b> 00+50'</p> <hr/> <p><b>Photo Number:</b>      <b>Date:</b> 5                              6/23/2021</p> <hr/> <p><b>Direction Photo Taken:</b> West</p> <hr/> <p><b>Description:</b> ~65 degree bank angle; Herbaceous vegetation established; live stakes not established; Jewelweed and many elms establishing; No invasive veg; sediment deposition observed. No erosion control fabric or geocell exposed due to dense herbaceous vegetation cover. Rock toe intact. Evidence of sediment deposition.</p>

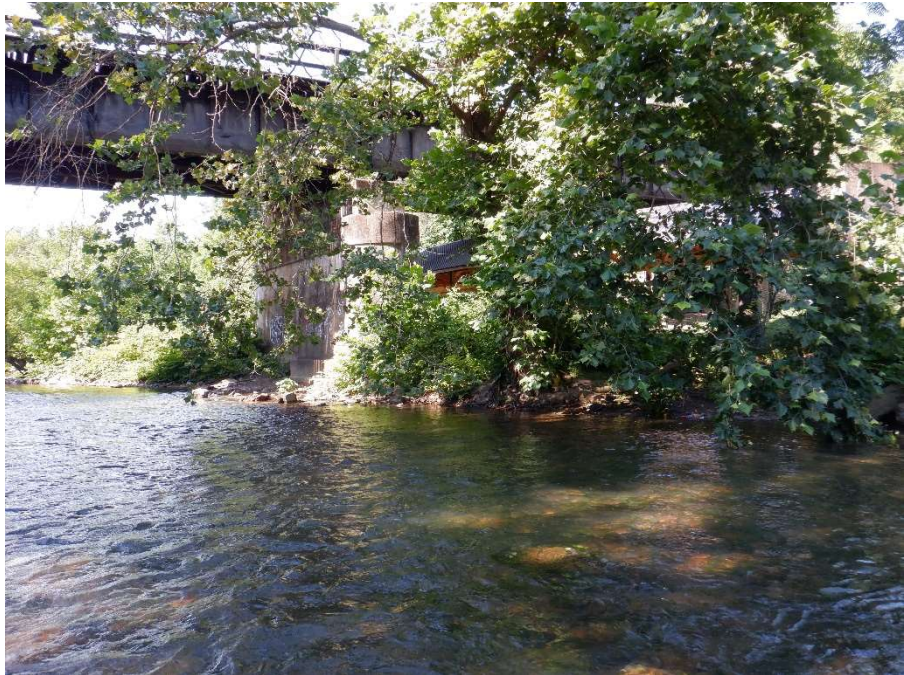
<p><b>Location:</b> 00+50'</p> <hr/> <p><b>Photo Title:</b>              <b>Date:</b> 6                                  6/23/2021</p> <hr/> <p><b>Direction Photo Taken:</b> Southwest</p> <hr/> <p><b>Description:</b> ~65 degree bank angle; Herbaceous vegetation established; live stakes not established; Jewelweed and many elms establishing; No invasive veg; sediment deposition observed. No erosion control fabric or geocell exposed due to dense herbaceous vegetation cover. Rock toe intact. Evidence of sediment deposition.</p>

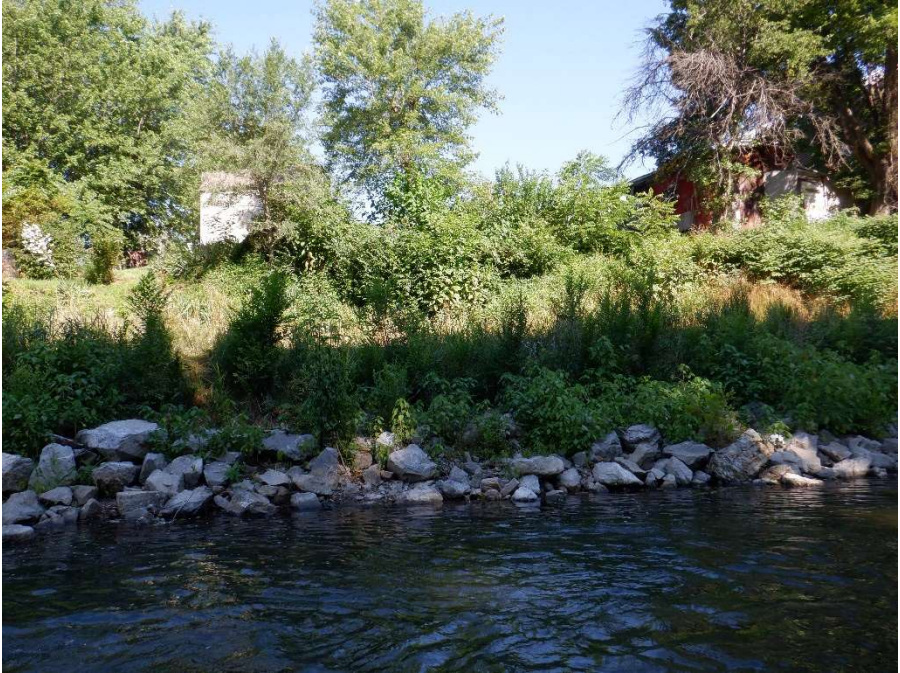
<p><b>Location:</b> 00+100'</p> <hr/> <p><b>Photo Number:</b>      <b>Date:</b> 7                              6/23/2021</p> <hr/> <p><b>Direction Photo Taken:</b> West</p> <hr/> <p><b>Description:</b> ~ 50 degree bank angle; Lower bank; ~40 degrees Upper bank; ~60 degrees; Herbaceous vegetation establishing; grasses are dominant; live stakes not established; public access path observed; jewelweed and elms at toe; no invasive veg; No trees adjacent to edge of water; No erosion control fabric or geocell exposed due to dense herbaceous vegetation cover. Small patches of exposed soil; Evidence of sediment deposition</p>

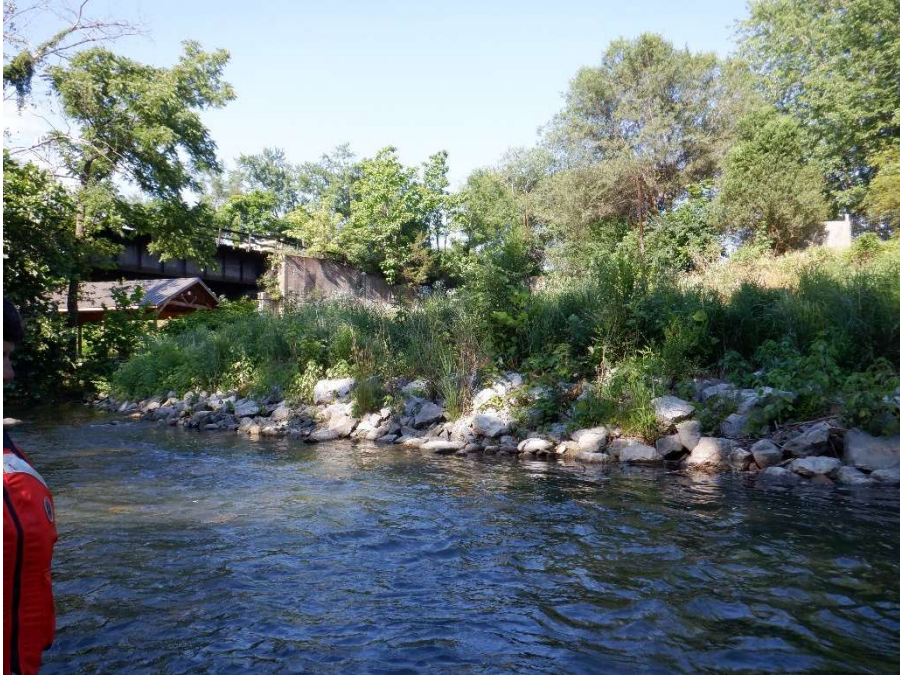
<p><b>Location:</b> 00+100'</p> <hr/> <p><b>Photo Title:</b>              <b>Date:</b> 8                                  6/23/2021</p> <hr/> <p><b>Direction Photo Taken:</b> Southwest</p> <hr/> <p><b>Description:</b> ~ 50 degree bank angle; Lower bank; ~40 degrees Upper bank; ~60 degrees; Herbaceous vegetation establishing; grasses are dominant; live stakes not established; public access path observed; jewelweed and elms at toe; no invasive veg; No trees adjacent to edge of water; No erosion control fabric or geocell exposed due to dense herbaceous vegetation cover. Small patches of exposed soil; Evidence of sediment deposition</p>

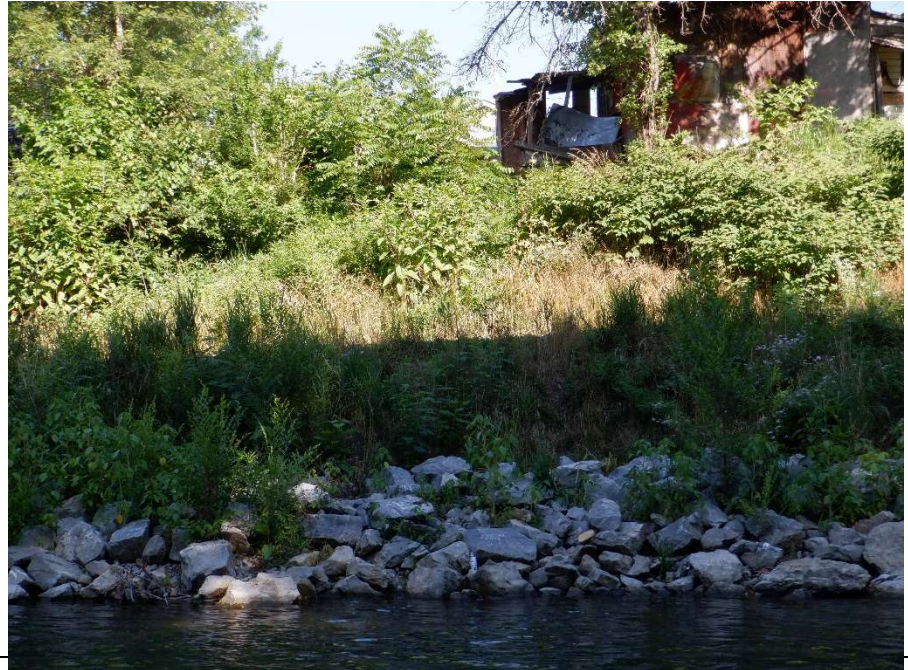
**Location:**  
00+150'

**Description:**  
~ 50 degree bank angle; Lower bank; ~40 degrees Upper bank; ~60 degrees Above Greenway Trail; ~60 degrees; Herbaceous vegetation establishing; live stakes not established; Jewelweed, elms establishing; no knotweed; No trees adjacent to edge of water; no fabric or geocell exposed;

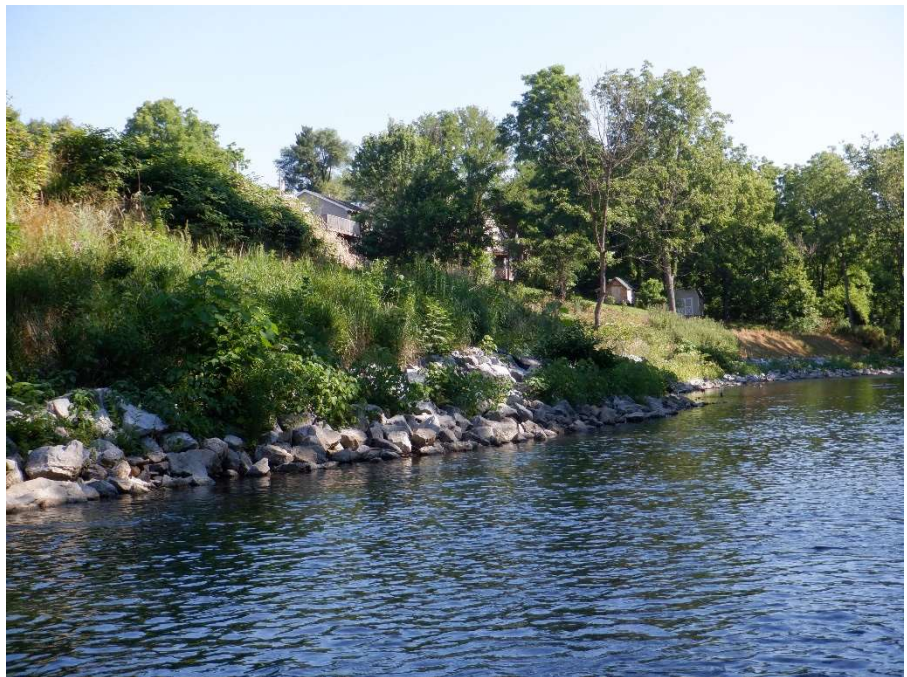
**Location:**  
00+150'

**Description:**  
~ 50 degree bank angle; Lower bank; ~40 degrees Upper bank; ~60 degrees Above Greenway Trail (GW); ~60 degrees; Herbaceous vegetation establishing; live stakes not established; Jewelweed, elms establishing; no knotweed; No trees adjacent to edge of water; no fabric or geocell exposed;

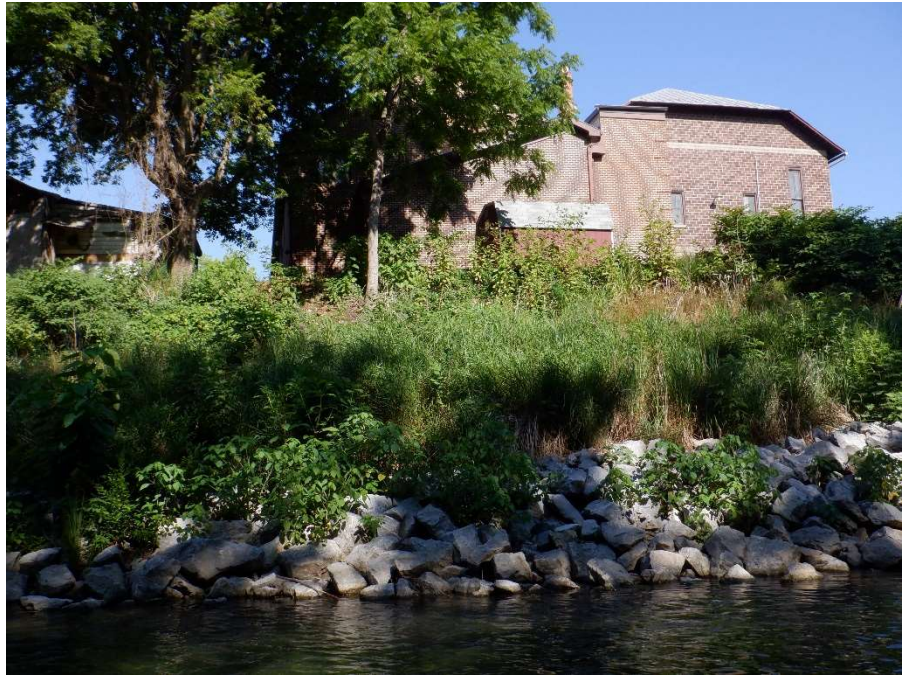
**Location:**  
00+200'

**Description:**  
~ 65 degree bank angle;  
Herbaceous vegetation  
establishing; live stakes  
establishing; herbaceous  
vegetation establishing above  
Greenway; planted saplings and  
shrubs intact; elms, oaks,  
catalpa, and jewelweed; catalpa  
saplings adjacent to edge of  
water; No erosion control fabric  
or geocell exposed due to dense  
herbaceous vegetation cover

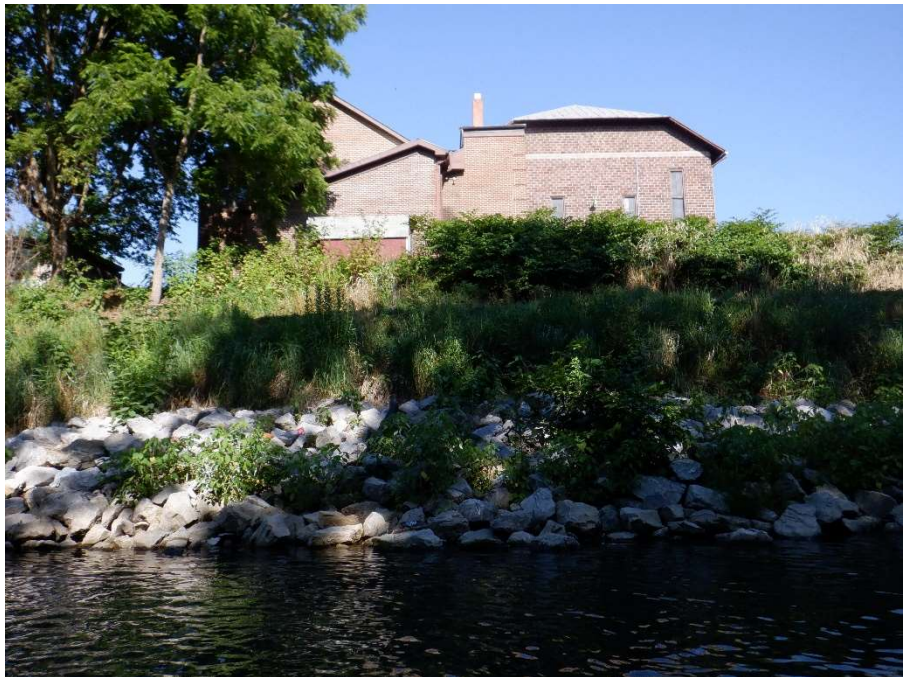
**Location:**  
00+250'

**Description:**  
~55 degree bank angle; Lower  
bank; ~45 degrees Upper bank;  
~65 degrees Above GW; ~70  
degrees; Herbaceous vegetation  
establishing; live stakes  
establishing; herbaceous  
vegetation establishing above  
Greenway; planted saplings and  
shrubs intact; minimal invasive  
knotweed establishing in rock  
toe; No trees adjacent to edge  
of water; No erosion control  
fabric or geocell exposed due to  
dense herbaceous vegetation  
cover. Greenway is intact.  
Drainage pipe to river; Evidence  
of sediment deposition.

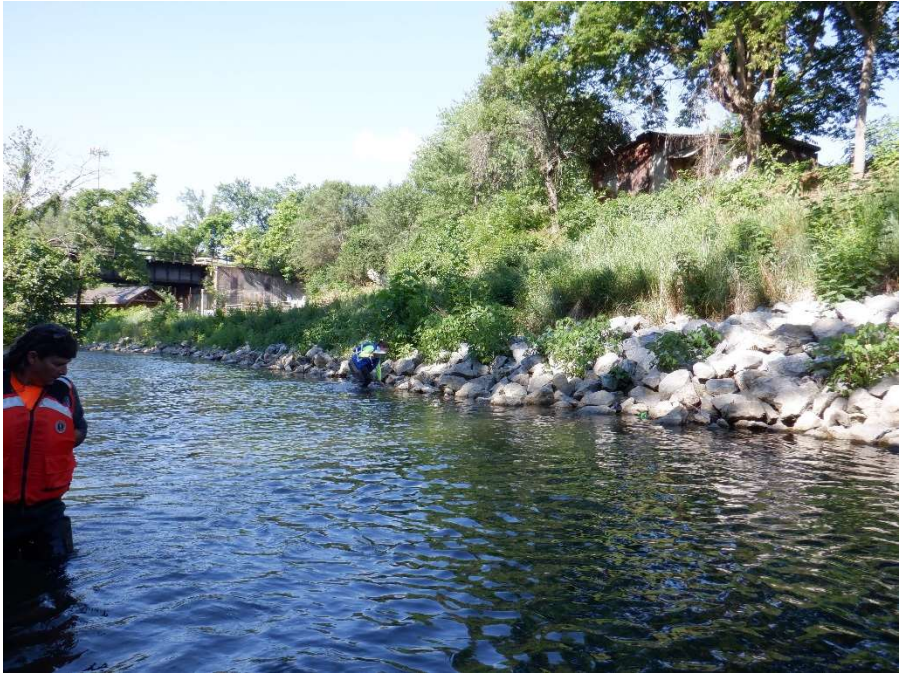
**Location:**  
00+250'

**Description:**  
~55 degree bank angle; Lower bank; ~45 degrees Upper bank; ~65 degrees Above GW; ~70 degrees; Herbaceous vegetation establishing; live stakes establishing; herbaceous vegetation establishing above Greenway; planted saplings and shrubs intact; minimal invasive knotweed establishing in rock toe; No trees adjacent to edge of water; No erosion control fabric or geocell exposed due to dense herbaceous vegetation cover. Greenway is intact. Drainage pipe to river; Evidence of sediment deposition.

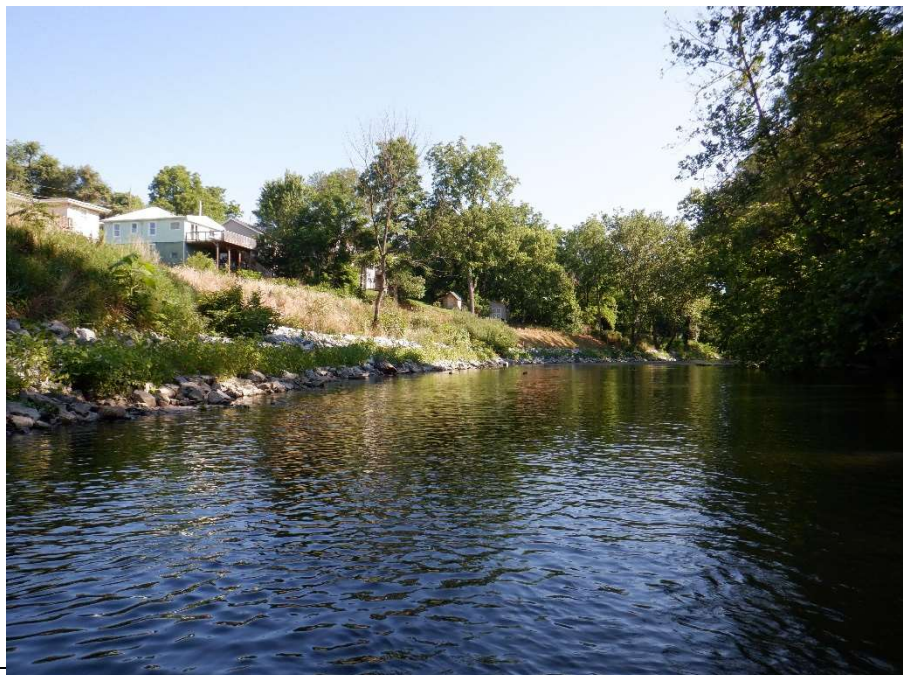
**Location:**  
00+250'

**Description:**  
No erosion control fabric or geocell exposed due to dense herbaceous vegetation cover. Greenway is intact. Drainage pipe to river; Evidence of sediment deposition.

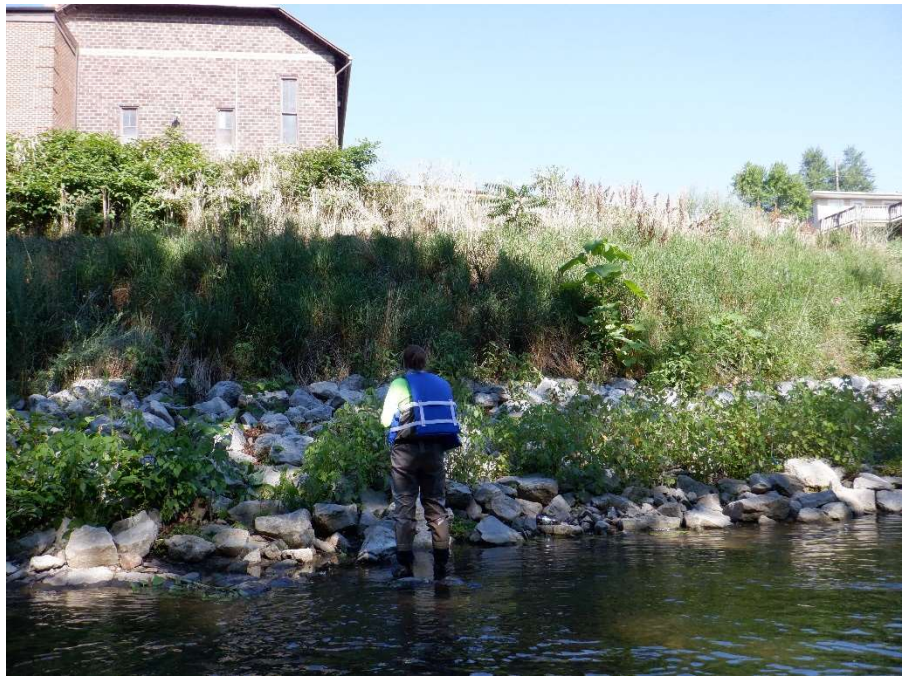
<p><b>Location:</b> 00+300'</p> <hr/> <p><b>Photo Number:</b>      <b>Date:</b> 15                      6/23/2021</p> <hr/> <p><b>Direction Photo Taken:</b> North</p> <hr/> <p><b>Description:</b> ~ 65 degree bank angle; Lower bank; ~45 degrees Upper bank; ~80 degrees Above GW; ~70 degrees; Herbaceous vegetation establishing; live stakes establishing; grasses dominant above rock toe; herbaceous vegetation establishing above Greenway; planted saplings and shrubs intact; minimal invasive knotweed establishing in rock toe~2% cover; No trees adjacent to edge of water;</p>

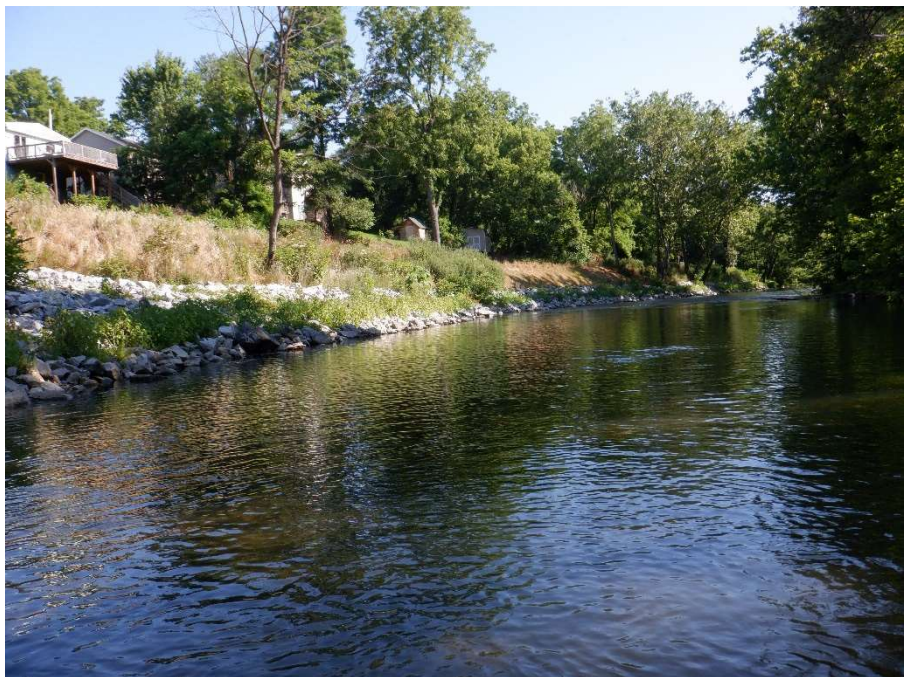
<p><b>Location:</b> 00+300'</p> <hr/> <p><b>Photo Title:</b>              <b>Date:</b> 16                      6/23/2021</p> <hr/> <p><b>Direction Photo Taken:</b> West</p> <hr/> <p><b>Description:</b> No erosion control fabric or geocell exposed due to dense herbaceous vegetation cover; Evidence of sediment deposition.</p>

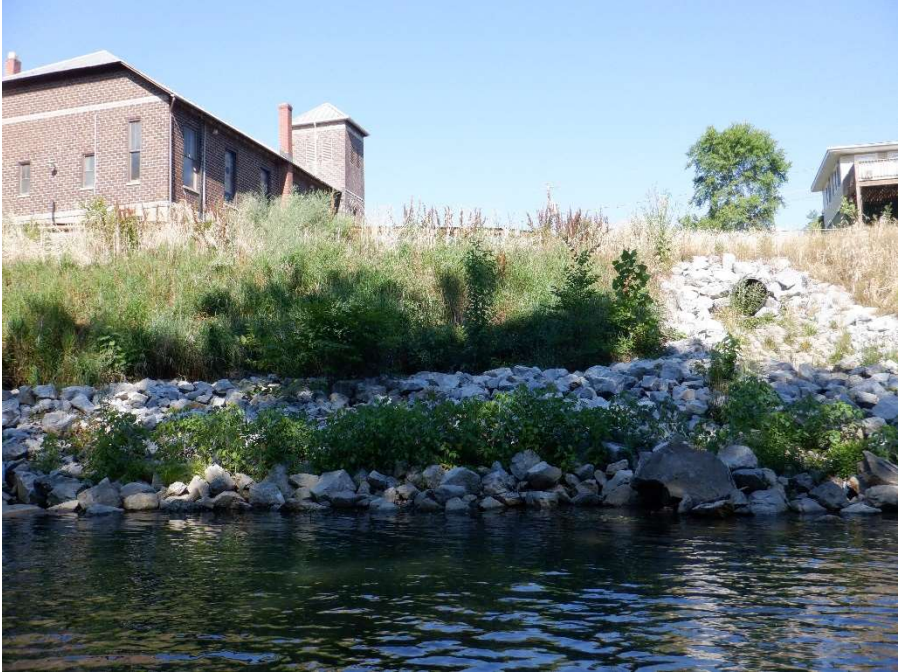
<p><b>Location:</b> 00+350'</p> <hr/> <p><b>Photo Number:</b>      <b>Date:</b> 17                              6/23/2021</p> <hr/> <p><b>Direction Photo Taken:</b> NA</p> <hr/> <p><b>Description:</b> ~ 50 degree bank angle; Grasses establishing around outfall; saplings and shrub plantings intact and establishing; grasses are dominant, jewelweed, elderberry, virginia creeper and elms; Invasive knotweed ~2% cover; No trees adjacent to edge of water; large plastic corrugated pipe and armorflex mat installed and intact; gravel deposition at outfall; sediment deposits at +325; no scour observed.</p>

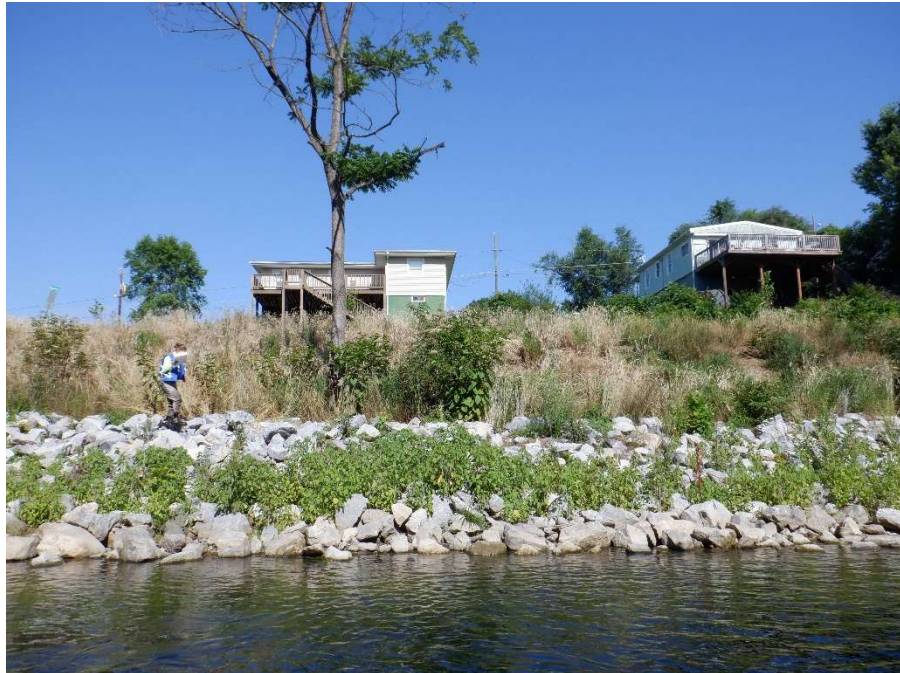
<p><b>Location:</b> 00+400'</p> <hr/> <p><b>Photo Title:</b>              <b>Date:</b> 18                              6/23/2021</p> <hr/> <p><b>Direction Photo Taken:</b> West</p> <hr/> <p><b>Description:</b> ~ 50 degree bank angle; Lower bank; ~45 degrees Upper bank; ~50 degrees; Dense herbaceous vegetation established; saplings and shrub plantings intact and establishing; pokeberry, Black walnut, box elder, sycamore saplings, no knotweed; No at-risk trees present</p>
