**Re: 2021 Leaf-on and Leaf-off Maintenance Inspections  
Former DuPont Waynesboro Site AOC 4  
Waynesboro, Virginia  
EPA ID# VAD003114832**

## Memorandum

Subject 2021 Leaf-on Maintenance Inspection  
Former DuPont Waynesboro Site, Area of Concern 4

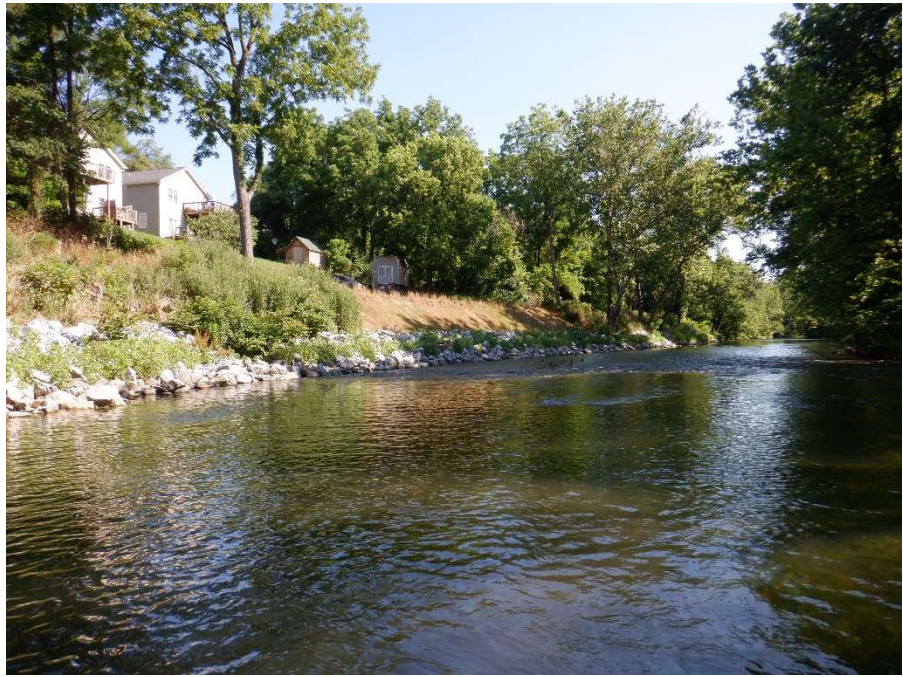
**Location:**  
00+400'

**Description:**  
No erosion control fabric or geocell exposed due to dense herbaceous vegetation cover; Evidence of sediment deposition between rocks

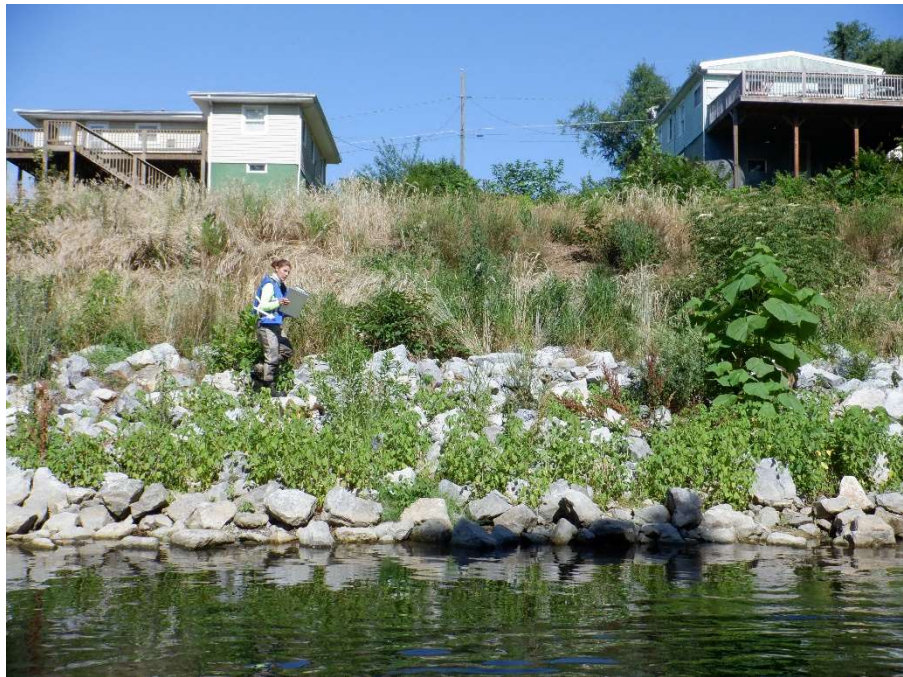
**Location:**  
00+450'

**Description:**  
~ 50 degree bank angle; Lower bank; ~45 degrees  
Upper bank; ~55 degrees  
Dense herbaceous vegetation established; saplings and shrub plantings intact and establishing; grasses are dominant; Elderberry is dominant in shrub stratum; sparse knotweed in rock toe  
~1% cover.

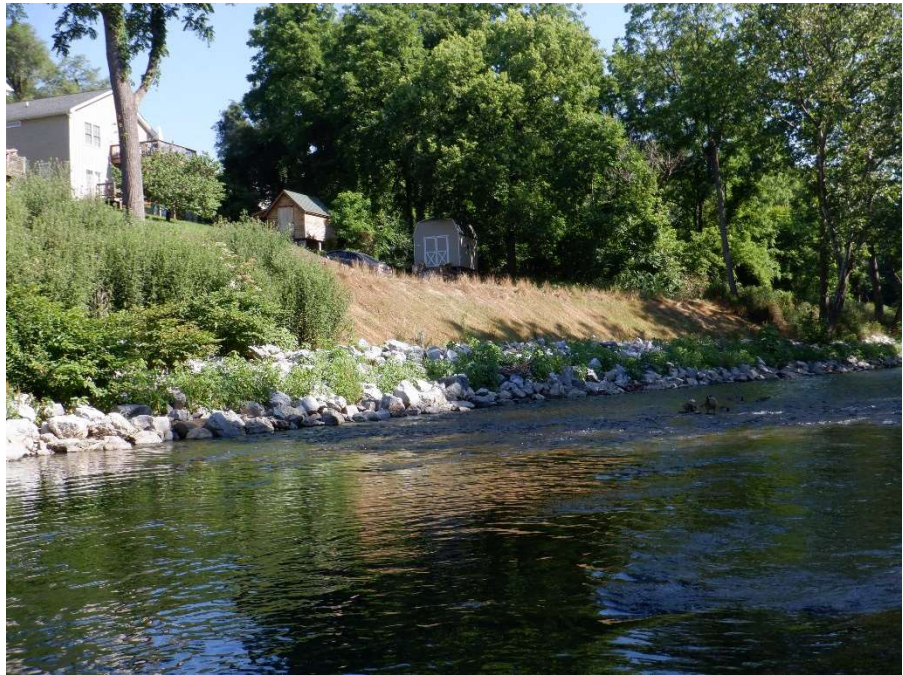
**Location:**  
00+450'

**Description:**  
Patches of exposed soil. Catalpa saplings adjacent to edge of water- could possibly be at risk in the future. No erosion control fabric or geocell exposed due to dense herbaceous vegetation cover. Evidence of sediment deposition. Patches of exposed soil on bank.

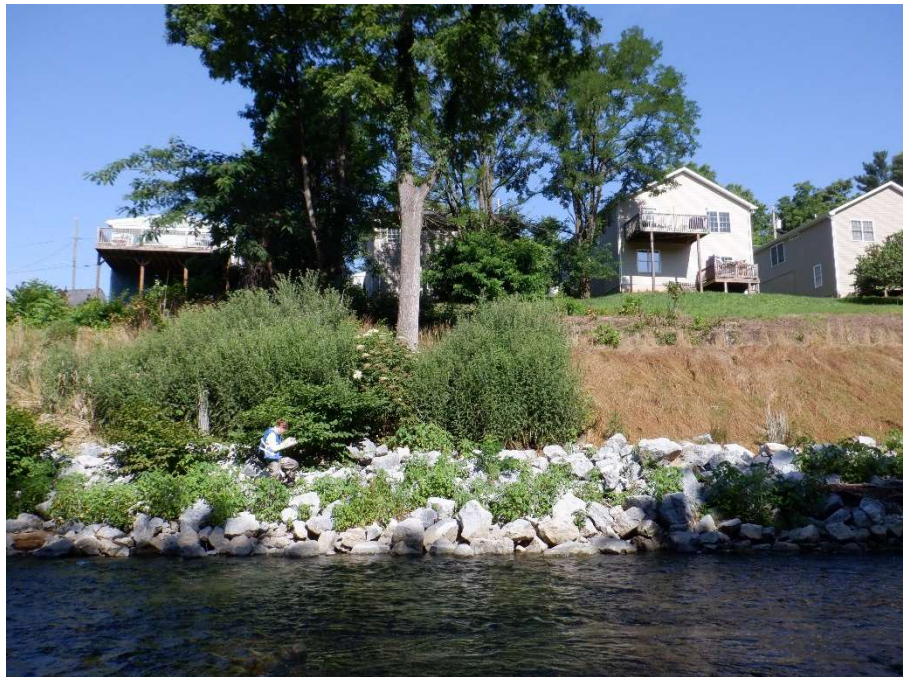
**Location:**  
00+500'

**Description:**  
~ 55 degree bank angle; Lower bank; ~45 degrees Upper bank; ~65 degrees; Dense herbaceous vegetation established; saplings and shrub plantings intact and establishing; No livestock growth; Elderberry ~10% cover; Thistle ~60% cover; Knotweed extent is at 35% cover; No at-risk trees present; No erosion control fabric or geocell exposed due to dense herbaceous vegetation cover; Evidence of sediment deposition.

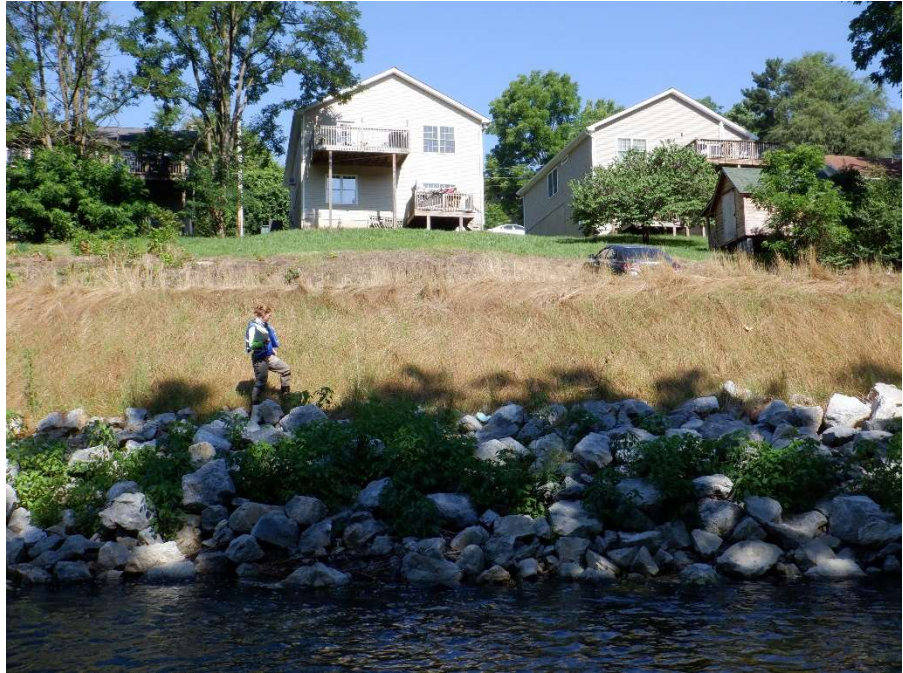
**Location:**  
00+550'

**Description:**  
~ 65 degree bank angle; Lower bank; ~60 degrees Upper bank; ~70 degrees; Dense herbaceous vegetation establishing, grasses are dominant; jewelweed at toe of slope; bank failed in 2020- was repaired and replanted with grass mix; No trees adjacent to edge of water; No erosion control fabric or geocell exposed due to dense herbaceous vegetation cover; Evidence of sediment deposition

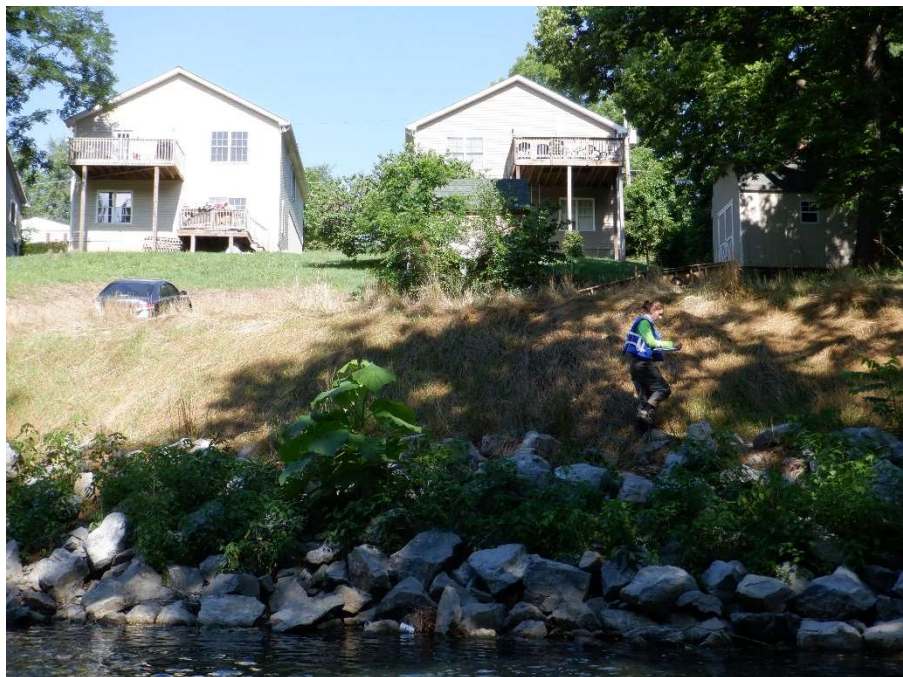
**Location:**  
00+600'

**Description:**  
~ 45 degree bank angle; Dense herbaceous vegetation establishing; saplings and shrub plantings intact and establishing-arrowwood Viburnum; sparse knotweed in rock toe; Black walnuts and sycamore; jewelweed at toe of slope; Possible sycamore at future risk adjacent to edge of water; No erosion control fabric or geocell exposed due to dense herbaceous vegetation cover; Evidence of sediment deposition

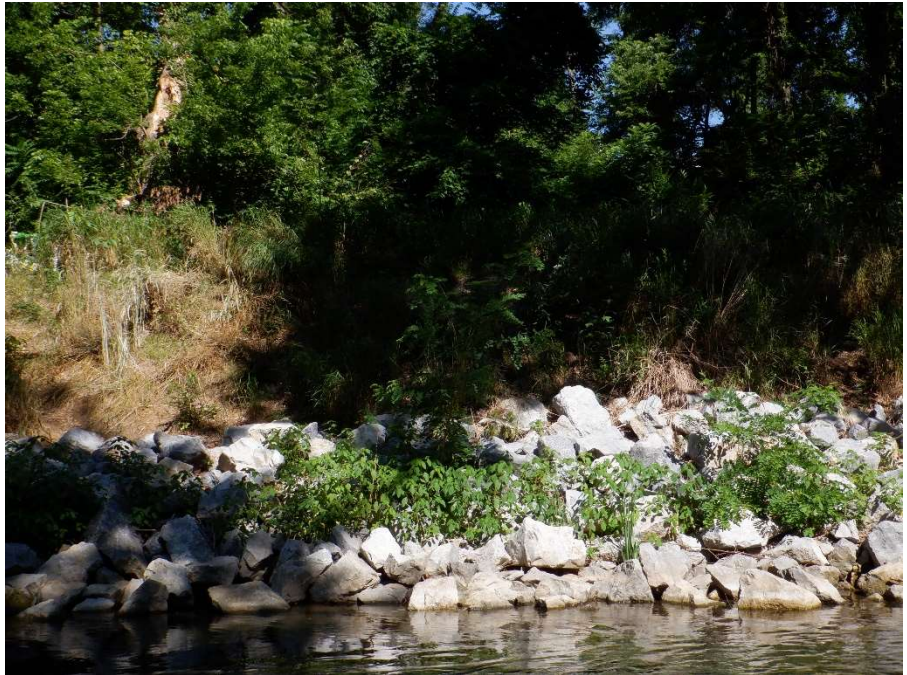
<p><b>Location:</b> 00+700'</p> <hr/> <p><b>Photo Title:</b>              <b>Date:</b> 26                              6/23/2021</p> <hr/> <p><b>Direction Photo Taken:</b> West</p> <hr/> <p><b>Description:</b> ~ 50 degree bank angle; Herbaceous vegetation establishing; saplings and shrub plantings intact and establishing; slight scour on bank; Jewelweed and grasses dominant; 1% honeysuckle; willow livestakes establishing; No at risk trees.</p>

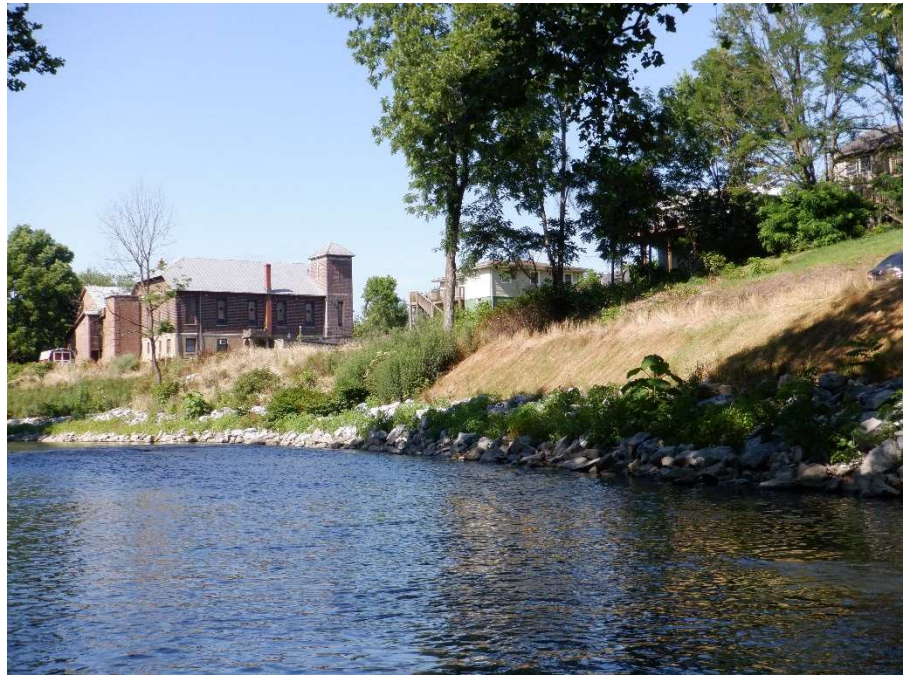
**Location:**  
00+700'

**Description:**  
No erosion control fabric or geocell exposed due to dense herbaceous vegetation cover. Surface water runoff at top of bank; Evidence of sediment deposition

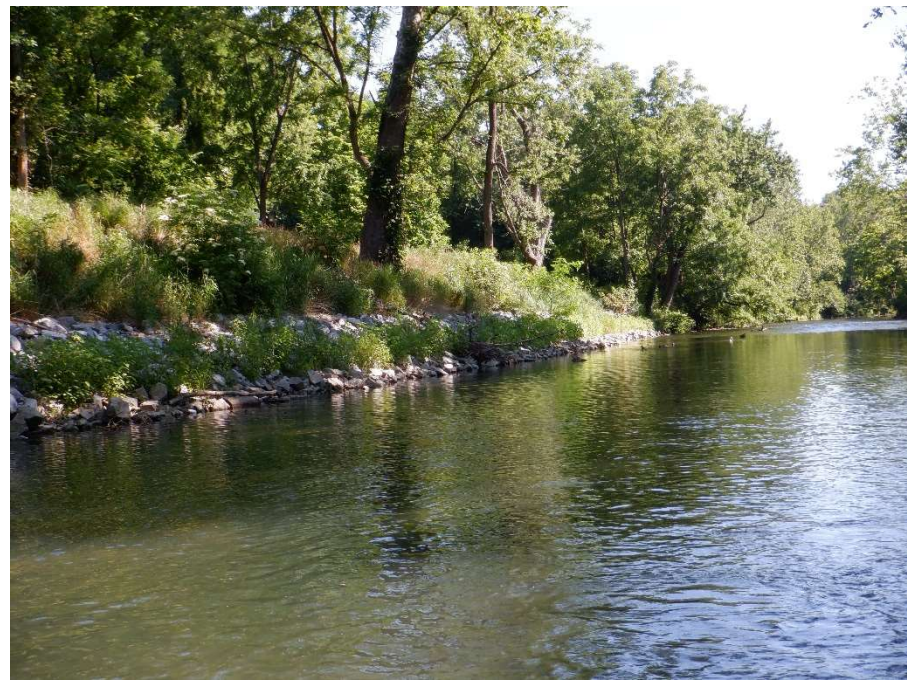
**Location:**  
00+700'

**Description:**  
~ 50 degree bank angle;  
Herbaceous vegetation establishing; saplings and shrub plantings intact and establishing; slight scour on bank; Jewelweed and grasses dominant; 1% honeysuckle; willow livestakes establishing; No at risk trees.

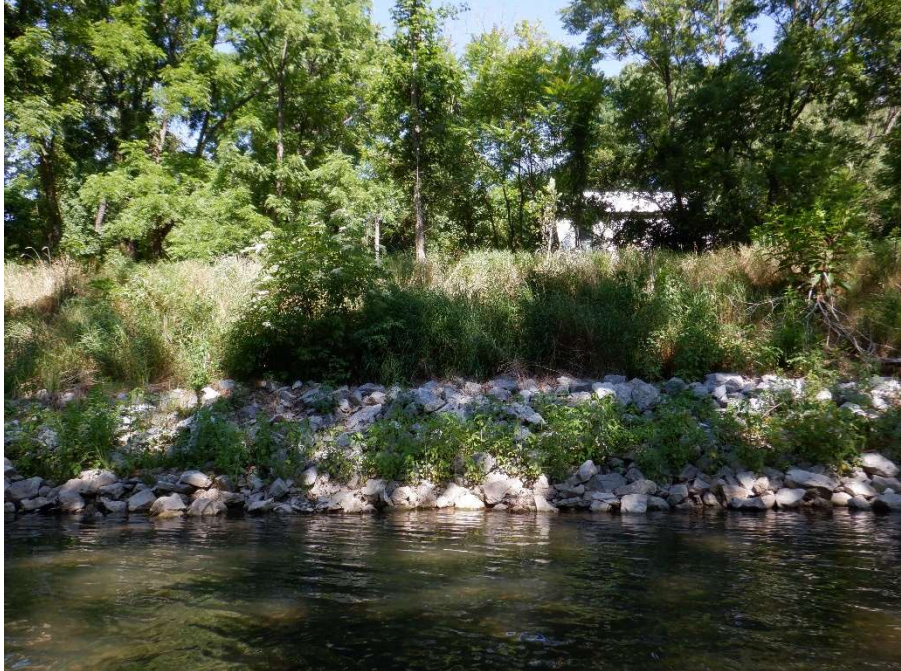
<p><b>Location:</b> 00+800'</p> <hr/> <p><b>Photo Title:</b>              <b>Date:</b> 30                              6/23/2021</p> <hr/> <p><b>Direction Photo Taken:</b> West</p> <hr/> <p><b>Description:</b> ~ 65 degree bank angle; Dense herbaceous vegetation established; grasses are dominant; no livestakes observed; jewelweed ~25% cover; saplings and shrub plantings intact and establishing; sparse knotweed in rock toe; No at-risk trees present; No erosion control fabric or geocell exposed due to dense herbaceous vegetation cover</p>

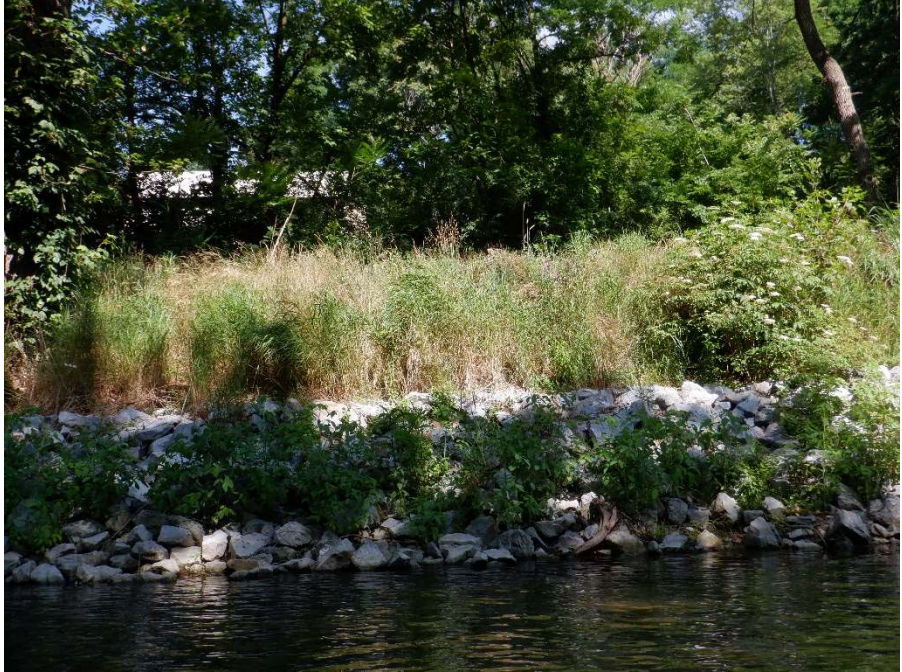
<p><b>Location:</b> 00+850'</p> <hr/> <p><b>Photo Number:</b>      <b>Date:</b> 31                              6/23/2021</p> <hr/> <p><b>Direction Photo Taken:</b> West</p> <hr/> <p><b>Description:</b> ~ 65 degree bank angle; Dense herbaceous vegetation established; grasses are dominant; elms, honeysuckle, jewelweed, goldenrod, pokeberry, elderberry; saplings and shrub plantings intact and establishing; Possible sycamore at future risk, adjacent to edge of water; No erosion control fabric or geocell exposed due to dense herbaceous vegetation cover. Rock toe intact; Evidence of sediment deposition</p>

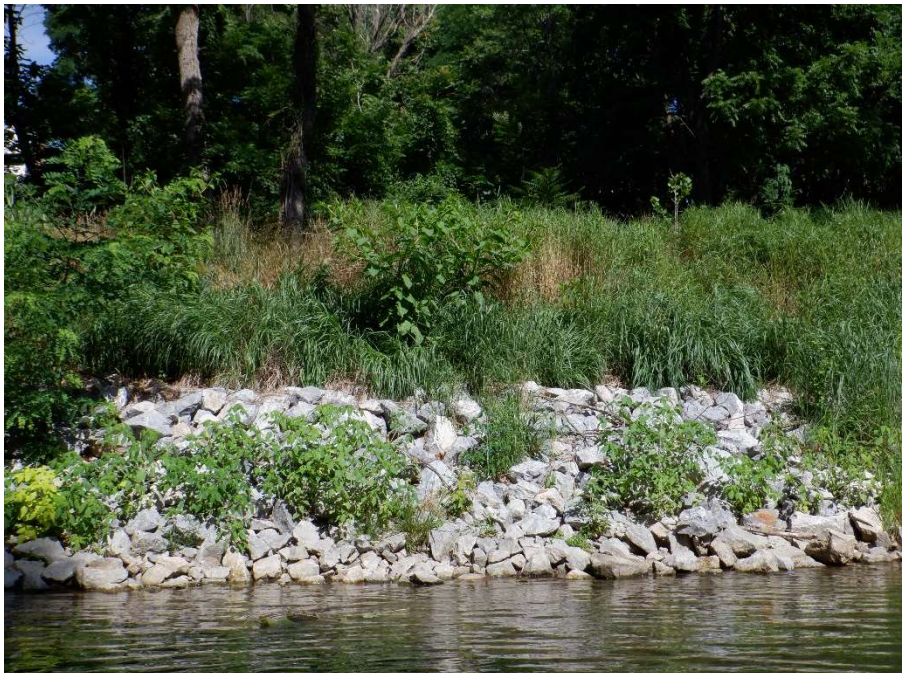
<p><b>Location:</b> 00+900'</p> <hr/> <p><b>Photo Title:</b>              <b>Date:</b> 32                              6/23/2021</p> <hr/> <p><b>Direction Photo Taken:</b> West</p> <hr/> <p><b>Description:</b> ~ 70 degree bank angle; Dense herbaceous vegetation established; grasses are 95% cover; 2 large black walnuts, locust sapling, pokeberry, jewelweed at toe; saplings and shrub plantings intact and establishing; No trees adjacent to edge of water; No erosion control fabric or geocell exposed due to dense herbaceous vegetation cover. No bare soil; Evidence of sediment deposition at toe of slope.</p>

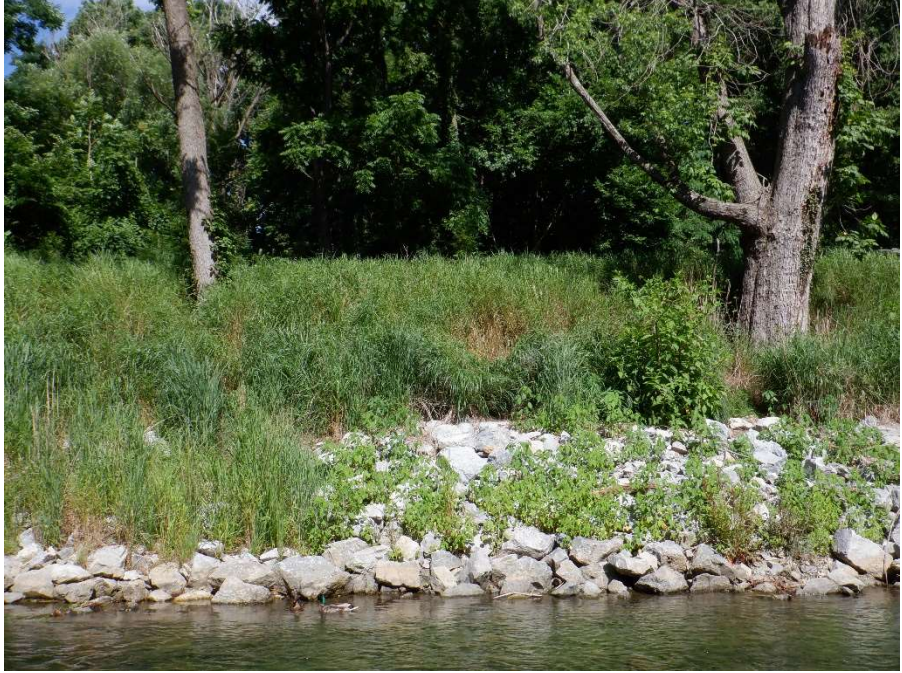
<p><b>Location:</b> 00+950'</p> <hr/> <p><b>Photo Number:</b>      <b>Date:</b> 33                              6/23/2021</p> <hr/> <p><b>Direction Photo Taken:</b> West</p> <hr/> <p><b>Description:</b> ~ 65 degree bank angle; Lower bank; ~70 degrees Upper bank; ~60 degrees; Dense herbaceous vegetation established; grasses are dominant; jewelweed, pokeweed, large black walnut, silver maple, saplings and shrub plantings intact and establishing; sparse knotweed in rock toe; No at-risk trees present; No erosion control fabric or geocell exposed due to dense herbaceous vegetation cover; No evidence of sediment deposition</p>

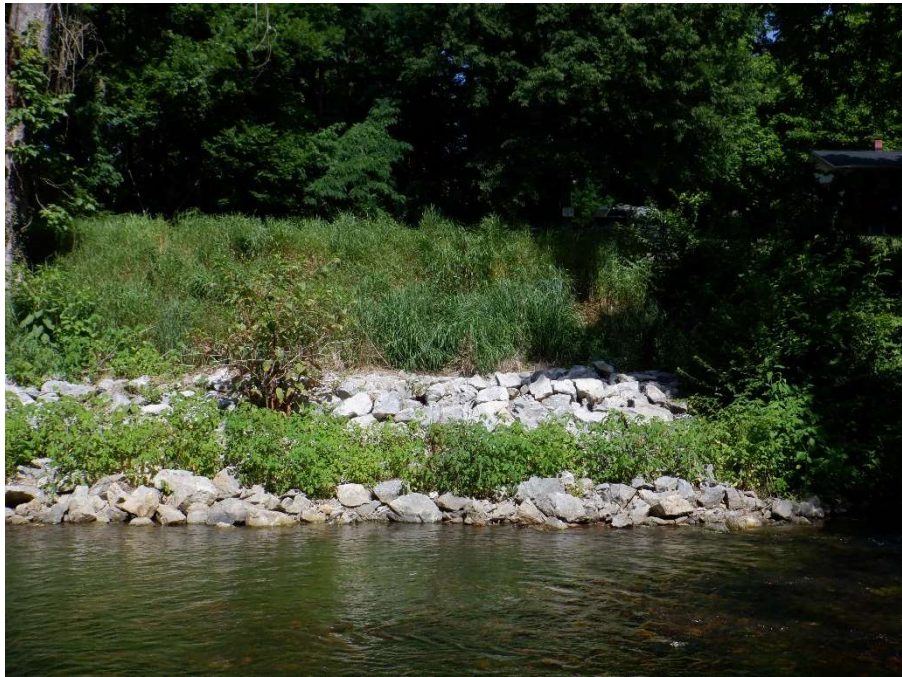
<p><b>Location:</b> 00+975'</p> <hr/> <p><b>Photo Title:</b>              <b>Date:</b> 34                              6/23/2021</p> <hr/> <p><b>Direction Photo Taken:</b> West</p> <hr/> <p><b>Description:</b> ~ 60 degree bank angle; end of remediation; Dense herbaceous vegetation established; non remediated area has established vegetative cover- sycamore saplings, chokeberry, boneset, honeysuckle, grasses are dominant</p>

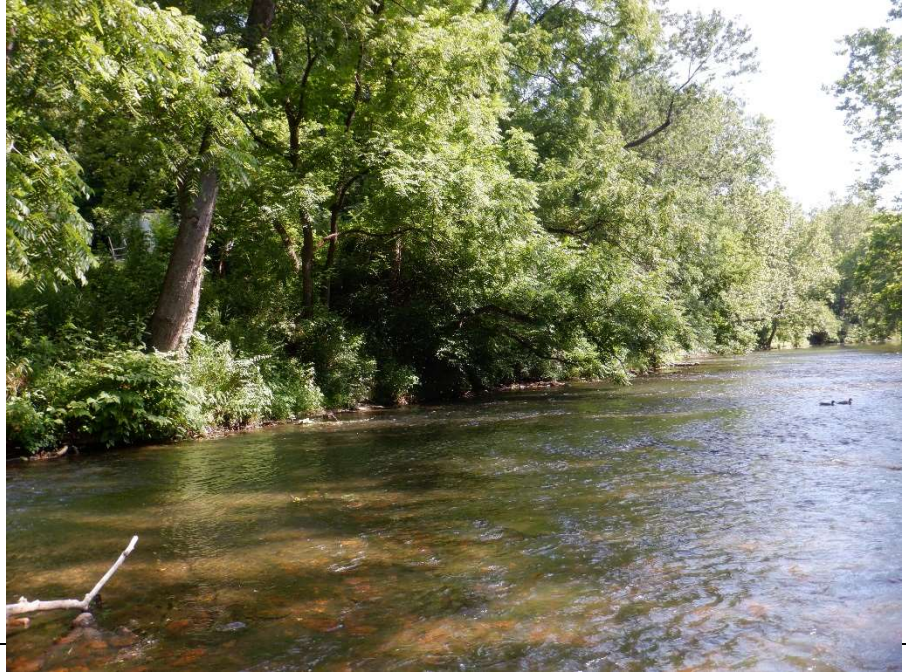
**Description:**  
~ 60 degree bank angle;  
downstream view of location; .  
No knotweed; Exposed roots  
and at risk trees present  
downstream of remediation; No  
erosion control fabric or geocell  
exposed due to dense  
herbaceous vegetation cover  
within remediation; No  
evidence of sediment  
deposition; scour present  
downstream of remediation.

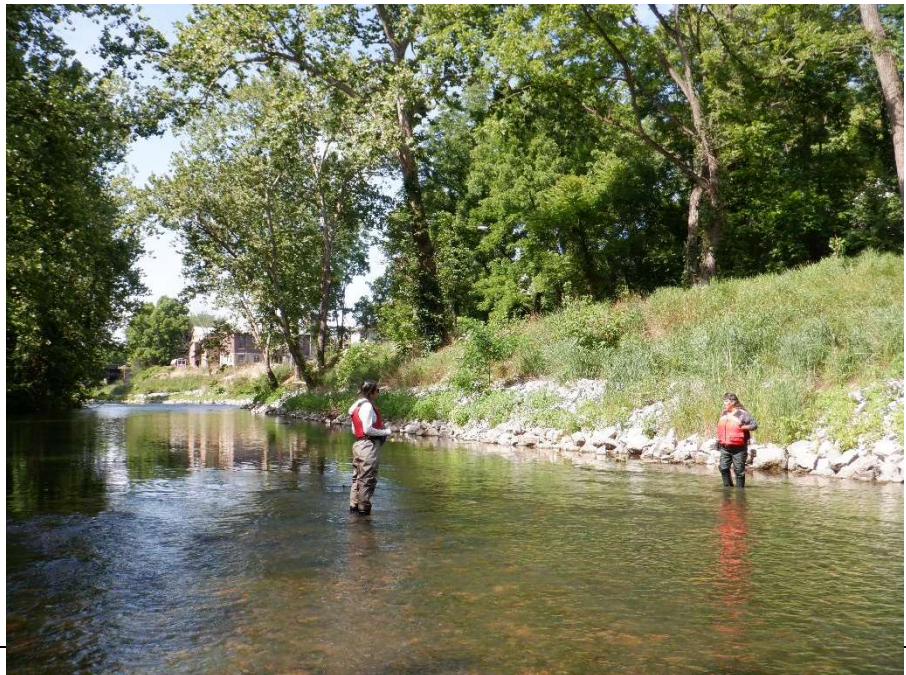
**Description:**  
~ 60 degree bank angle;  
upstream view of location;  
end of remediation(dense  
herbaceous vegetation  
establishing and sparse  
knotweed in rock toe within  
remediated area)

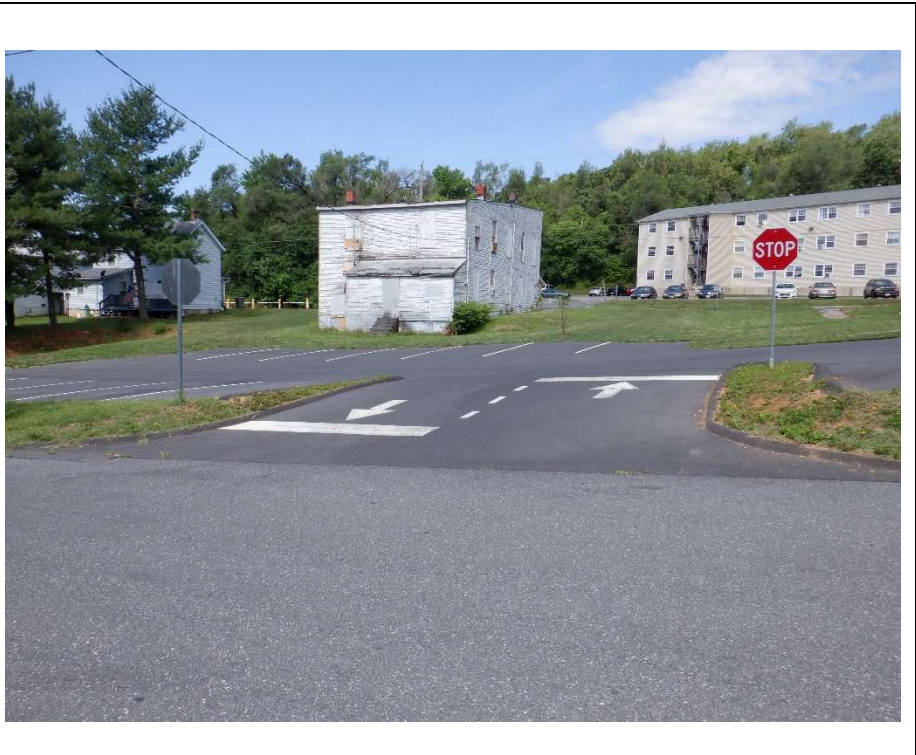
**Description:**  
No exposed roots around parking lot; shrubs, herbaceous vegetation, and grasses growing around perimeter and are being maintained except around the south edge; no trees around perjimeter of parking lot; parking lot and stairway intact.

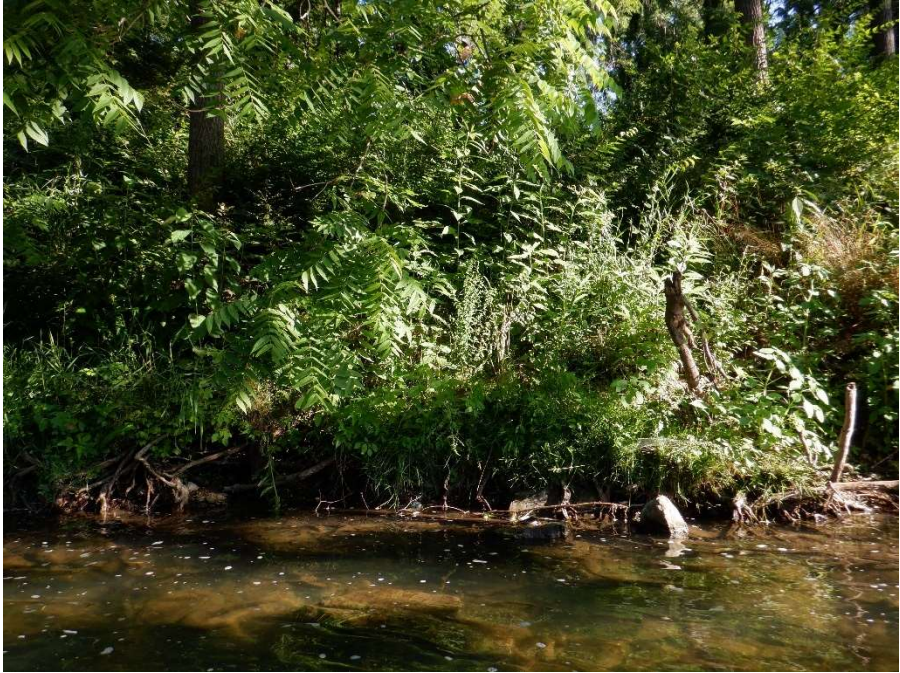
<p><b>Location:</b> 00-25'</p> <hr/> <p><b>Photo Number:</b>      <b>Date:</b> 1                              6/23/2021</p> <hr/> <p><b>Direction Photo Taken:</b> Northwest</p> <hr/> <p><b>Description:</b> ~ 60 degree bank angle; upper Bank: 30 degrees- bank: 70 degrees - lower bank: 20 degrees; unremiated portion; roots exposed at toe of slope; honeysuckle bush, 3 mature walnut trees; wingstem, patches of exposed soil; no at risk trees; scour present at toe of slope.</p>

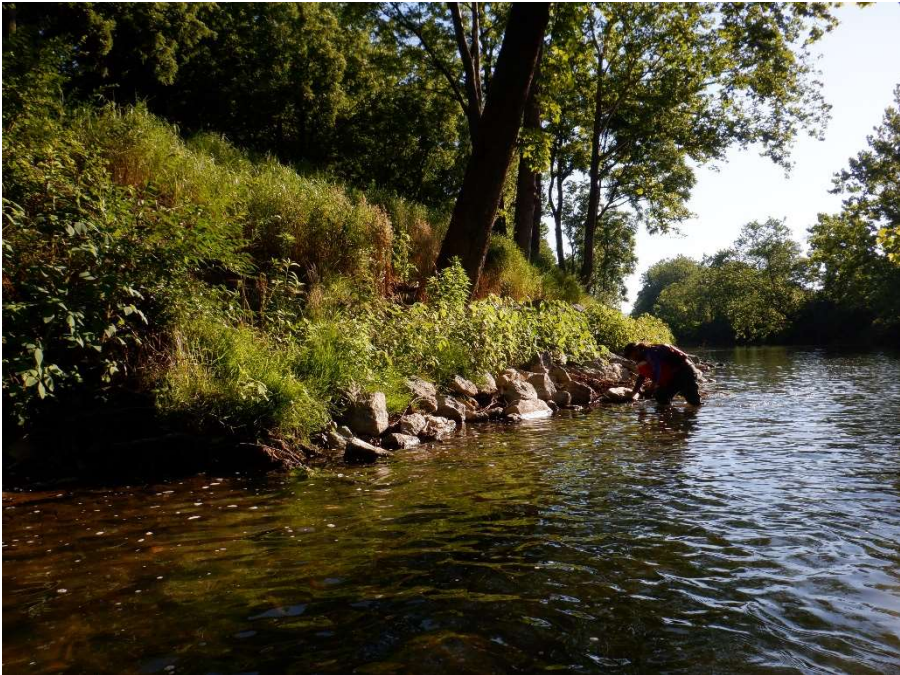
<p><b>Location:</b> 00-25'</p> <hr/> <p><b>Photo Title:</b>              <b>Date:</b> 2                              6/23/2021</p> <hr/> <p><b>Direction Photo Taken:</b> North</p> <hr/> <p><b>Description:</b> ~ 60 degree bank angle; downstream view of location; upper Bank: 30 degrees-bank: 70 degrees - lower bank: 20 degrees; unremiated portion; roots exposed at toe of slope; patches of exposed soil; no at risk trees; scour present at toe of slope.</p>

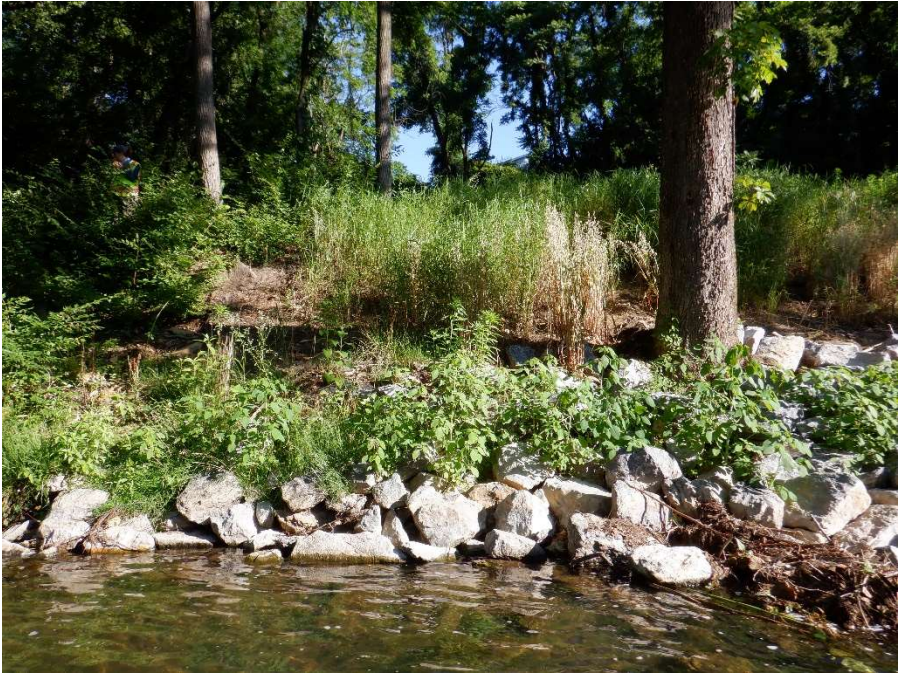
<p><b>Location:</b> 00+00</p> <hr/> <p><b>Photo Number:</b>      <b>Date:</b> 3                              6/23/2021</p> <hr/> <p><b>Direction Photo Taken:</b> Northwest</p> <hr/> <p><b>Description:</b> ~ 50 degree bank angle; upper bank: 10 degrees- bank: 70 degrees - lower Bank: 20 degrees; no exposed roots; no knotweed present; grasses are dominant ~75-80% cover, black walnuts and sycamore also present; sycamore is possibly at risk; patches of fabric visible; no scour.</p>

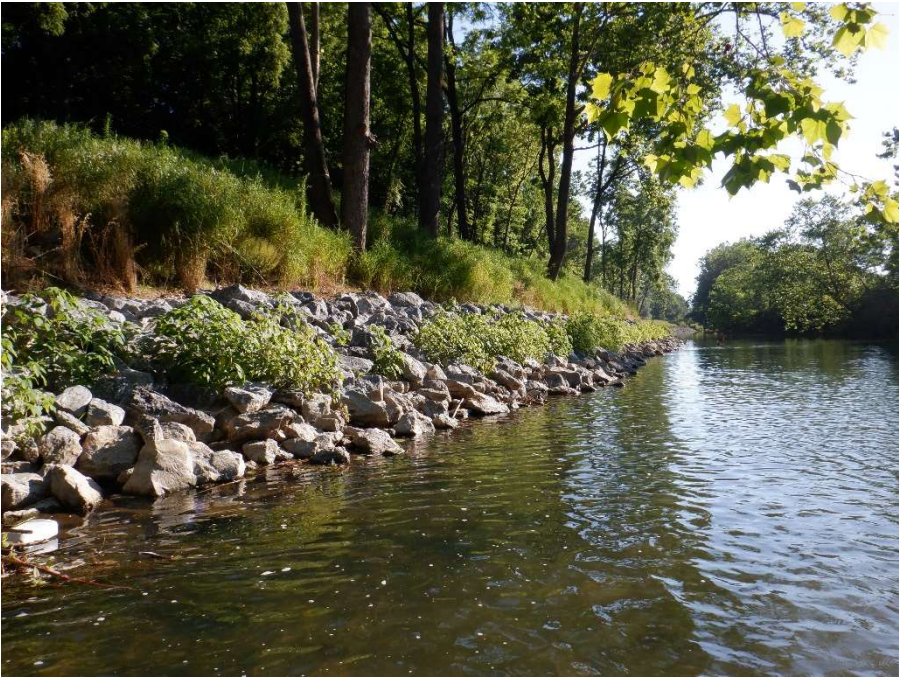
<p><b>Location:</b> 00+00</p> <hr/> <p><b>Photo Title:</b>              <b>Date:</b> 4                              6/23/2021</p> <hr/> <p><b>Direction Photo Taken:</b> North</p> <hr/> <p><b>Description:</b> ~ 50 degree bank angle; downstream view of location; upper bank: 10 degrees- bank: 70 degrees - lower Bank: 20 degrees; no exposed roots; no knotweed present; grasses are dominant ~75-80% cover, black walnuts and sycamore also present; sycamore is possibly at risk; patches of fabric visible; no scour.</p>

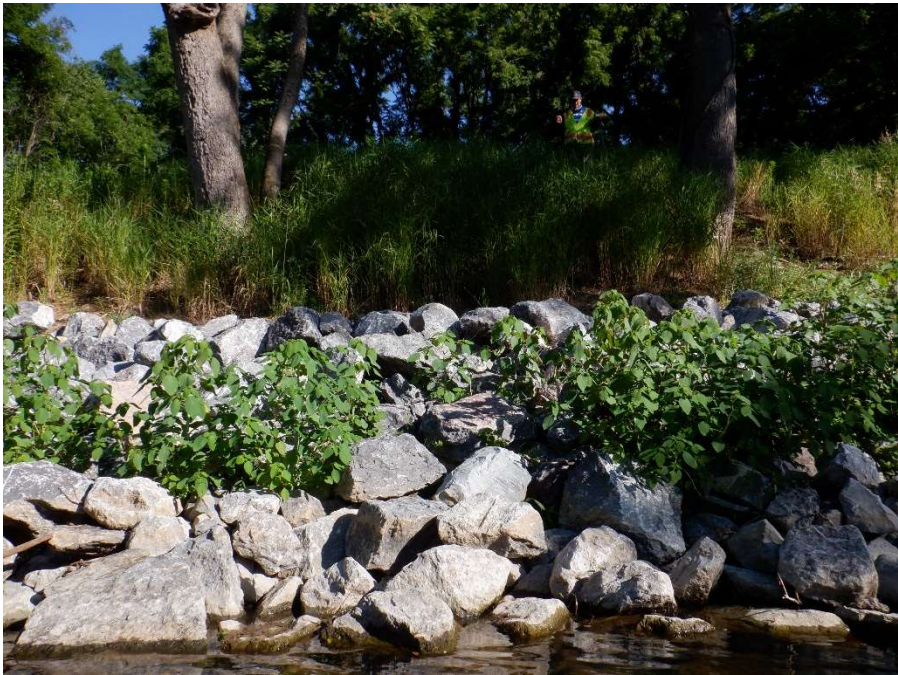
<p><b>Location:</b> 00+50'</p> <hr/> <p><b>Photo Number:</b>      <b>Date:</b> 5                              6/23/2021</p> <hr/> <p><b>Direction Photo Taken:</b> Northwest</p> <hr/> <p><b>Description:</b> ~ 40 degree bank angle; bank: 45 degrees - lower bank: 20 degrees; sycamore roots exposed; sewelweed is established at toe of slope; grasses are becoming established; no at risk trees; fabric exposed in large patches ~35%; no scour.</p>

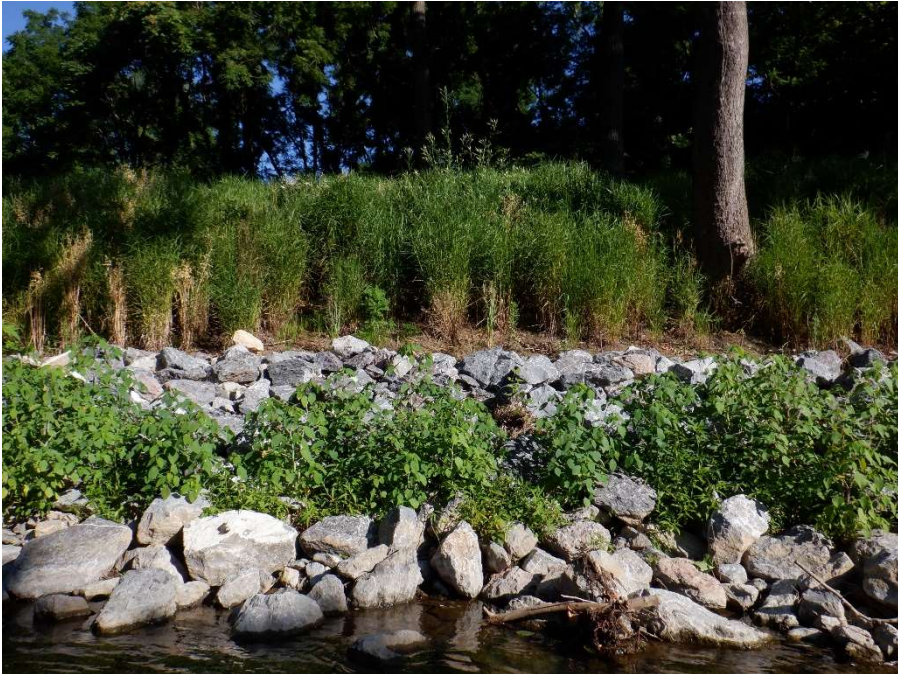
<p><b>Location:</b> 00+100'</p> <hr/> <p><b>Photo Title:</b>              <b>Date:</b> 6                                  6/23/2021</p> <hr/> <p><b>Direction Photo Taken:</b> Northwest</p> <hr/> <p><b>Description:</b> ~ 60 degree bank angle; lower bank: 10 degrees; no exposed roots; 3 Sycamores on bank, jewelweed at toe of slope; native grasses are dominant ~80% cover, goldenrods ~10%; no at risk trees; patches of exposed fabric ~15%; no scour.</p>

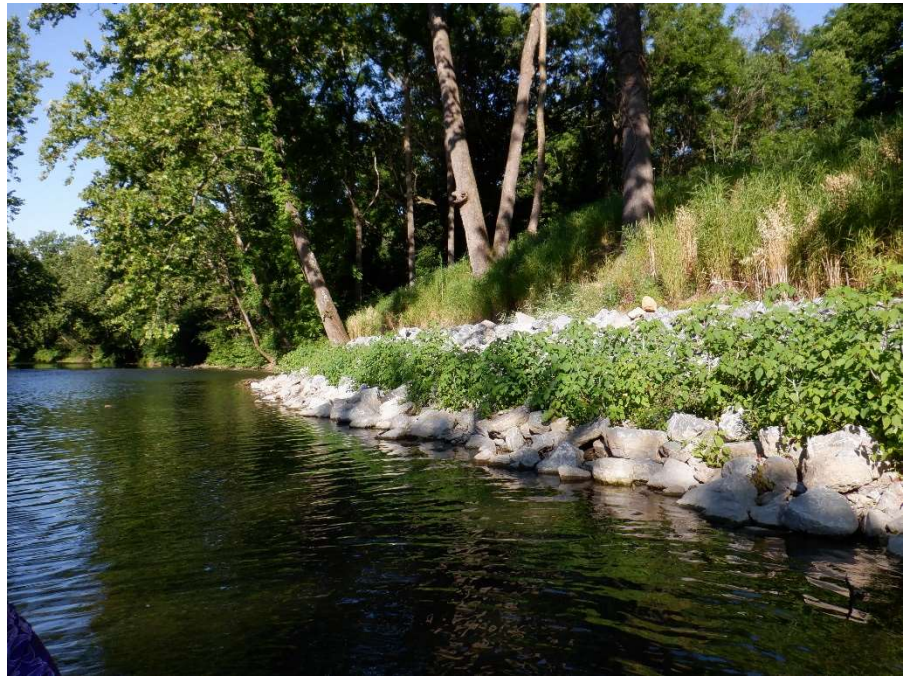
~ 60 degree bank angle;  
upstream view of location;  
bank: 60 degrees - lower  
bank: 10 degrees; no  
exposed roots; no at risk  
trees; patches of exposed  
fabric ~15%; no scour.

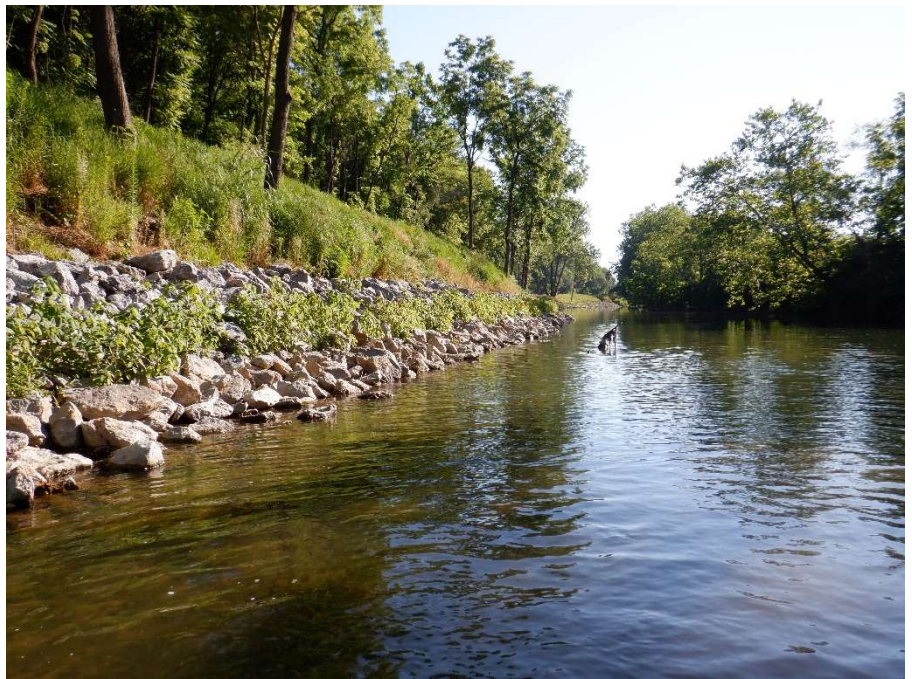
~ 60 degree bank angle;  
downstream view of location;  
lower bank: 10 degrees; no  
exposed roots; no at risk  
trees; patches of exposed  
fabric ~15%; no scour.

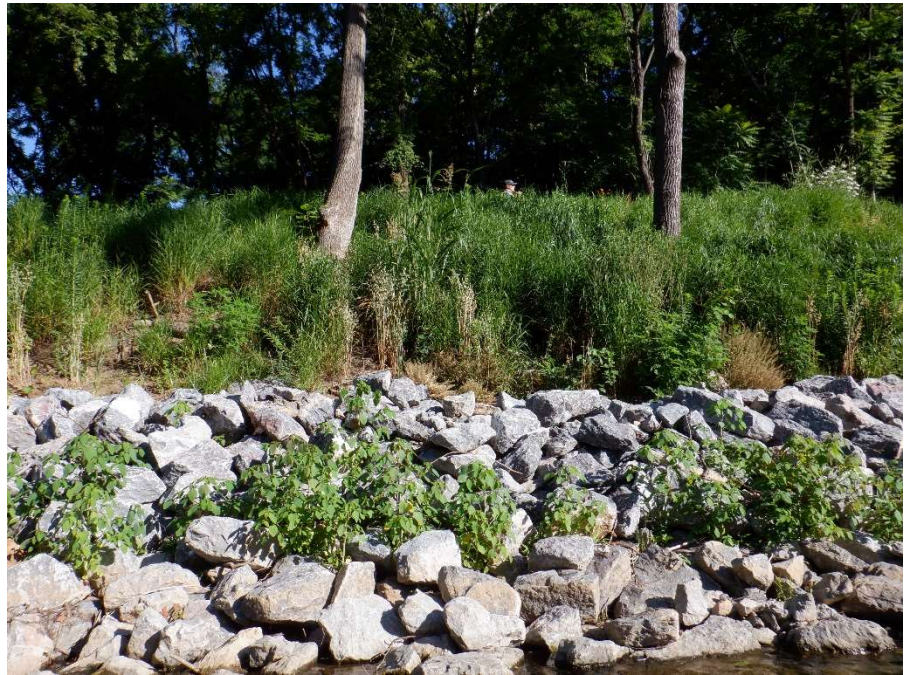
~ 60 degree bank angle; 10 degrees at toe of slope; Jewelweed at toe of slope; walnut and catalpa trees; native grasses are dominant-95% cover; no at risk trees; patches of geocell exposed ~5% overall; no exposed fabric; no scour.

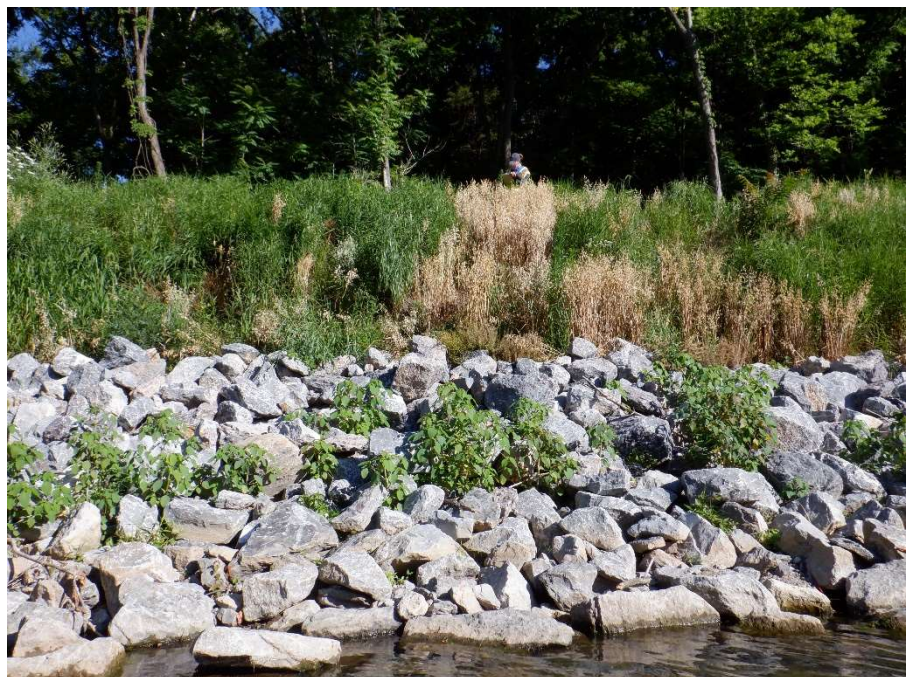
~ 60 degree bank angle; 10 degrees at toe of slope; oats ~50% cover, other grasses are 50% cover; jewelweed dominant at toe of slope; no trees present; patch of exposed soil/fabric ~5% overall; no scour.

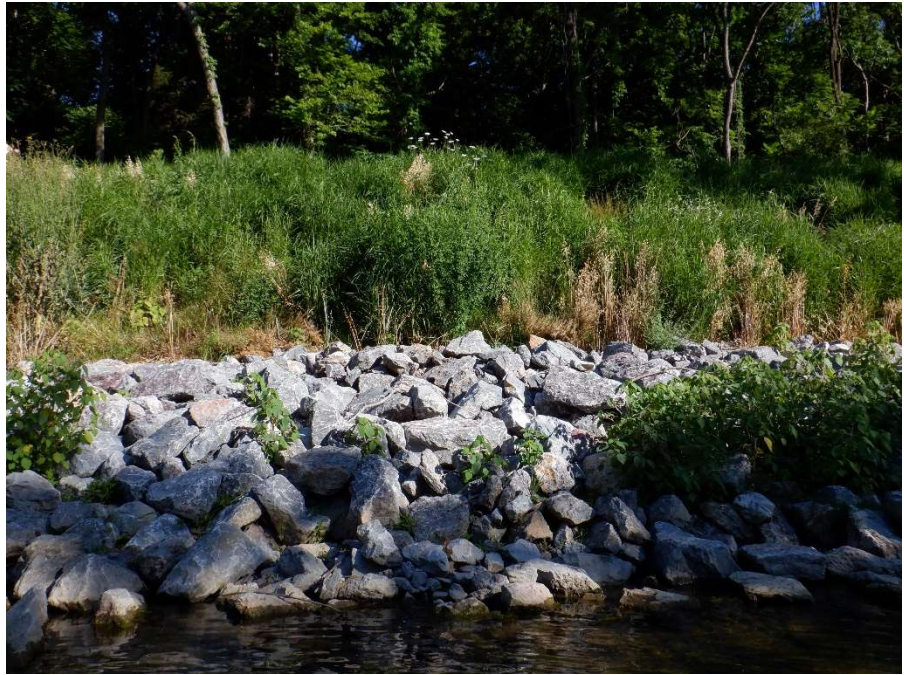
~ 60 degree bank angle; 10 degrees at toe of slope; grasses are dominant; no trees present; fabric exposed above rock toe 2% overall; 2% exposed on bank; no scour.

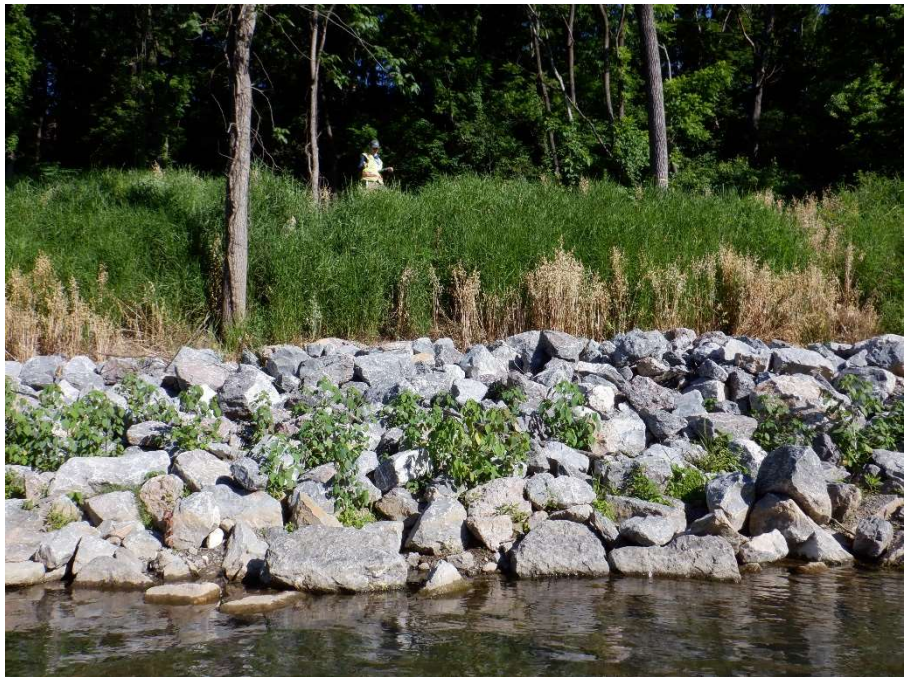
~ 60 degree bank angle; 10 degrees at toe of slope; black walnut tree with poison ivy vine, oats ~100% cover; jewelweed 10% cover at toe of slope; no at risk trees; exposed fabric ~10% overall at top of slope; no scour.

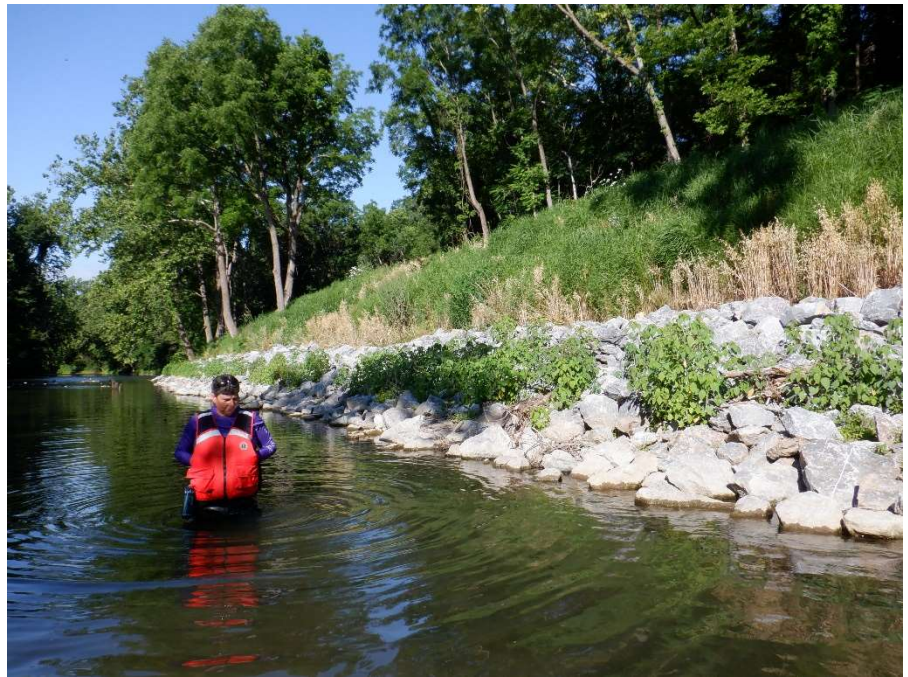
**Photo Number:** 13      **Date:** 6/23/2021

**Description:**  
~ 60 degree bank angle;  
upstream view of location; 10  
degrees at toe of slope; no at  
risk trees; exposed fabric  
~10% overall at top of slope;  
no scour.

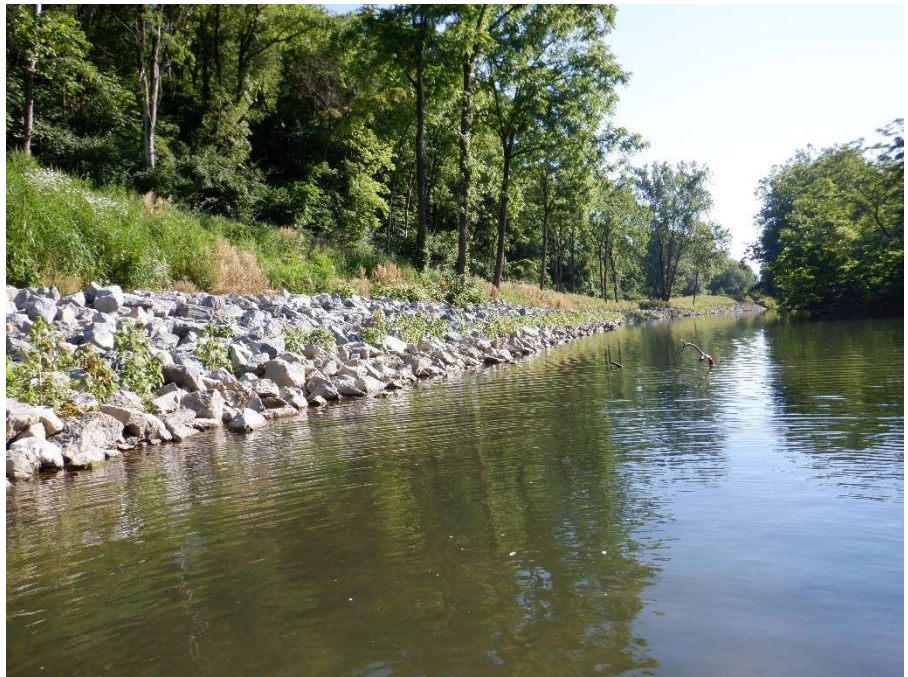
**Photo Title:** 14      **Date:** 6/23/2021

**Description:**  
~ 60 degree bank angle;  
downstream view of location;  
10 degrees at toe of slope; no  
at risk trees; exposed fabric  
~10% overall at top of slope;  
no scour.

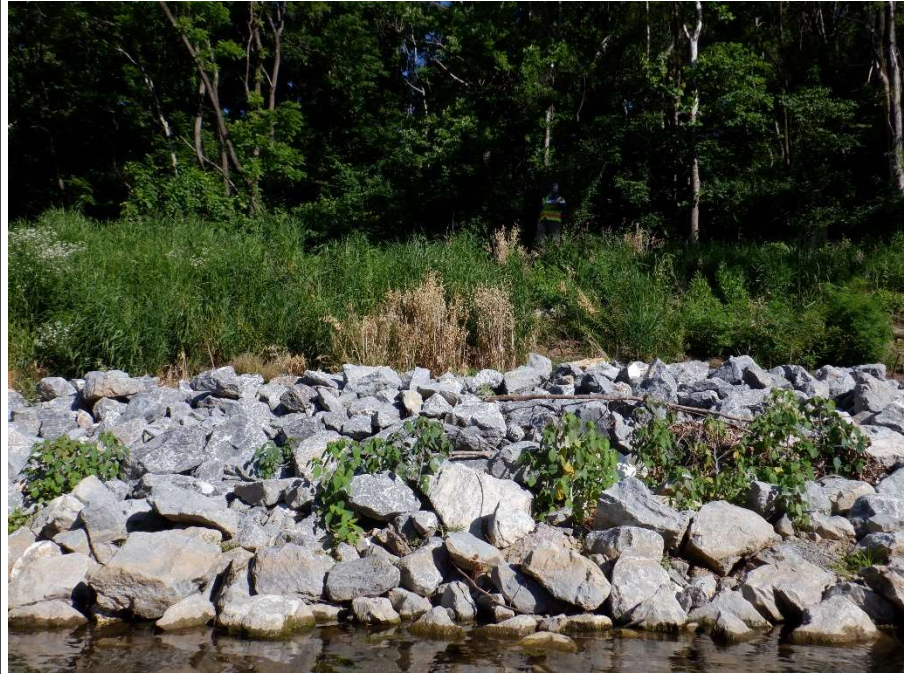
~ 50 degree bank angle; 25 degrees at toe of slope; oats are dominant, ~70% cover; large patches of exposed fabric; jewelweed at toe ~5% cover; no at risk trees; large patches of exposed fabric ~30% cover; no scour.
