**Re: 2021 Leaf-on and Leaf-off Maintenance Inspections  
Former DuPont Waynesboro Site AOC 4  
Waynesboro, Virginia  
EPA ID# VAD003114832**

## Memorandum

Subject 2021 Leaf-on Maintenance Inspection  
Former DuPont Waynesboro Site, Area of Concern 4

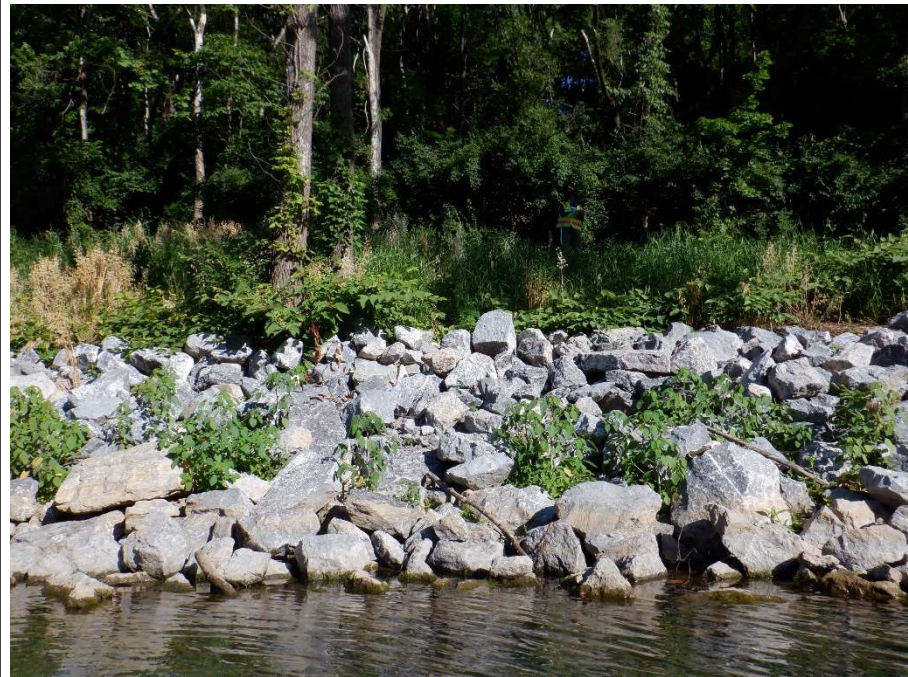
~ 40 degree bank angle; lower bank: 20 degrees; 3 walnut trees, invasive knotweed (10% cover overall) and poison ivy around based of walnuts; no at risk trees; exposed fabric ~20%; no scour.

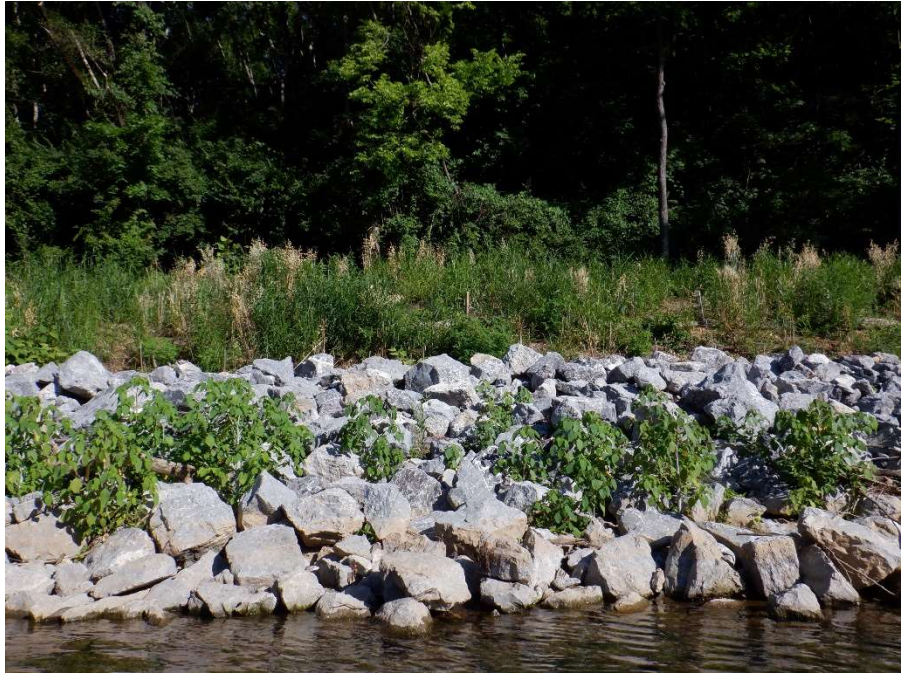
~ 30 degree bank angle;  
lower bank: 20 degrees;  
dominated by grasses,  
Jewelweed at toe ~25%  
cover, planted dogwoods are  
establishing, no growth on  
live stakes; no at risk trees;  
exposed coir log and fabric  
~15%; no scour.

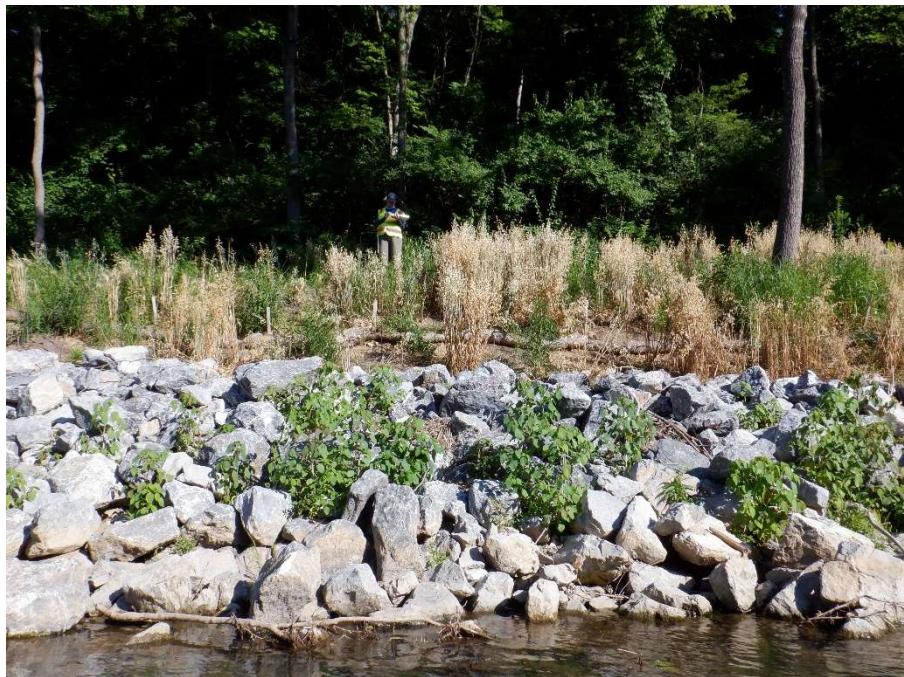
~ 45 degree bank angle;  
dominated by grasses,  
Jewelweed at toe ~5% cover,  
grasses are dominant;  
planted dogwoods and birch  
trees are establishing, no  
growth on live stakes; no at  
risk trees; exposed fabric on  
slope is ~45% cover; coir logs  
and stakes are also exposed;  
no scour.

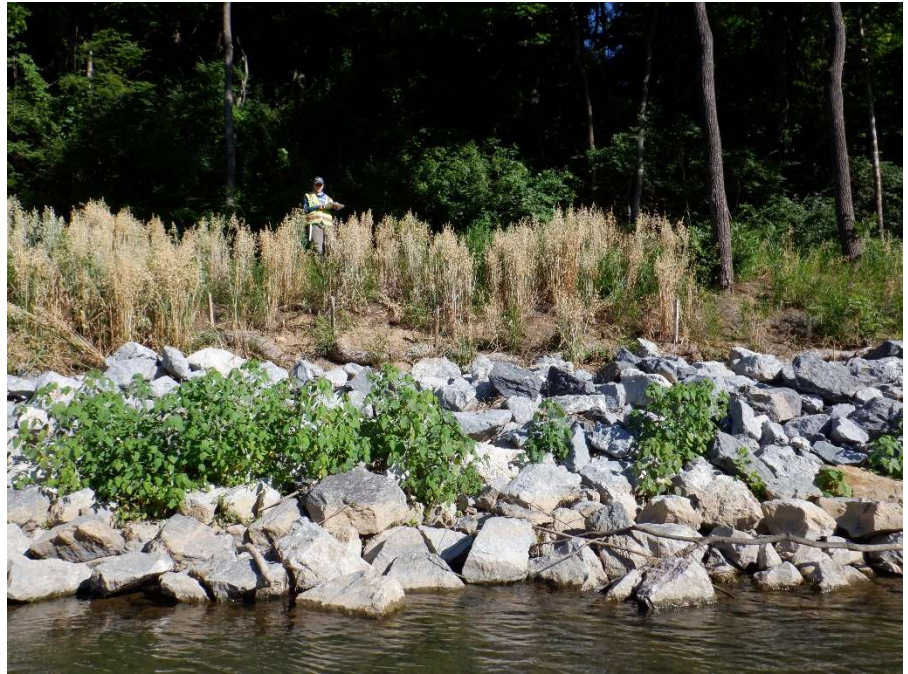
~ 40 degree bank angle;  
grasses are dominant ~60%  
cover; planted paw paw and  
red maple tree; some  
invasive honeysuckle  
establishing; exposed fabric  
~35% cover; no at risk trees;  
exposed fabric and coir log  
on slope ~35% cover; no  
scour.

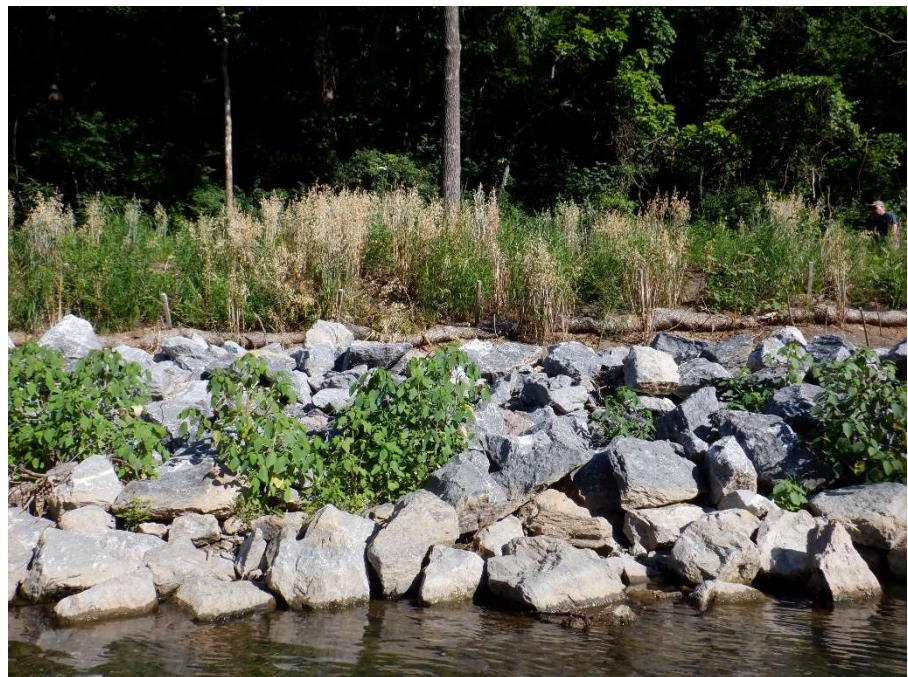
~ 45 degree bank angle;  
grasses ~45% cover on bank;  
black walnut tree; jewelweed  
established at toe of slope;  
planted birch tree; patches of  
invasive honeysuckle; no at  
risk trees; exposed fabric  
~50% cover; no scour.

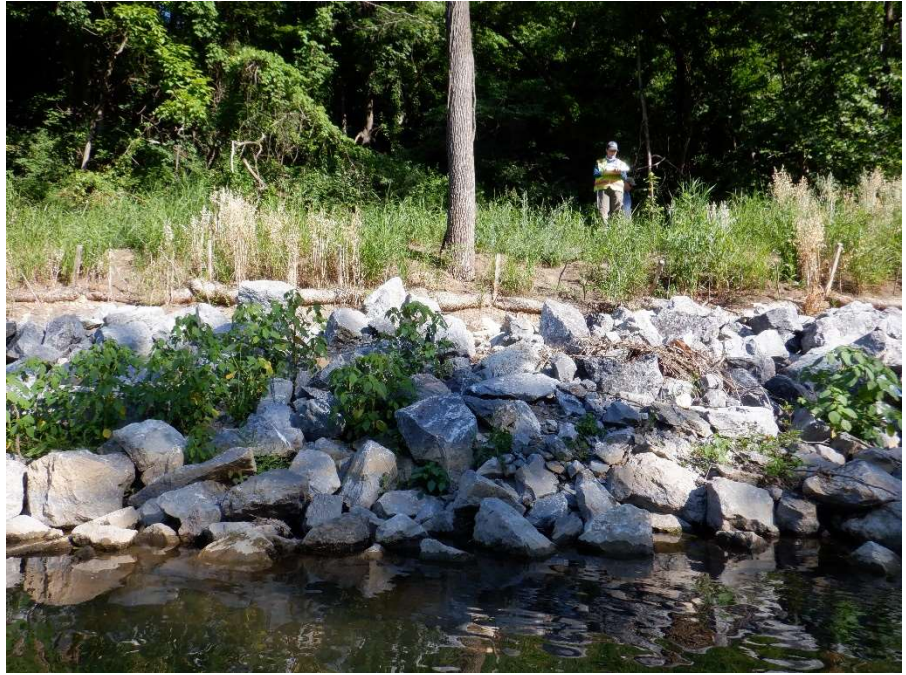
~ 45 degree bank angle;  
lower bank: 20 degrees; black  
walnut tree; planted red  
maple; no at risk trees;  
exposed fabric ~50% cover,  
coir log also exposed; no  
scour.

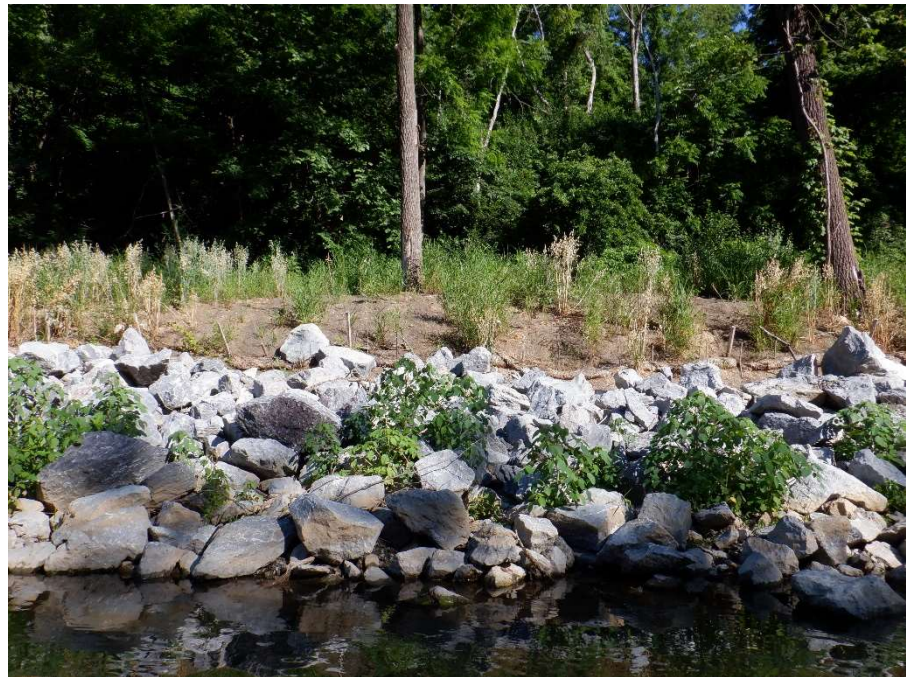
~ 45 degree bank angle;  
lower bank: 10 degrees; 2  
black walnuts with poison  
ivy; jewelweed ~15% cover at  
toe; grasses are dominant; no  
at risk trees; exposed fabric  
~70%; no scour.

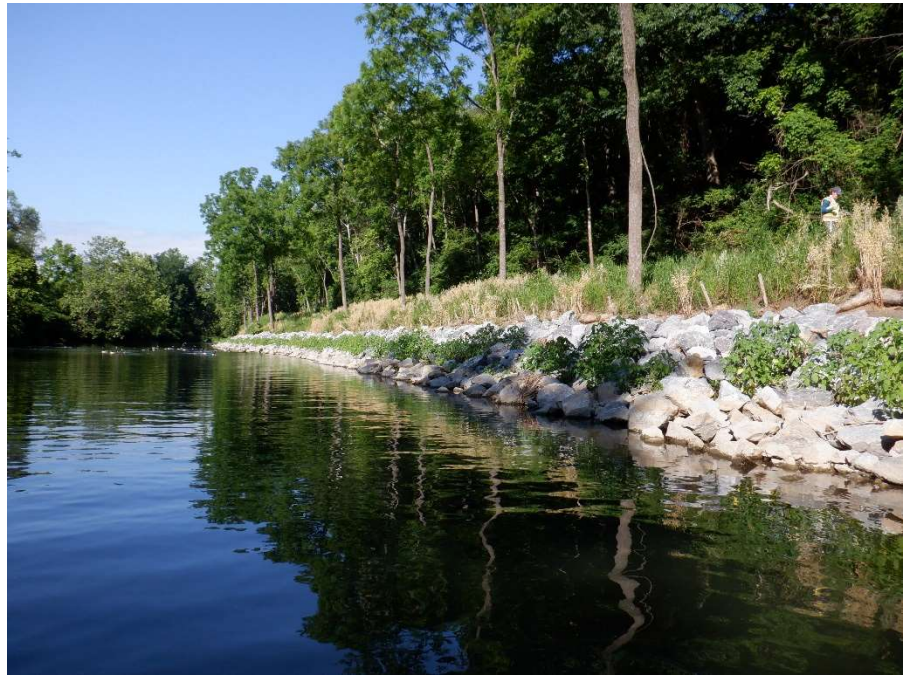
**Photo Number:** 23      **Date:** 6/23/2021

**Description:**  
~ 45 degree bank angle;  
upstream view of location;  
lower bank: 10 degrees; 2  
black walnuts with poison  
ivy; jewelweed ~15% cover at  
toe; grasses are dominant; no  
at risk trees; exposed fabric  
~70%; no scour.

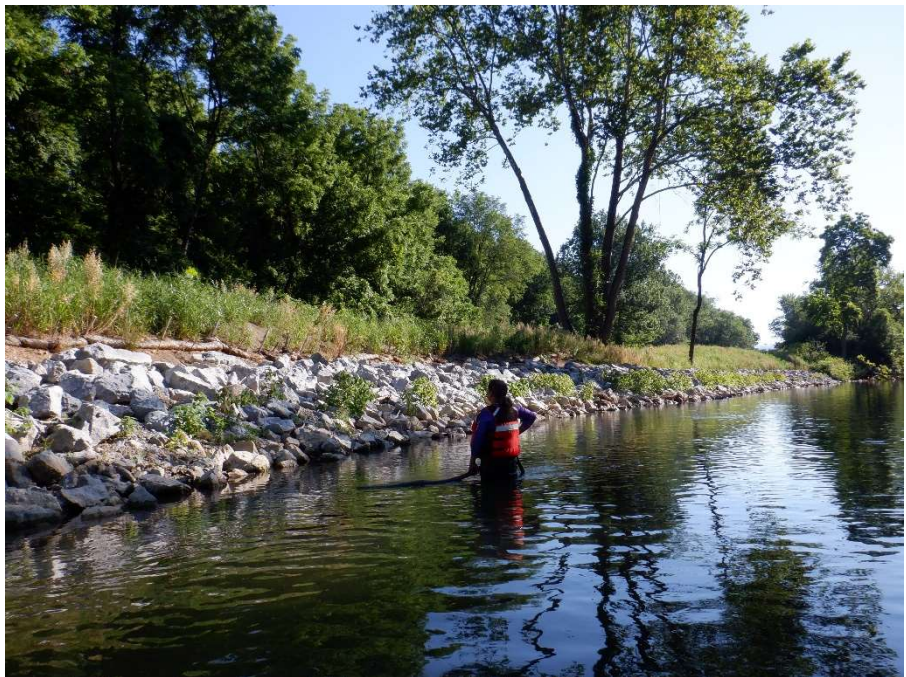
**Photo Title:** 24      **Date:** 6/23/2021

**Description:**  
~ 45 degree bank angle;  
downstream view of location;  
lower bank: 10 degrees; no  
at risk trees; exposed fabric  
~70%; no scour.

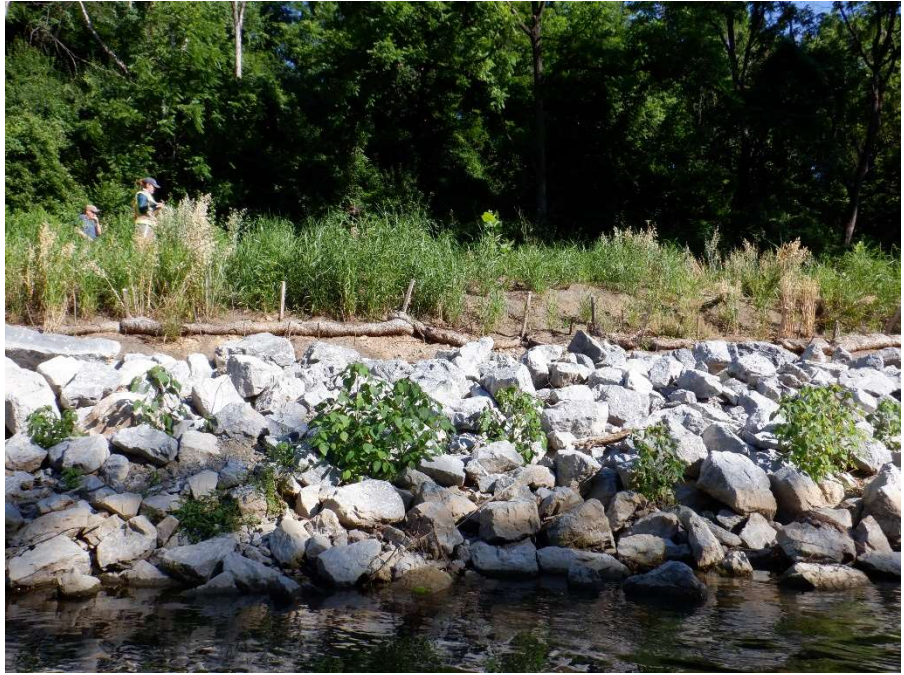
~ 45 degree bank angle;  
lower bank: 20 degrees; 2  
planted sycamores; grasses  
dominant; closer spacing for  
planted saplings; no at risk  
trees; exposed fabric ~20%;  
no scour.

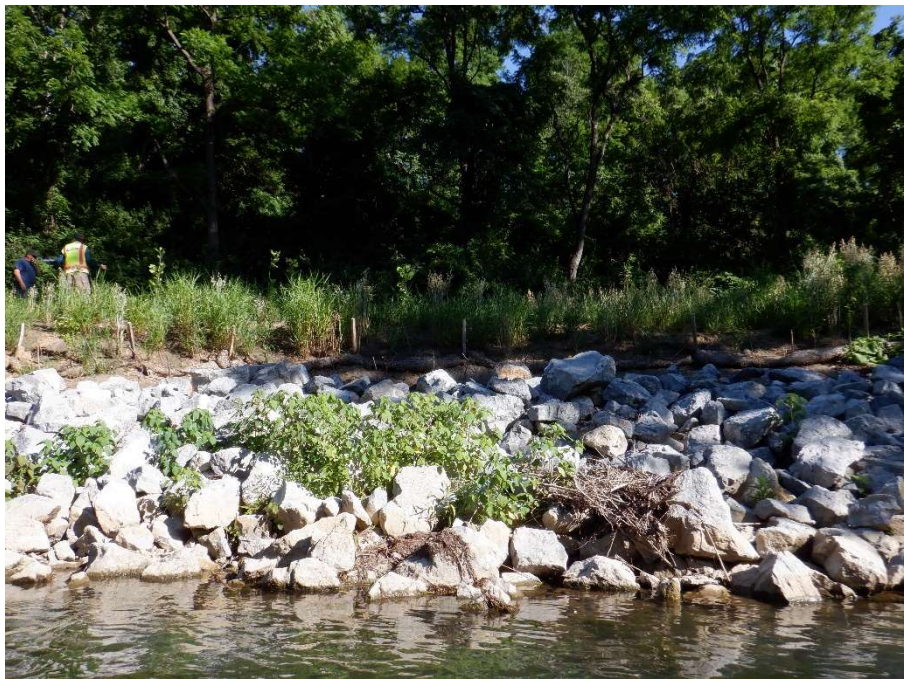
~ 45 degree bank angle;  
upper bank: 45 degrees -  
lower bank: 20 degrees;  
planted sycamore, maples  
and birch trees; grasses are  
dominant ; no at risk trees;  
exposed fabric ~40%; no  
scour.

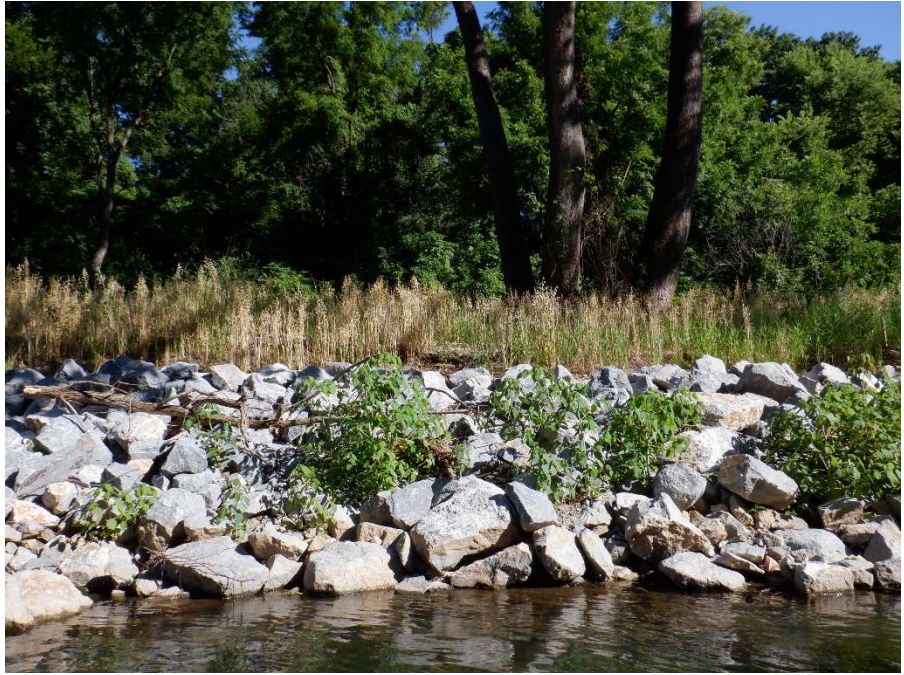
~ 35 degree bank angle;  
lower bank: 10 degrees;  
growth observed on willow  
live stakes; sycamore,  
elderberry and 2 paw paw  
trees are healthy; no at risk  
trees; exposed fabric ~30%;  
no scour.

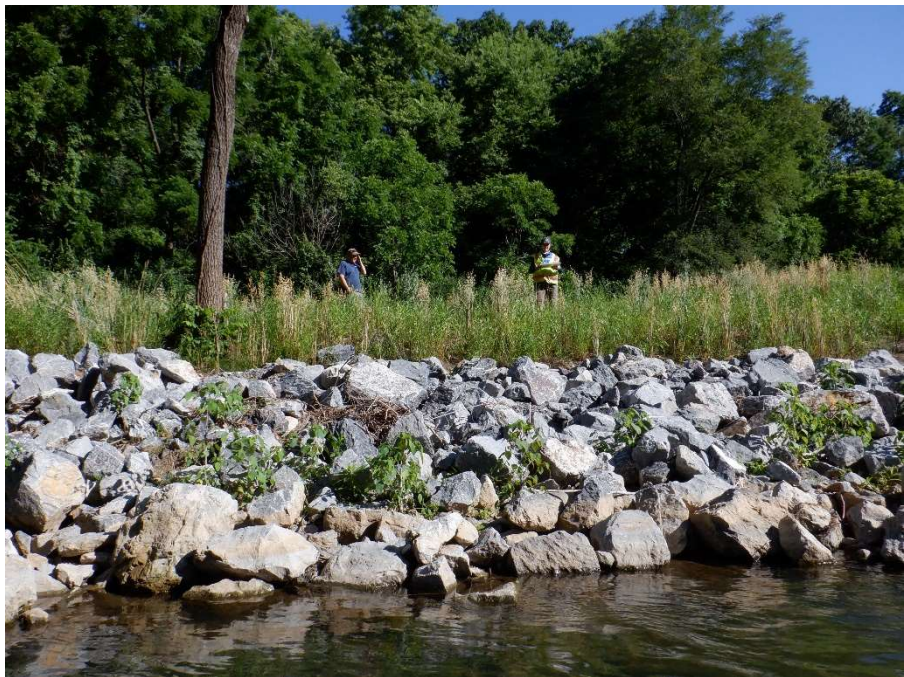
~ 10 degree bank angle;  
native grasses are dominant;  
no at risk trees; exposed  
fabric ~5%; no scour.

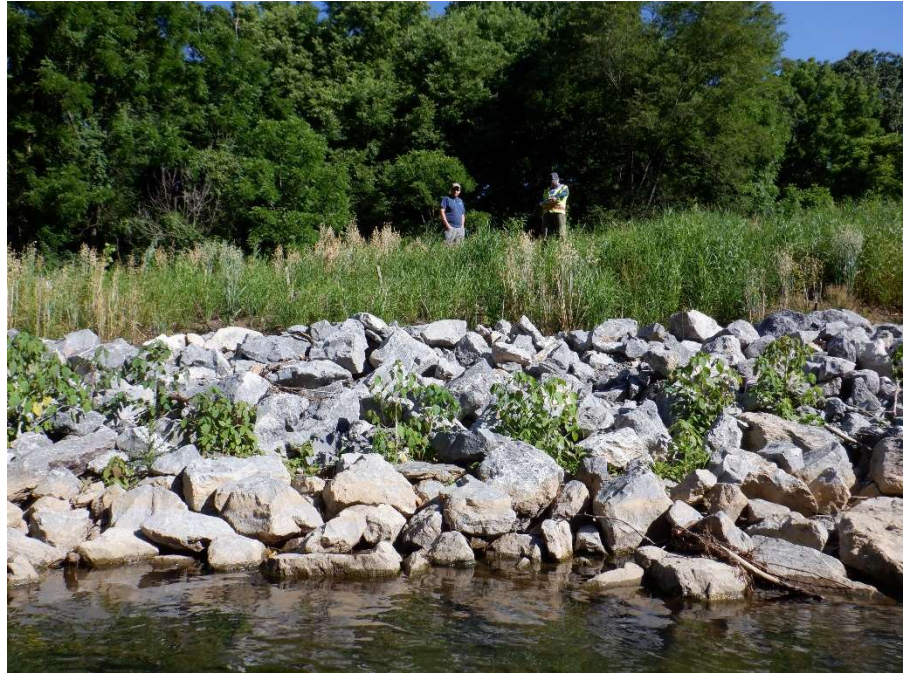
~ 35 degree bank angle;  
lower bank: 25 degrees;  
native grasses are dominant;  
planted dogwoods and  
sycamore; no at risk trees;  
exposed fabric ~5%; no  
scour.

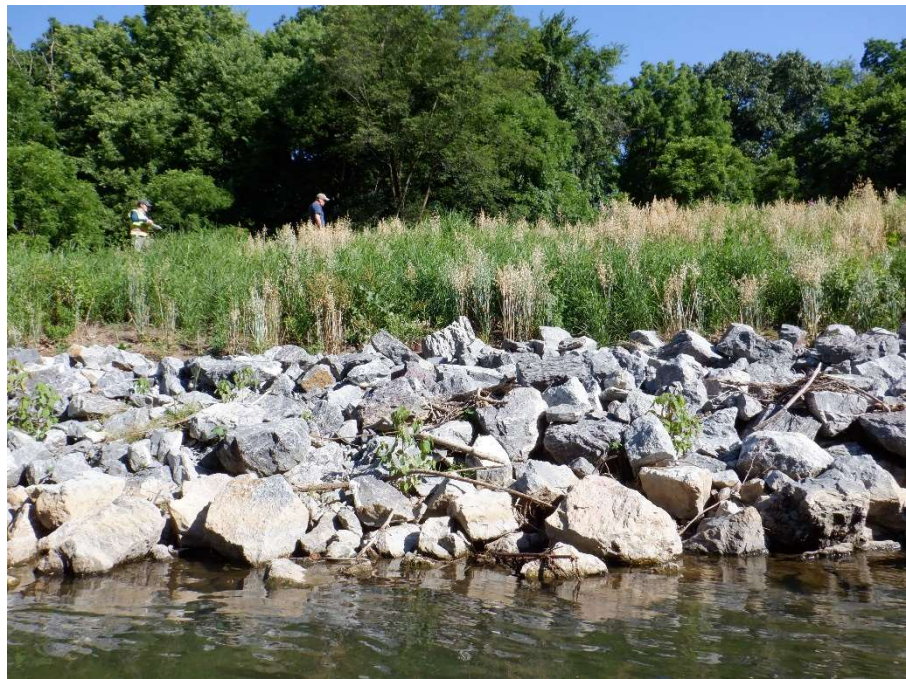
~ 45 degree bank angle;  
lower bank: 25 degrees;  
sweet pea ~10% cover;  
invasive crown vetch ~ 2%  
cover; native grasses are  
dominant; no at risk trees;  
exposed fabric ~5%; no  
scour.

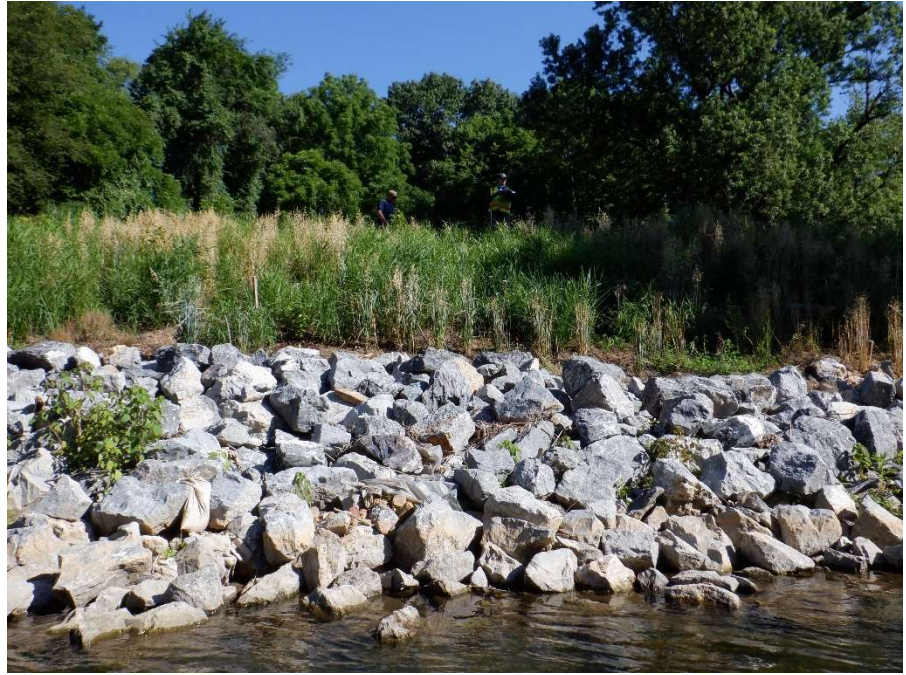
~ 40 degree bank angle;  
lower bank: 25 degrees;  
native grasses are dominant  
~85% cover; no at risk trees;  
exposed fabric ~5%; no  
scour.

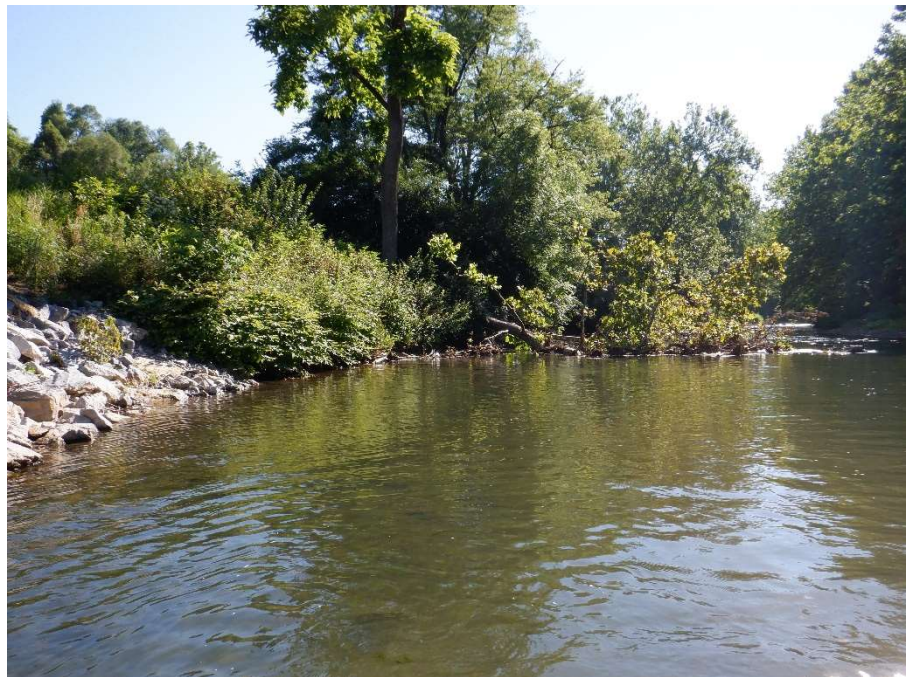
~ 40 degree bank angle;  
downstream view of location;  
lower bank: 25 degrees; no at  
risk trees; exposed fabric  
~5%; no scour.

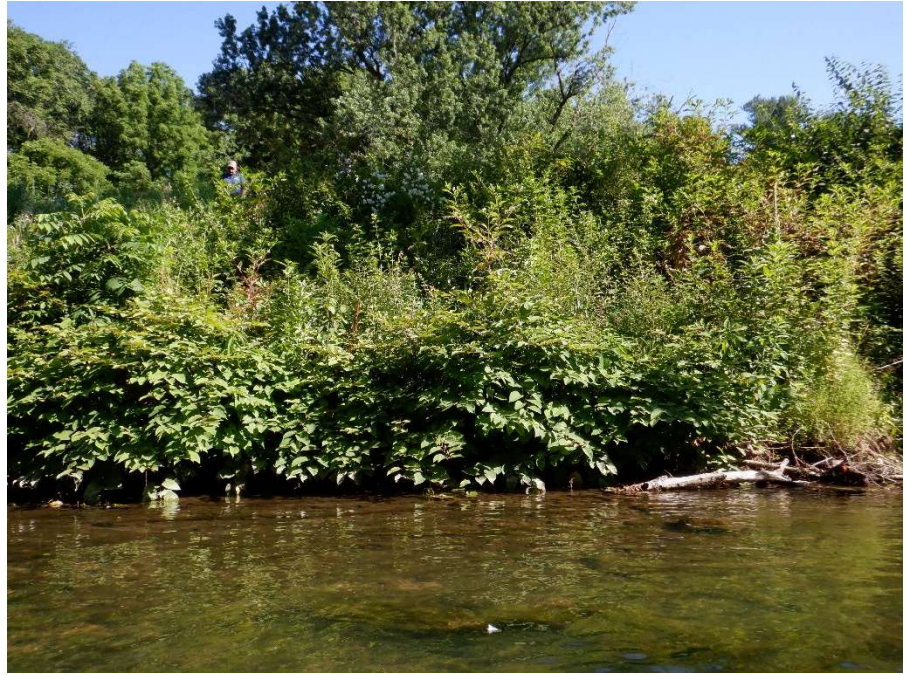
**Description:**  
~ 55 degree bank angle;  
invasive knotweed ~60%  
cover; native pokeberry ~20%;  
invasive honeysuckle ~10%;  
oats and grasses throughout,  
yucca plants; no at risk trees;  
exposed fabric ~25% cover;  
no scour.

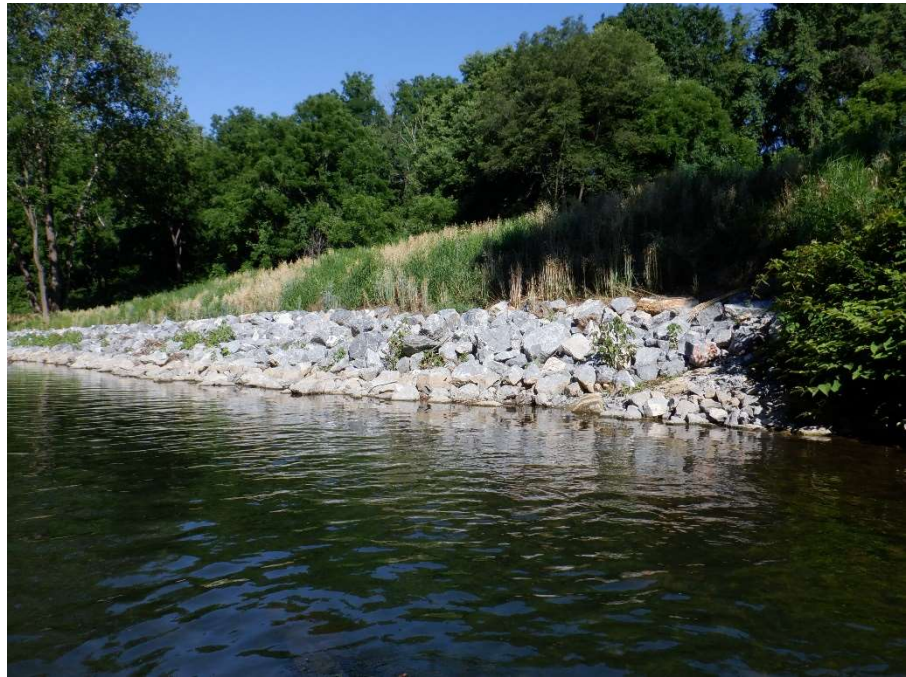
**Description:**  
~ 55 degree bank angle;  
upstream view of location;  
no at risk trees; exposed  
fabric ~25% cover; no scour.

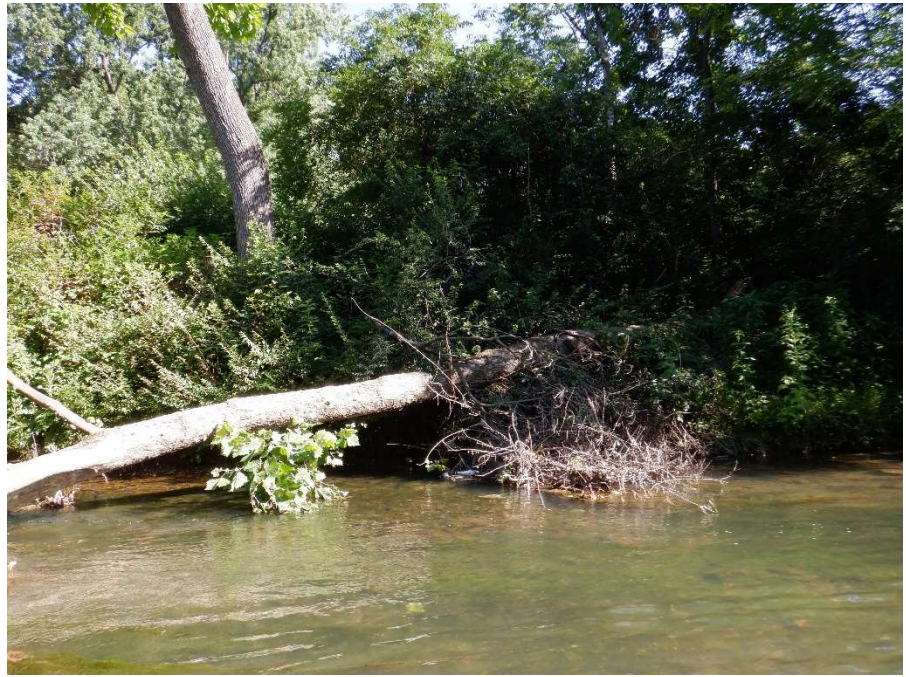
**Description:**  
~ 50 degree bank angle;  
fallen sycamore, vegetative  
cover ~100%; no at risk trees;  
no exposed fabric; no scour.

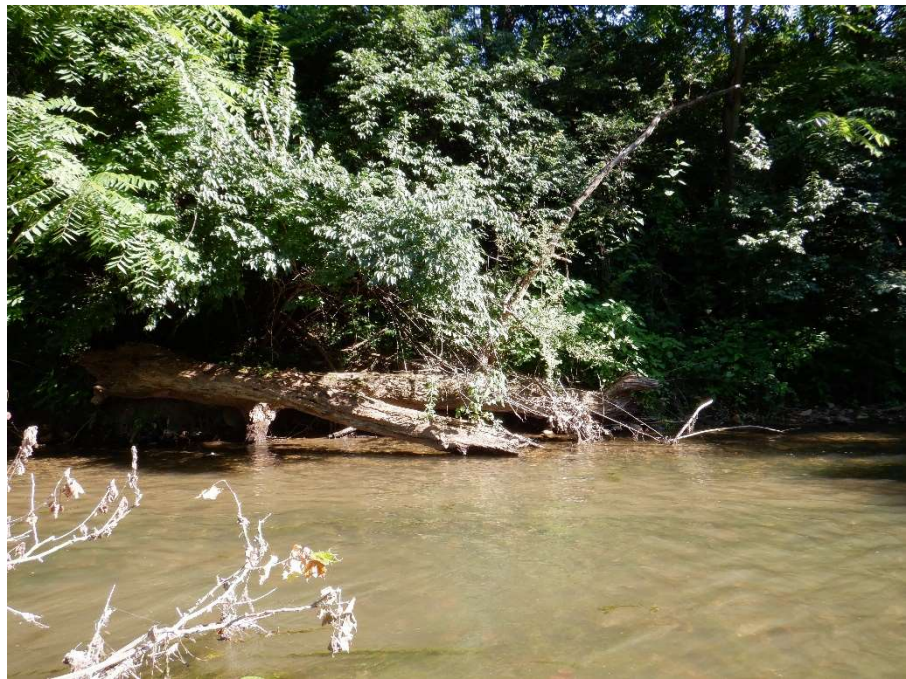
**Description:**  
~ 50 degree bank angle;  
exposed roots ~5%; invasive  
honeysuckle, black walnuts;  
silver maples; red maple,  
established vegetation cover;  
no at risk trees; no exposed  
fabric; no scour.

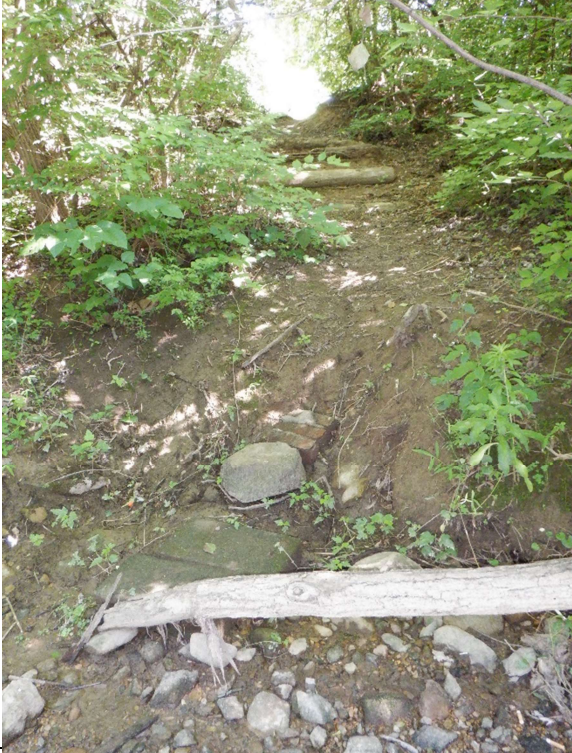
<p><b>Location:</b> 00+1250'</p> <hr/> <p><b>Photo Title:</b>              <b>Date:</b> 38                              6/23/2021</p> <hr/> <p><b>Direction Photo Taken:</b> Northwest</p> <hr/> <p><b>Description:</b> ~ 65 degree bank angle; pedestrian access path; no at risk trees; no exposed fabric; no scour.</p>

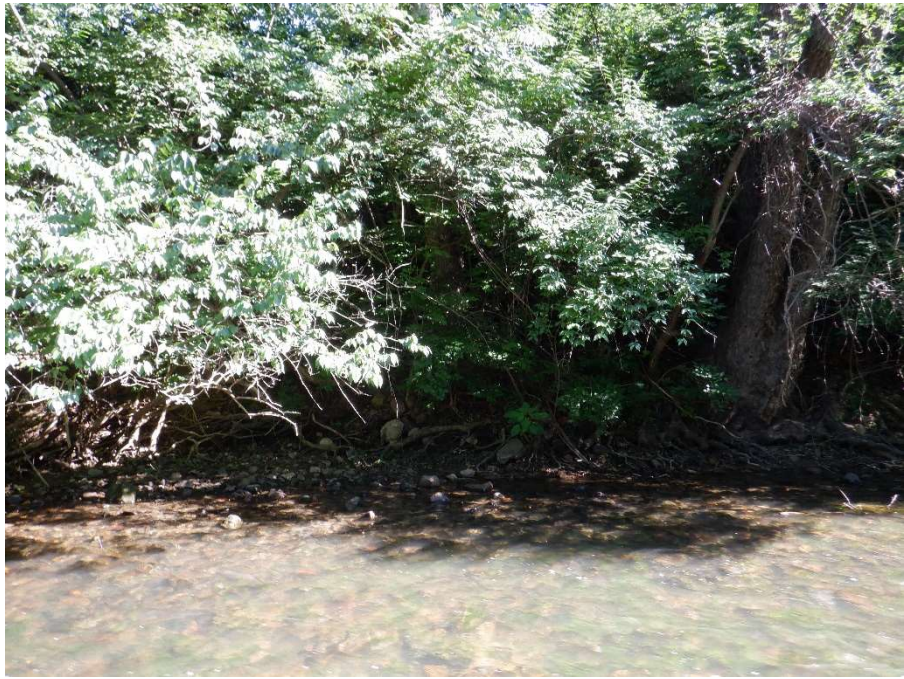
**Description:**  
~ 70 degree bank angle;  
unremediated section;  
exposed roots; invasive  
honeysuckle along bank;  
silver maple; exposed roots;  
scour under roots.

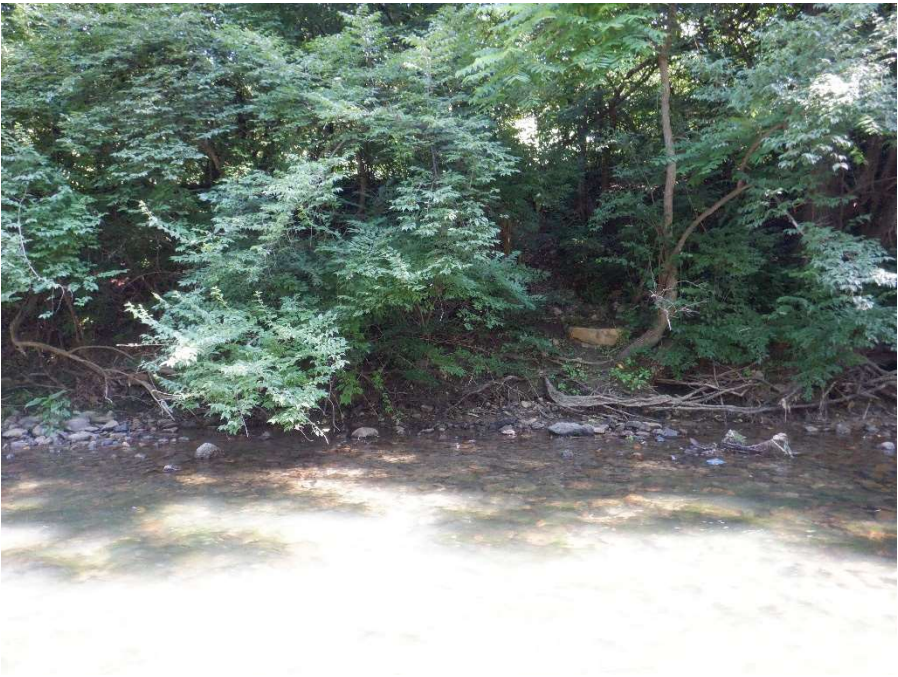
<p><b>Location:</b> 00+1400'</p> <hr/> <p><b>Photo Number:</b>      <b>Date:</b> 41                      6/23/2021</p> <hr/> <p><b>Direction Photo Taken:</b> Northwest</p> <hr/> <p><b>Description:</b> ~ 65 degree bank angle; unremediated section; exposed roots of black walnut, red maple; pedestrian path/access; exposed roots; minimal scour under roots; exposed rocks and gravel.</p>

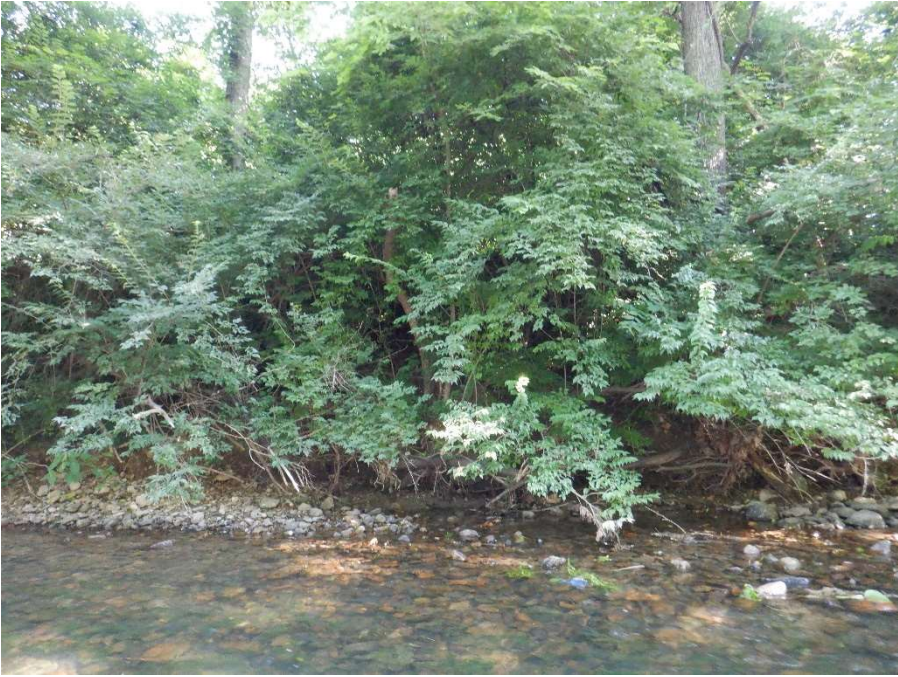
<p><b>Location:</b> 00+1450'</p> <hr/> <p><b>Photo Title:</b>              <b>Date:</b> 42                      6/23/2021</p> <hr/> <p><b>Direction Photo Taken:</b> Northwest</p> <hr/> <p><b>Description:</b> ~ 65 degree bank angle; unremediated section; exposed roots of black walnut, invasive honeysuckle; minimal scour under roots. exposed rocks and gravel.</p>

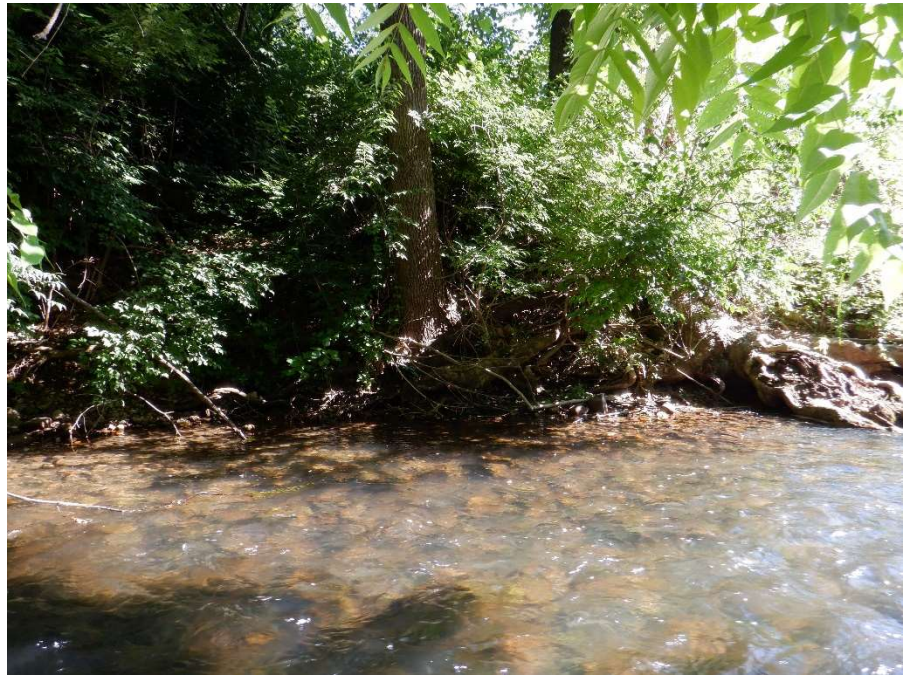
**Description:**  
~ 55 degree bank angle; black walnut, sycamore, invasive honeysuckle; unremediated section; exposed roots; scour under roots, gravel and pebbles at toe.

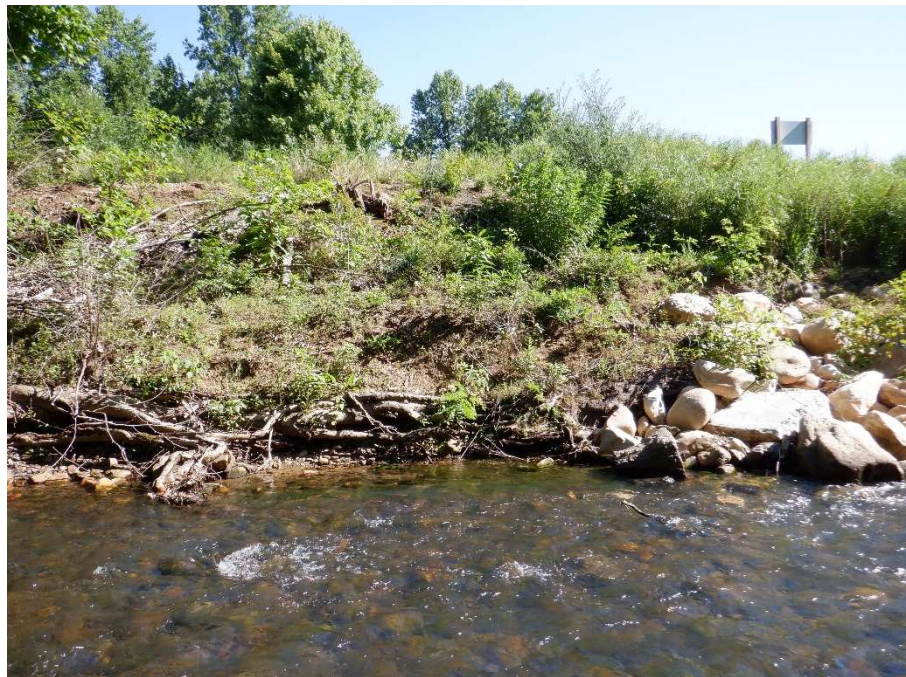
**Description:**  
~ 60 degree bank angle; exposed roots and soil; vegetation cover ~65% overall; pedestrian access path; exposed roots and soil, exposed fabric; scour under toe of slope.

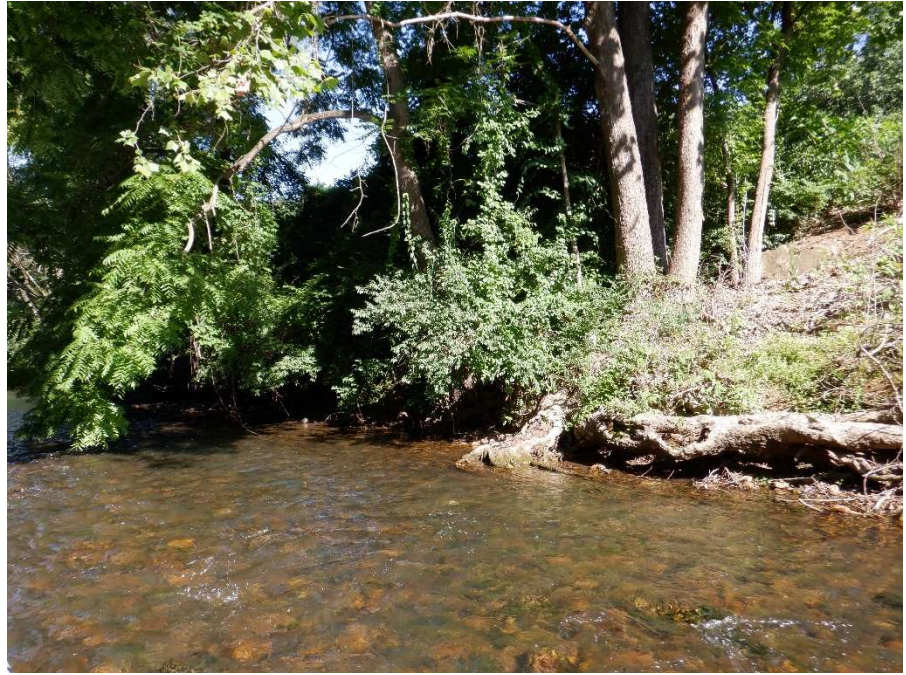
**Description:**  
~ 60 degree bank angle;  
exposed roots and soil;  
vegetation cover ~65%  
overall; exposed fabric; scour  
under toe of slope.

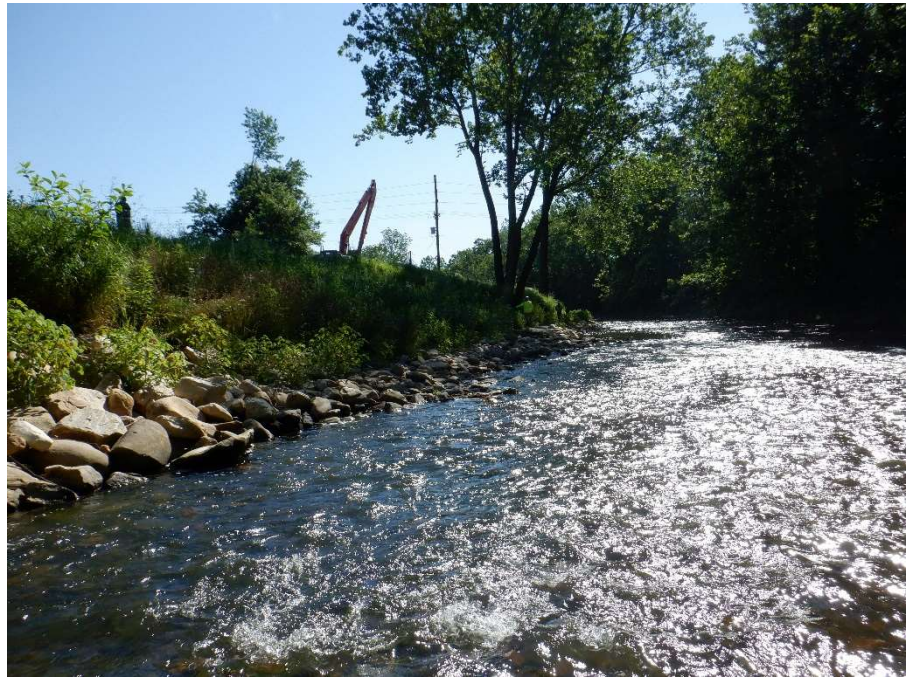
**Description:**  
~ 60 degree bank angle;  
downstream view of location;  
exposed roots and soil;  
vegetation cover ~65%  
overall; pedestrian access  
path; exposed fabric; scour  
under toe of slope.

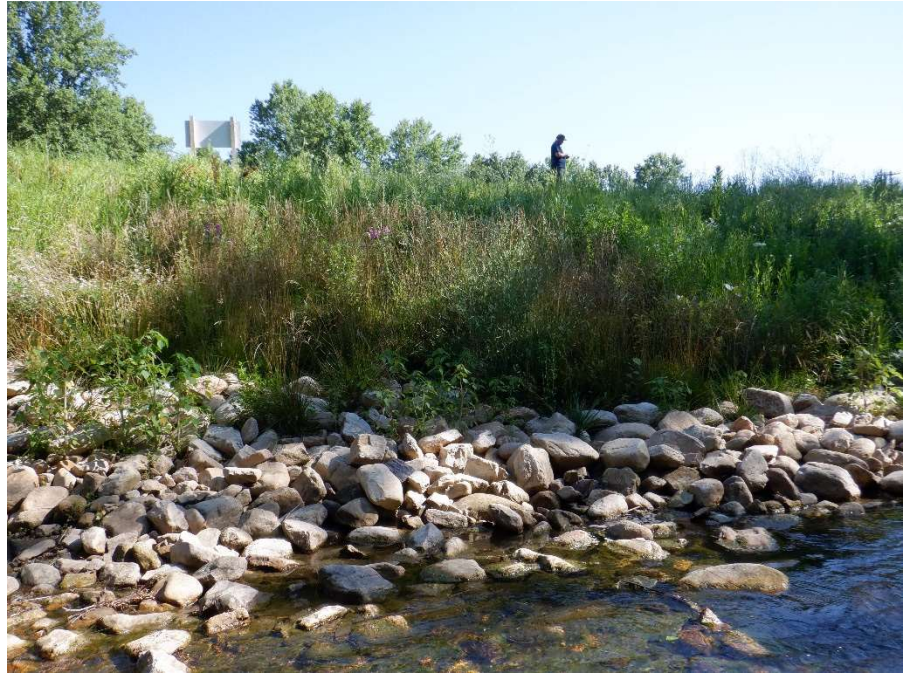
**Description:**  
~ 45 degree bank angle;  
vegetation cover ~90%;  
exposed fabric ~10% cover;  
rock toe is ~4ft. wide, no  
roots; exposed fabric; no  
scour.

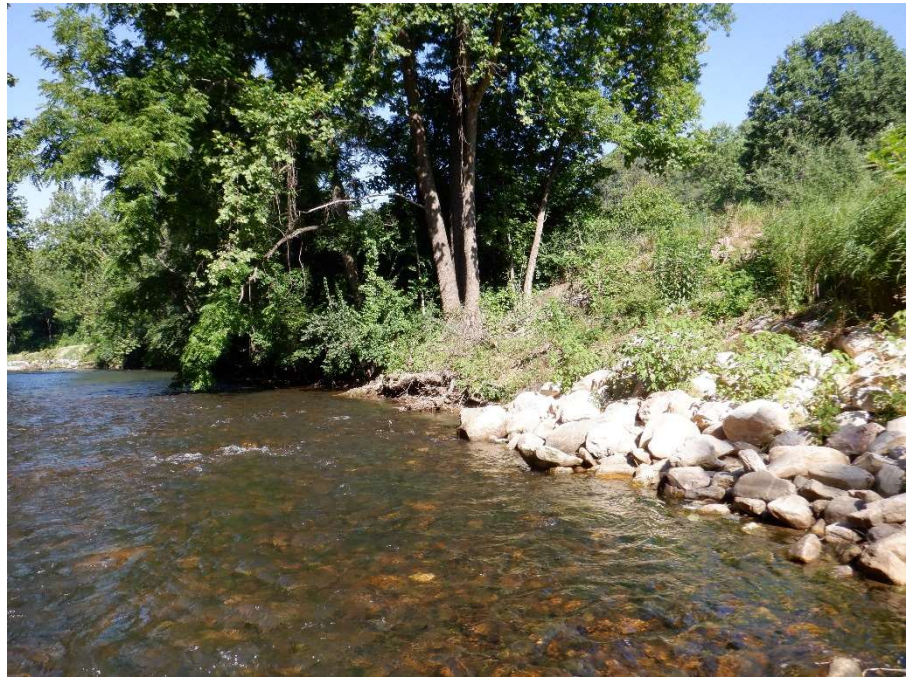
**Description:**  
~ 45 degree bank angle;  
upstream view of location;  
vegetation cover ~90%;  
exposed fabric ~10% cover;  
rock toe is ~4ft. wide, no  
roots; exposed fabric; no  
scour.

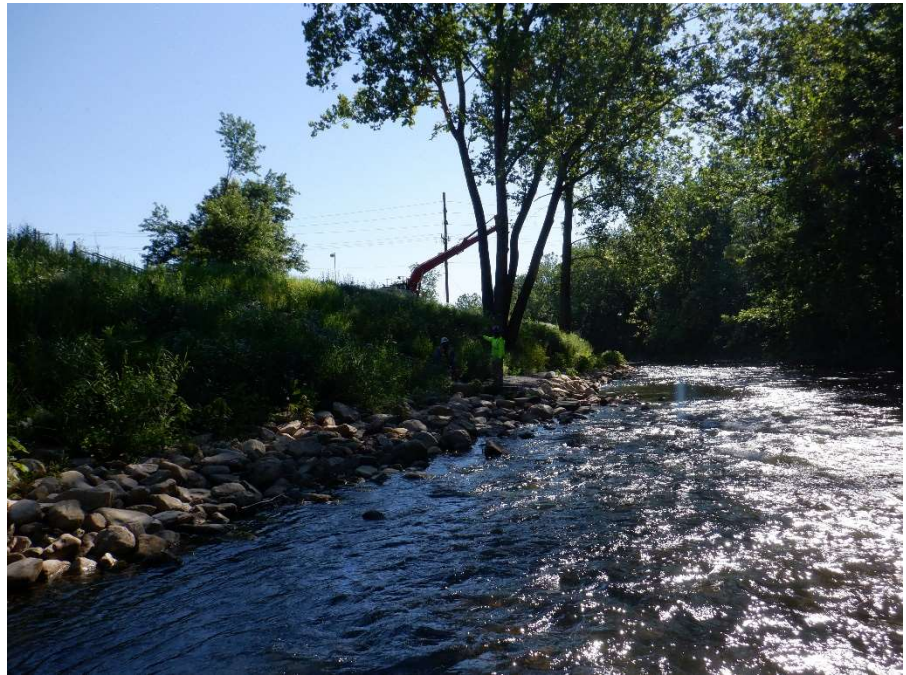
**Description:**  
~ 45 degree bank angle;  
Vegetation cover ~90%;  
Exposed fabric ~10% cover;  
rock toe is ~4ft. Wide, no  
scour, no roots; Exposed  
fabric; No scour.

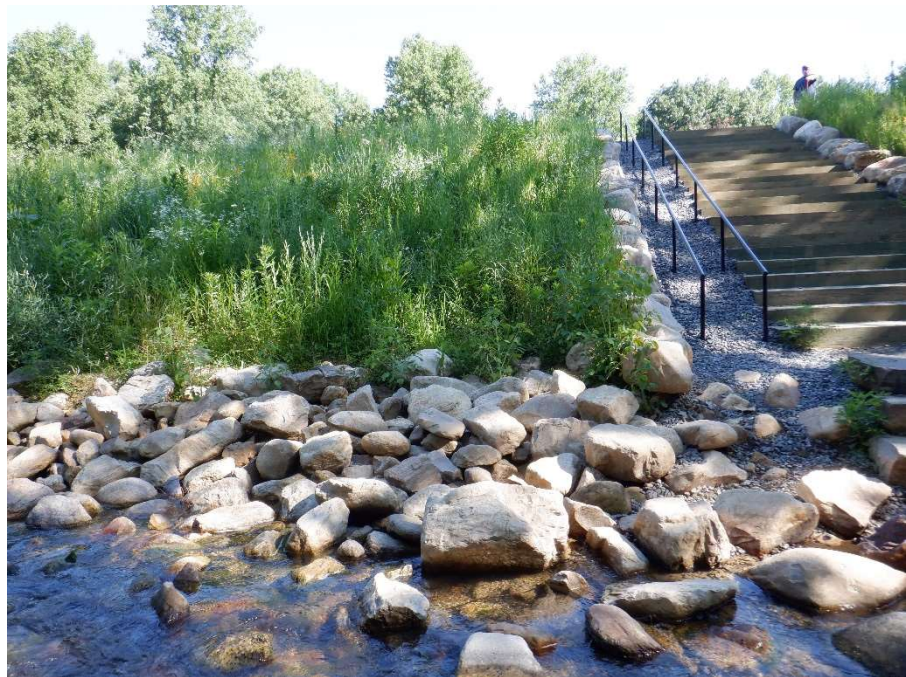
**Description:**  
~ 45 degree bank angle;  
vegetation cover adjacent to  
stairs~95% cover- grasses,  
coreopsis; rock toe intact;  
stairs intact; no exposed  
fabric; no scour.

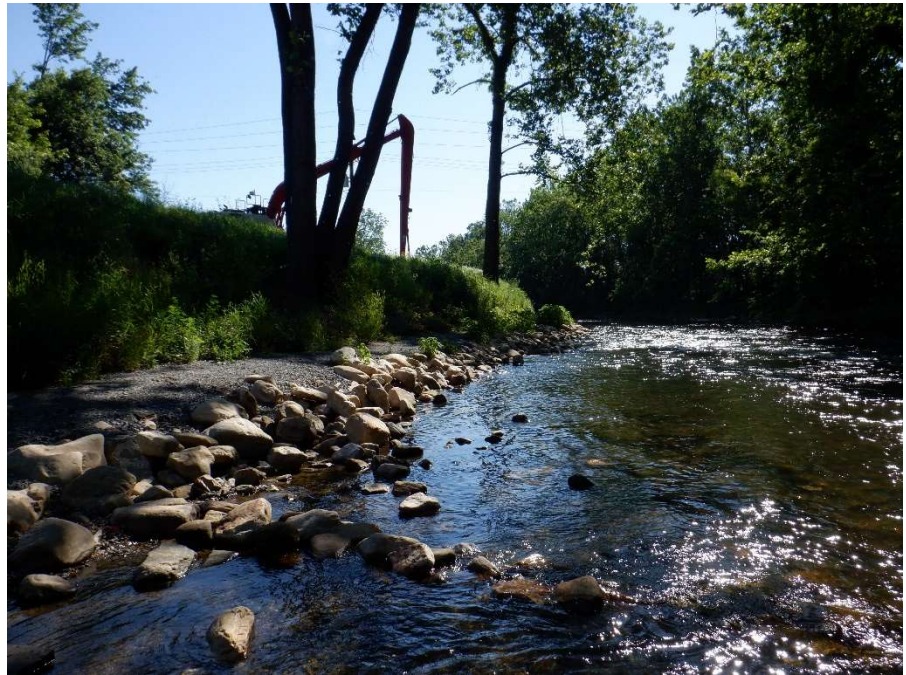
**Description:**  
~ 45 degree bank angle;  
downstream view of location;  
vegetation cover adjacent to  
stairs~95% cover- grasses,  
coreopsis; rock toe intact;  
stairs intact; no exposed  
fabric; no scour.
