**Re: 2021 Leaf-on and Leaf-off Maintenance Inspections  
Former DuPont Waynesboro Site AOC 4  
Waynesboro, Virginia  
EPA ID# VAD003114832**

## Memorandum

Subject 2021 Leaf-on Maintenance Inspection  
Former DuPont Waynesboro Site, Area of Concern 4

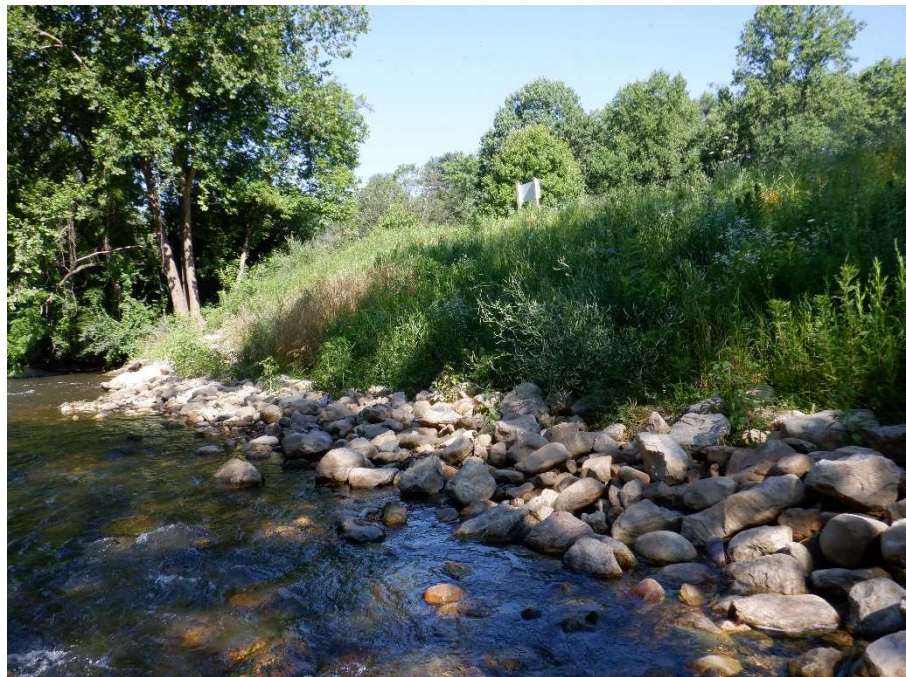
**Description:**  
~ 50 degree bank angle; rock  
toe is 20 degrees; upstream  
view of location; same day  
repairs are scheduled for  
exposed geocell and fabric; 3  
sycamores; 2ft. wide rock  
toe; fabric exposed ~20%; no  
scour.

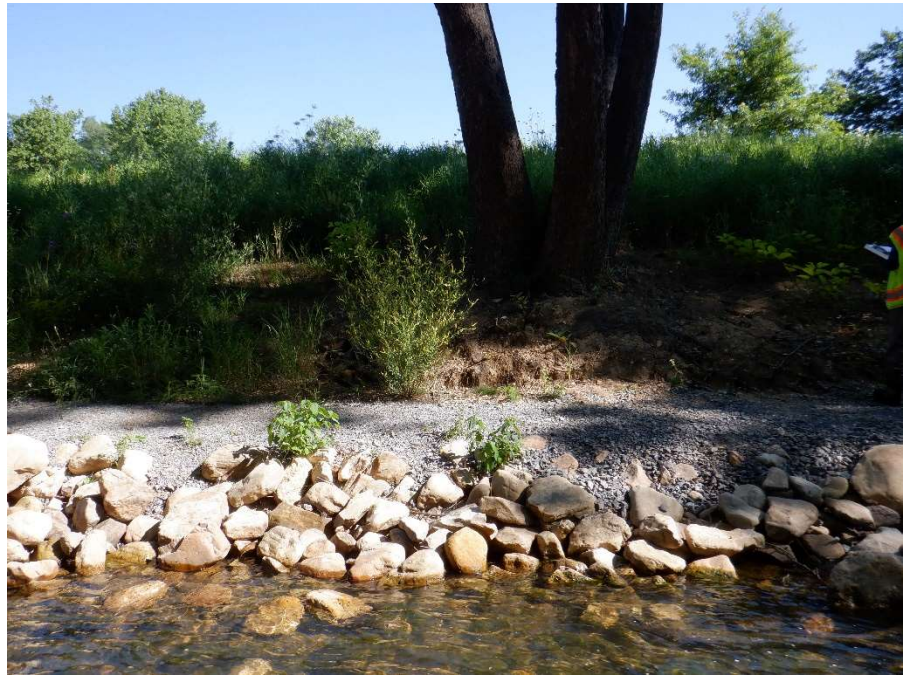
**Description:**  
~ 50 degree bank angle; rock toe is 20 degrees; same day repairs are scheduled for exposed geocell and fabric; 3 sycamores; 2ft. wide rock toe; pedestrian access path at toe of slope; fabric exposed ~20%; no scour.

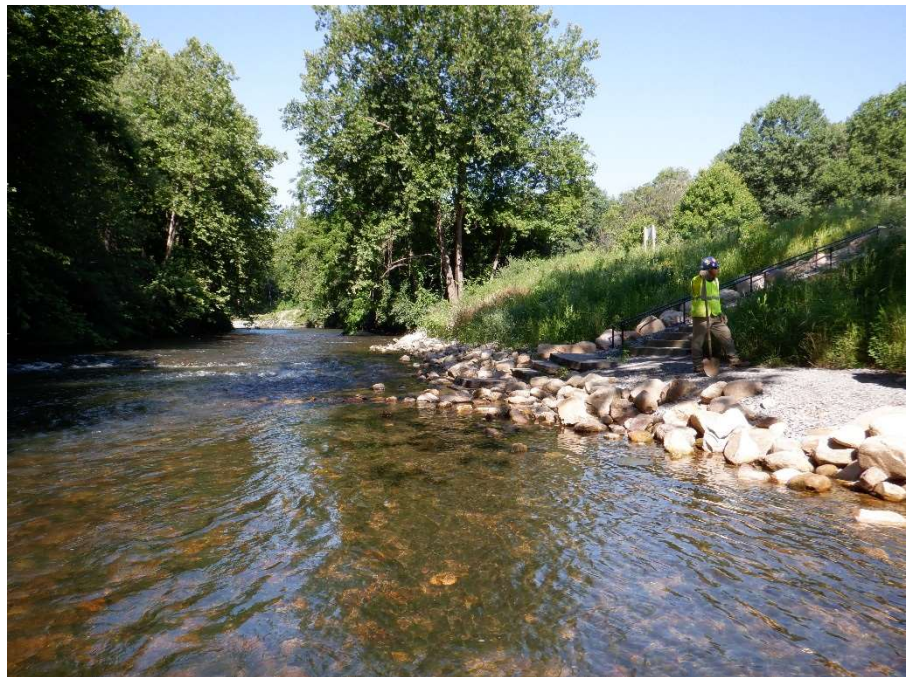
**Description:**  
~ 50 degree bank angle; rock toe is 20 degrees; upstream view of location; same day repairs are scheduled for exposed geocell and fabric; 3 sycamores; 2ft. wide rock toe; pedestrian access path at toe of slope; fabric exposed ~20%; no scour.

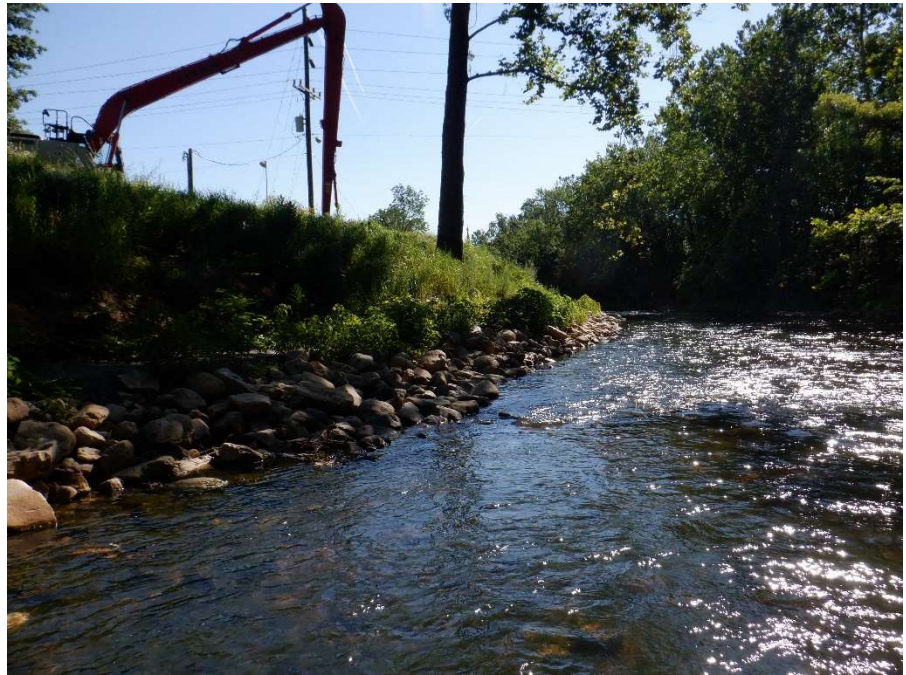
**Description:**  
~ 50 degree bank angle; rock toe is 20 degrees; downstream view of location; same day repairs are scheduled for exposed geocell and fabric; 3 sycamores; 2ft. wide rock toe; pedestrian access path at toe of slope; fabric exposed ~20%; no scour.

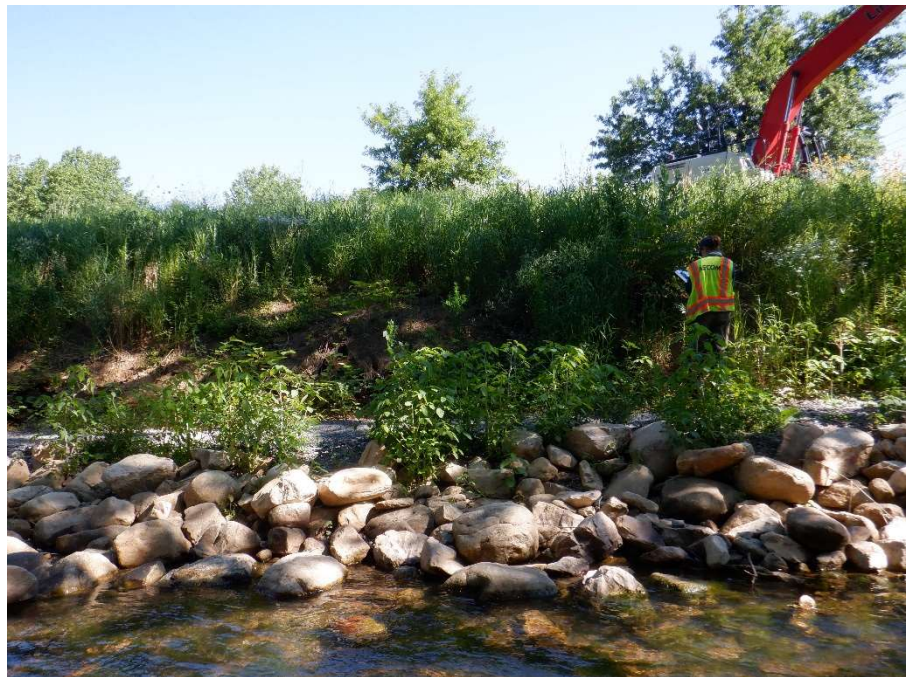
00-1750	65	N	Bank: ~35 degrees Rock Toe: ~20 degrees	56	None	5 isolated patches of Invasive Knothead, Jeeleweed at toe of slope. Vegetation cover ~80%. Walnut saplings. Pedestrian access path at toe of slope.	56	None	None	56	Y	Y	Y	No exposed fabric.	56	N	No scour.	56	Y	New patches of Knothead.
00-1800	50	N	Bank: ~30 degrees Rock Toe: ~20 degrees	57	None	Sycamore tree- geocell and fabric exposed around roots. Pedestrian access path at toe of slope.	57	None	None	57	Y	Y	Y	Exposed fabric and geocell around base of Sycamore tree.	57	N	No scour.	57	Y	Same day repairs to occur at location of exposed geocell and fabric.
00-1850	30	N	Bank: ~30 degrees Rock Toe: ~20 degrees	58	None	Vegetation covers 95% of bank. Small Sycamore saplings are establishing, small patches of Invasive Knothead ~5%. Pedestrian access path at toe of slope.	58,59	None	None	58,59	Y	Y	Y	No exposed fabric.	58,59	N	No scour.	58,59	Y	Increased vegetation cover.

**Description:**  
~ 65 degree bank angle; rock toe is 20 degrees; 5 isolated patches of invasive knotweed; jewelweed at toe of slope; vegetation cover ~80%; walnut saplings; pedestrian access path at toe of slope; no exposed fabric; no scour.

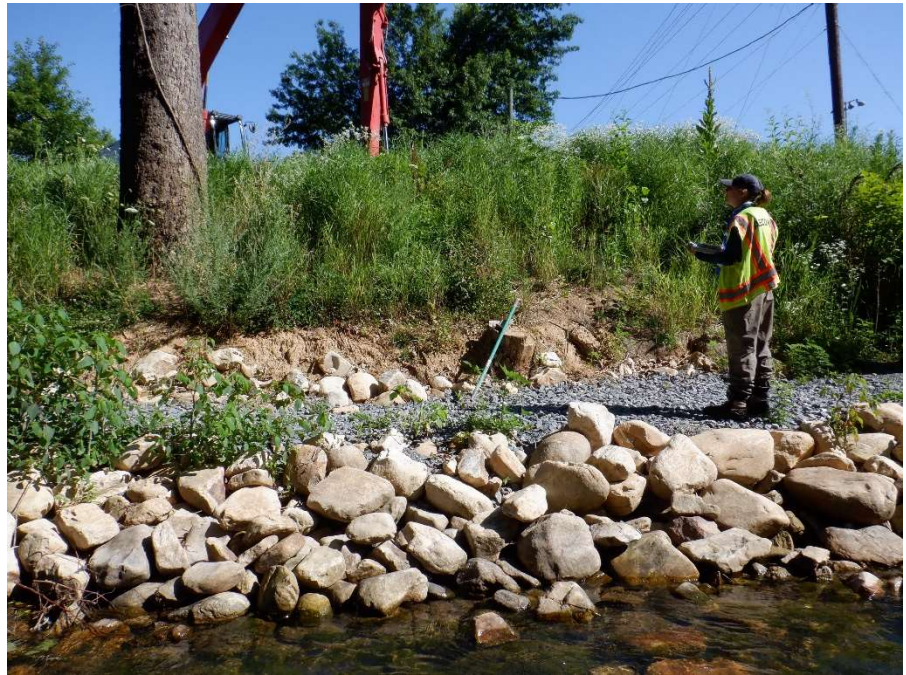
**Description:**  
~ 50 degree bank angle; rock toe is 20 degrees; sycamore tree- geocell and fabric exposed around roots; pedestrian access path at toe of slope; exposed fabric and geocell around base of sycamore tree; no scour.

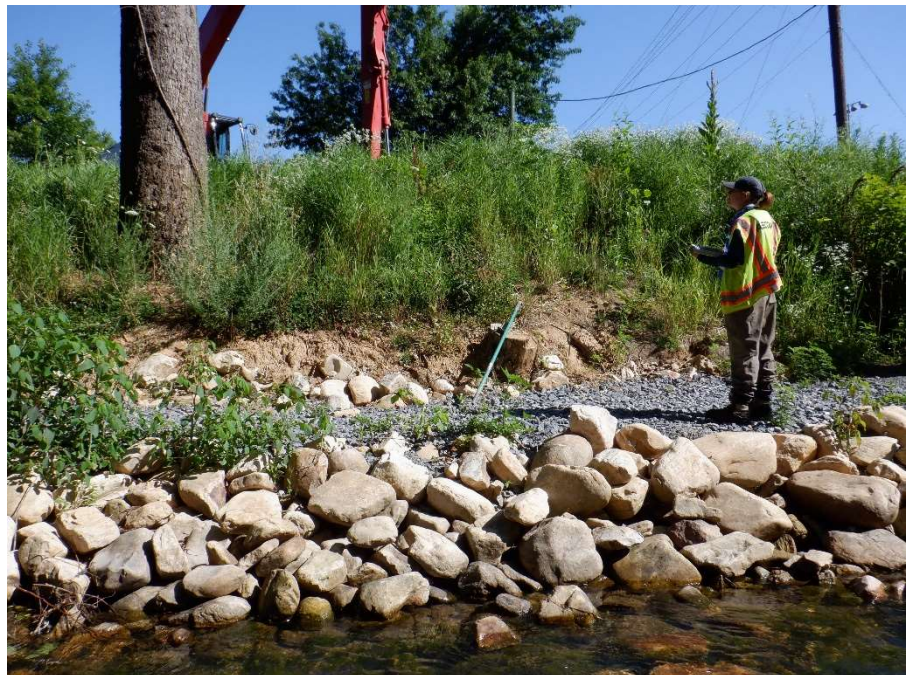
**Description:**  
~ 30 degree bank angle; rock toe is 20 degrees; vegetation covers 95% of bank; small sycamore saplings are establishing, small patches of invasive knotweed ~5%; pedestrian access path at toe of slope; no exposed fabric; no scour.

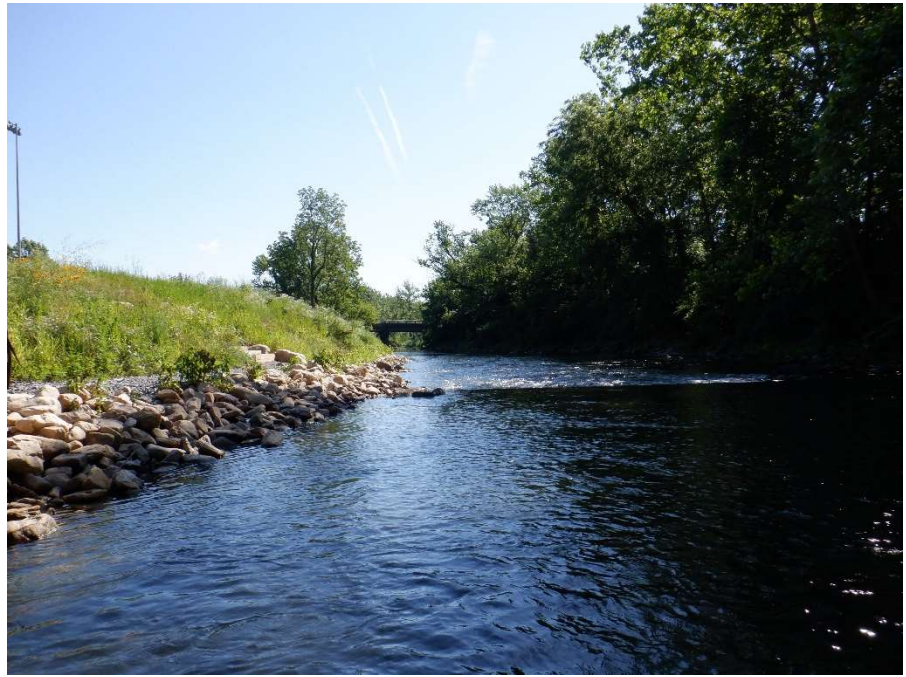
**Description:**  
~ 30 degree bank angle;  
downstream view of location;  
rock toe is 20 degrees;  
vegetation covers 95% of  
bank; small sycamore  
saplings are establishing,  
small patches of invasive  
knotweed ~5%; pedestrian  
access path at toe of slope;  
no exposed fabric; no scour.

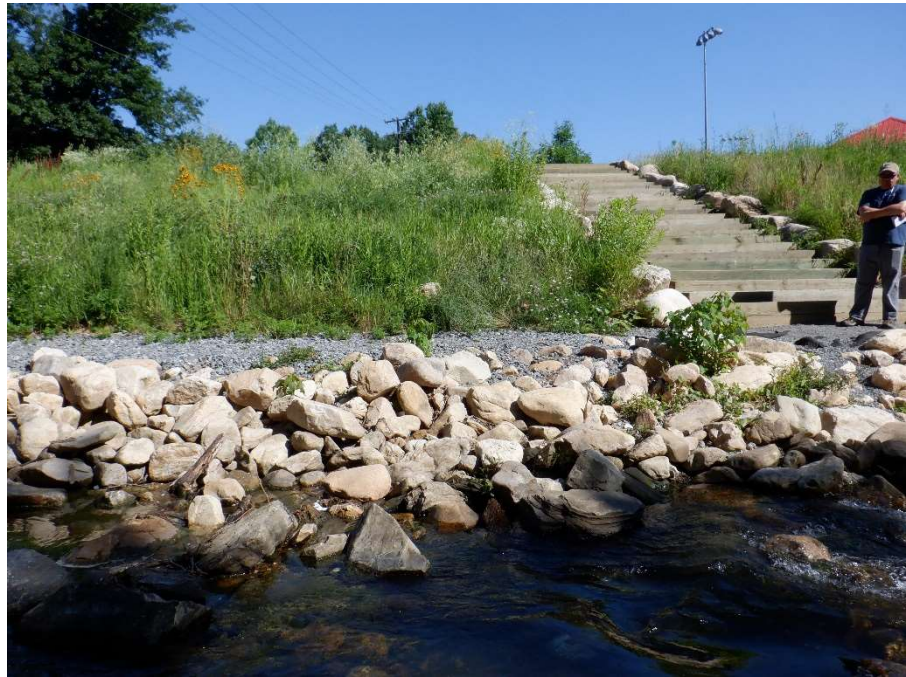
00-1900	30	N	Bank: ~30 degrees Rock Toe: ~20 degrees	60	None	Vegetation covers ~95% of bank. No Knothead observed. Jeeleweed at toe of slope. Slight scour at toe of stairs. Pedestrian access path at toe of slope.	60	None	None	60	Y	Y	Y	Small patches of exposed soil. Exposed fabric at toe of stairs.	60	Y	Slight scour at toe of stairs.	60	Y	Slight scour and increased vegetation cover.
00-1950	70	N	Bank: ~70 degrees Rock Toe: ~20 degrees	61	None	Willow live stakes are establishing. Jeeleweed at toe of slope. Culvert is in good condition, path of Invasive Knothead ~1%; no pedestrian pathway.	61	None	None	61	Y	Y	Y	Exposed fabric ~10%.	61	N	No scour.	61	Y	Patch of Knothead.
00-2000	75	N	Bank: ~75 degrees Rock toe: ~20 degrees	62	None	Vegetation cover ~95%. Exposed patches of soil ~2%.	62	None	None	62	Y	Y	Y	Exposed fabric ~2%.	62	N	No scour.	62	Y	Patch of exposed fabric, increased vegetation cover.

**Description:**  
~ 30 degree bank angle; rock  
toe is 20 degrees; small  
patches of exposed soil;  
exposed fabric at toe of  
stairs; slight scour at toe of  
stairs.

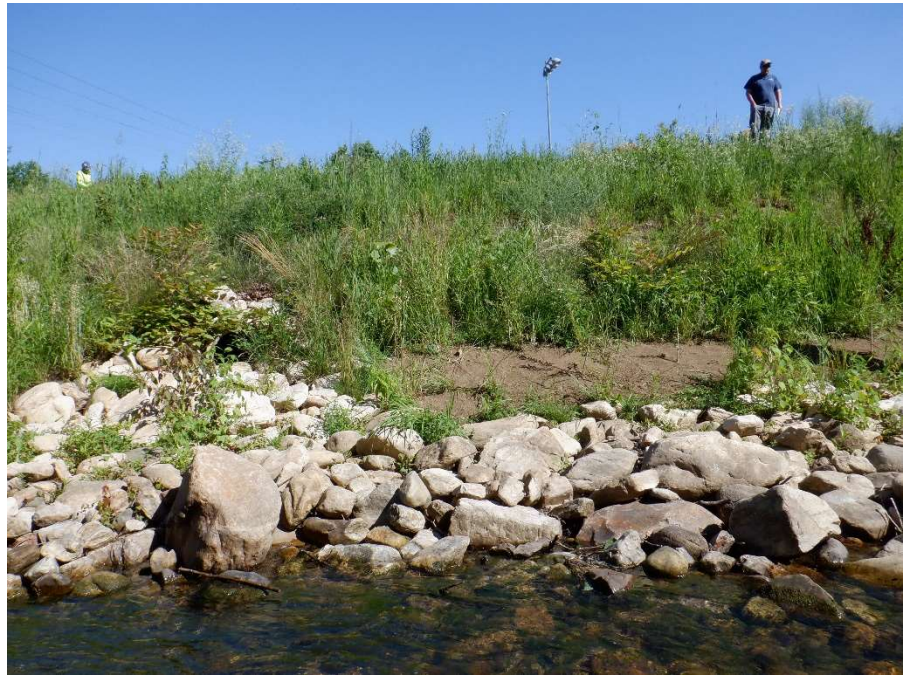
**Description:**  
~ 70 degree bank angle; rock toe is 20 degrees; willow live stakes are establishing; jewelweed at toe of slope; culvert is in good condition; patch of invasive knotweed ~1%; no pedestrian pathway; exposed fabric 10%; No scour.

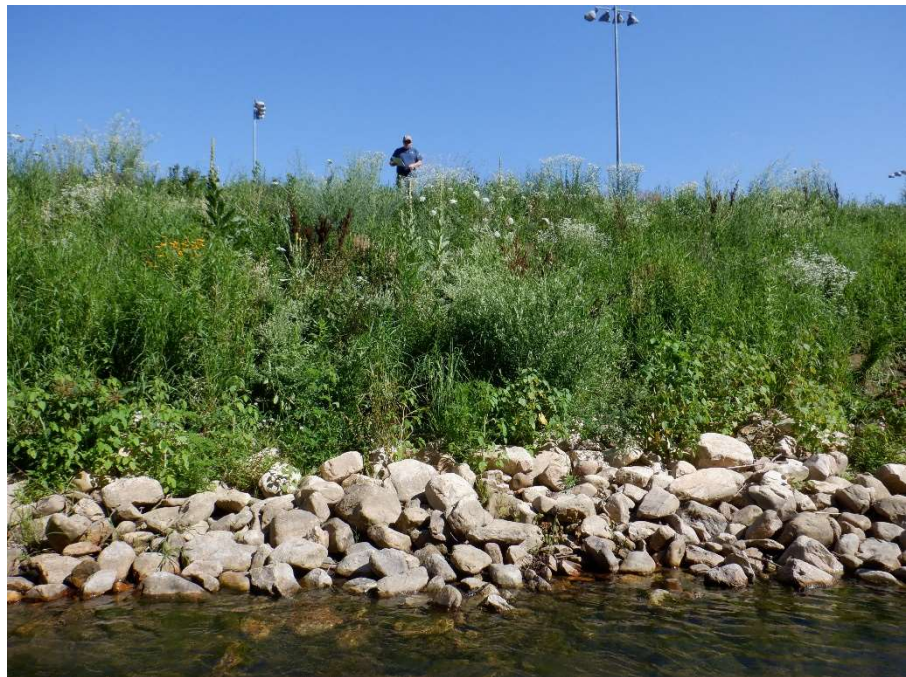
**Description:**  
~ 75 degree bank angle; rock toe is 20 degrees; vegetation cover ~95%, exposed patches of soil ~2%; exposed fabric 2%; no scour.

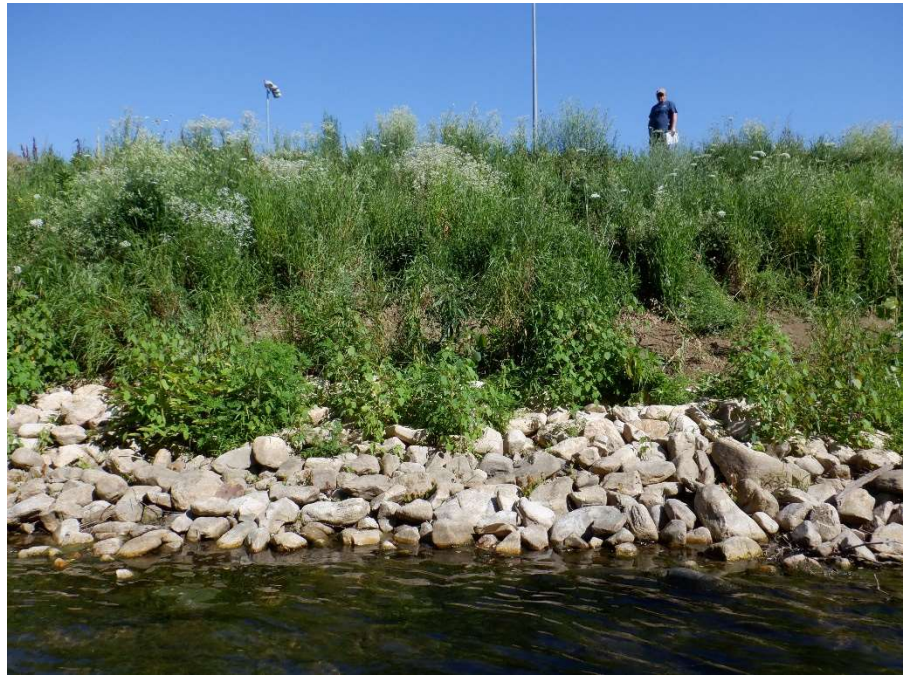
**Description:**  
~ 60 degree bank angle; rock toe is 20 degrees; minimum growth on live stakes; jewelweed at toe of slope; exposed soil ~5%; no exposed fabric, but exposed soil ~5%; no scour.

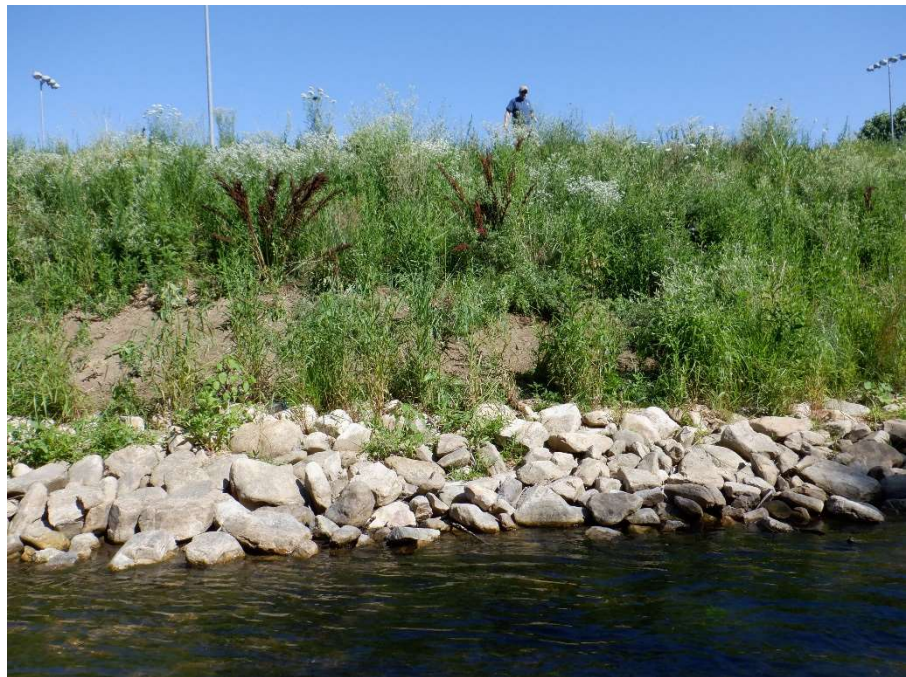
**Description:**  
~ 70 degree bank angle; native vegetation cover ~95%; minimum growth on livestakes, no scour, no exposed roots; small patches of invasive knotweed; no scour.

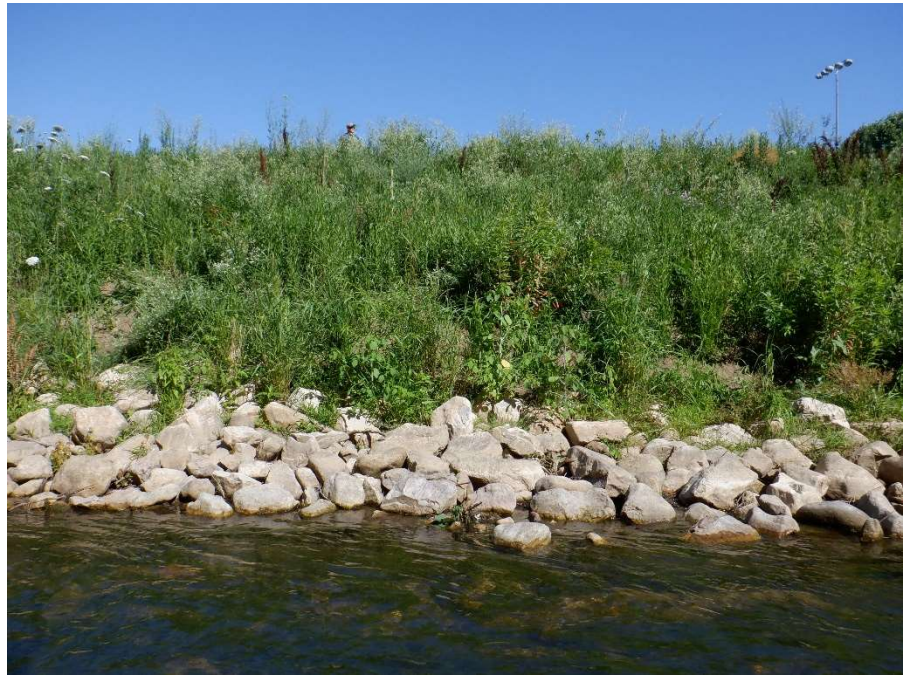
**Description:**  
~ 70 degree bank angle;  
minimum growth on live  
stakes; native vegetation  
cover 98%- grasses are  
dominant; small patches of  
invasive knotweed;  
jewelweed and blue vervain  
at toe of slope. exposed soil  
~2%; no scour.

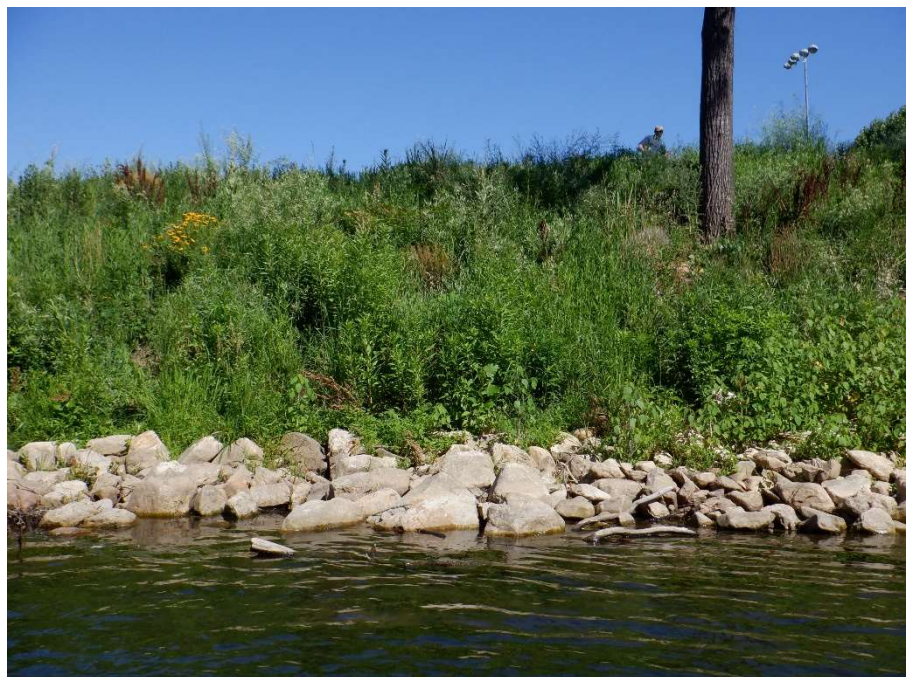
**Description:**  
~ 60 degree bank angle;  
native vegetation cover 99%-  
grasses are dominant; black  
walnut tree canopy; bare soil  
patch at base of walnut; rock  
toe widens at downstream  
end ~8' wide; no scour.

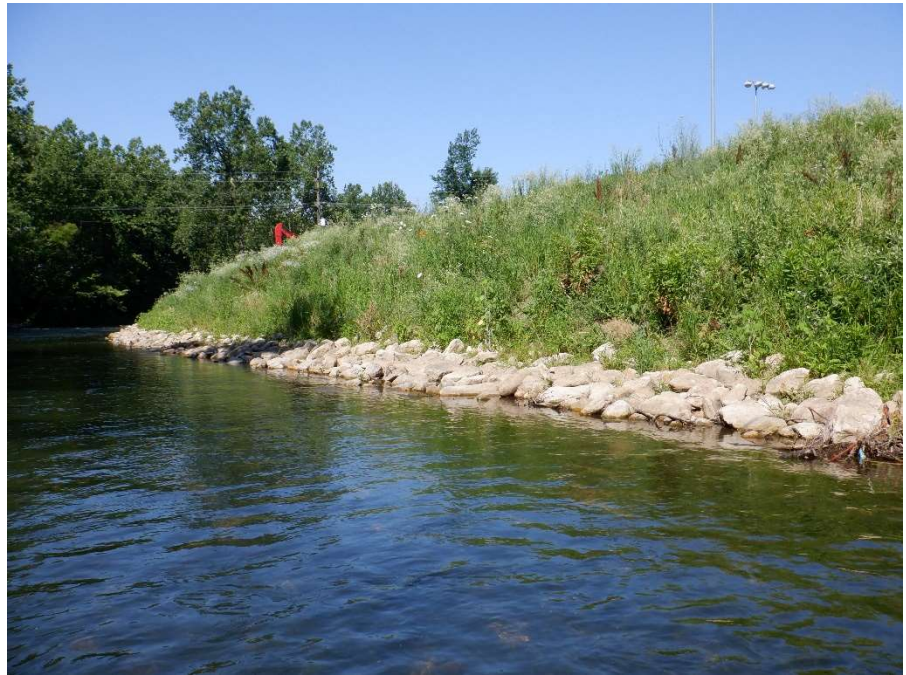
**Description:**  
~ 60 degree bank angle;  
upstream view of location;  
native vegetation cover 99%-  
grasses are dominant; black  
walnut tree canopy; bare soil  
patch at base of walnut; rock  
toe widens at downstream  
end ~8' wide; no scour.

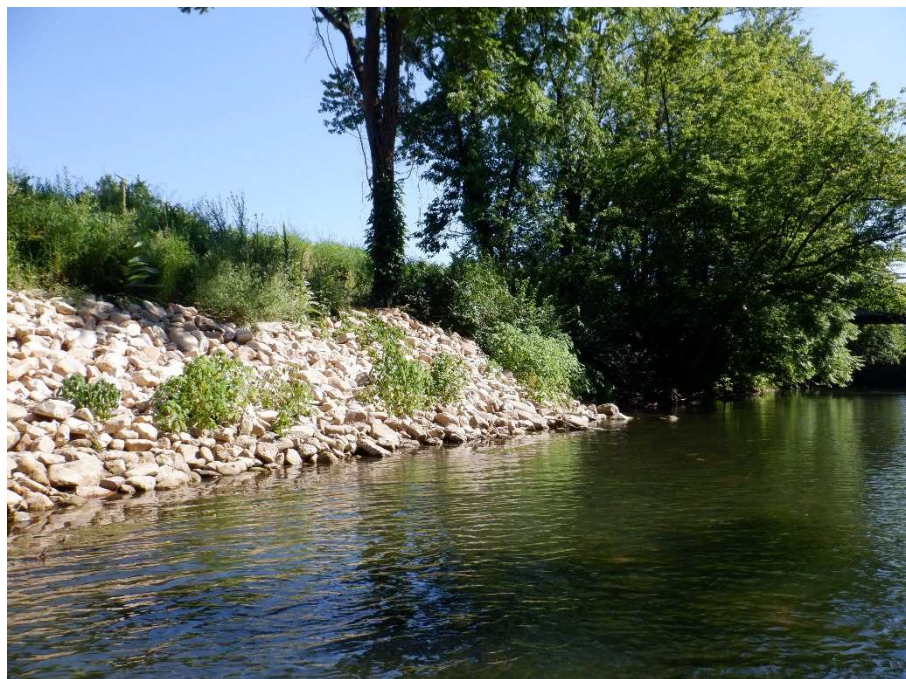
**Description:**  
~ 60 degree bank angle;  
downstream view of location;  
native vegetation cover 99%-  
grasses are dominant; black  
walnut tree canopy; bare soil  
patch at base of walnut; rock  
toe widens at downstream  
end ~8' wide; no scour.

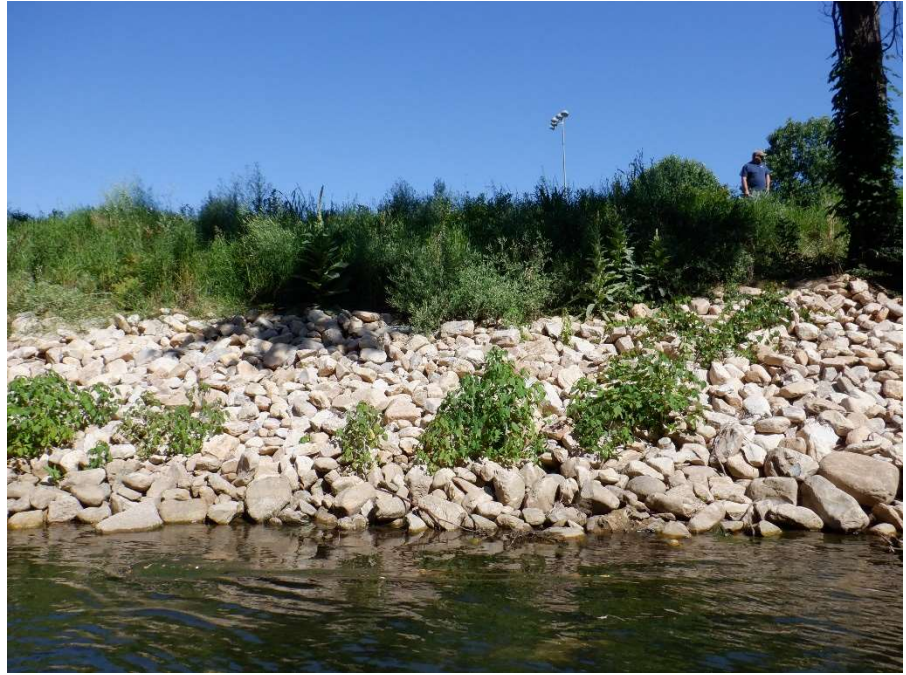
**Description:**  
~ 65 degree bank angle;  
black walnut- patch of soil at  
base, no knotweed, no  
exposed roots, significant  
native veg cover; no scour.

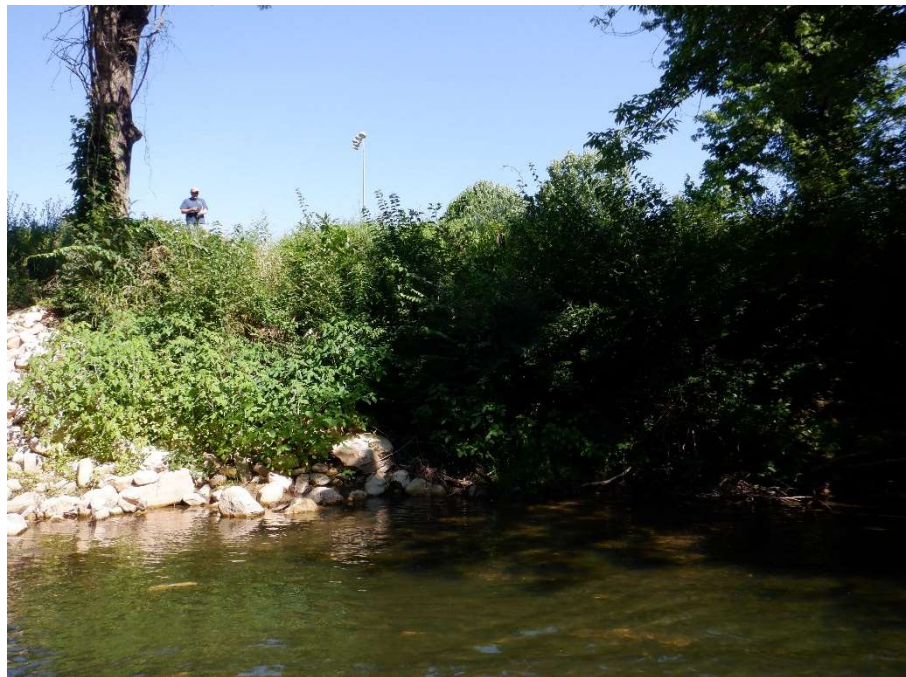
**Description:**  
~ 60 degree bank angle;  
exposed roots of box elder  
tree; invasive honeysuckle;  
black walnut; water pipe box  
and pedestrian access at toe;  
box elder at risk; sScour  
under tree roots.

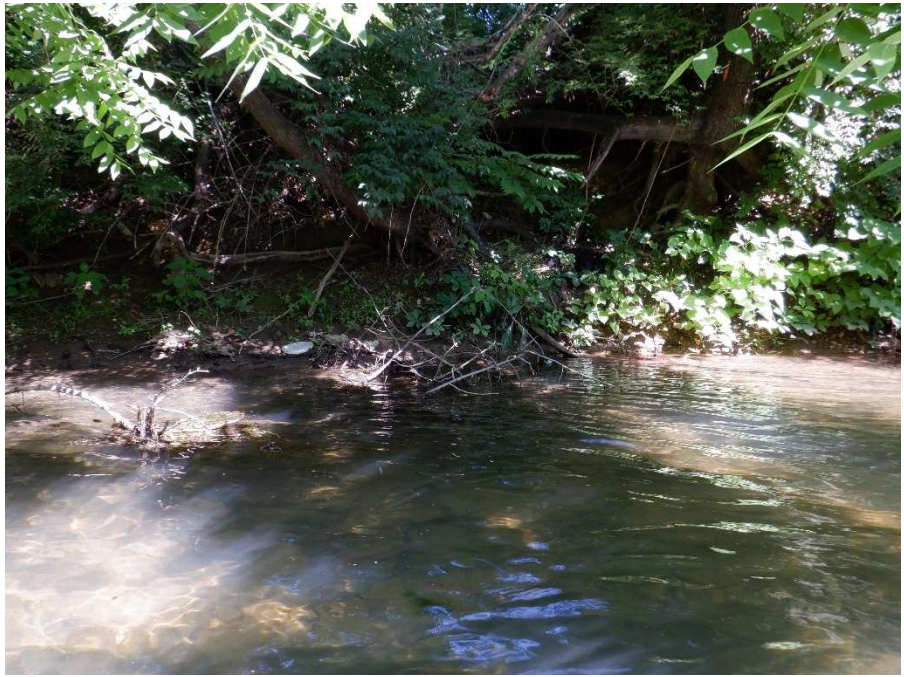
**Description:**  
~ 65 degree bank angle;  
invasive honeysuckle; black  
walnut exhibits exposed  
roots; black walder at risk;  
20% exposed soil; significant  
scour under roots.

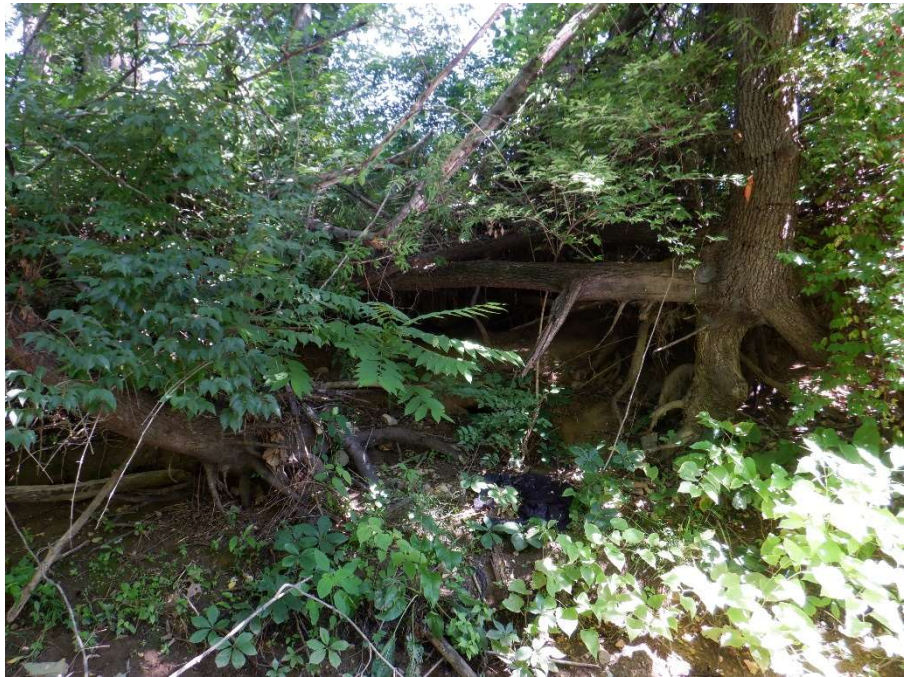
**Location:**  
00+2380'

**Description:**  
~ 70 degree bank angle;  
invasve honeysuckle  
alongside bridge abuttment;  
elm sapling and ailanthus  
tree at risk; jewelweed at  
toe of slope; elm sapling and  
ailanthus at risk; 5% exposed  
soil; minimum scour under  
roots.

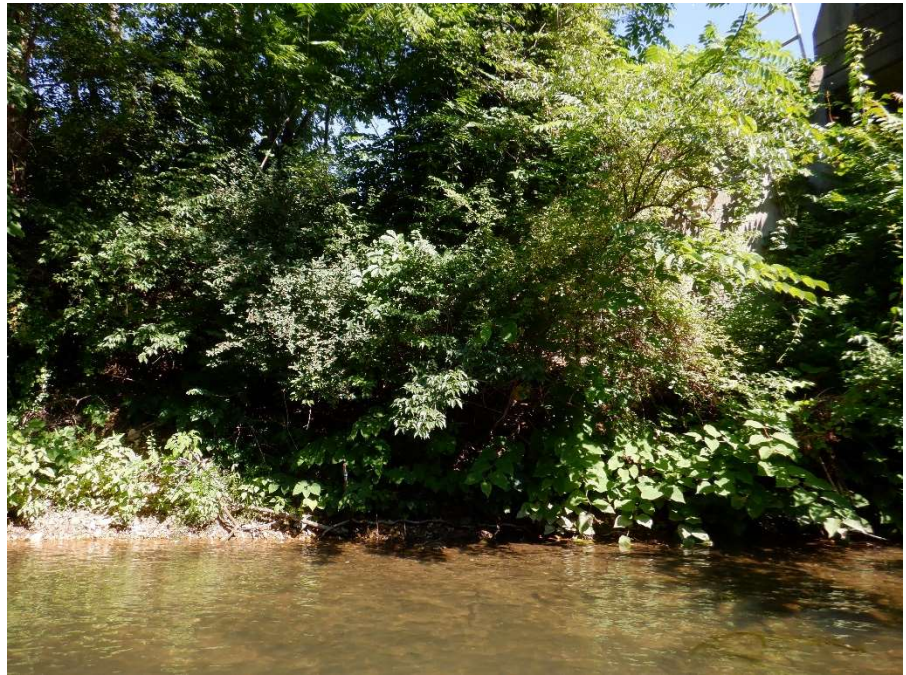
**Location:**  
00+2380'

**Description:**  
~ 70 degree bank angle;  
upstream view of location;  
invasve honeysuckle  
alongside bridge abuttment;  
elm sapling and ailanthus  
tree at risk; jewelweed at  
toe of slope; elm sapling and  
ailanthus at risk; 5% exposed  
soil; minimum scour under  
roots.
