**VIRGINIA DEPARTMENT OF ENVIRONMENTAL QUALITY**

**Re: 2021 Leaf-on and Leaf-off Maintenance Inspections  
Former DuPont Waynesboro Site AOC 4  
Waynesboro, Virginia  
EPA ID# VAD003114832**

Subject South River BMA - 2021 Leaf-Off Maintenance Inspection  
Former DuPont Waynesboro Site, Area of Concern 4

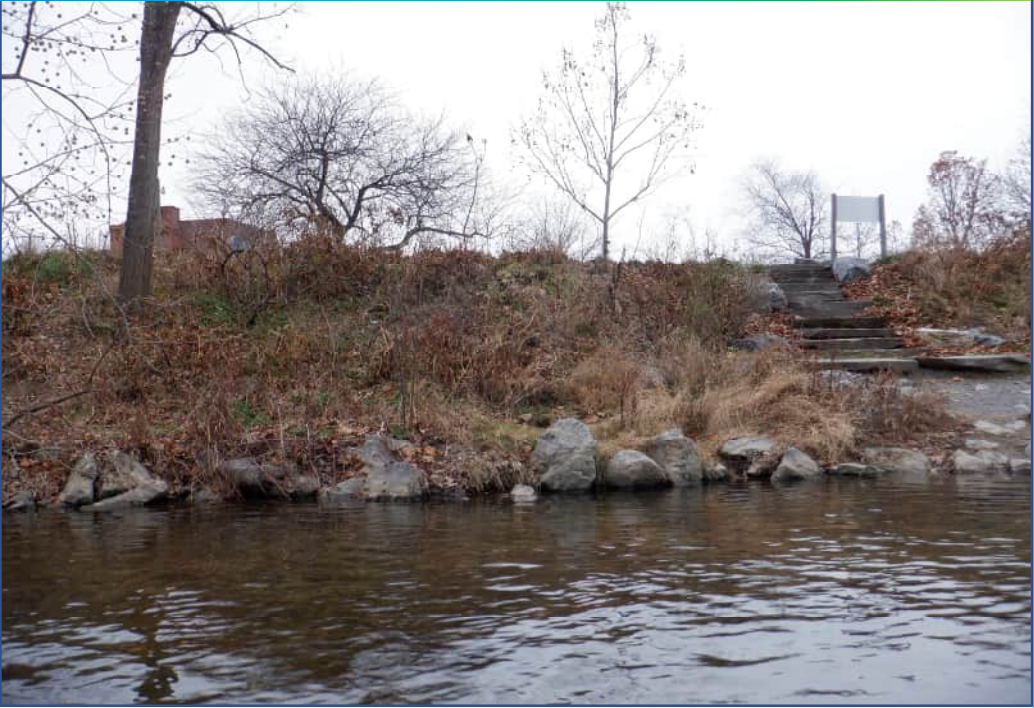
<b>Photo Number: 07</b>		<b>Location: 00 + 100'</b>
<b>Date: 12/8/2021</b>

<b>Direction: West</b>		
<b>Description:</b> Lower bank ~10°; upper bank ~45°; live stakes not visible; 80% vegetation cover; no at-risk trees present; sediment deposition adjacent to rock toe boulders.

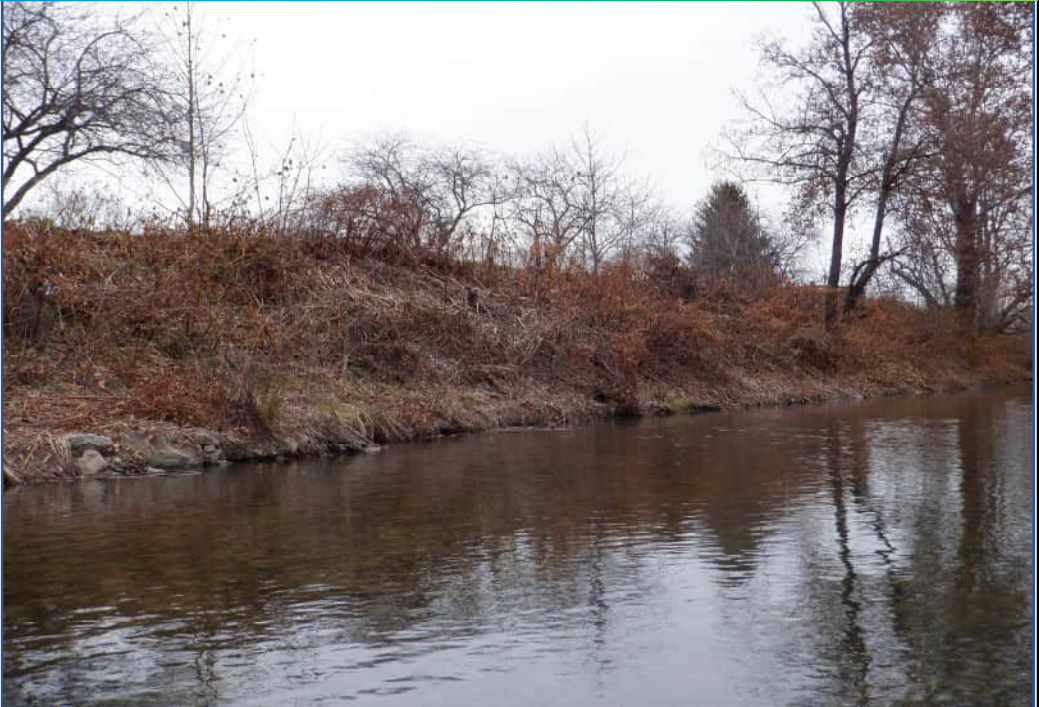
<b>Photo Number:</b> 10		<b>Location:</b> 00 + 150'	
<b>Date:</b> 12/8/2021

<b>Direction:</b> Northwest			
<b>Description:</b> Downstream view of bank remediation; significant geocell exposure along bank (~50 feet across bank by 3-4' height).

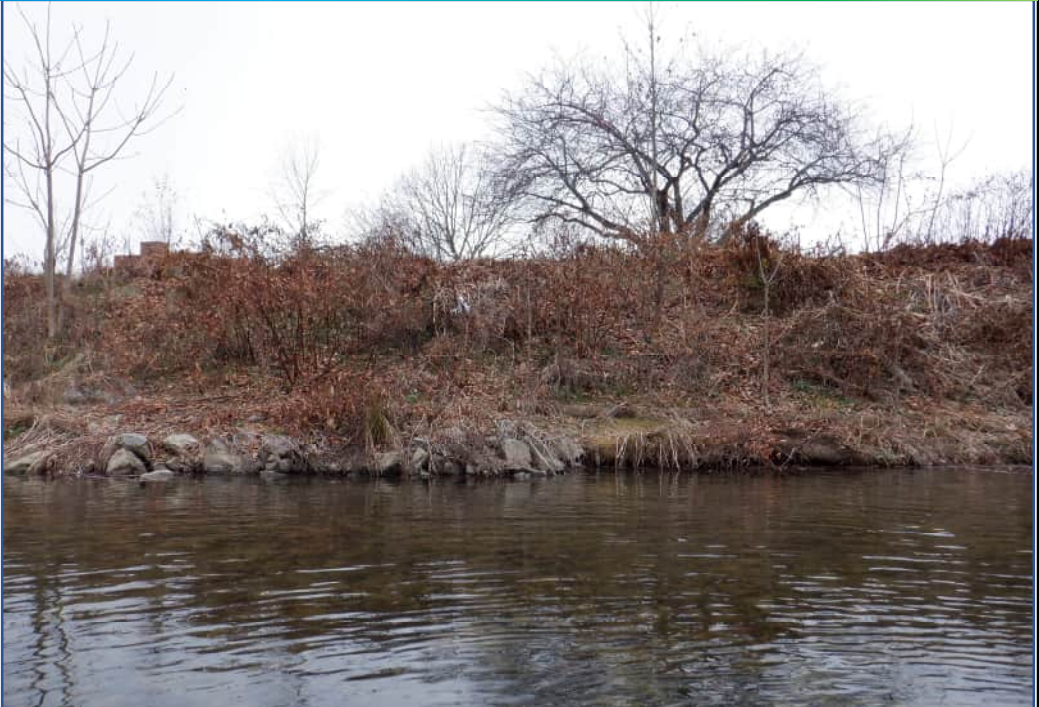
<b>Photo Number:</b> 12		<b>Location:</b> 00 + 200'	
<b>Date:</b> 12/8/2021

<b>Direction:</b> West			
<b>Description:</b> ~55° bank angle; small patches of invasive vegetation present; 75% vegetation cover; geocell visible; evidence of foot traffic along the toe of slope; minimal scour along toe.

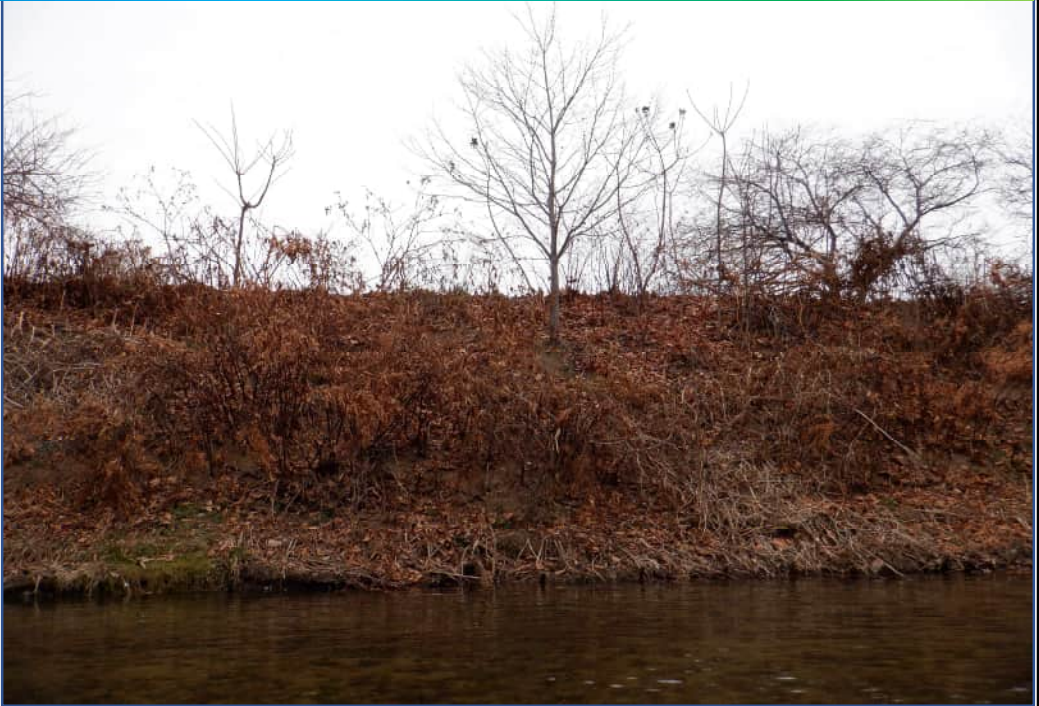
<b>Photo Number:</b> 13		<b>Location:</b> 00 + 250'
<b>Date:</b> 12/8/2021

<b>Direction:</b> West		
<b>Description:</b> ~55° bank angle; patches of invasive vegetation present; live stakes 20% established; 60% vegetation cover; no trees adjacent to edge of water.

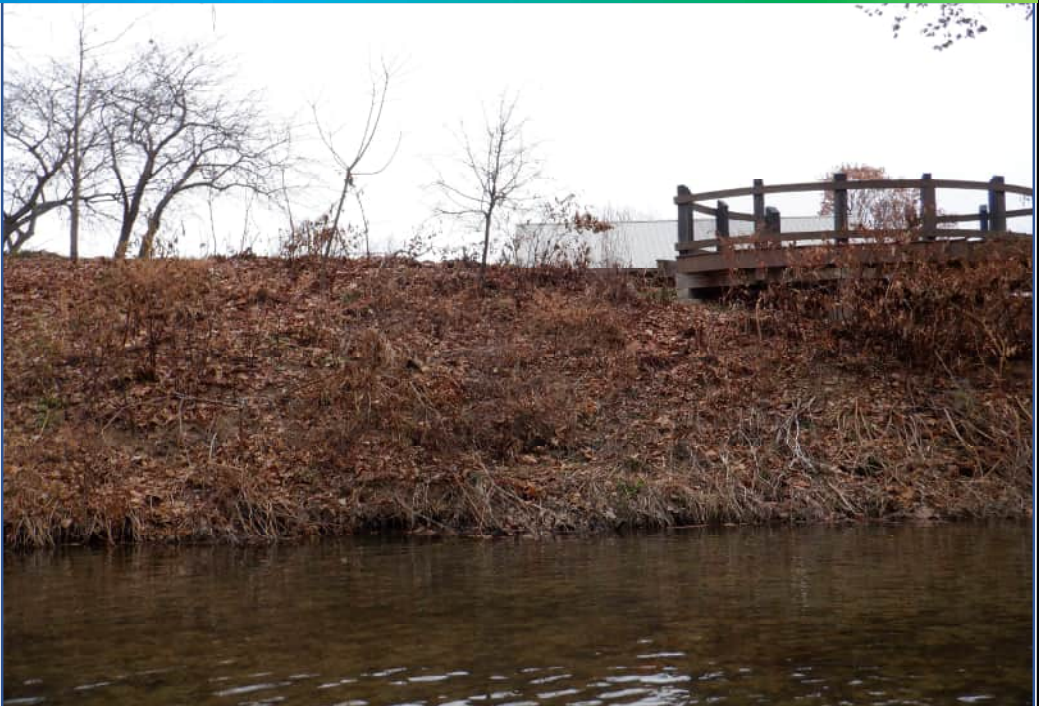
<b>Photo Number:</b> 16		<b>Location:</b> 00+350'
<b>Date:</b> 12/8/2021

<b>Direction:</b> West		
<b>Description:</b> ~70° bank angle; minimal vegetation present; live stakes 30% established; 40% vegetation cover; geocell partially exposed; no trees adjacent to edge of water.

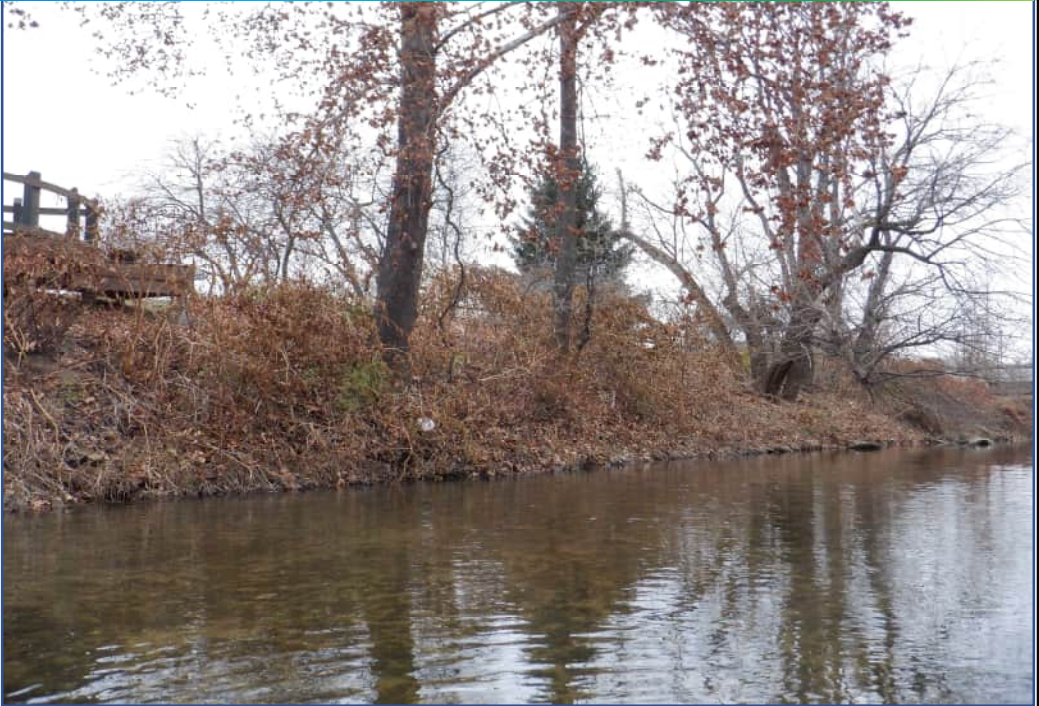
<b>Photo Number:</b> 17		<b>Location:</b> 00+350'	
<b>Date:</b> 12/8/2021

<b>Direction:</b> Northwest			
<b>Description:</b> Downstream view of bank remediation; scour at toe.

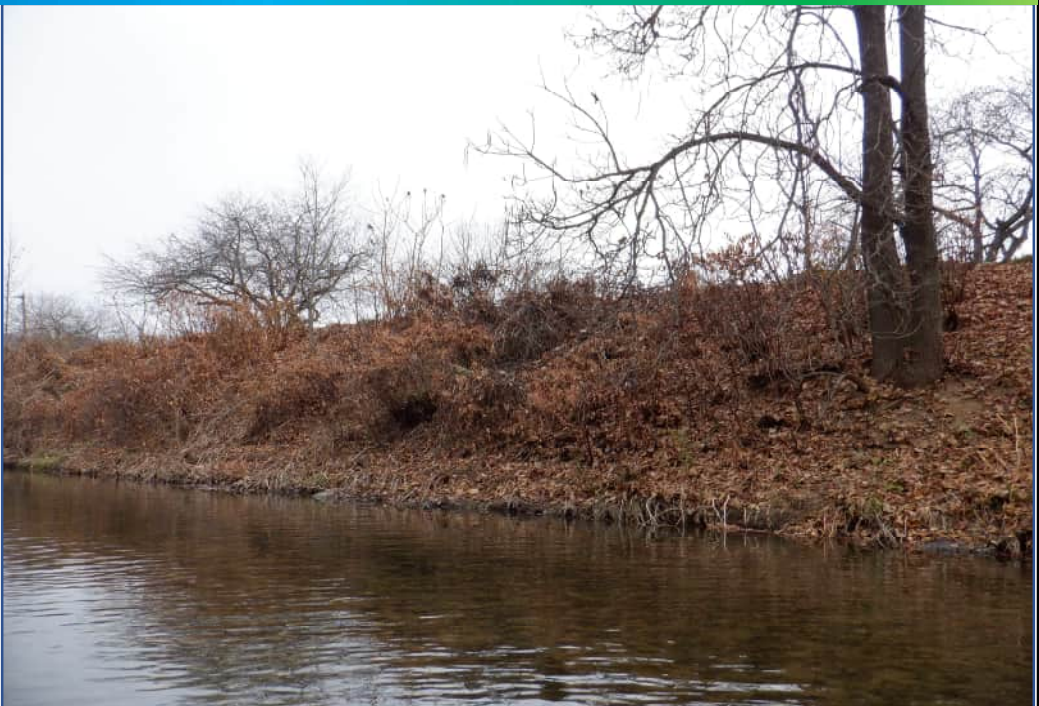
<b>Photo Number:</b> 18		<b>Location:</b> 00+350'	
<b>Date:</b> 12/8/2021

<b>Direction:</b> Southwest			
<b>Description:</b> Upstream view of bank remediation; minimal vegetation cover; geocell partially exposed; scour at toe.

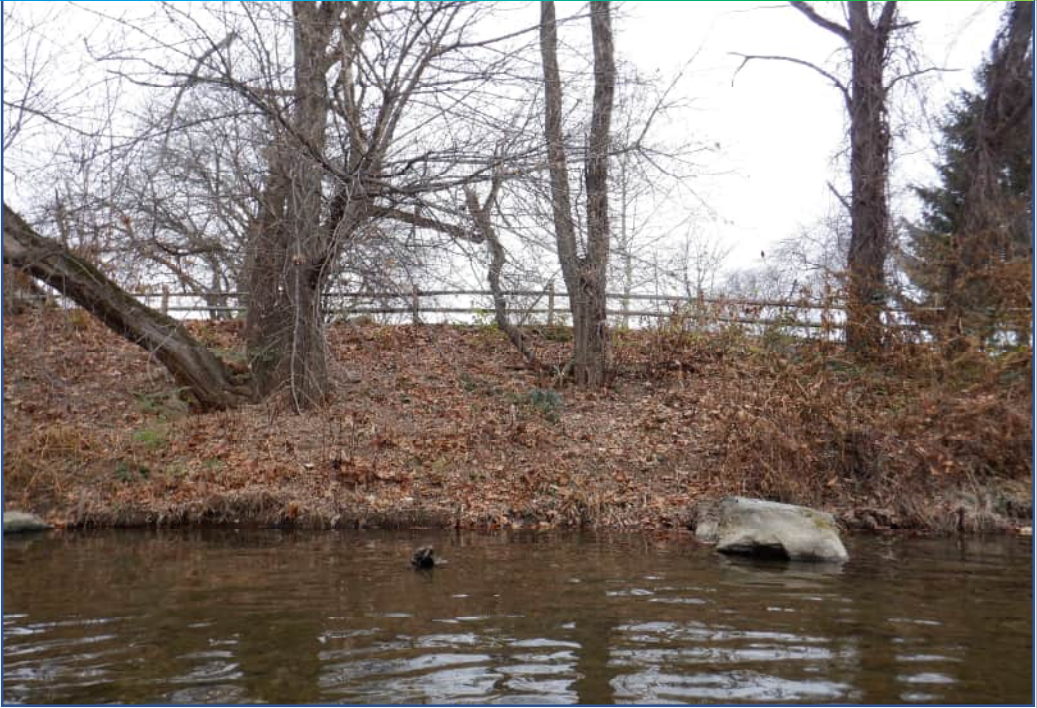
<b>Photo Number:</b> 21		<b>Location:</b> 00+450'	
<b>Date:</b> 12/8/2021

<b>Direction:</b> West			
<b>Description:</b> ~50° bank angle; minimal vegetation present; live stakes 20% established; 20% vegetation cover.

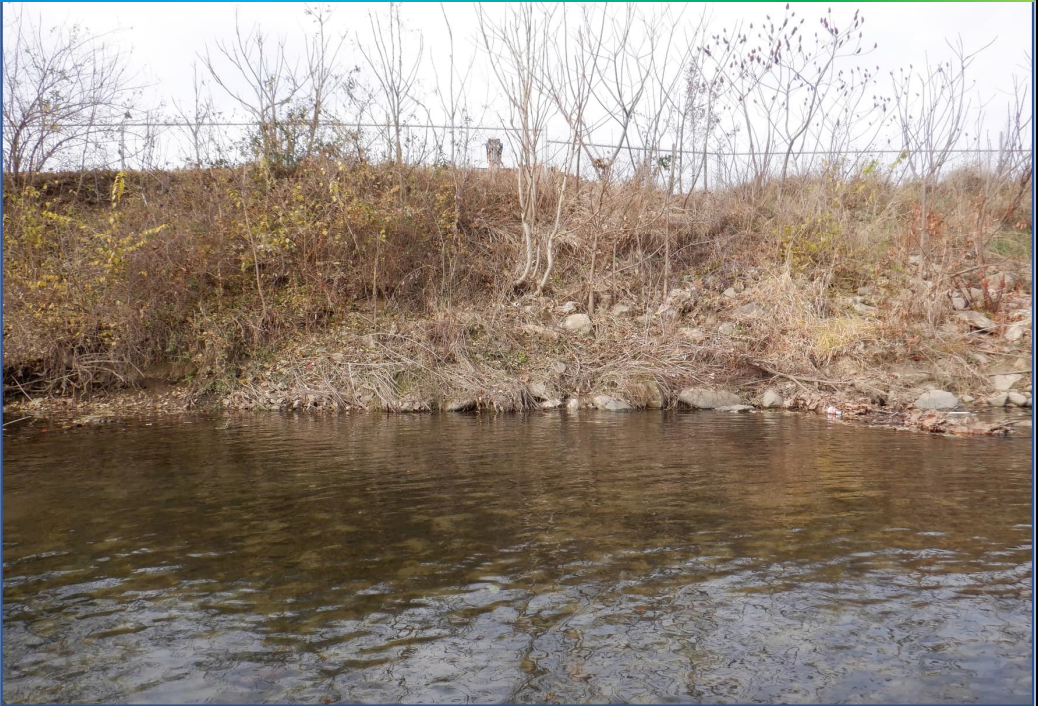
Photo Number: 03		Location: 00+00'	
Date: 12/7/2021

Direction: Northwest			
<p>Description: Start of remediated area; lower bank ~60°; upper bank ~80°; no woody plants adjacent to edge of water; vegetation fully established and grasses establishing by rock toe; no woody plants adjacent to edge of water; some scour present from rock toe to mid bank upstream of remediation.</p>

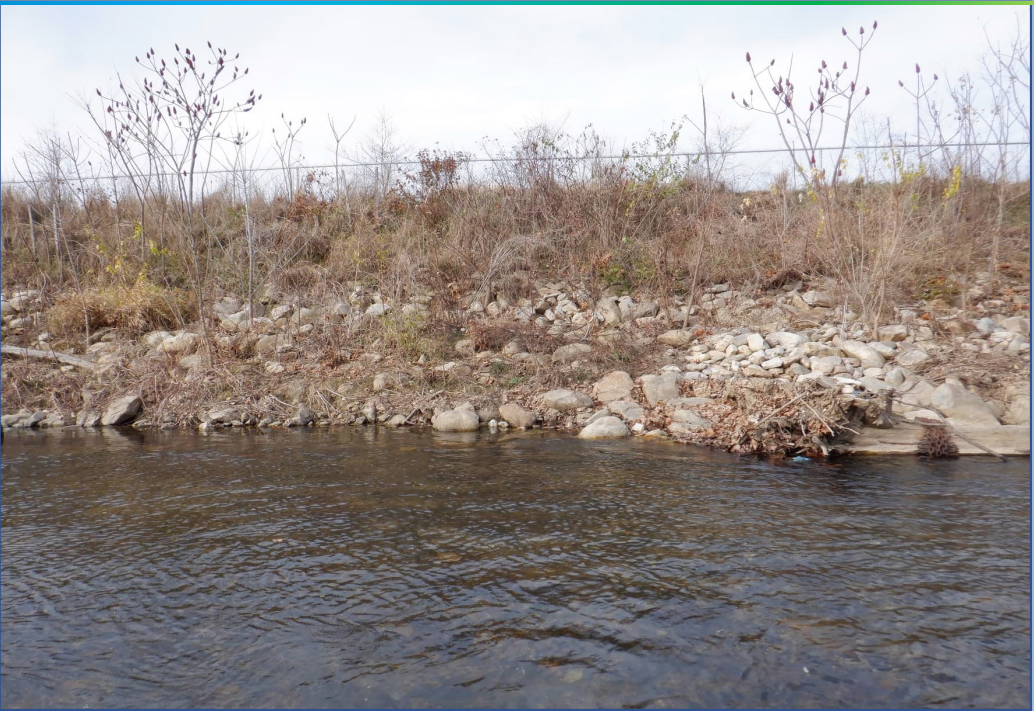
Photo Number: 06		Location: 00+100'	
Date: 12/7/2021

Direction: Northwest			
Description: ~45° bank angle; predominantly native vegetation above rock toe; flood debris on rock toe; vegetation fully established; grasses establishing in rock toe; no woody plants adjacent to edge of water; LWD intact.

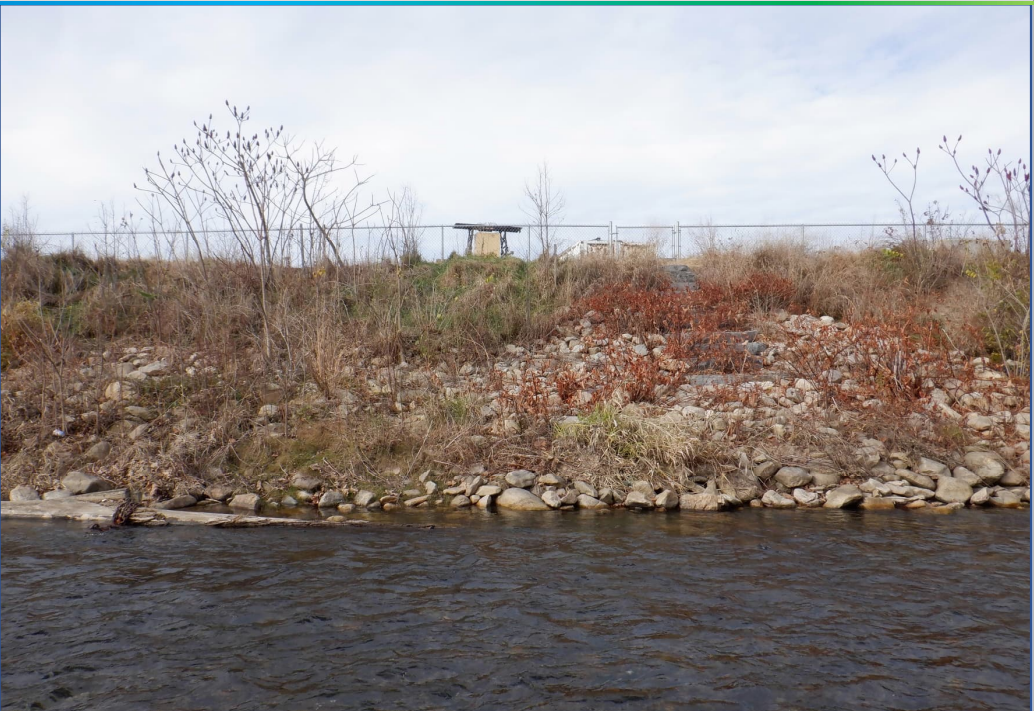
Photo Number: 08		Location: 00+200'	
Date: 12/7/2021

Direction: Northwest			
<p>Description: ~45° bank angle; predominantly native vegetation; flood debris on top of rock toe; vegetation fully established and grasses establishing in rock toe; no woody plants adjacent to edge of water; stairs and gate intact; outfall intact.</p>

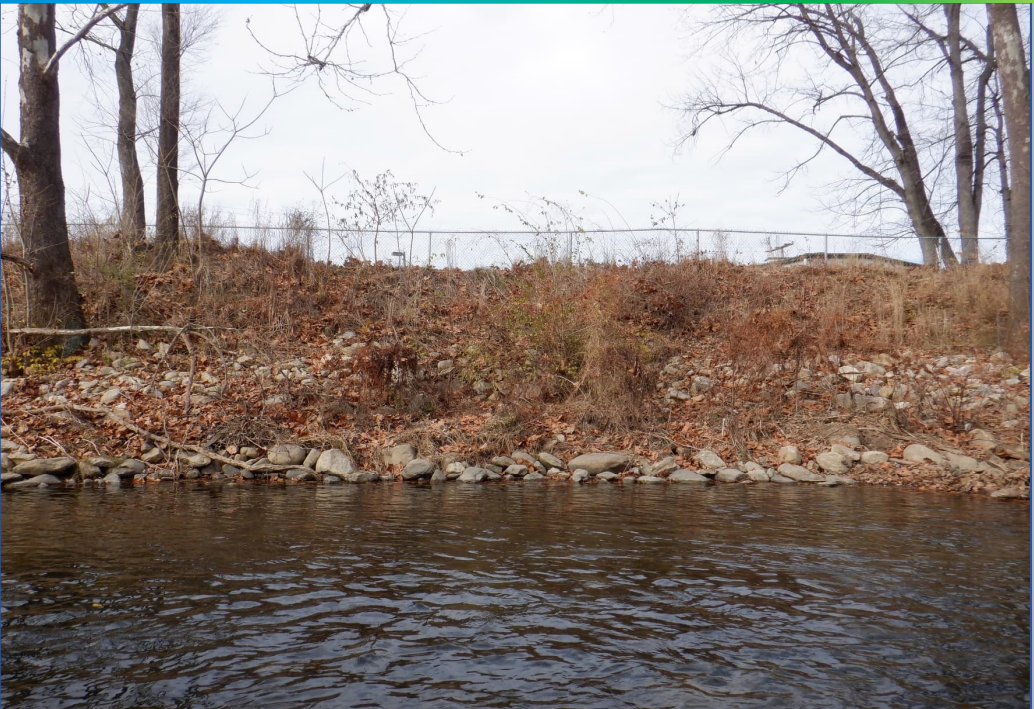
Photo Number: 14		Location: 00+400'	
Date: 12/7/2021

Direction: Northwest			
Description: ~45° bank angle; predominantly native vegetation with flood debris on top of intact rock toe; vegetation fully established; no at-risk trees present; erosion control fabric exposed on upper bank; upstream LWD shifted and is parallel to downstream LWD; outfall pipes intact.

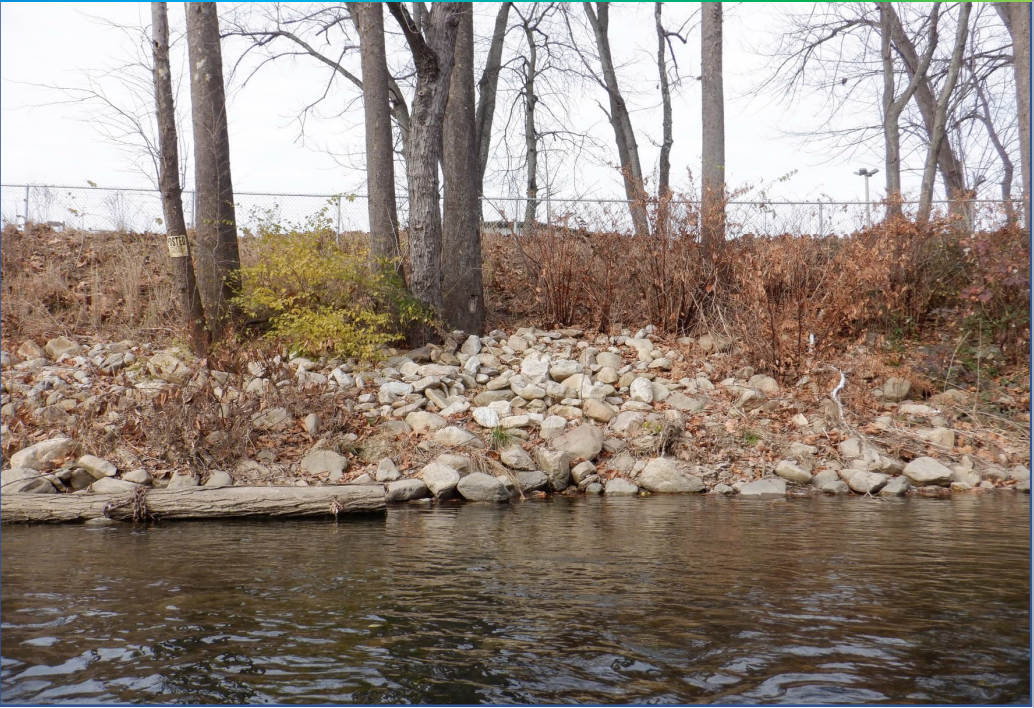
Photo Number: 15		Location: 00+450'	
Date: 12/7/2021

Direction: Northwest			
Description: ~45° bank angle; native vegetation above rock toe; vegetation fully established; no at-risk trees present; erosion control fabric exposed at top of bank and around tree bases; rock toe intact.

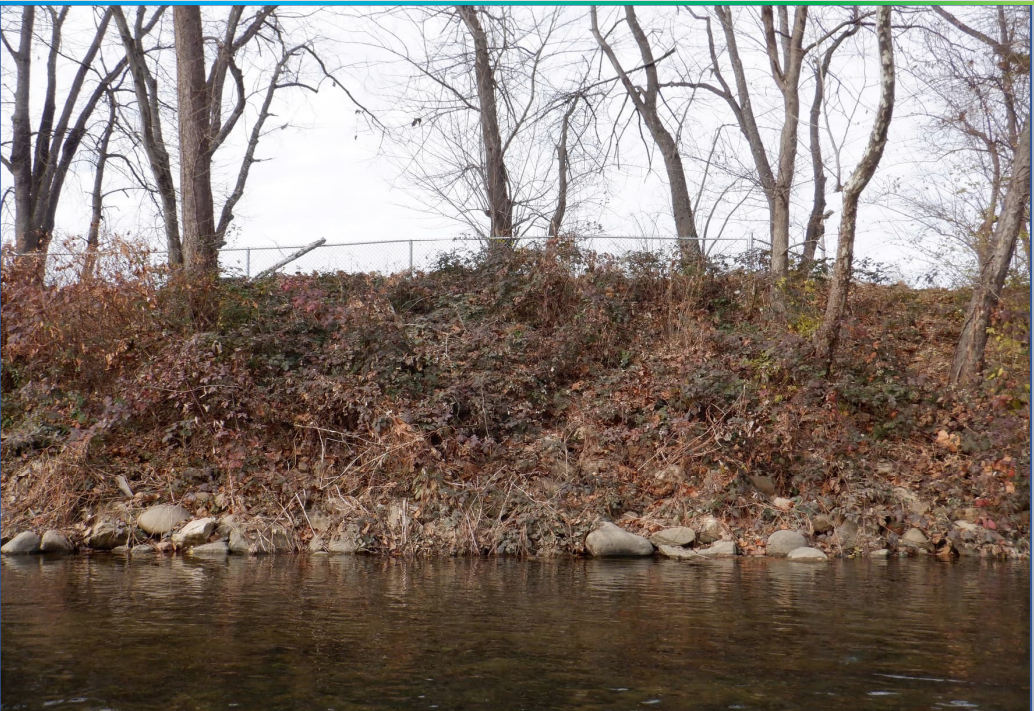
Photo Number: 16		Location: 00+500'	
Date: 12/7/2021

Direction: Northwest			
Description: ~45° bank angle; end of 1 <sup>st</sup> remediated section; native vegetation above rock toe; vegetation fully established; small at- risk sycamore on mid- bank; rock toe intact.

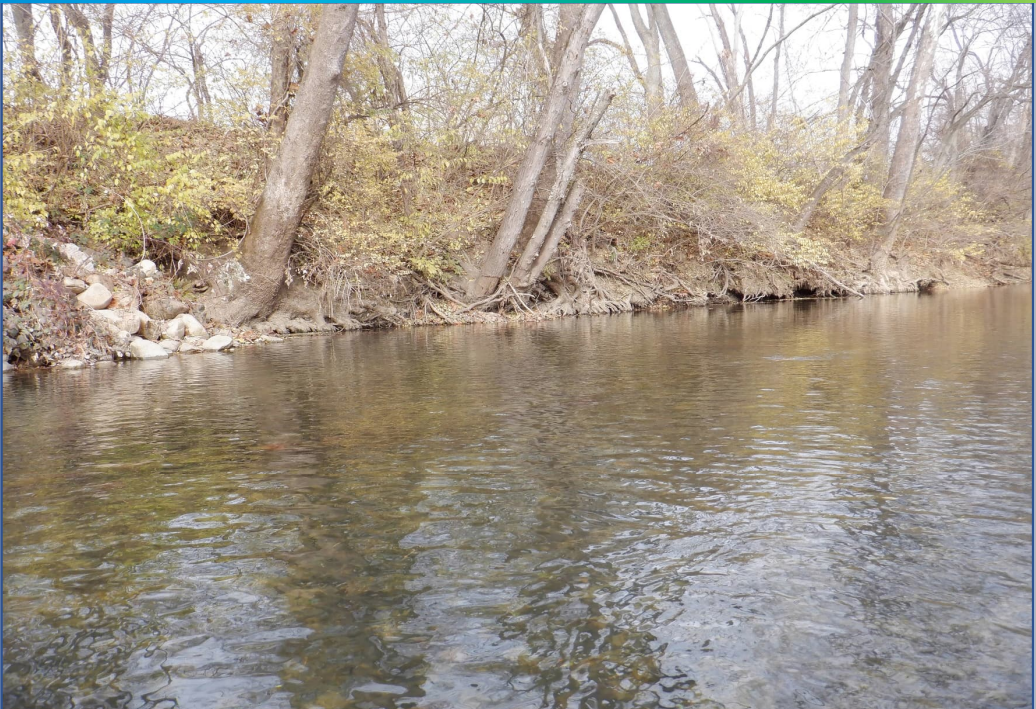
Photo Number: 18		Location: 00+500'	
Date: 12/7/2021

Direction: Northeast			
Description: Downstream view of the end of the 1 <sup>st</sup> remediated section; significant erosion and scour; at-risk trees present.

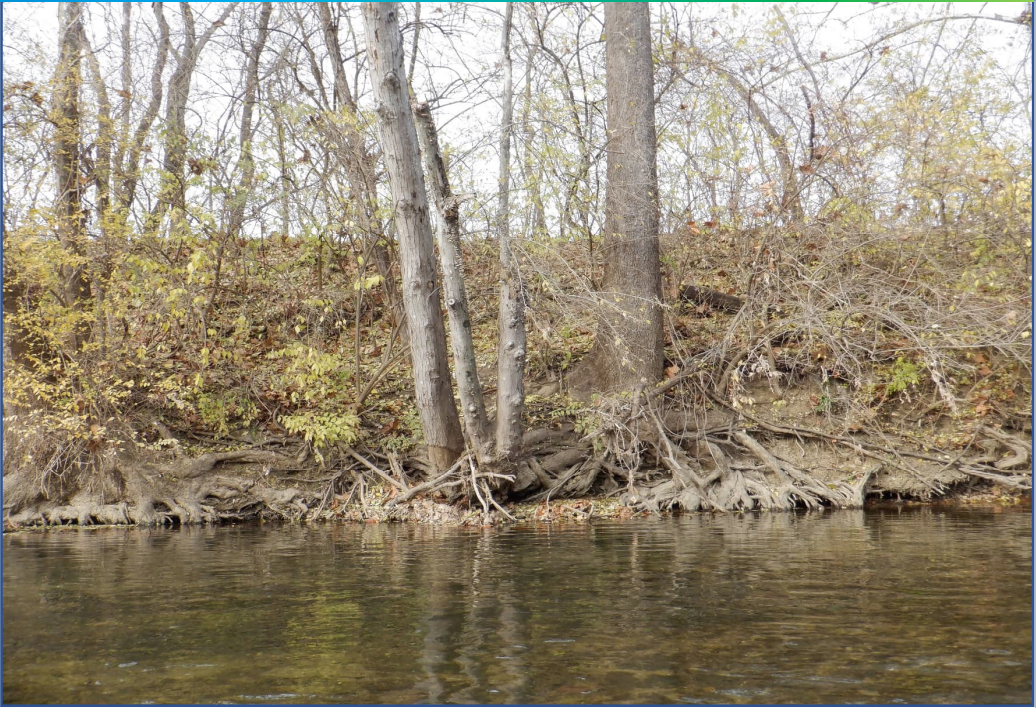
Photo Number: 19		Location: 00+550'	
Date: 12/7/2021

Direction: Northwest			
Description: Non-remediated area; ~70° bank angle; significant bank erosion and undercutting; high density of exposed roots; several large at-risk; significant scour lower bank.

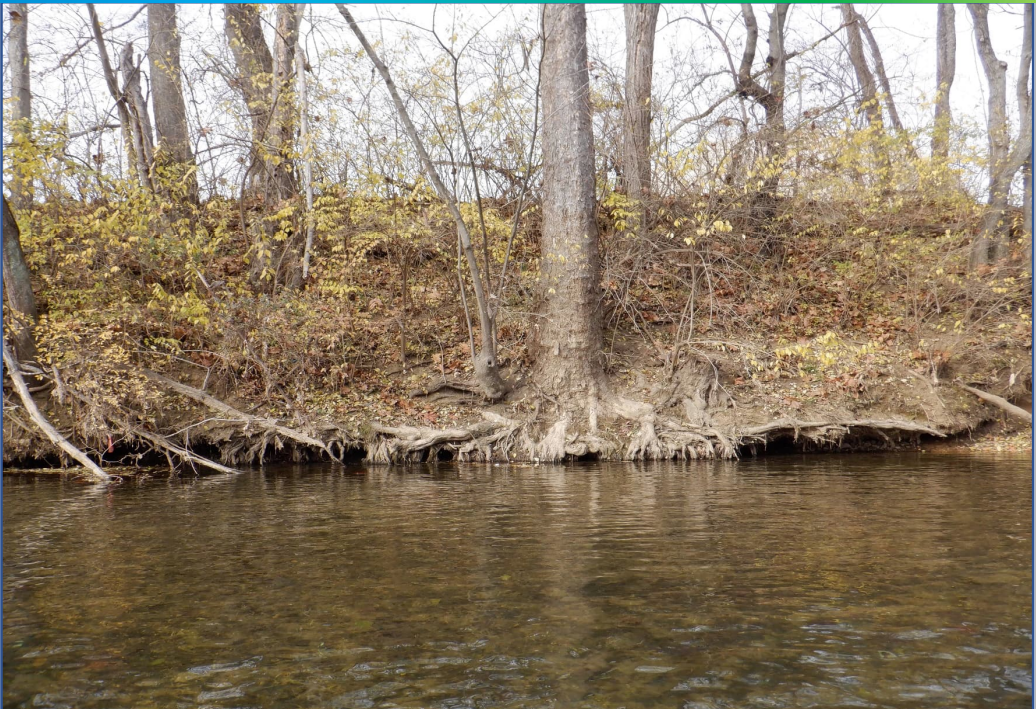
Photo Number: 20		Location: 00+600'	
Date: 12/7/2021

Direction: Northwest			
Description: Non-remediated area; ~75° bank angle; significant bank erosion and undercutting; high density of exposed roots; significant scour lower bank.

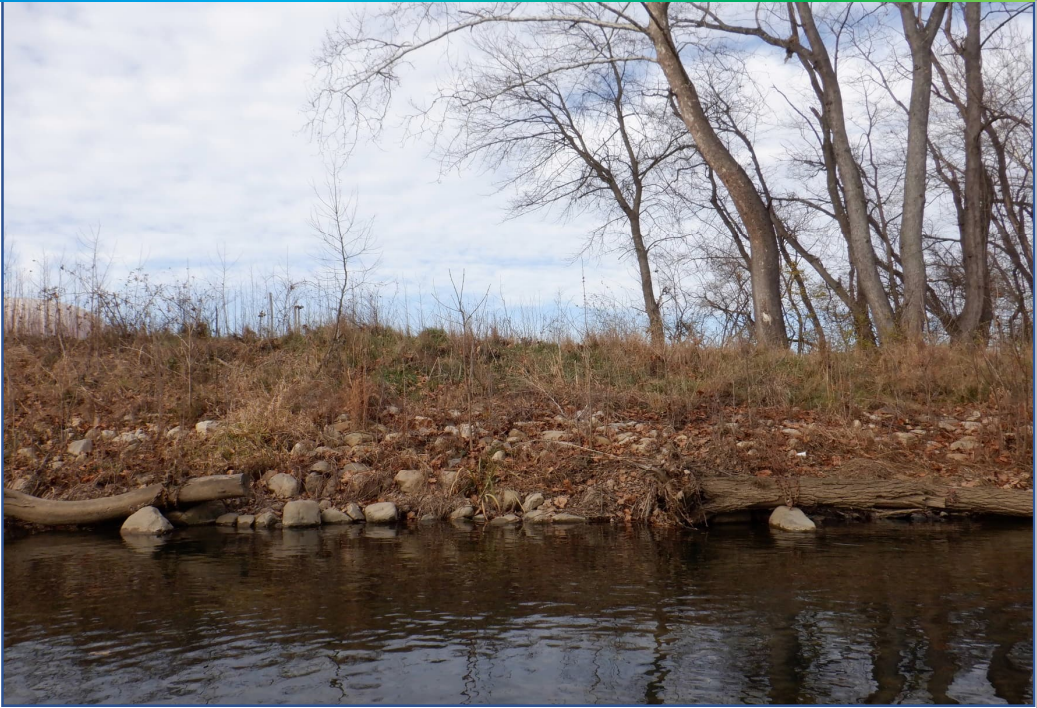
Photo Number: 27		Location: 00+800'	
Date: 12/7/2021

Direction: Northwest			
Description: ~40° bank angle; vegetation established above rock toe; no at-risk trees present; rock toe intact; LWD intact.

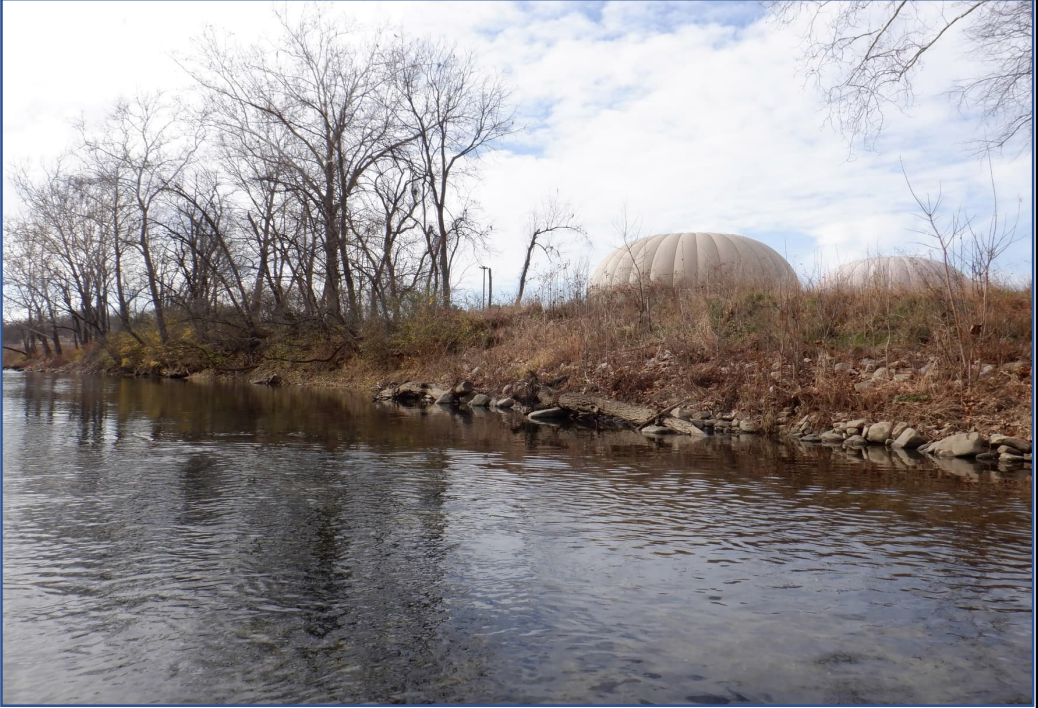
Photo Number: 29	Location: 00+850'
Date: 12/7/2021

Direction: Southeast	
Description: Upstream view of remediated bank; rock toe intact; LWD intact; vegetation established.

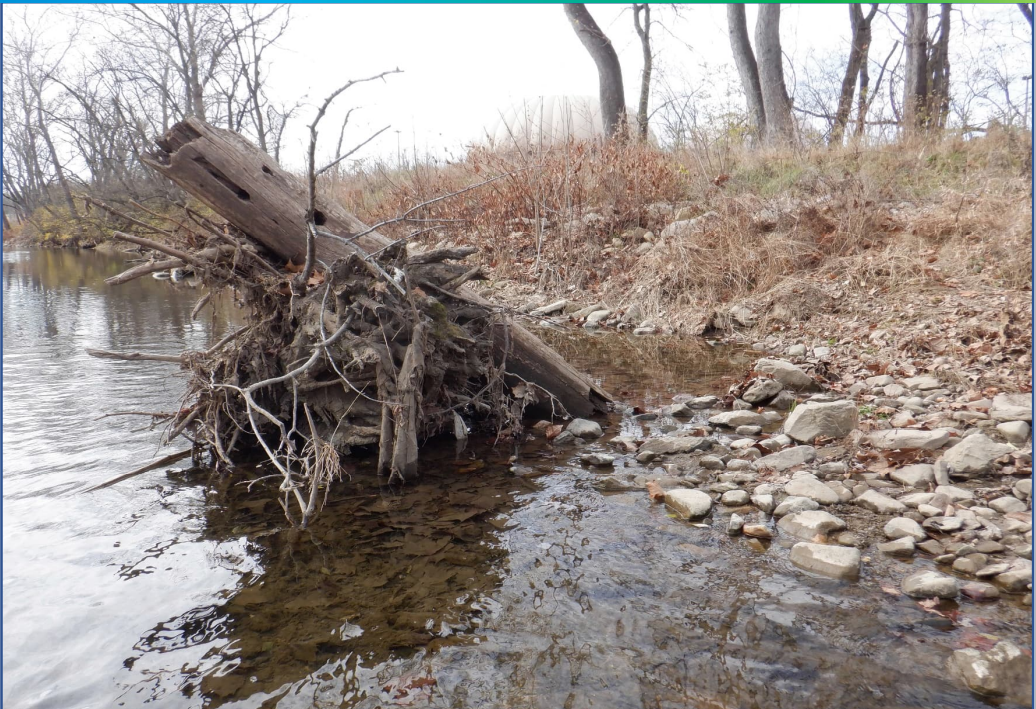
Photo Number: 32	Location: 00+880'
Date: 12/7/2021

Direction: Southeast	
Description: Upstream view of remediated bank; sediment deposition around shifted LWD.

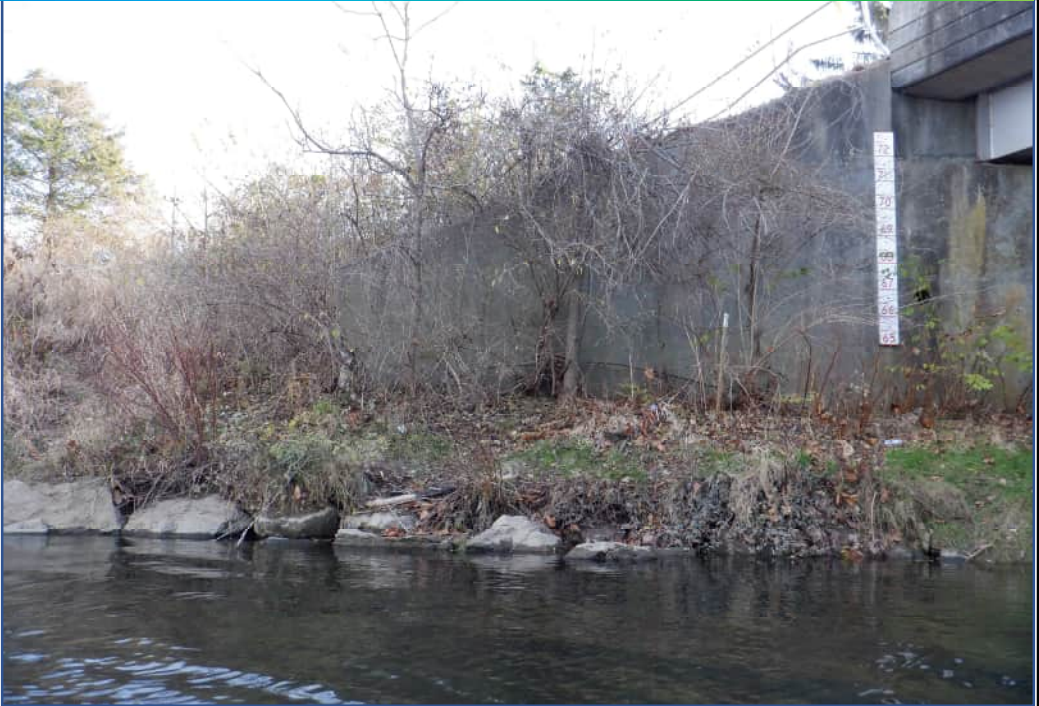
<b>Photo Number:</b> 01		<b>Location:</b> 00-20'	
<b>Date:</b> 12/7/2021

<b>Direction:</b> Southeast			
<b>Description:</b> ~20° bank angle; no woody plants adjacent to edge of water; upstream of remediation; heavy foot traffic along bank is evident.

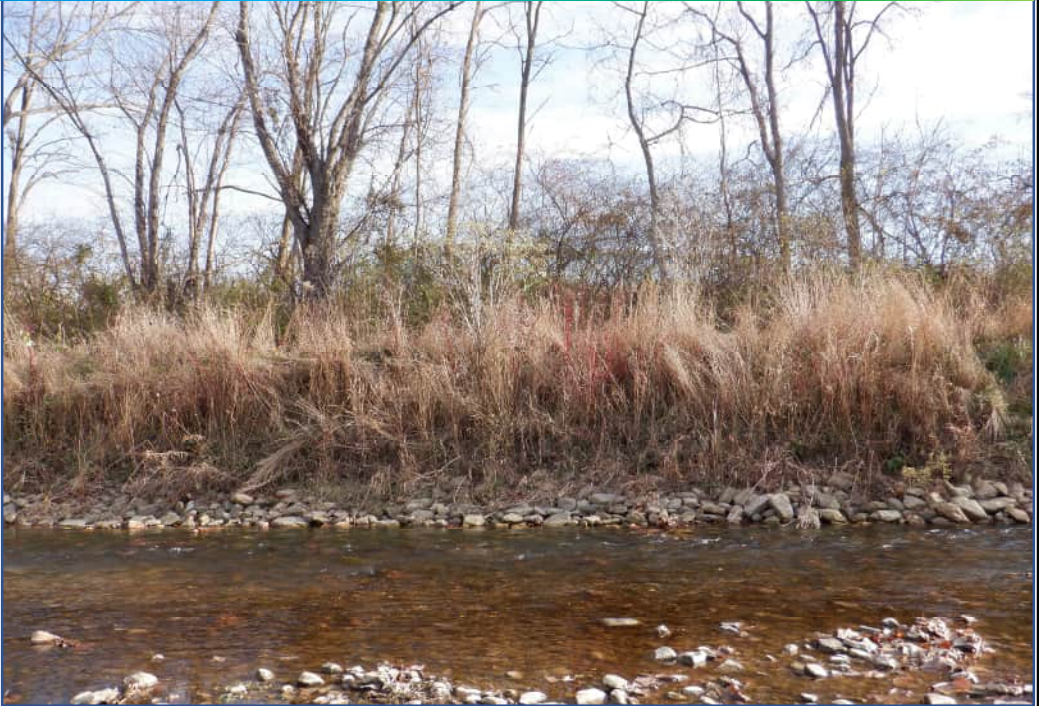
<b>Photo Number:</b> 07		<b>Location:</b> 00+150'	
<b>Date:</b> 12/7/2021

<b>Direction:</b> Southeast			
<b>Description:</b> ~50° bank angle; live stakes 60% established; herbaceous vegetation fully established; no at-risk trees present; rock toe intact; sand deposition at toe of bank.

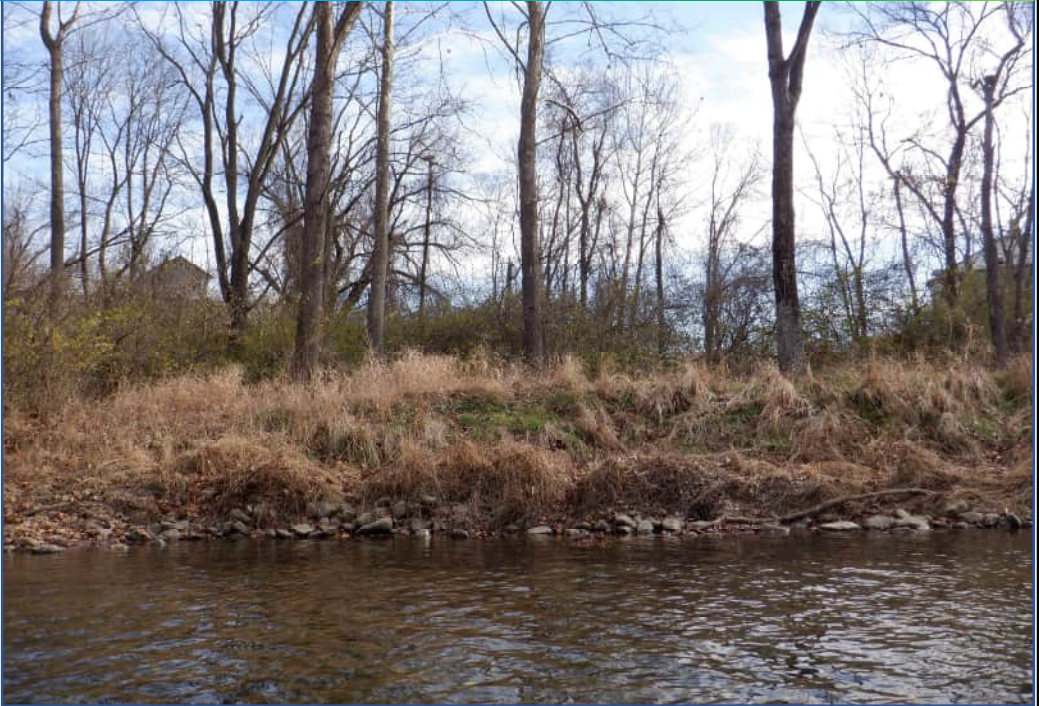
<b>Photo Number:</b> 19		<b>Location:</b> 00+700'	
<b>Date:</b> 12/7/2021

<b>Direction:</b> Southeast			
<b>Description:</b> Lower bank ~20°; upper bank ~40°; live stakes 20% established; herbaceous vegetation fully established; no at-risk trees present; rock toe intact; sand deposition at toe of bank.

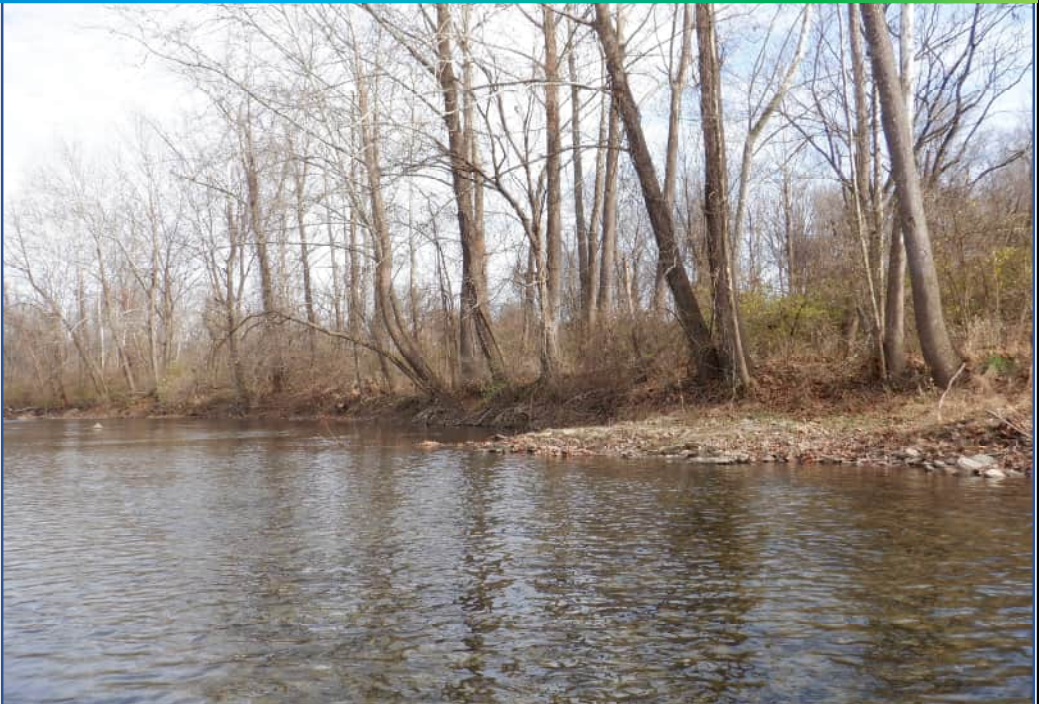
<b>Photo Number:</b> 20		<b>Location:</b> 00+700'	
<b>Date:</b> 12/7/2021

<b>Direction:</b> East			
<b>Description:</b> Downstream view of remediated bank; herbaceous vegetation fully established; no at-risk trees present.

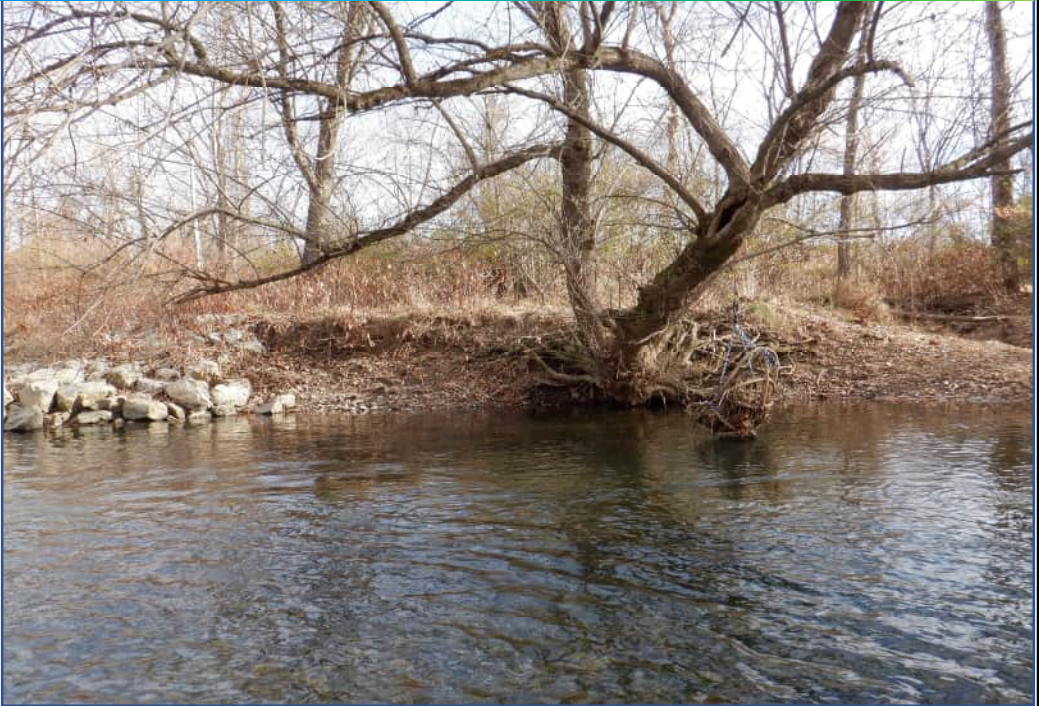
<b>Photo Number:</b> 23		<b>Location:</b> 00+1250'
<b>Date:</b> 12/7/2021

<b>Direction:</b> Southeast		
<b>Description:</b> Start of 2 <sup>nd</sup> remediated section; bank angle non-remediated upstream section ~80°; remediated section ~40°; exposed roots just upstream of remediated bank; herbaceous vegetation fully established; one large at-risk tree upstream of remediated bank.

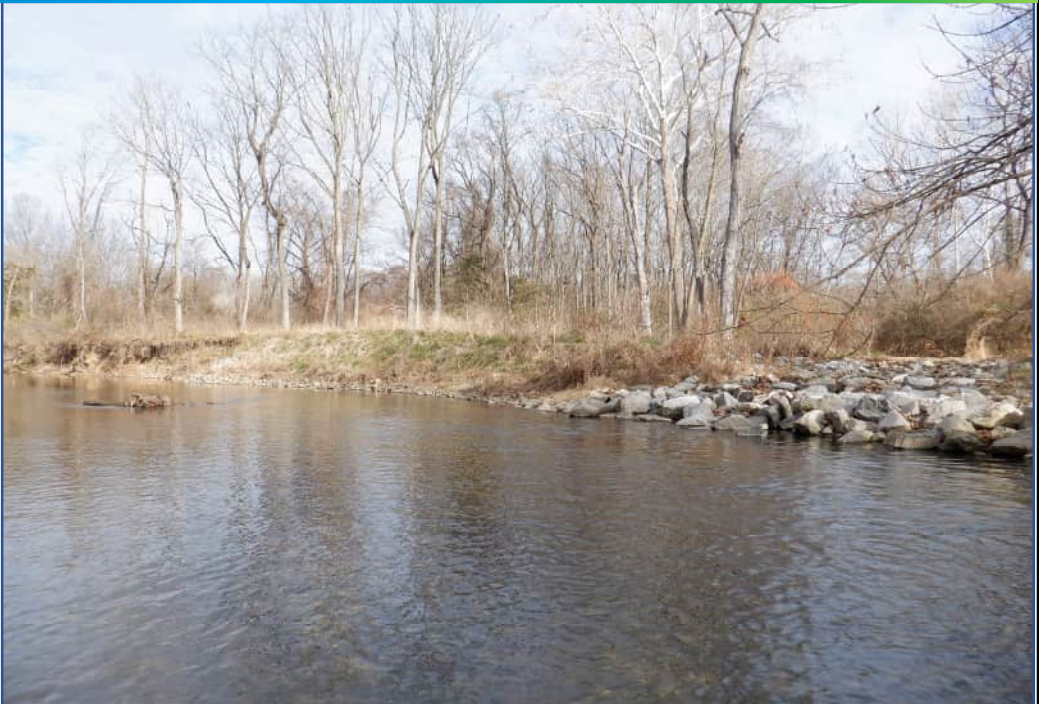
<b>Photo Number:</b> 24		<b>Location:</b> 00+1250'
<b>Date:</b> 12/7/2021

<b>Direction:</b> East		
<b>Description:</b> Downstream view of start of 2 <sup>nd</sup> remediated bank; entirely rip rap portion of bank; remediation downstream.

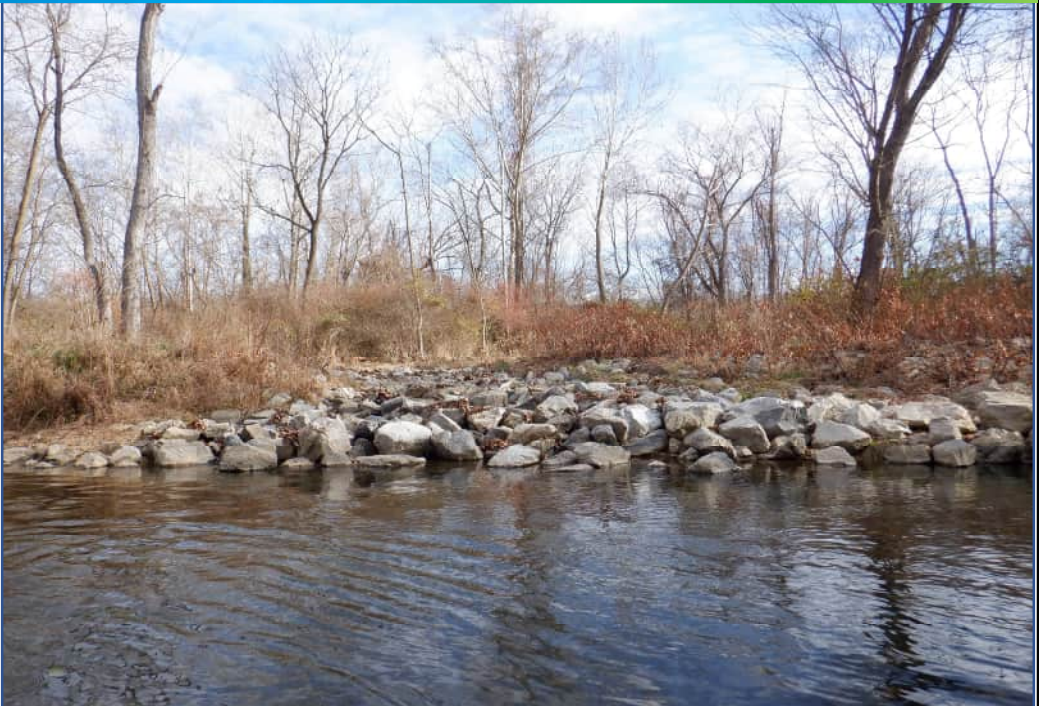
<b>Photo Number:</b> 26		<b>Location:</b> 00+1300'	
<b>Date:</b> 12/7/2021

<b>Direction:</b> Southeast			
<b>Description:</b> ~20° bank angle; fortified tributary channel; no exposed roots; herbaceous vegetation fully established around channel; no at-risk trees present; entirely rip rap portion of bank.

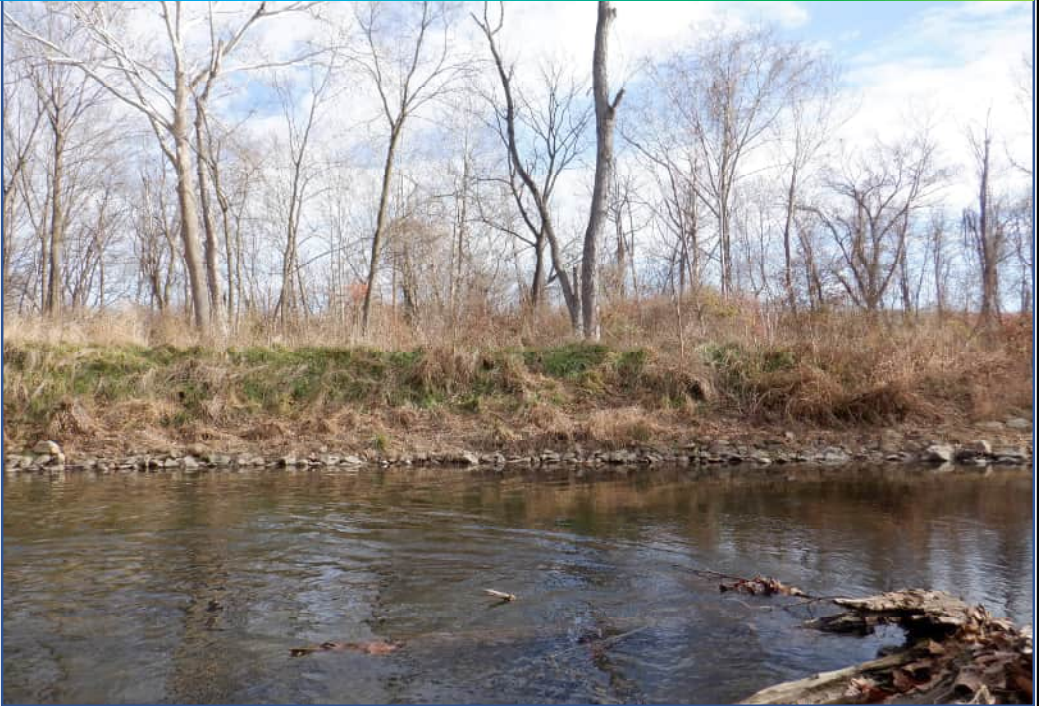
<b>Photo Number:</b> 27		<b>Location:</b> 00+1350'	
<b>Date:</b> 12/7/2021

<b>Direction:</b> Southeast			
<b>Description:</b> ~50° bank angle; live stakes 20% established; herbaceous vegetation fully established; no at-risk trees present; rock toe intact.
