**VIRGINIA DEPARTMENT OF ENVIRONMENTAL QUALITY**

**Re: 2021 Leaf-on and Leaf-off Maintenance Inspections  
Former DuPont Waynesboro Site AOC 4  
Waynesboro, Virginia  
EPA ID# VAD003114832**

Subject South River BMA - 2021 Leaf-Off Maintenance Inspection  
Former DuPont Waynesboro Site, Area of Concern 4

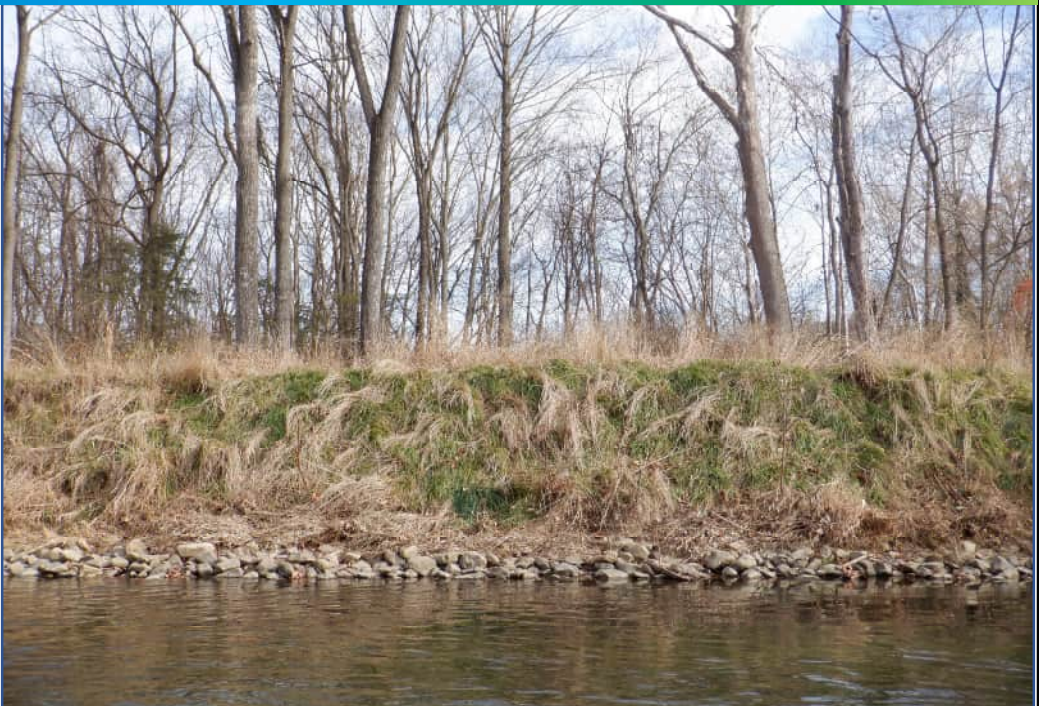
<b>Photo Number:</b> 28		<b>Location:</b> 00+1400'	
<b>Date:</b> 12/7/2021

<b>Direction:</b> Southeast			
<b>Description:</b> ~80° bank angle; live stakes 50% established; herbaceous vegetation fully established; no at-risk trees present; rock toe intact.

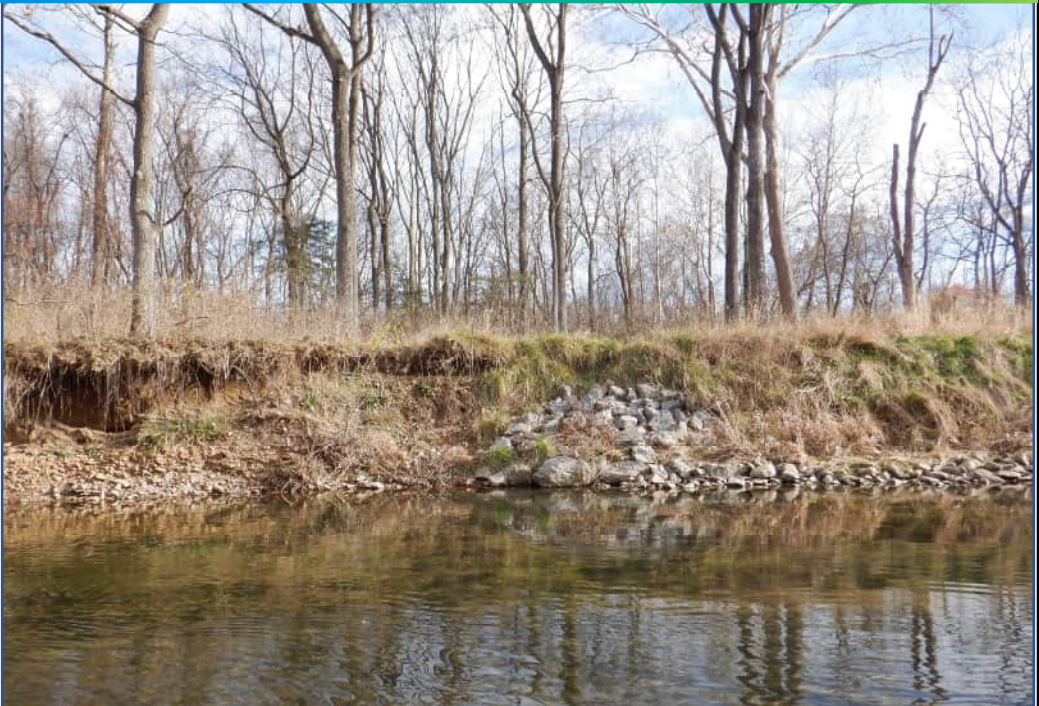
<b>Photo Number:</b> 30		<b>Location:</b> 00+1450'	
<b>Date:</b> 12/7/2021

<b>Direction:</b> Southeast			
<b>Description:</b> ~80° bank angle; live stakes 50% established; herbaceous vegetation fully established; no at-risk trees present; rip rap bank abutment intact.

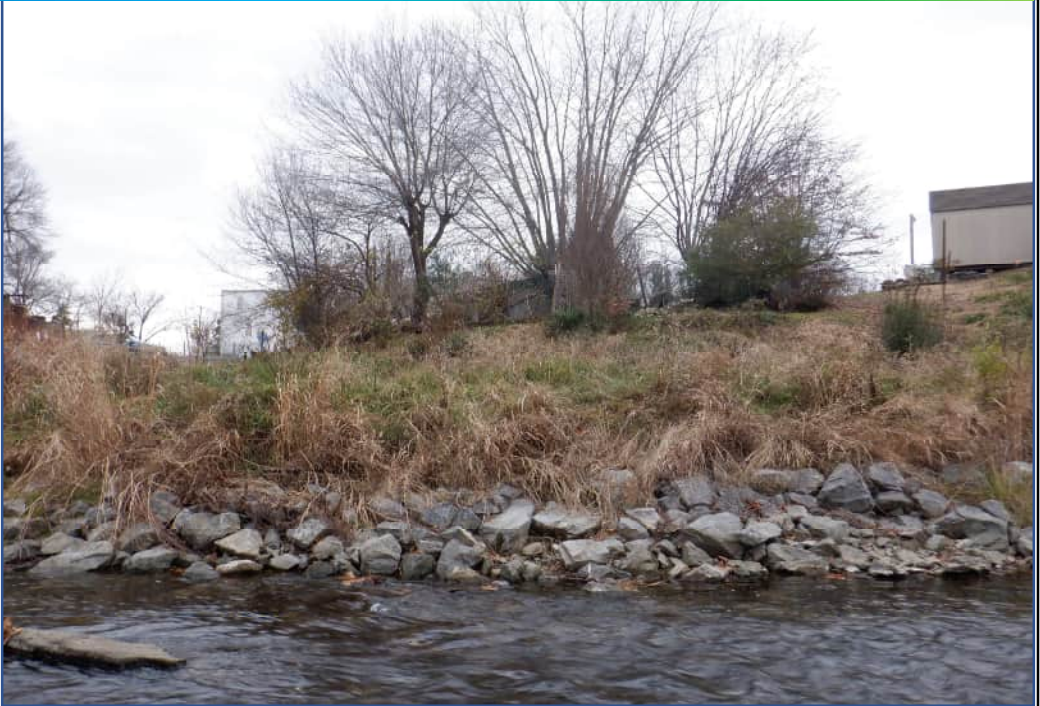
<b>Photo Number:</b> 03	<b>Location:</b> 00+50'
<b>Date:</b> 12/6/2021

<b>Direction:</b> West	
<b>Description:</b> ~ 65° bank angle; live stakes and plantings previously removed from bank; vegetation establishing, 95% cover; no trees adjacent to edge of water; rock toe intact; sediment deposition in rock toe.

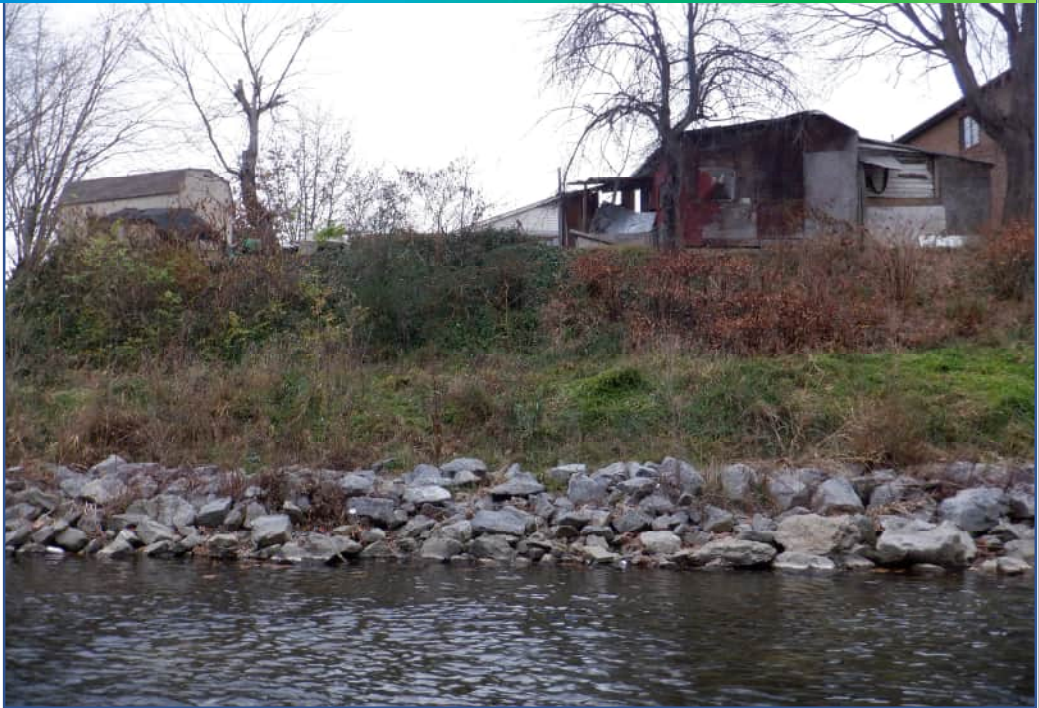
<b>Photo Number:</b> 07		<b>Location:</b> 00+150'	
<b>Date:</b> 12/6/2021

<b>Direction:</b> West			
<b>Description:</b> lower bank ~40°; upper bank ~60°; above greenway ~60°; live stakes and plantings removed from bank; vegetation establishing, 95% cover; no trees adjacent to edge of water; sediment deposition in rock toe.

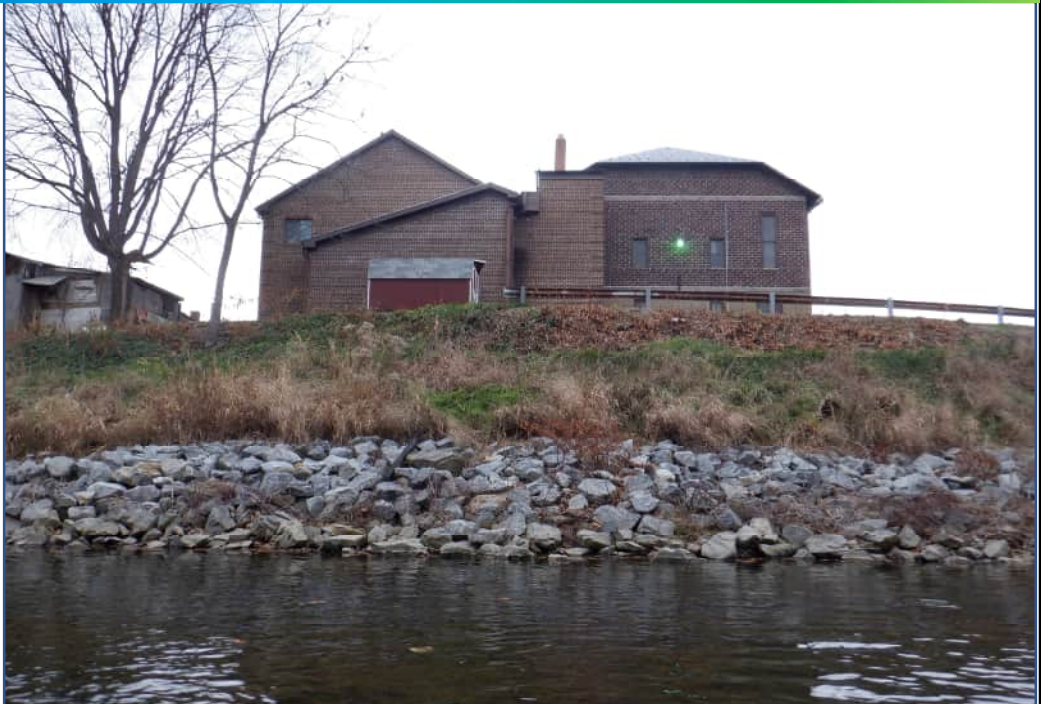
<b>Photo Number:</b> 10		<b>Location:</b> 00+250'	
<b>Date:</b> 12/6/2021

<b>Direction:</b> West			
<b>Description:</b> lower bank ~45°; upper bank ~65°; above greenway ~70°; vegetation establishing; no trees adjacent to edge of water; sediment deposition in rock toe.

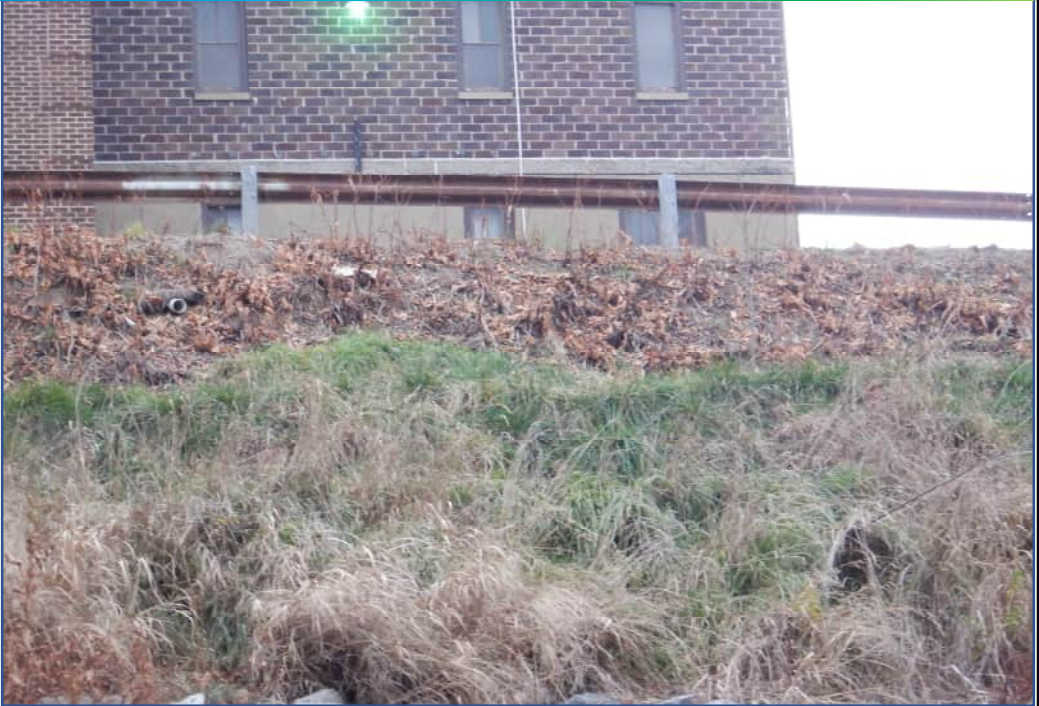
<b>Photo Number:</b> 11	<b>Location:</b> 00+250'
<b>Date:</b> 12/6/2021

<b>Direction:</b> West	
<p><b>Description:</b> Herbaceous vegetation establishing; plantings installed above and below greenway intact; 40% of bank above greenway exposed; geocell minimally exposed above greenway.</p>

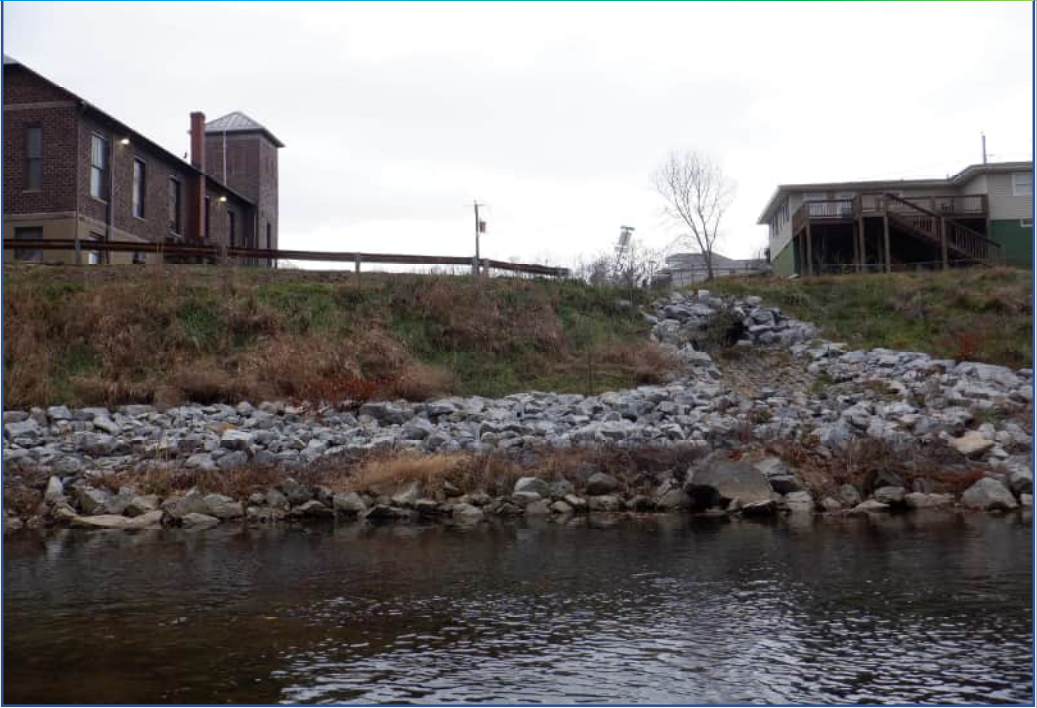
<b>Photo Number:</b> 13		<b>Location:</b> 00+350'	
<b>Date:</b> 12/6/2021

<b>Direction:</b> West			
<b>Description:</b> ~ 65° bank angle; live stakes not establishing; vegetation establishing; 95% cover; no trees adjacent to edge of water; large plastic corrugated pipe and Armorflex mat intact; gravel deposition at outfall.

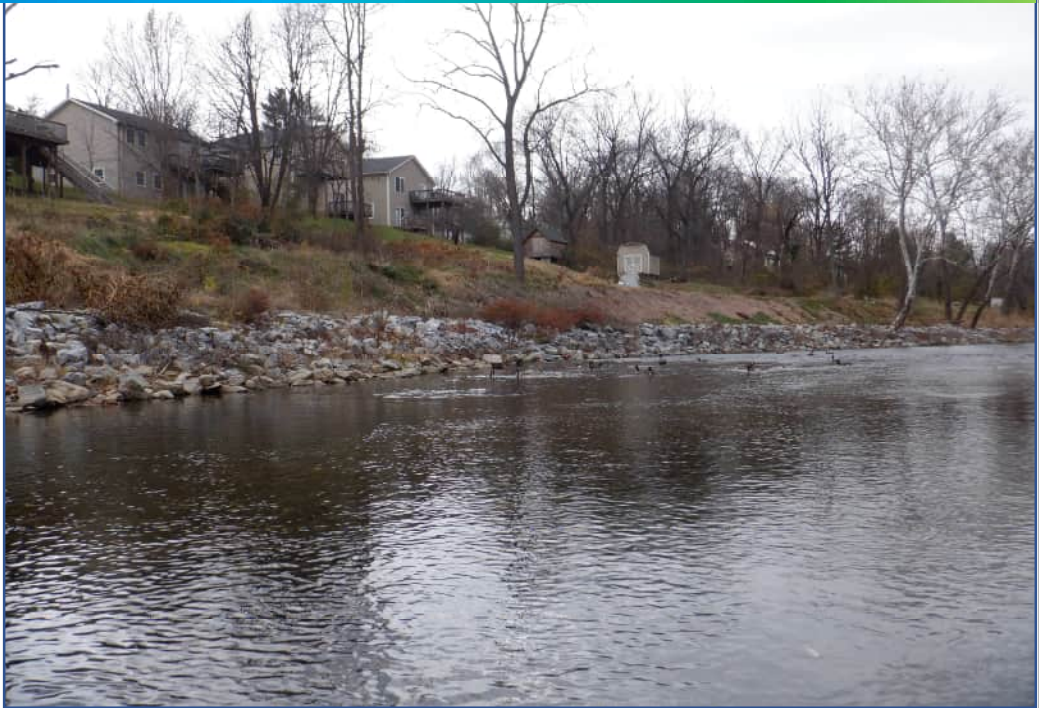
<b>Photo Number:</b> 15	<b>Location:</b> 00+350'
<b>Date:</b> 12/6/2021

<b>Direction:</b> North	
<b>Description:</b> Downstream view of remediated bank; plantings intact; vegetation establishing; rock toe intact.

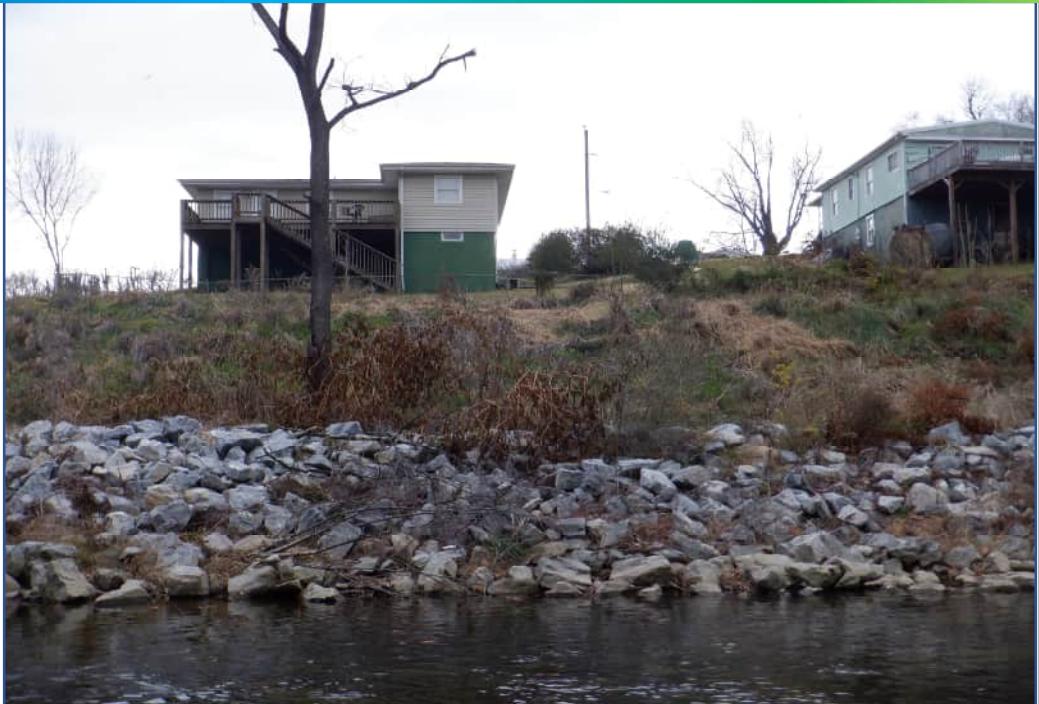
<b>Photo Number:</b> 16	<b>Location:</b> 00+400'
<b>Date:</b> 12/6/2021

<b>Direction:</b> West	
<b>Description:</b> lower bank ~45°; upper bank ~50°; live stakes and plantings not establishing; vegetation establishing, 95% cover; no at-risk trees present; rock toe intact; sediment deposition in rock toe.

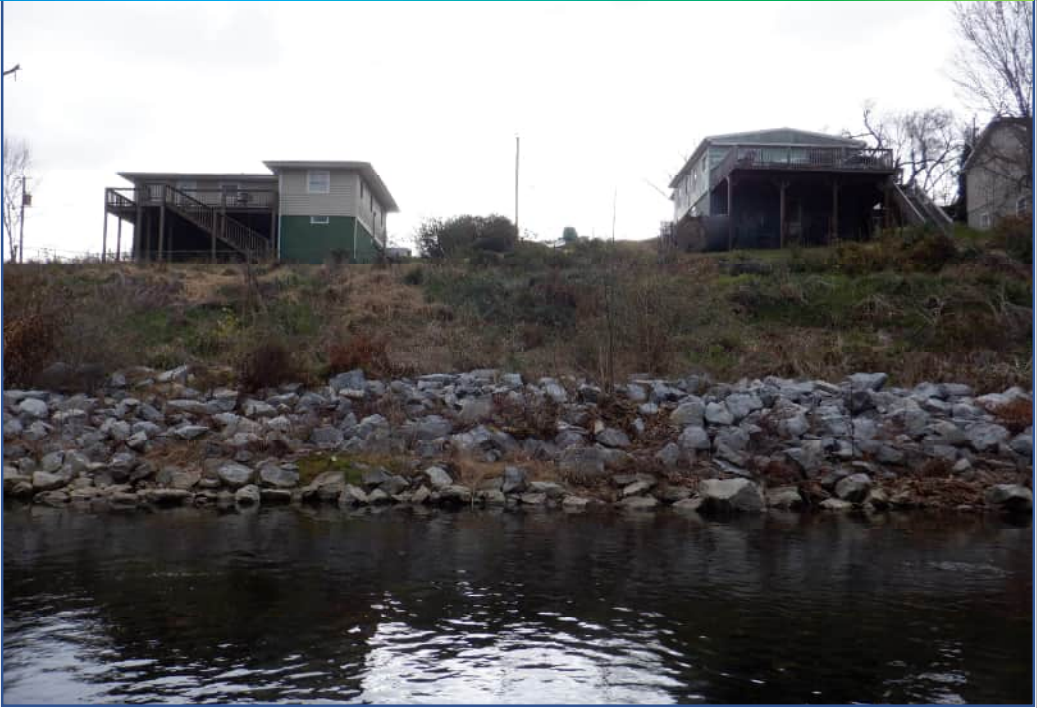
<b>Photo Number:</b> 17		<b>Location:</b> 00+450'	
<b>Date:</b> 12/6/2021

<b>Direction:</b> West			
<b>Description:</b> lower bank ~45°; upper bank ~55°; live stakes and plantings not establishing; vegetation establishing, 95% cover; sapling growth in rock toe; rock toe intact.

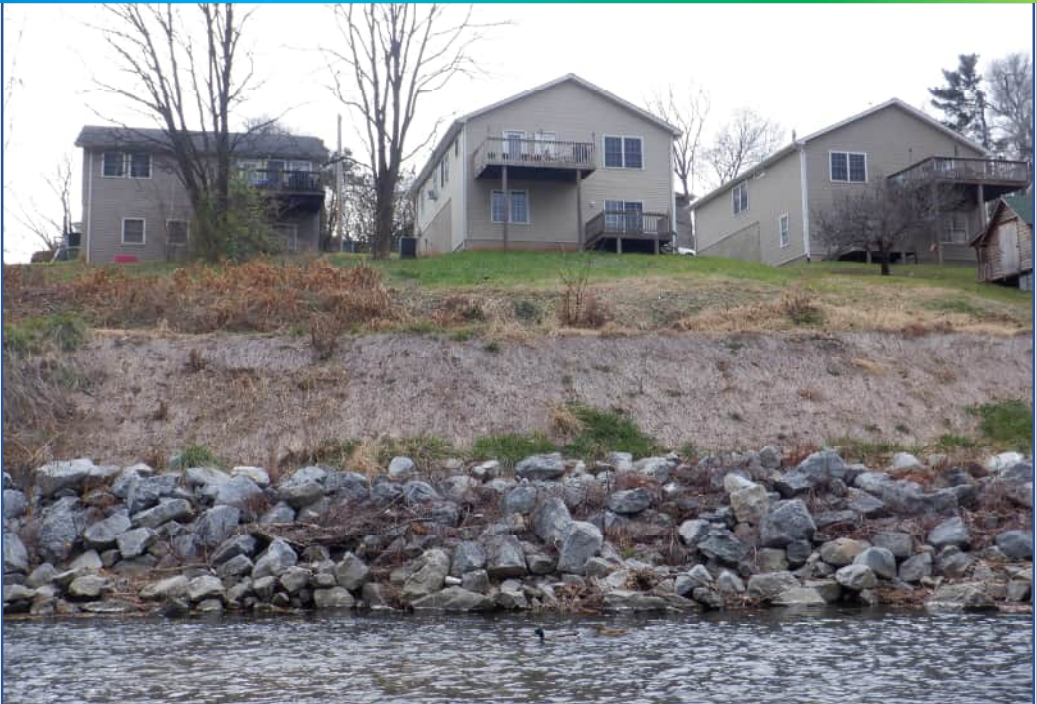
<p><b>Photo Number:</b> 20 <span style="float: right;"><b>Location:</b> 00+550'</span></p>	
<p><b>Date:</b> 12/6/2021</p> <hr/> <p><b>Direction:</b> West</p> <hr/> <p><b>Description:</b> lower bank; ~60°; upper bank; ~70°; reseeded grasses not establishing on repaired bank section; vegetation 20% cover; no trees adjacent to edge of water; rock toe intact; repaired bank intact; sediment deposition in rock toe.</p>

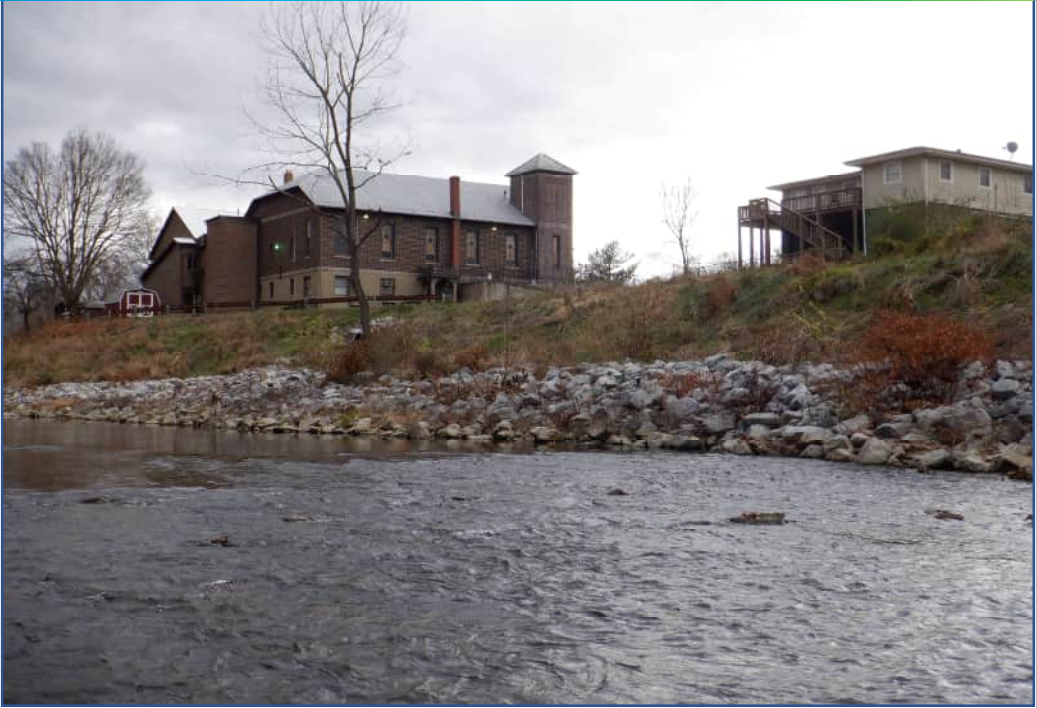
<b>Photo Number:</b> 21	<b>Location:</b> 00+550'
<b>Date:</b> 12/6/2021

<b>Direction:</b> South	
<b>Description:</b> Upstream view of remediated bank; vegetation establishing; rock toe intact.

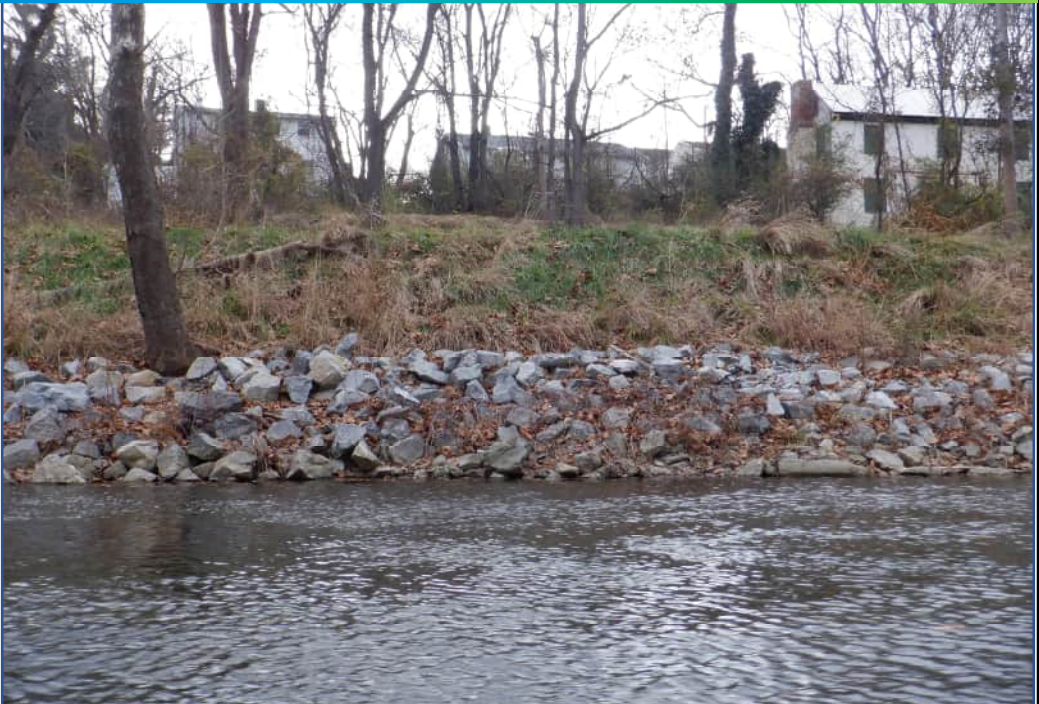
<b>Photo Number: 26</b>		<b>Location: 00+750'</b>	
<b>Date: 12/6/2021</b>

<b>Direction: West</b>			
<b>Description:</b> ~ 60° bank angle; live stakes and plantings not established; 95% vegetation cover; no at-risk trees present; rock toe intact; sediment deposition in rock toe.

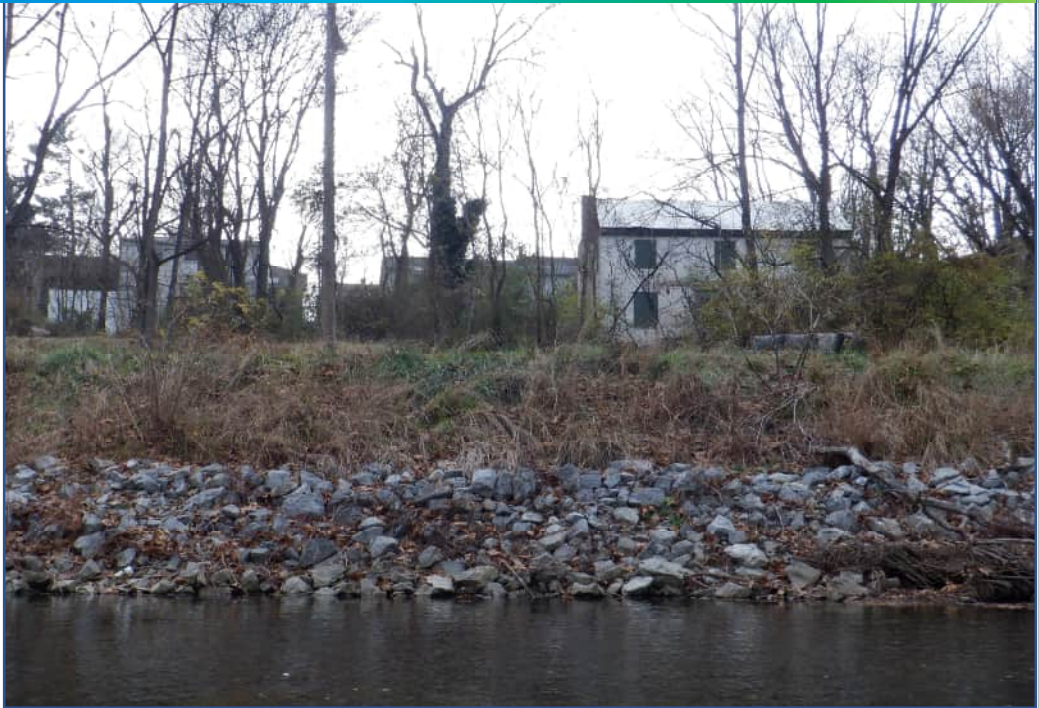
<b>Photo Number: 27</b>		<b>Location: 00+800'</b>	
<b>Date: 12/6/2021</b>

<b>Direction: West</b>			
<b>Description:</b> ~ 65° bank angle; live stakes and plantings not established; 80% vegetation cover; no trees adjacent to edge of water; rock toe intact; sofa dumped on top of bank along greenway; sediment deposition in rock toe.

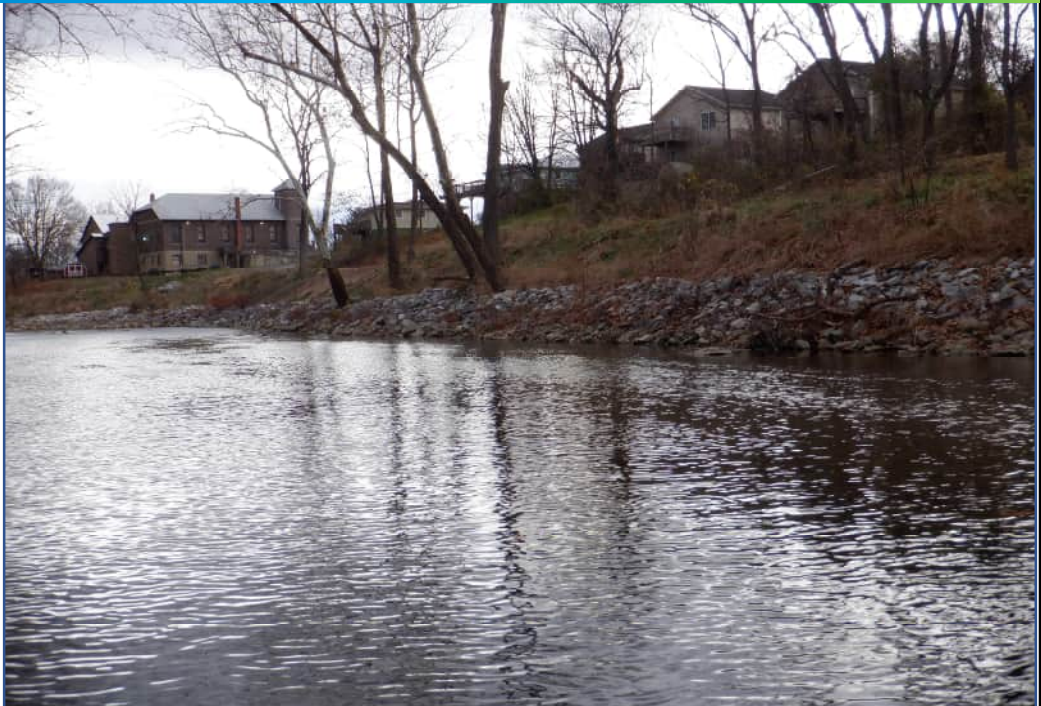
<b>Photo Number:</b> 30		<b>Location:</b> 00+900'	
<b>Date:</b> 12/6/2021

<b>Direction:</b> South			
<b>Description:</b> Upstream view of remediated bank; live stakes and plantings not established; vegetation establishing; rock toe intact.

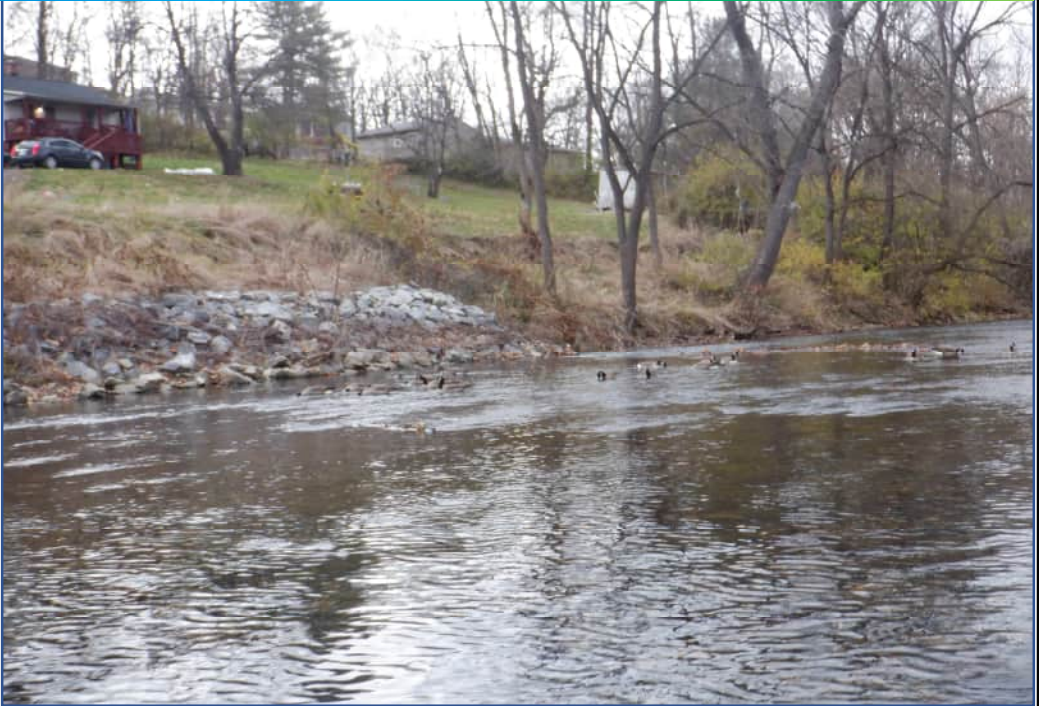
<b>Photo Number:</b> 31		<b>Location:</b> 00+900'	
<b>Date:</b> 12/6/2021

<b>Direction:</b> North			
<b>Description:</b> Downstream view of remediated bank; live stakes and plantings not established; vegetation establishing; rock toe intact; sediment deposition in rock toe.

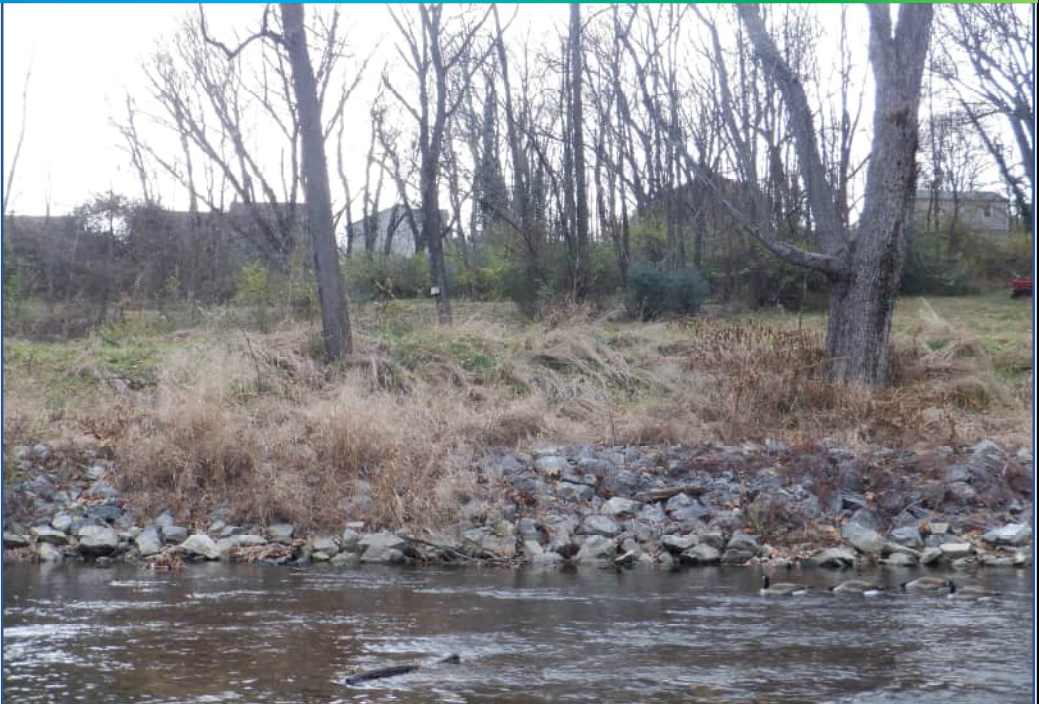
<b>Photo Number:</b> 32		<b>Location:</b> 00+950'	
<b>Date:</b> 12/6/2021

<b>Direction:</b> West			
<b>Description:</b> lower bank ~70°; upper bank ~60°; 90% vegetation cover; no at-risk trees present; rock toe intact; sediment deposition in rock toe.

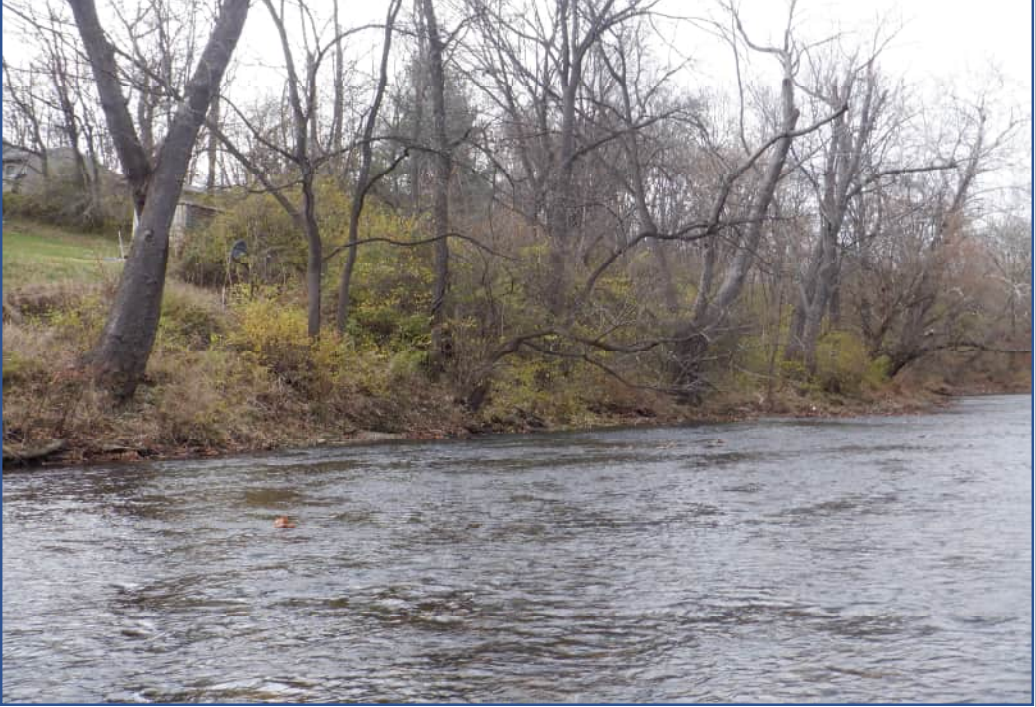
<b>Photo Number:</b> 35		<b>Location:</b> 00+975'	
<b>Date:</b> 12/6/2021

<b>Direction:</b> North			
<b>Description:</b> Downstream view from end of remediated bank; exposed roots and at-risk trees present downstream of remediation; scour present in non-remediated section.

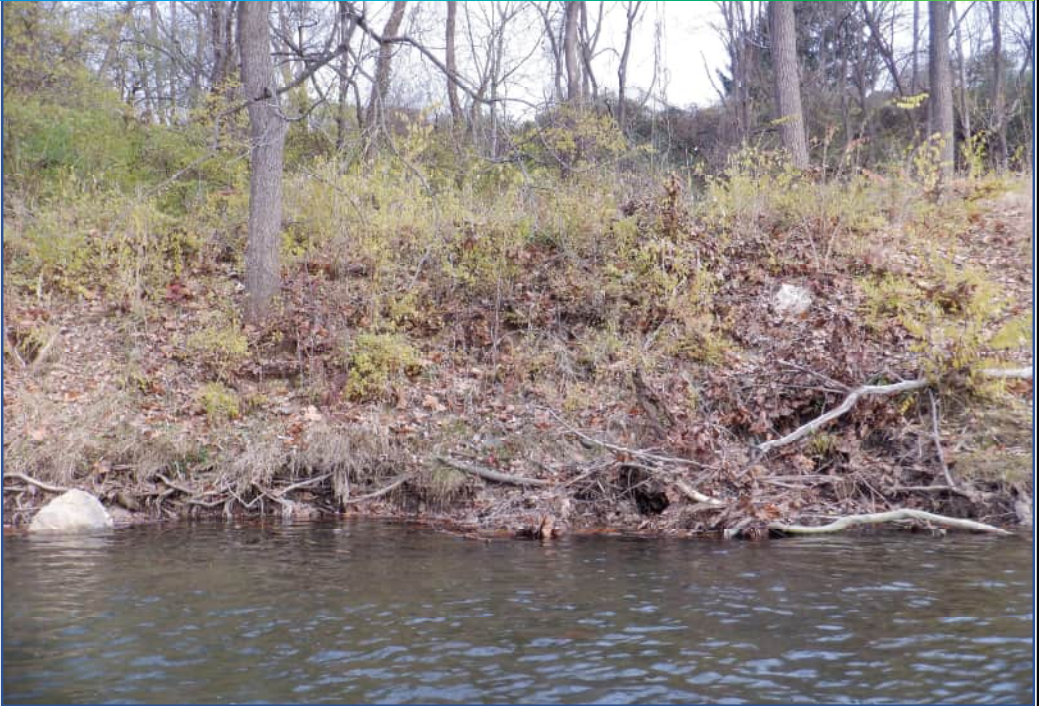
<b>Photo Number:</b> 01	<b>Location:</b> 00-25'
<b>Date:</b> 12/7/2021

<b>Direction:</b> Northwest	
<b>Description:</b> Upstream of remediation; ~ 70° bank angle; vertical drop at toe; undercut bank with exposed roots; minimal scour present.

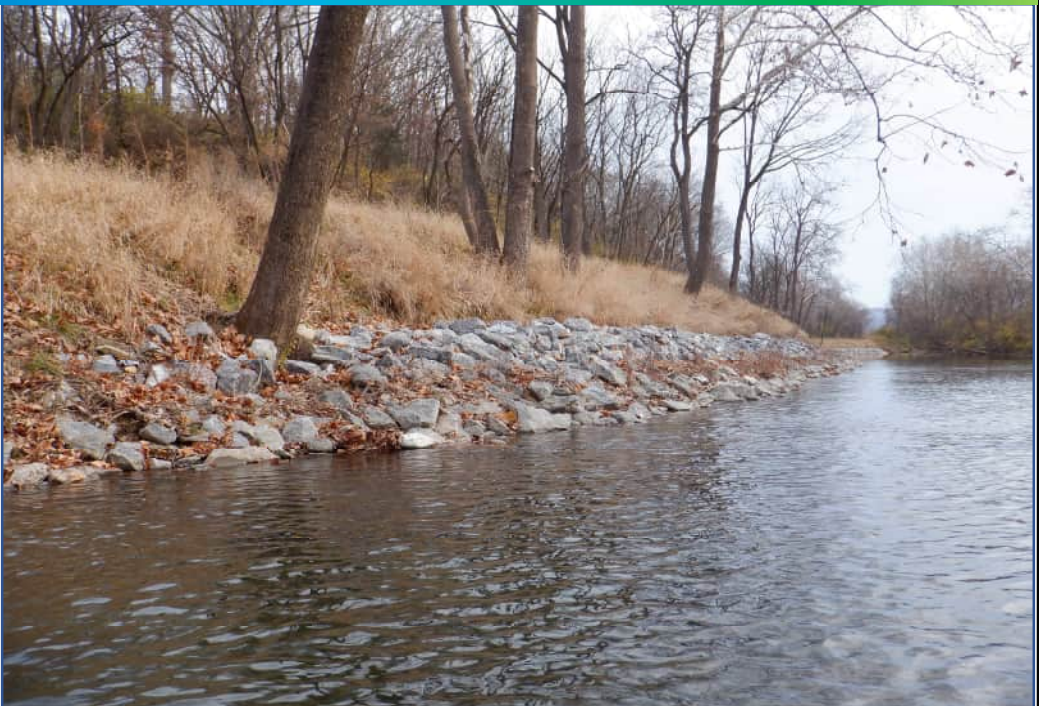
<b>Photo Number:</b> 02	<b>Location:</b> 00-25'
<b>Date:</b> 12/7/2021

<b>Direction:</b> North	
<b>Description:</b> Downstream view of start of remediated section; rock toe intact.

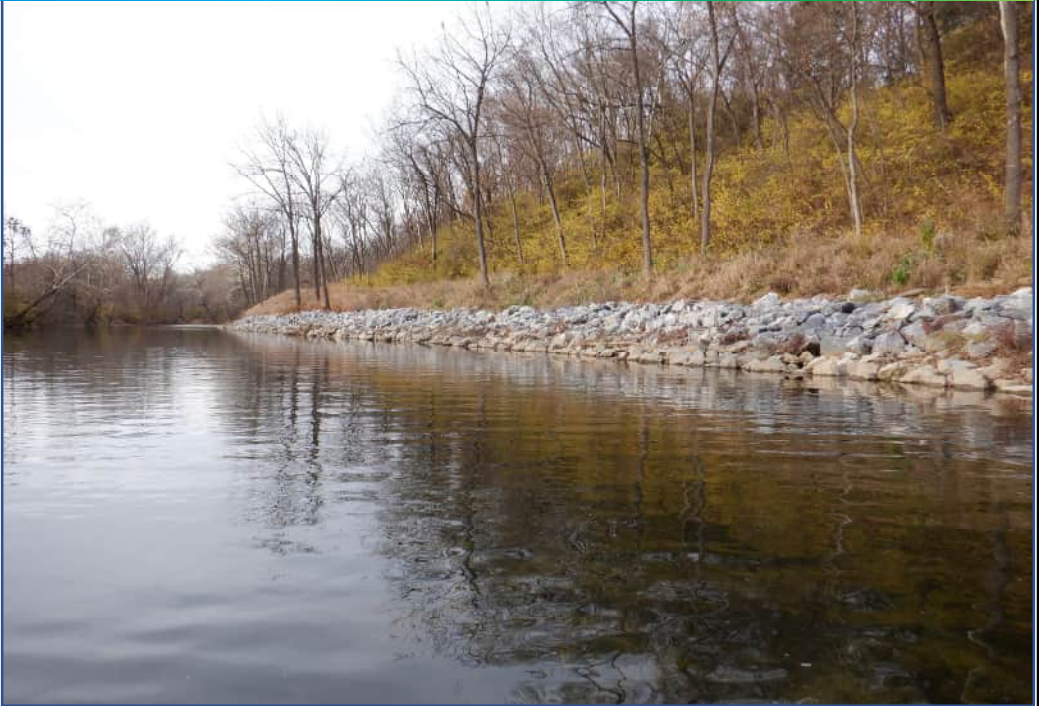
<b>Photo Number:</b> 23		<b>Location:</b> 00+650'
<b>Date:</b> 12/7/2021

<b>Direction:</b> West		
<b>Description:</b> Upstream view of remediated bank; rock toe intact; vegetation establishing.

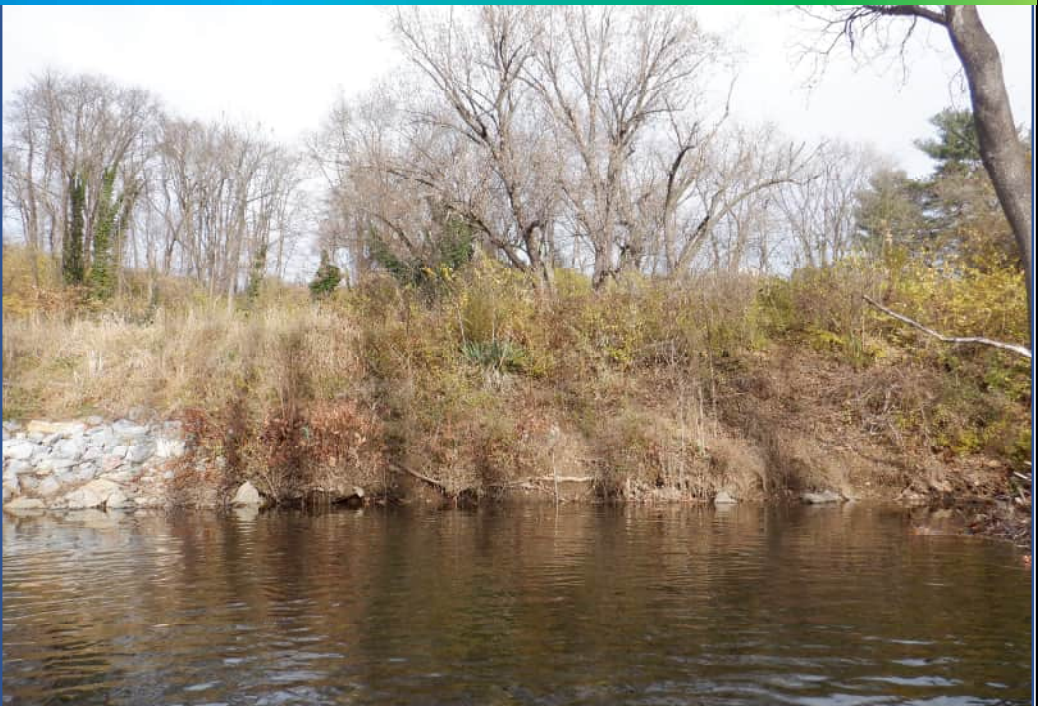
<b>Photo Number:</b> 34		<b>Location:</b> 00+1100'
<b>Date:</b> 12/7/2021

00 + 1100	34	45	Y	start of non-remediated section	M	grass adjacent to water's edge; shrubs mid and upper bank; vegetation 70% cover	N	no at-risk trees present	N/A	N/A	N/A	minimal undercutting at toe of bank	N	Minimal scour at end of remediation	Y (Plants established)
00 + 1150	35, 36	45	Y		M	grass adjacent to water's edge; shrubs mid and upper bank; vegetation 80% cover	N	one tree mid bank in good condition	N/A	N/A	N/A	minimal undercutting at toe of bank	N	no scour	N
00 + 1200	37	45	Y		M	sparse grasses at toe; shrubs on upper bank; vegetation 50% cover	N	3 trees mid bank in good condition	N/A	N/A	N/A	minimal undercutting at toe of bank; LWD present	N	no scour	N
00 + 1250	38, 39	55	N	Lower bank ~70 degrees Upper bank ~45 degrees	M	no vegetation at toe; woody vegetation on mid and upper bank; vegetation 30% cover	N	one tree mid bank in good condition	N/A	N/A	N/A	wooden steps present from top of bank to mid bank then a mostly vertical drop from scour and erosion at the base of steps	Y	Scour present at base of wooden steps	N

<b>Direction:</b> Northwest		
<b>Description:</b> Non-remediated section; ~ 45° bank angle; grasses adjacent to water's edge; shrubs mid and upper bank; 70% vegetation cover; no at-risk trees present; minimal undercutting at toe of bank; minimal scour at end of remediation.

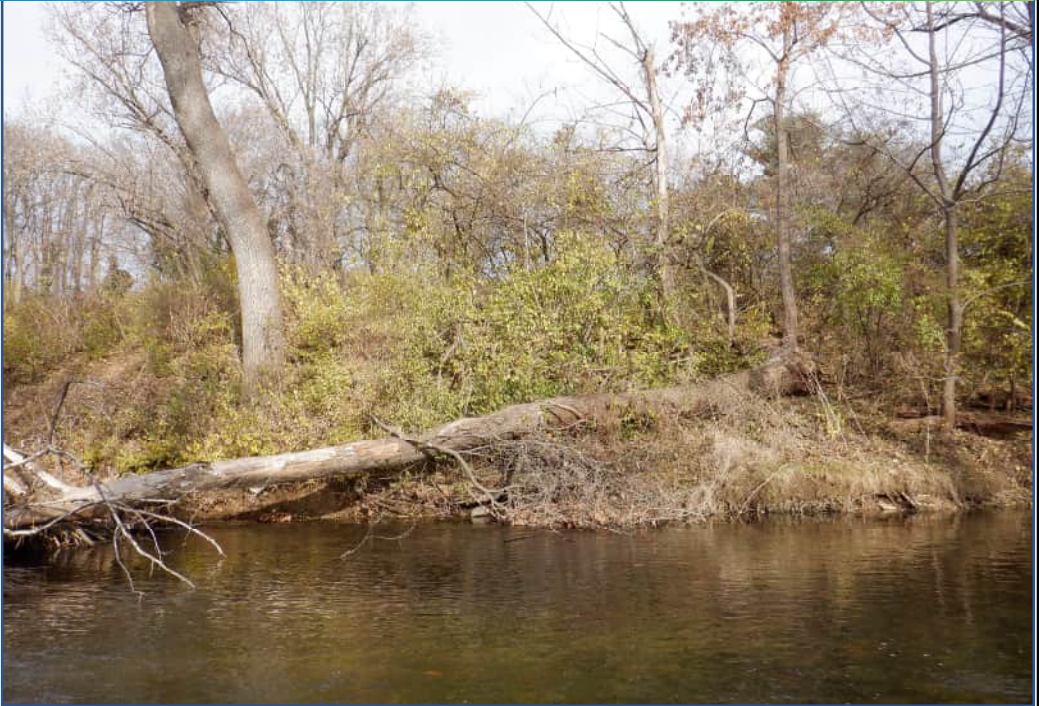
<b>Photo Number:</b> 35		<b>Location:</b> 00+1150'	
<b>Date:</b> 12/7/2021

<b>Direction:</b> Northwest			
<b>Description:</b> Non-remediated section; ~ 45° bank angle; grasses adjacent to water's edge; shrubs mid and upper bank; 80% vegetation cover; one tree mid bank in good condition; fallen tree now LWD; minimal undercutting at toe of bank; no scour.

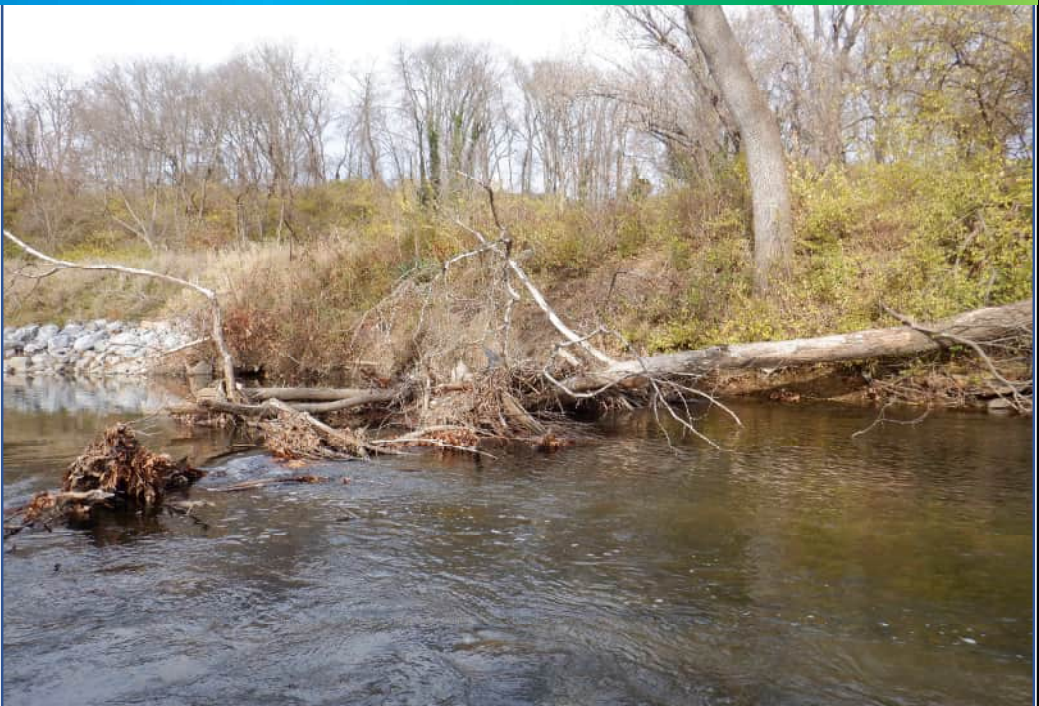
<b>Photo Number:</b> 36		<b>Location:</b> 00+1150'	
<b>Date:</b> 12/7/2021

<b>Direction:</b> Northwest			
<b>Description:</b> Non-remediated section; fallen tree providing LWD along bank.

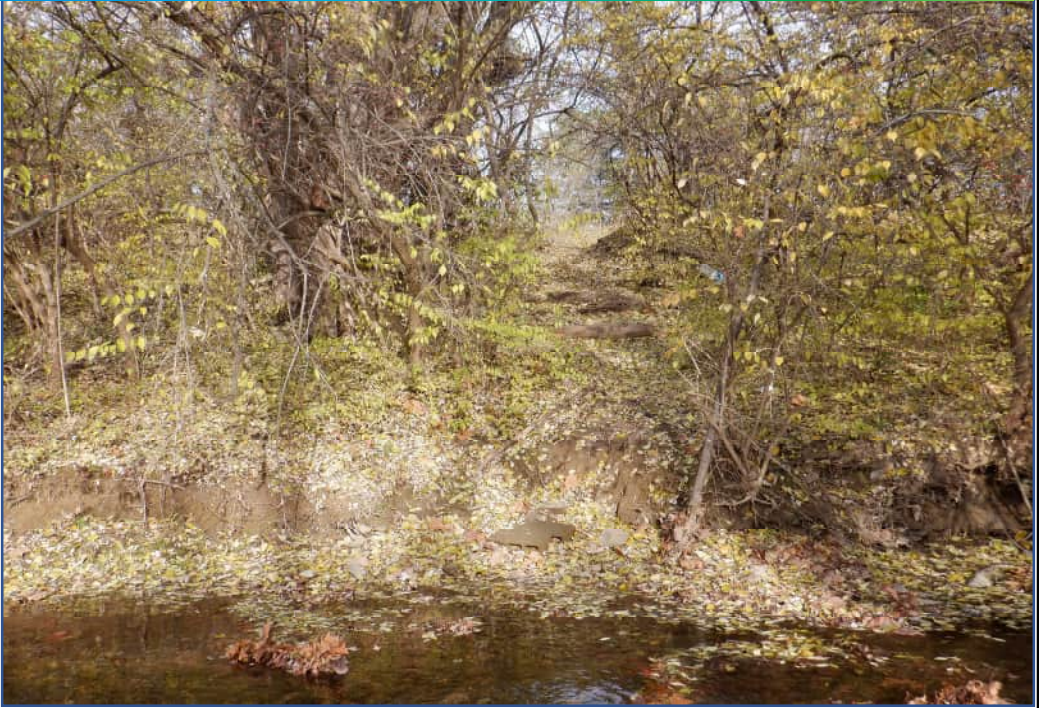
<b>Photo Number:</b> 39		<b>Location:</b> 00+1250'	
<b>Date:</b> 12/7/2021

<b>Direction:</b> Northwest			
<b>Description:</b> Non-remediated section; wooden steps present from top of bank to mid bank then a mostly vertical drop; scour and erosion at the base of steps.

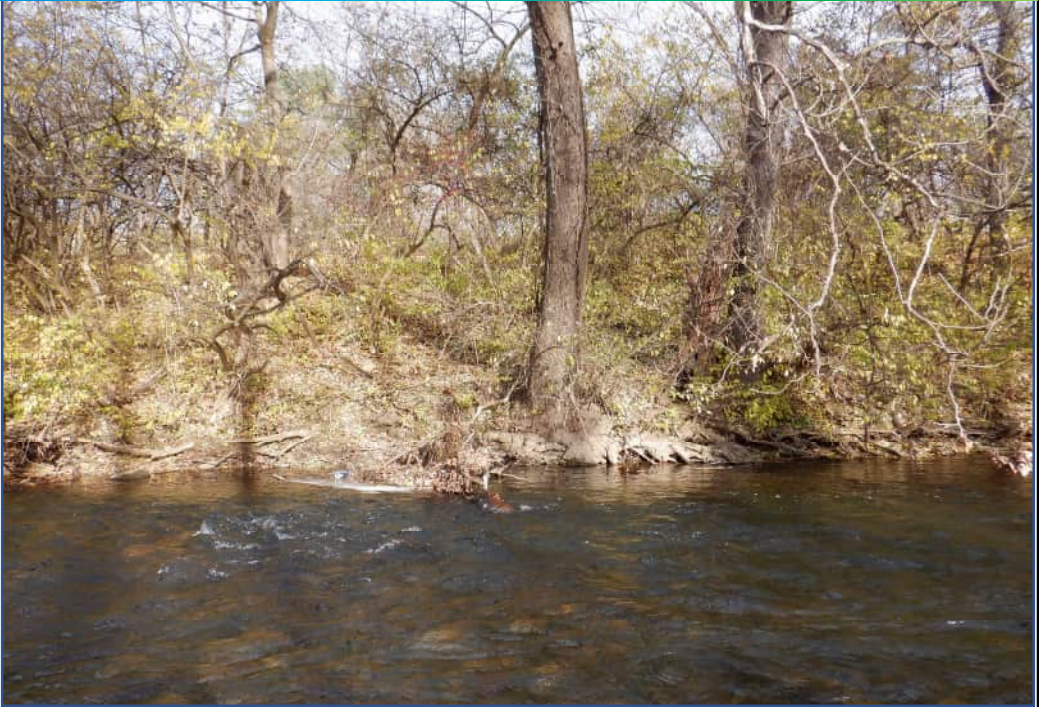
<b>Photo Number:</b> 40		<b>Location:</b> 00+1300'	
<b>Date:</b> 12/7/2021

00 + 1300	40	45	Y		H	no vegetation at toe; woody vegetation on mid and upper bank; exposed roots on one tree at toe; vegetation 30% cover	Y	1 tree at toe and 1 at mid bank; tree mid bank appears to be dead	N/A	N/A	N/A	significant undercutting mostly at tree at toe of bank	Y	some scour at exposed roots at toe of bank	N
00 + 1350	41	45	Y		H	woody vegetation at water's edge; entire bank shows exposed roots; vegetation 40% cover	N	1 tree at toe and 3 at mid bank in good condition	N/A	N/A	N/A	undercutting at bank toe	N	no scour	N
00 + 1400	42	45	Y		H	highly exposed roots throughout bank; bank covered with woody vegetation; sparse grasses at toe; vegetation 40% cover	N	one tree mid bank in good condition	N/A	N/A	N/A	bank undercutting at base of toe	N	no scour	N
00 + 1450	43	50	Y		H	exposed roots throughout bank; bank covered with woody vegetation; sparse grasses at toe; vegetation 40% cover	N	one tree mid bank in good condition	N/A	N/A	N/A	bank undercutting at base of toe	Y	minimal scour	N

<b>Direction:</b> Northwest			
<b>Description:</b> Non-remediated section; ~ 45° bank angle; no vegetation at toe; woody vegetation on mid and upper bank; exposed roots; 30% vegetation cover; tree mid bank appears to be dead; significant undercutting mostly at toe of bank; some scour at exposed roots at toe of bank.

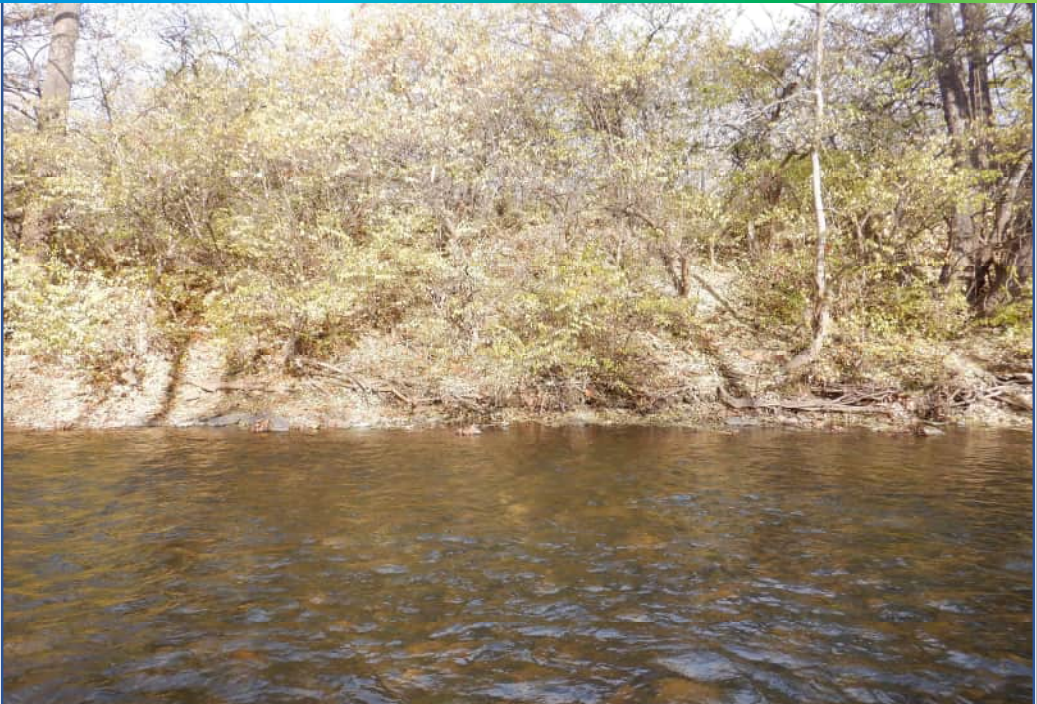
<b>Photo Number:</b> 42		<b>Location:</b> 00+1400'	
<b>Date:</b> 12/7/2021

<b>Direction:</b> Northwest			
<b>Description:</b> Non-remediated section; ~ 45° bank angle; highly exposed roots throughout bank; bank covered with woody vegetation; sparse grasses at toe; 40% vegetation cover; one tree mid bank in good condition; bank undercutting at base of toe; no scour.
