**VIRGINIA DEPARTMENT OF ENVIRONMENTAL QUALITY**

**Re: 2021 Leaf-on and Leaf-off Maintenance Inspections  
Former DuPont Waynesboro Site AOC 4  
Waynesboro, Virginia  
EPA ID# VAD003114832**

Subject South River BMA - 2021 Leaf-Off Maintenance Inspection  
Former DuPont Waynesboro Site, Area of Concern 4

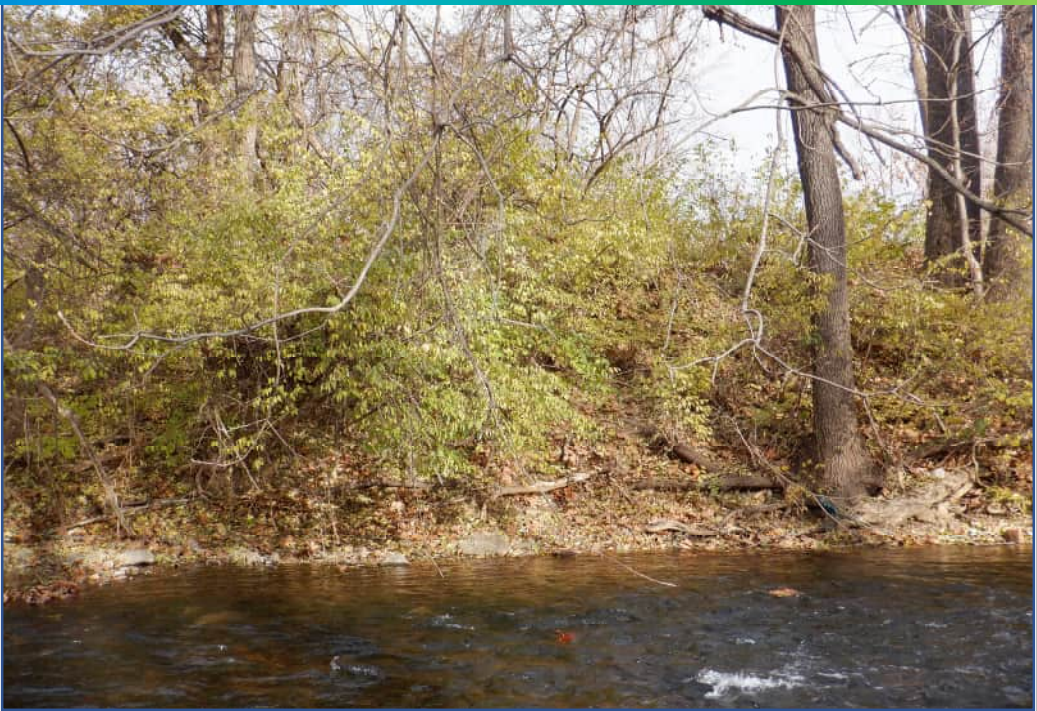
<b>Photo Number:</b> 44		<b>Location:</b> 00+1500'
<b>Date:</b> 12/7/2021

00 + 1500	44	60	Y	end of non-remediated section	M	no vegetation mid bank to toe; shrubs mid bank to top with exposed roots; vegetation 40% cover	N	1 tree at toe and 1 on upper bank in good condition	N/A	N/A	N/A	Footpath; minimal undercutting at tree roots at toe of bank	Y	minimal scour at exposed tree roots at toe	N
00 + 1550'	45, 46, 47	60	N	start of 2nd section of bank remediation; lower bank ~50 degrees upper bank ~ 75 degrees	N/A	Vegetation 95% cover	N	no at-risk trees present	Y (rock toe)	N	Y	erosion control fabric 20% exposed; rock toe intact; significant undercutting, with large exposed root, and bare ground just upstream of remediated section.	N	Minimal sediment deposition	Y (Vegetation establishing)
00 + 1600'	48	50	Y		N/A	live stakes and plantings not established; vegetation 95% cover	N	no at-risk trees present	Y (rock toe)	N	N	Rock toe intact	N	Minimal sediment deposition	Y (Vegetation establishing)

<b>Direction:</b> Northwest		
<b>Description:</b> End of non-remediated section; ~ 60° bank angle; no vegetation mid bank to toe; shrubs mid bank to top with exposed roots; 40% vegetation cover; 1 tree at toe and 1 on upper bank in good condition; footpath present; minimal undercutting at tree roots; minimal scour at exposed tree roots.

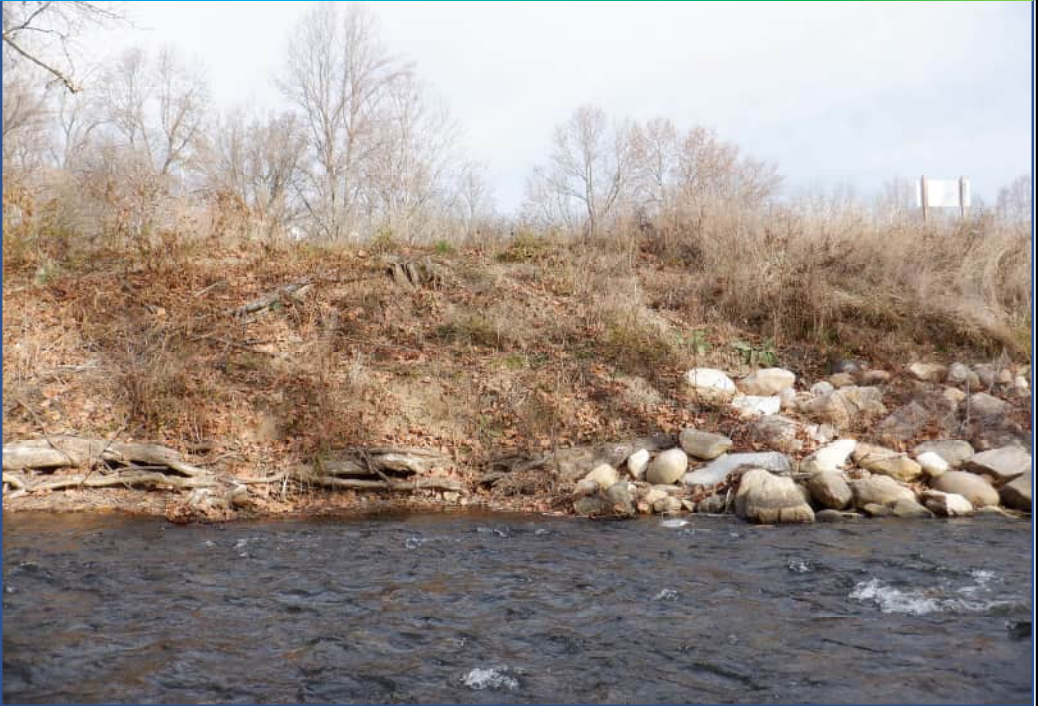
<b>Photo Number:</b> 45		<b>Location:</b> 00+1550'	
<b>Date:</b> 12/7/2021

<b>Direction:</b> Northwest			
<b>Description:</b> Start of 2 <sup>nd</sup> remediated section; lower bank ~50°; upper bank ~ 75°; 95% vegetation cover; no at-risk trees present; erosion control fabric 20% exposed; rock toe intact, significant undercutting in non-remediated section.

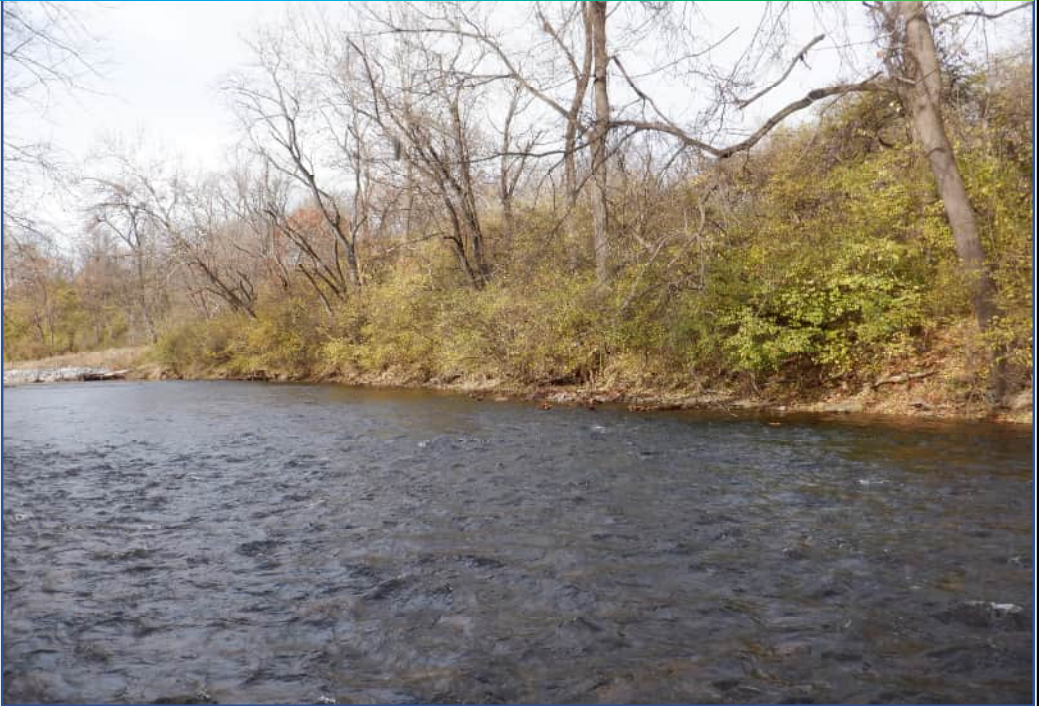
<b>Photo Number:</b> 47		<b>Location:</b> 00+1550'
<b>Date:</b> 12/7/2021

<b>Direction:</b> West		
<b>Description:</b> Upstream view of non-remediated bank; erosion and undercutting on non-remediated bank section.

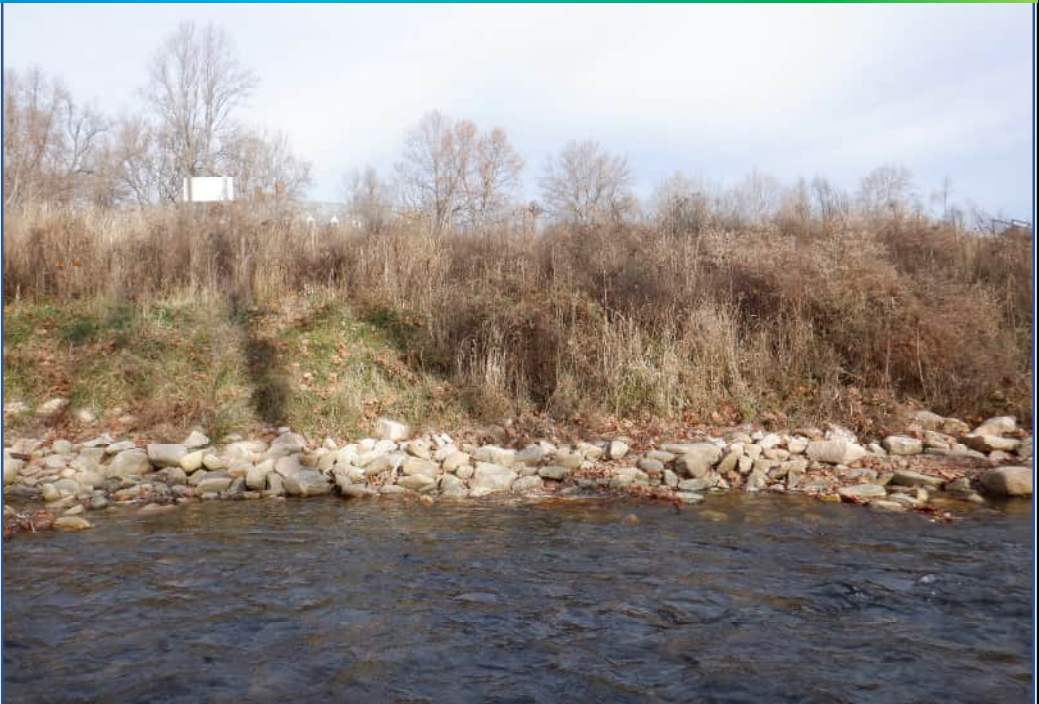
<b>Photo Number:</b> 48		<b>Location:</b> 00+1600'
<b>Date:</b> 12/7/2021

<b>Direction:</b> Northwest		
<b>Description:</b> ~ 50° bank angle; live stakes and plantings not established; 95% vegetation cover; no at-risk trees present; rock toe intact; minimal sediment deposition; vegetation establishing.

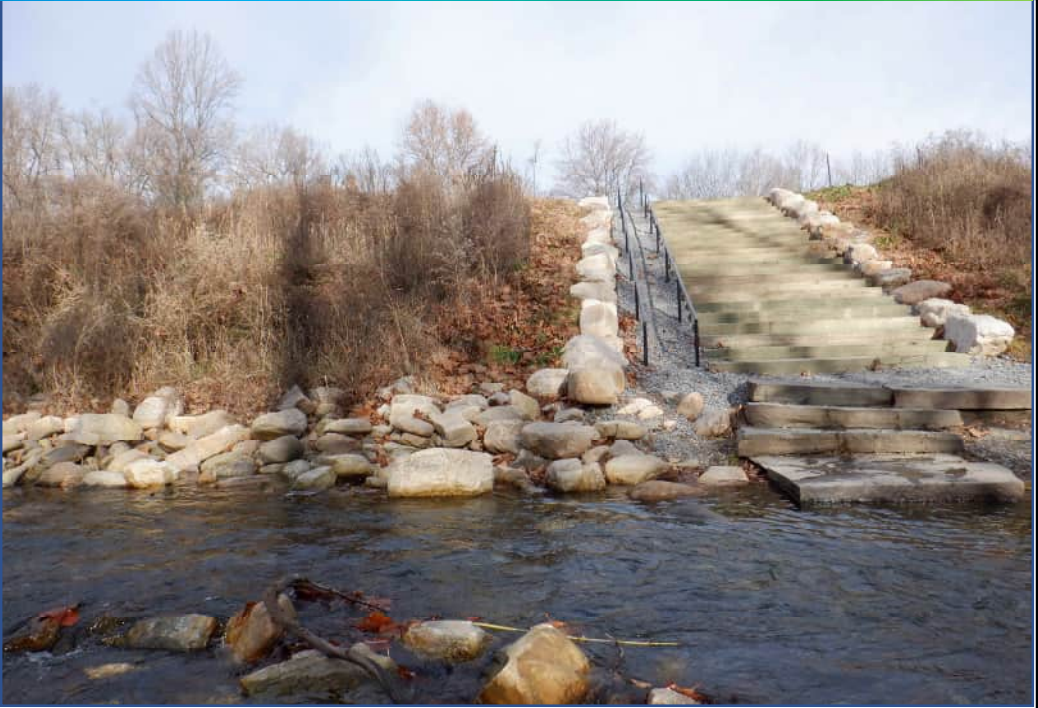
<b>Photo Number:</b> 49		<b>Location:</b> 00+1650'
<b>Date:</b> 12/7/2021

<b>Direction:</b> Northwest		
<b>Description:</b> ~ 45° bank angle; live stakes and plantings not established; 95% vegetation cover; no at-risk trees present; erosion control fabric 5% exposed; kayak launch and steps intact, stonedust eroded revealing larger grade gravel, cobbles from rock toe moved into river; minimal sediment deposition.

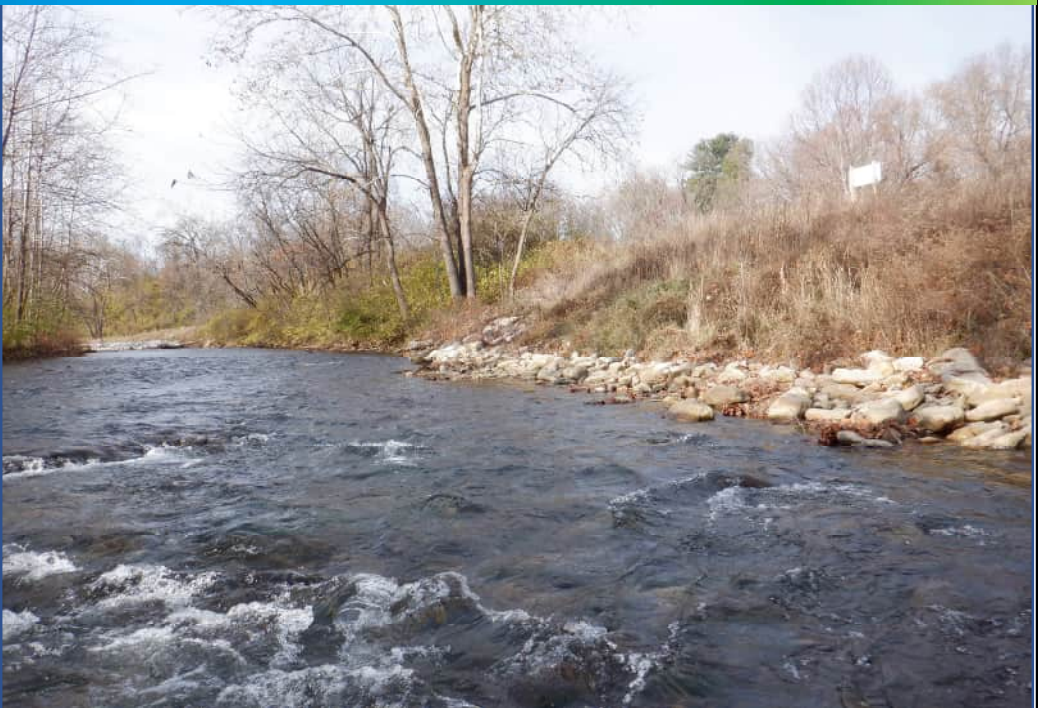
<b>Photo Number:</b> 50		<b>Location:</b> 00+1650'
<b>Date:</b> 12/7/2021

<b>Direction:</b> West		
<b>Description:</b> Upstream view of remediated bank; minimal sediment deposition; vegetation establishing.

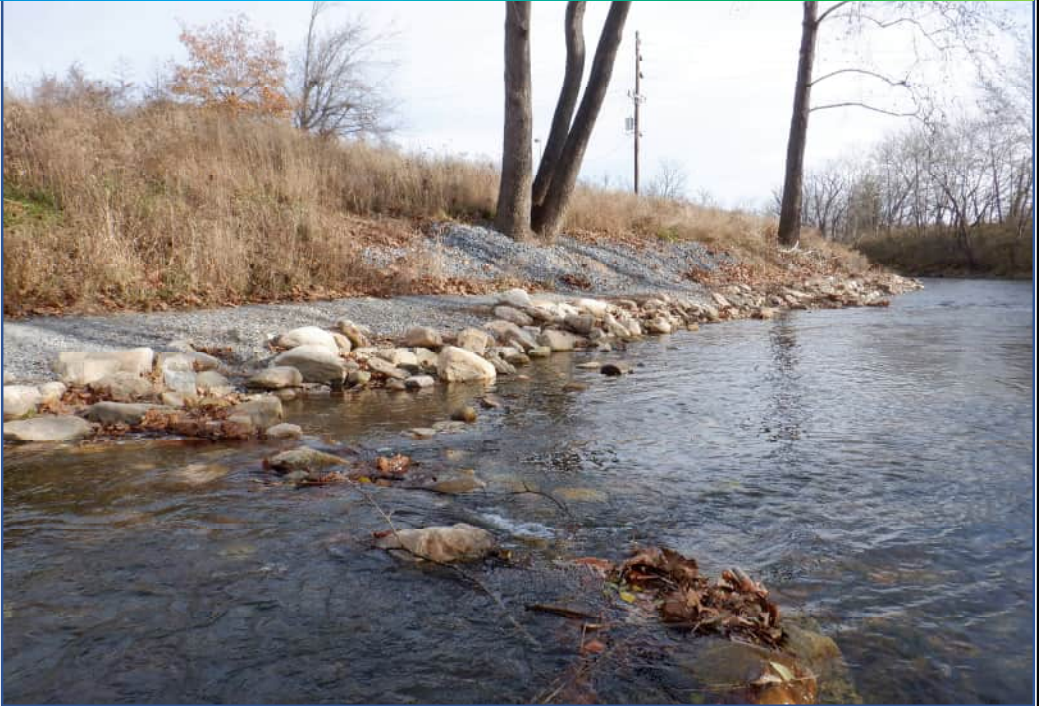
<b>Photo Number:</b> 51		<b>Location:</b> 00+1650'	
<b>Date:</b> 12/7/2021

<b>Direction:</b> North			
<b>Description:</b> Downstream view of remediated bank; minimal sediment deposition; vegetation establishing; cobbles from rock toe moved into river.

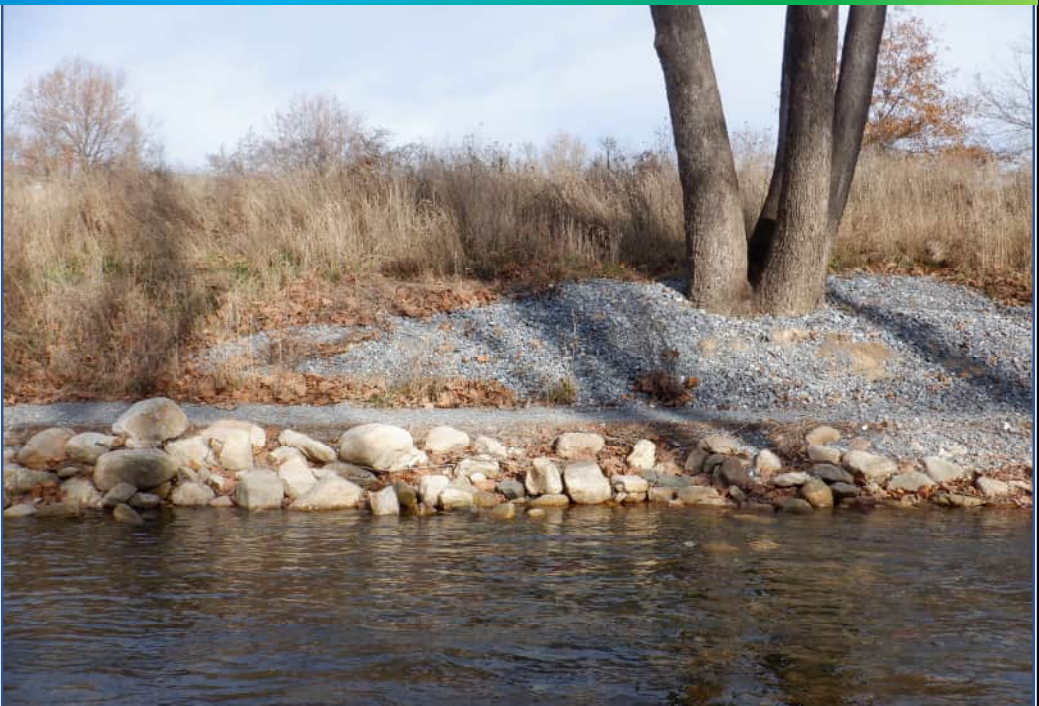
<b>Photo Number:</b> 52		<b>Location:</b> 00+1700'	
<b>Date:</b> 12/7/2021

<b>Direction:</b> Northwest			
<b>Description:</b> ~ 50° bank angle; live stakes and plantings not established; 95% vegetation cover; group of 4 trees above gravel walking path in good condition; erosion control fabric 10% exposed; rock toe intact.

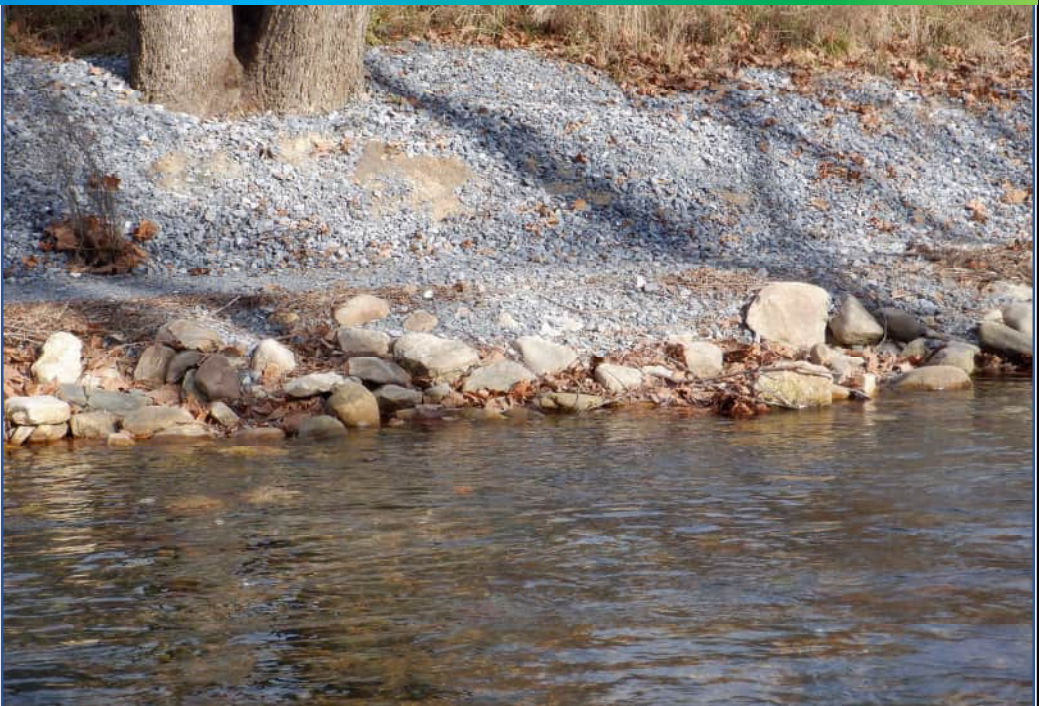
<b>Photo Number:</b> 54	<b>Location:</b> 00+1700'
<b>Date:</b> 12/7/2021

<b>Direction:</b> Northwest	
<b>Description:</b> Cobbles from rock toe moved into water, stonedust from path eroding.

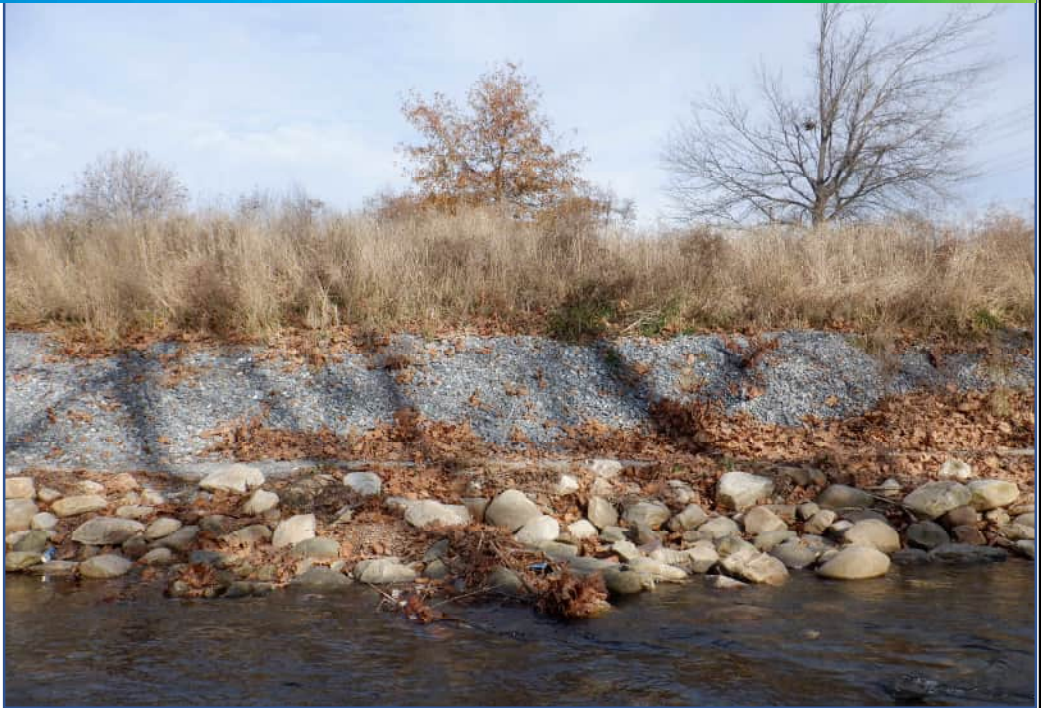
<b>Photo Number:</b> 55	<b>Location:</b> 00+1750'
<b>Date:</b> 12/7/2021

<b>Direction:</b> Northwest	
<b>Description:</b> ~ 50° bank angle; live stakes and plantings not established; 95% vegetation cover; no at-risk trees present; rock toe intact; rock toe intact; vegetation establishing.

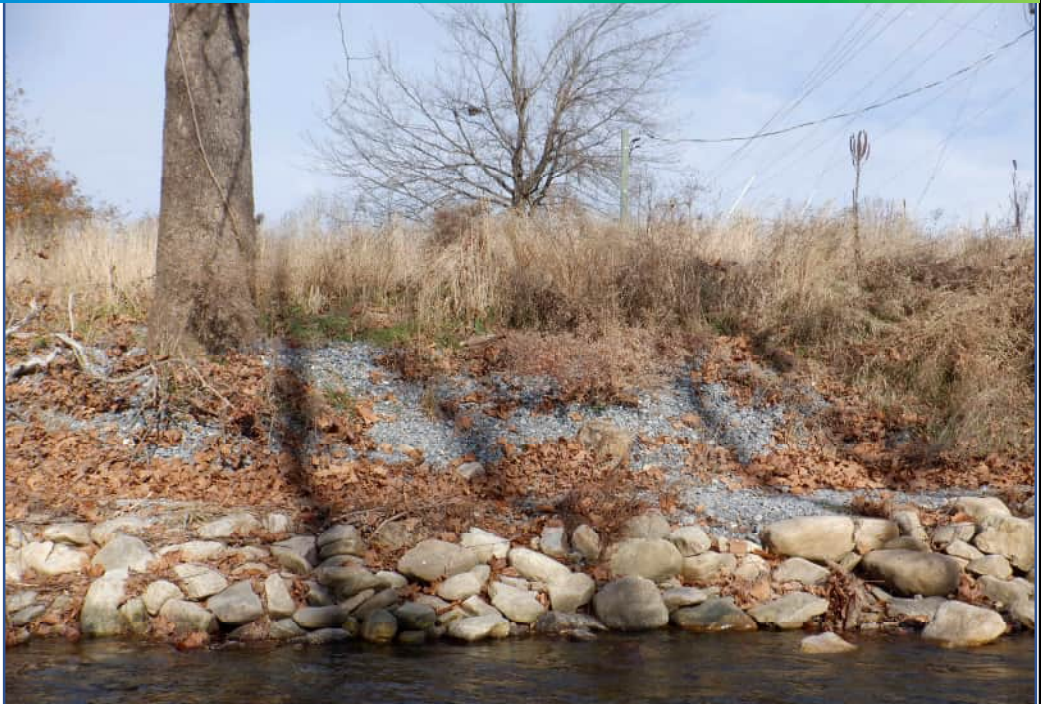
<b>Photo Number:</b> 56	<b>Location:</b> 00+1800'
<b>Date:</b> 12/7/2021

<b>Direction:</b> Northwest	
<b>Description:</b> ~ 50° bank angle; live stakes and plantings not established; 95% vegetation cover; no at-risk trees present; rock toe intact; vegetation establishing.

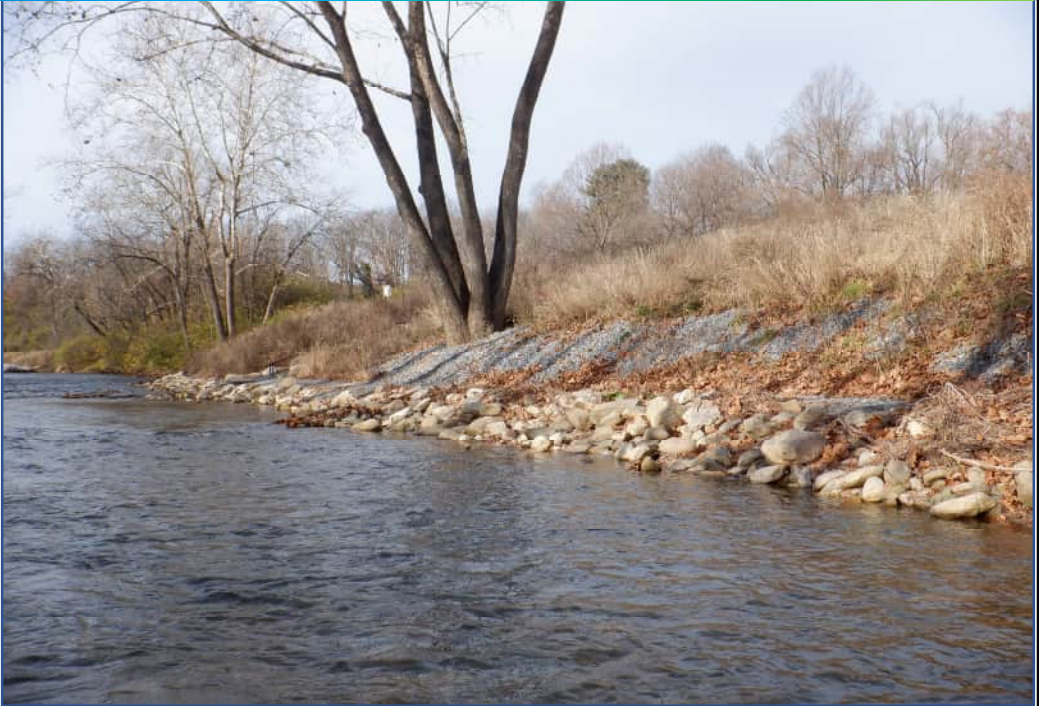
<b>Photo Number:</b> 57		<b>Location:</b> 00+1800'	
<b>Date:</b> 12/7/2021

<b>Direction:</b> West			
<b>Description:</b> Upstream view of remediated bank; minimal sediment deposition; vegetation establishing.

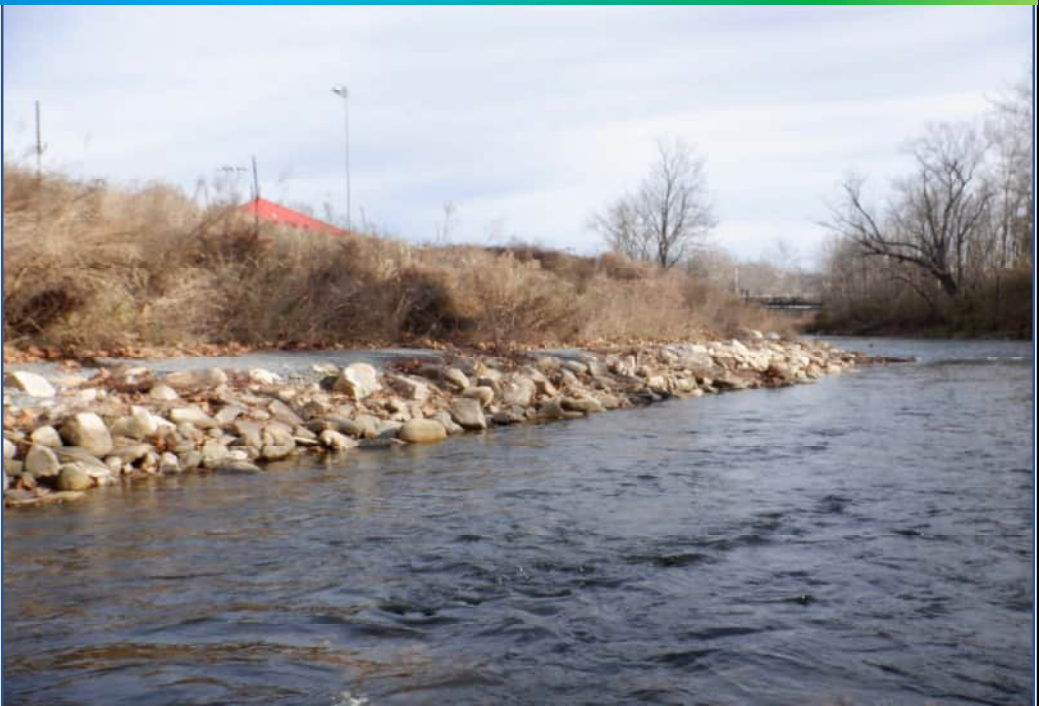
<b>Photo Number:</b> 58		<b>Location:</b> 00+1800'	
<b>Date:</b> 12/7/2021

<b>Direction:</b> North			
<b>Description:</b> Downstream view of remediated bank; minimal sediment deposition; vegetation establishing.

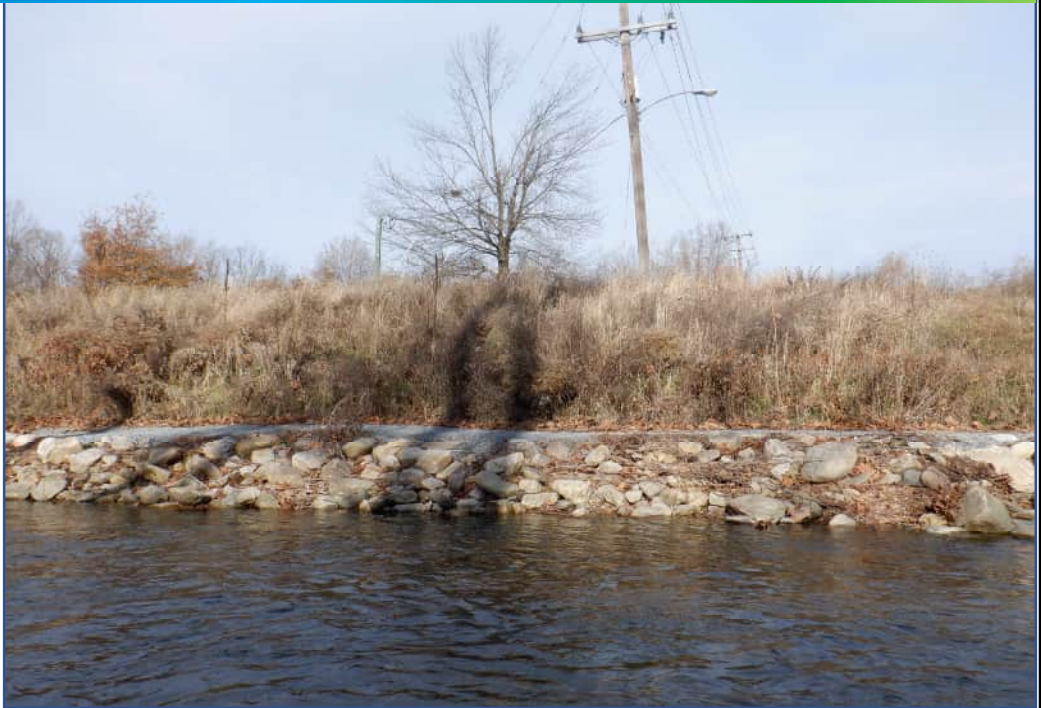
<b>Photo Number:</b> 59		<b>Location:</b> 00+1850'	
<b>Date:</b> 12/7/2021

<b>Direction:</b> Northwest			
<b>Description:</b> ~ 40° bank angle; live stakes and plantings not established; 95% vegetation cover; no at-risk trees present; rock toe intact; minimal sediment deposition; vegetation establishing.

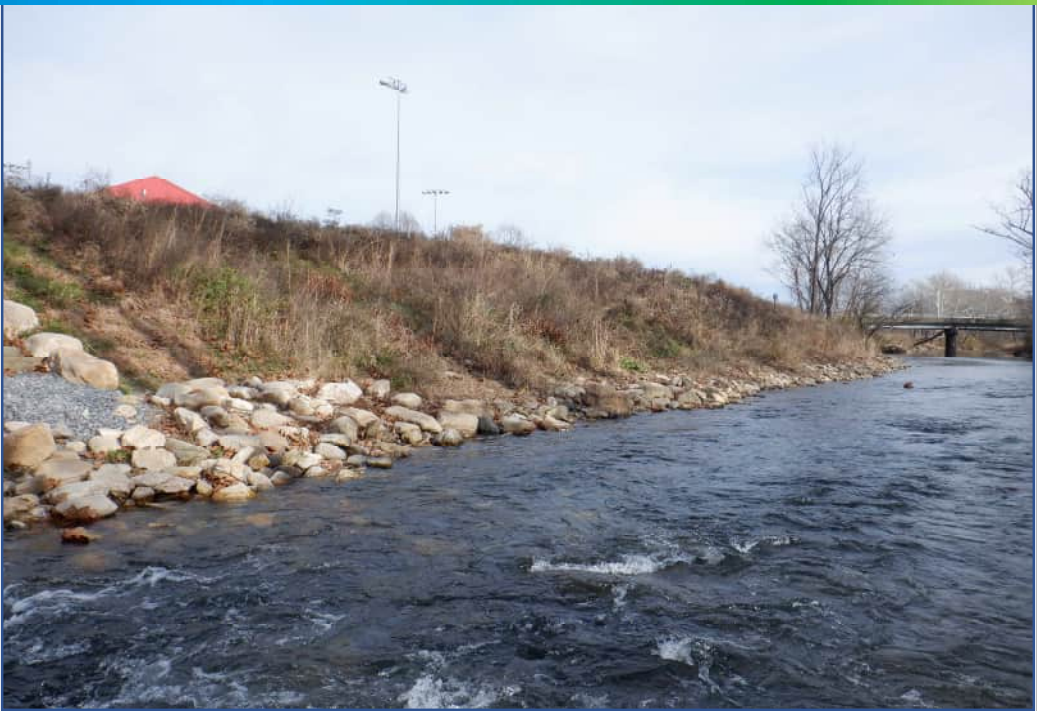
<b>Photo Number:</b> 62		<b>Location:</b> 00+1900'	
<b>Date:</b> 12/7/2021

<b>Direction:</b> North			
<b>Description:</b> Downstream view of remediated bank; vegetation establishing; rock toe intact.

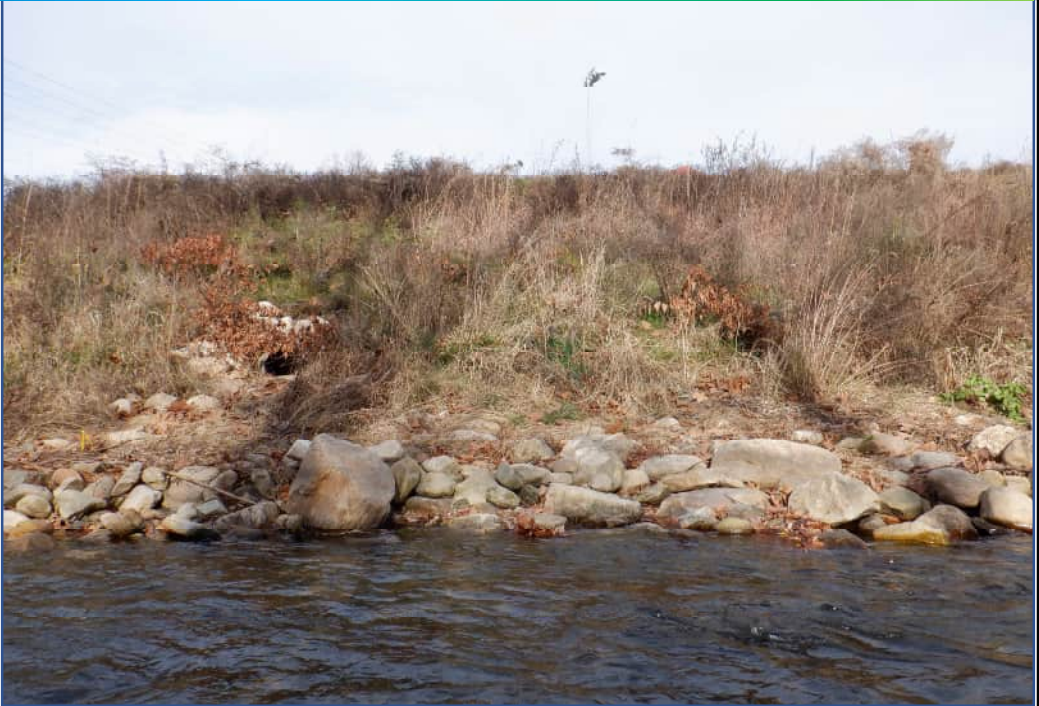
<b>Photo Number:</b> 63		<b>Location:</b> 00+1950'
<b>Date:</b> 12/7/2021

<b>Direction:</b> Northwest		
<b>Description:</b> ~ 60° bank angle; live stakes and plantings not established; 95% vegetation cover; no at-risk trees present; concrete outfall pipe above rock toe intact; rock toe intact; minimal sediment deposition; vegetation establishing; new footpath.

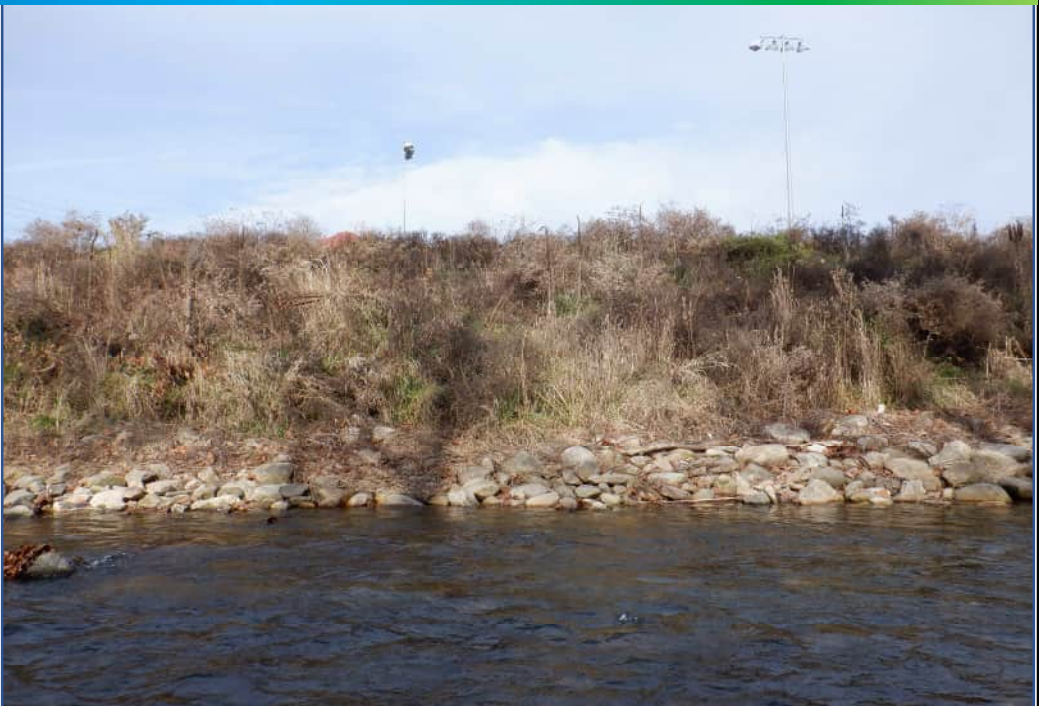
<b>Photo Number:</b> 64		<b>Location:</b> 00+2000'
<b>Date:</b> 12/7/2021

<b>Direction:</b> Northwest		
<b>Description:</b> ~ 60° bank angle; live stakes and plantings not established; 95% vegetation cover; no at-risk trees present; rock toe intact; minimal sediment deposition; vegetation establishing.

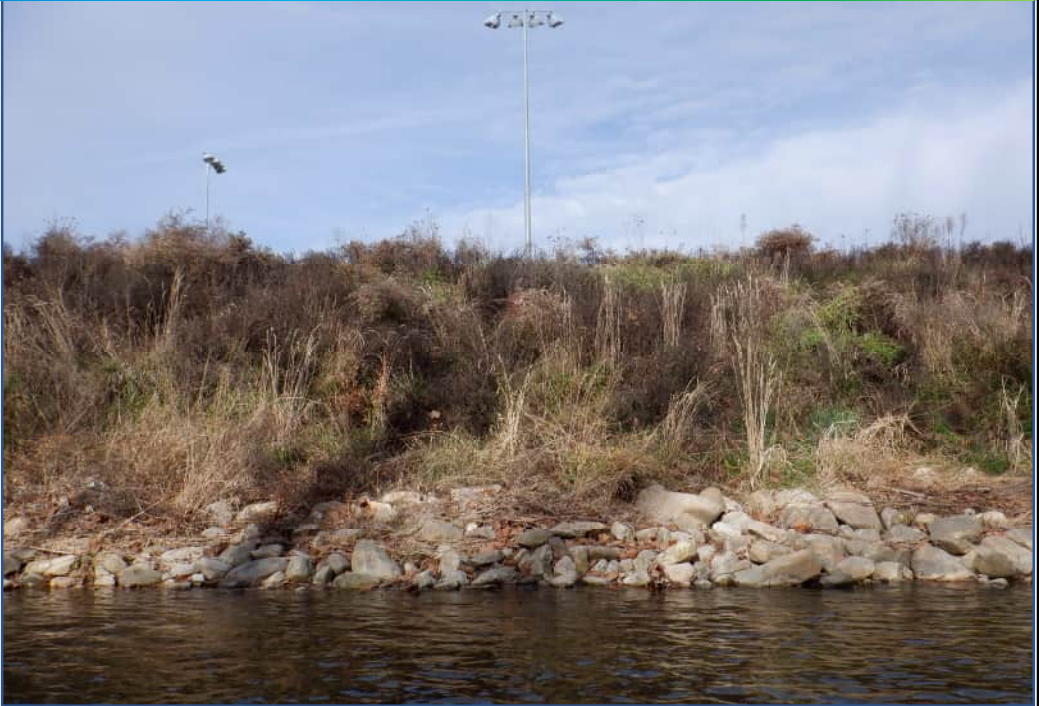
<b>Photo Number:</b> 65	<b>Location:</b> 00+2050'
<b>Date:</b> 12/7/2021

<b>Direction:</b> Northwest	
<b>Description:</b> ~ 60° bank angle; live stakes and plantings not established; 95% vegetation cover; no at-risk trees present; rock toe intact; minimal sediment deposition; vegetation establishing.

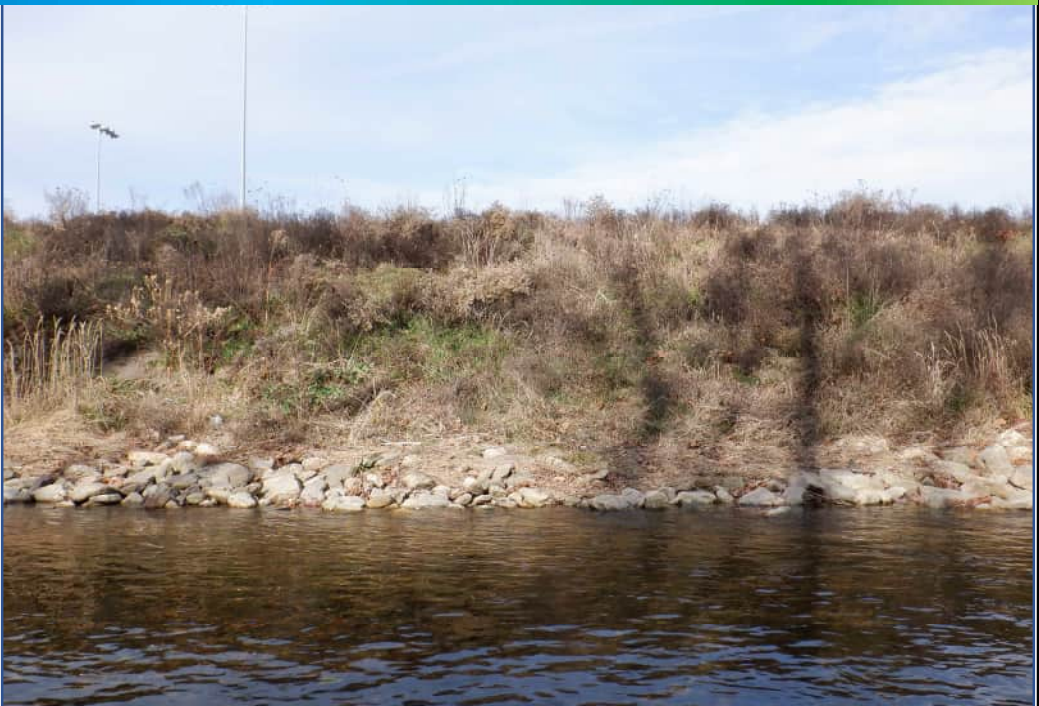
<b>Photo Number:</b> 66	<b>Location:</b> 00+2100'
<b>Date:</b> 12/7/2021

<b>Direction:</b> Northwest	
<b>Description:</b> ~ 60° bank angle; live stakes and plantings not established; 95% vegetation cover; no at-risk trees present; erosion control fabric minimally exposed above rock toe; rock toe intact; minimal sediment deposition; vegetation established.

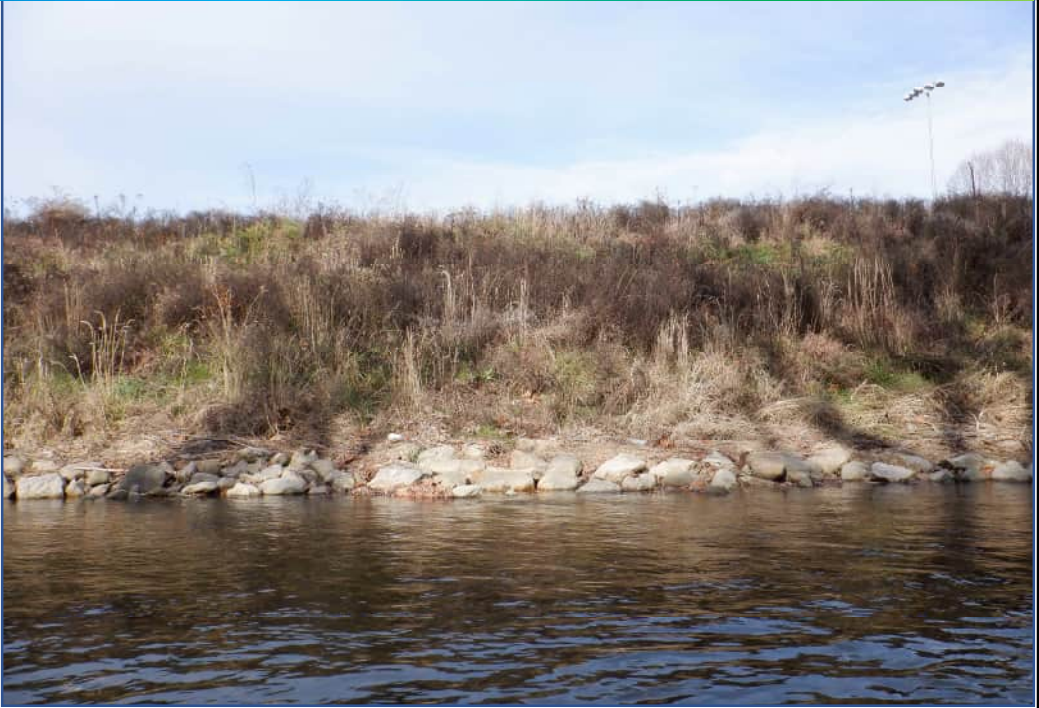
<b>Photo Number:</b> 67		<b>Location:</b> 00+2150'
<b>Date:</b> 12/7/2021

<b>Direction:</b> Northwest		
<b>Description:</b> ~ 60° bank angle; live stakes and plantings not established; 95% vegetation cover; no at-risk trees present; rock toe intact; minimal sediment deposition; vegetation establishing.

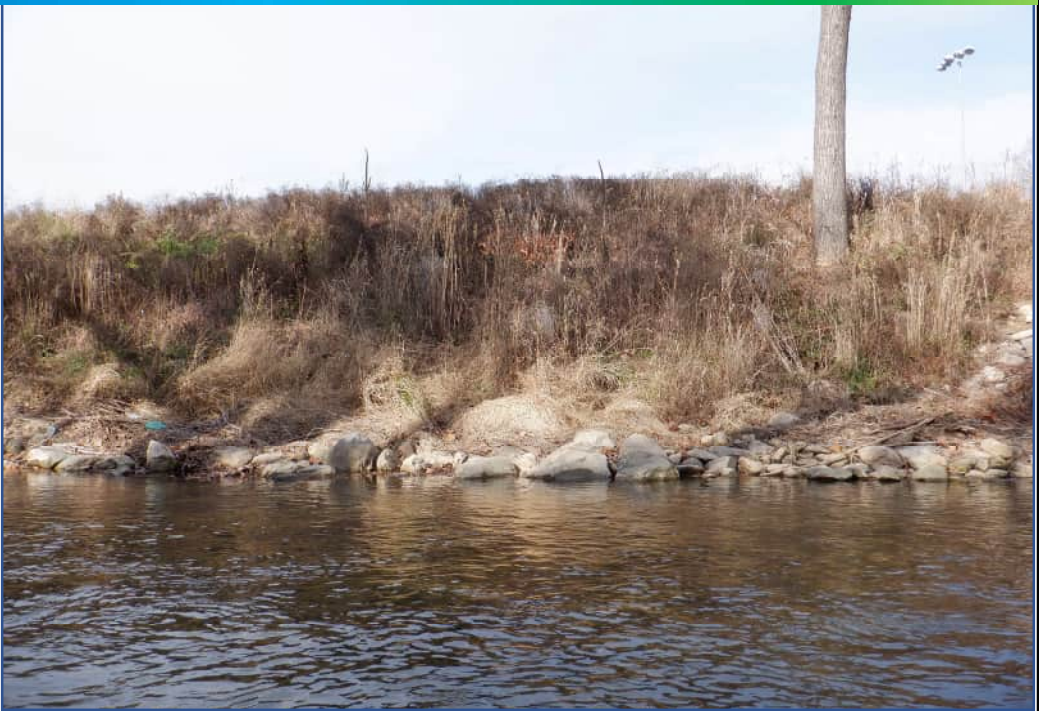
<b>Photo Number:</b> 68		<b>Location:</b> 00+2200'
<b>Date:</b> 12/7/2021

<b>Direction:</b> Northwest		
<b>Description:</b> ~ 60° bank angle; live stakes and plantings not established; 95% vegetation cover; one tree mid bank in good condition; rock toe intact; minimal sediment deposition; vegetation establishing.

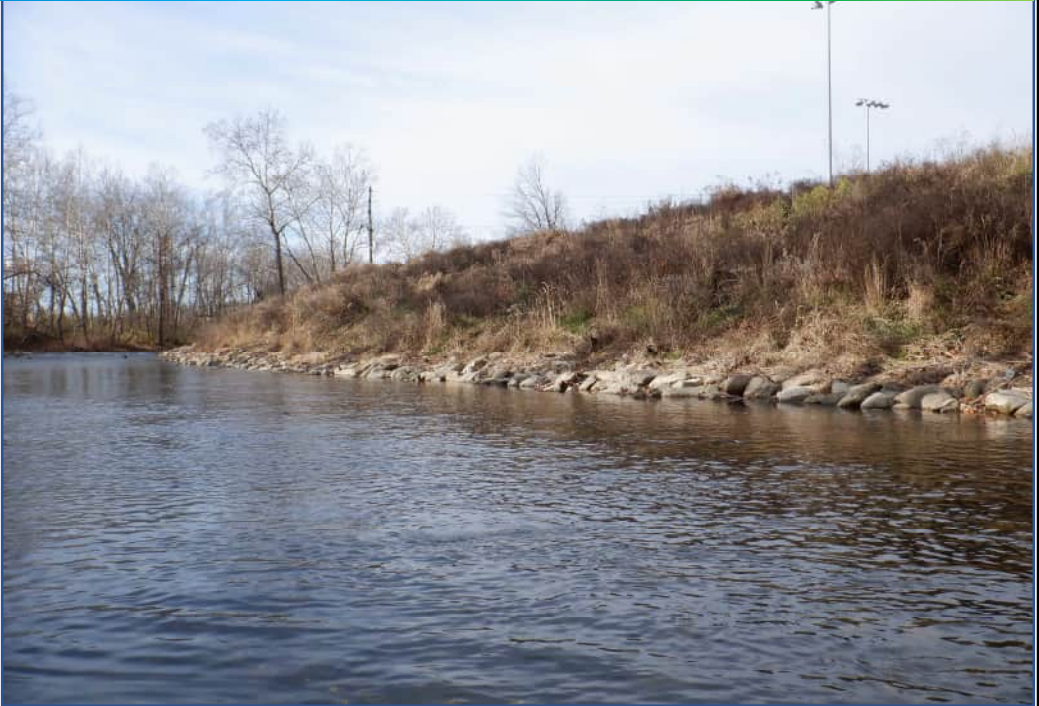
<b>Photo Number:</b> 69		<b>Location:</b> 00+2200'	
<b>Date:</b> 12/7/2021

<b>Direction:</b> West			
<b>Description:</b> Upstream view of remediated bank; live stakes and plantings not established; rock toe intact; minimal sediment deposition; vegetation establishing.

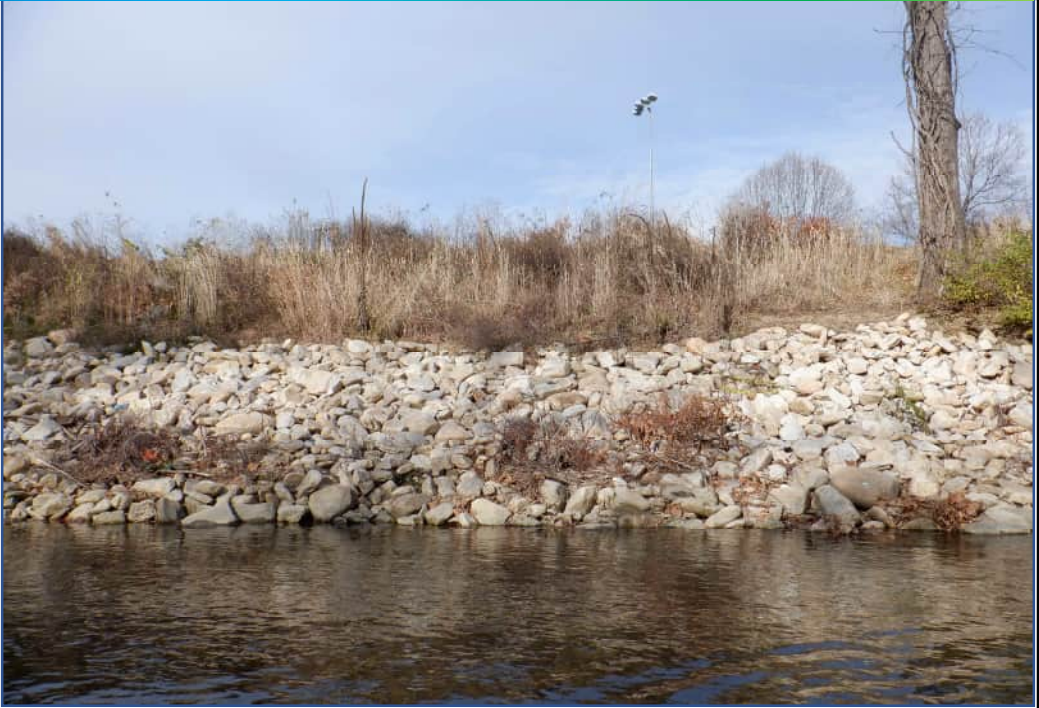
<b>Photo Number:</b> 71		<b>Location:</b> 00+2250'	
<b>Date:</b> 12/7/2021

<b>Direction:</b> Northwest			
<b>Description:</b> ~ 60° bank angle; live stakes and plantings not established; 95% vegetation cover; no at-risk trees; footpath at end of remediation; rock toe intact; vegetation establishing; minimal sediment deposition.

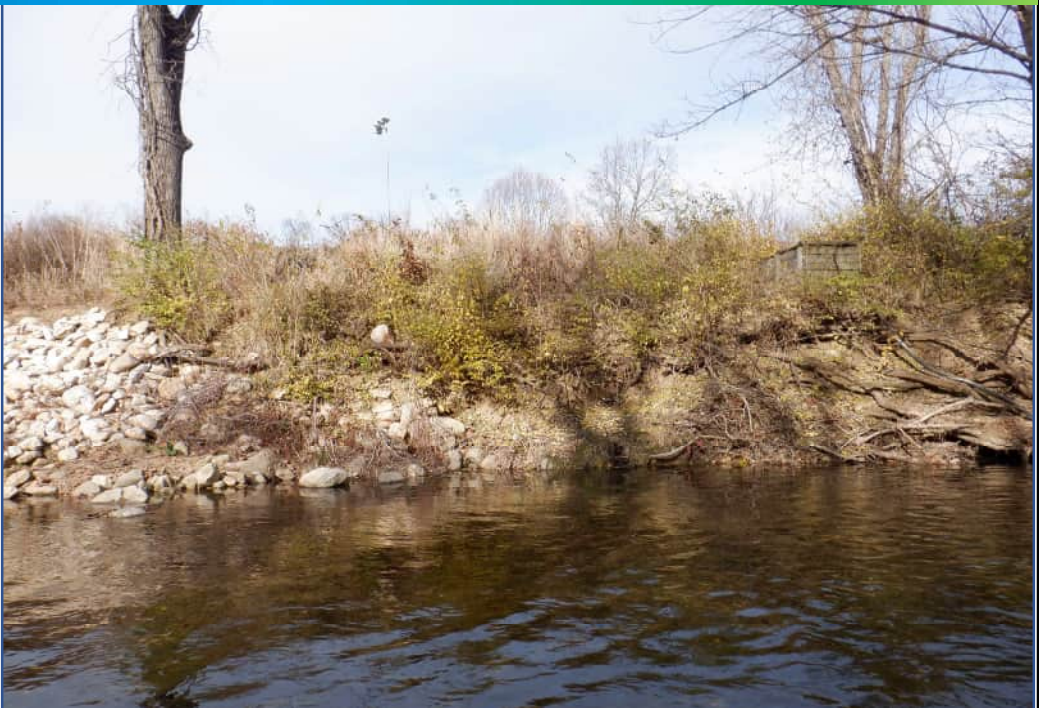
<b>Photo Number:</b> 72		<b>Location:</b> 00+2300'	
<b>Date:</b> 12/7/2021

<b>Direction:</b> Northwest			
<b>Description:</b> ~ 65° bank angle; start of non-remediated section; lower bank ~90° upper bank ~40°; woody vegetation throughout bank; medium exposed roots mid to lower bank; sparse vegetation; no at-risk trees present; moderate bank undercutting.

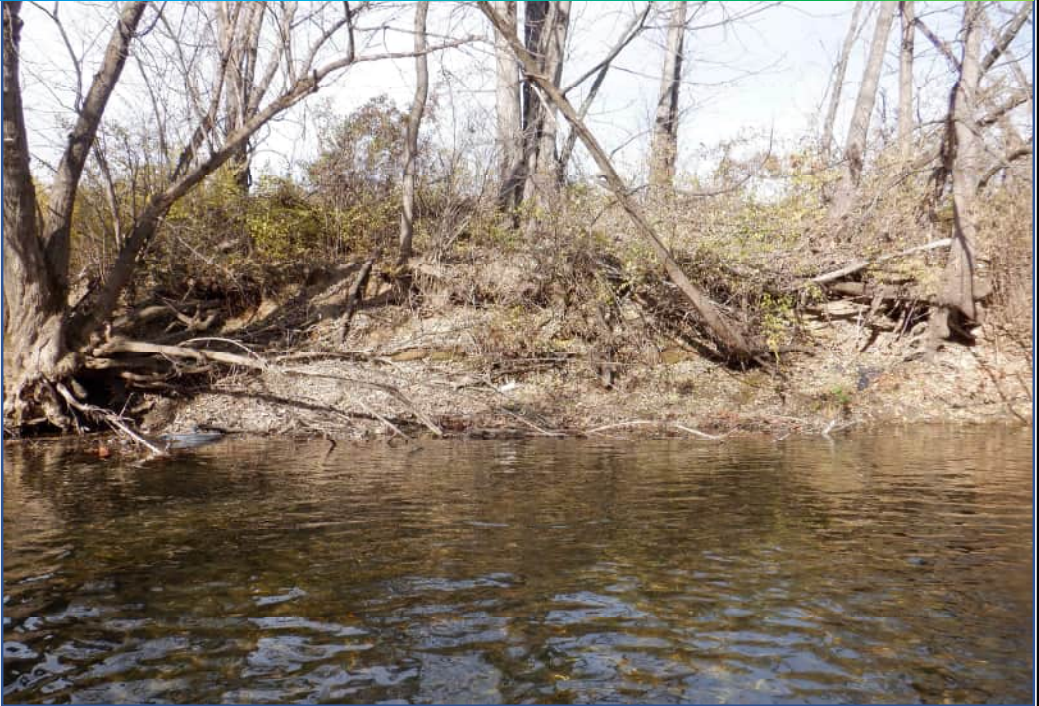
<b>Photo Number:</b> 73		<b>Location:</b> 00+2350'	
<b>Date:</b> 12/7/2021

<b>Direction:</b> Northwest			
<b>Description:</b> ~ 65° bank angle; lower bank ~90° upper bank ~40°; woody vegetation mid to upper bank; highly exposed roots; no vegetation established adjacent to water's edge; several trees on upper bank at risk; rock toe.

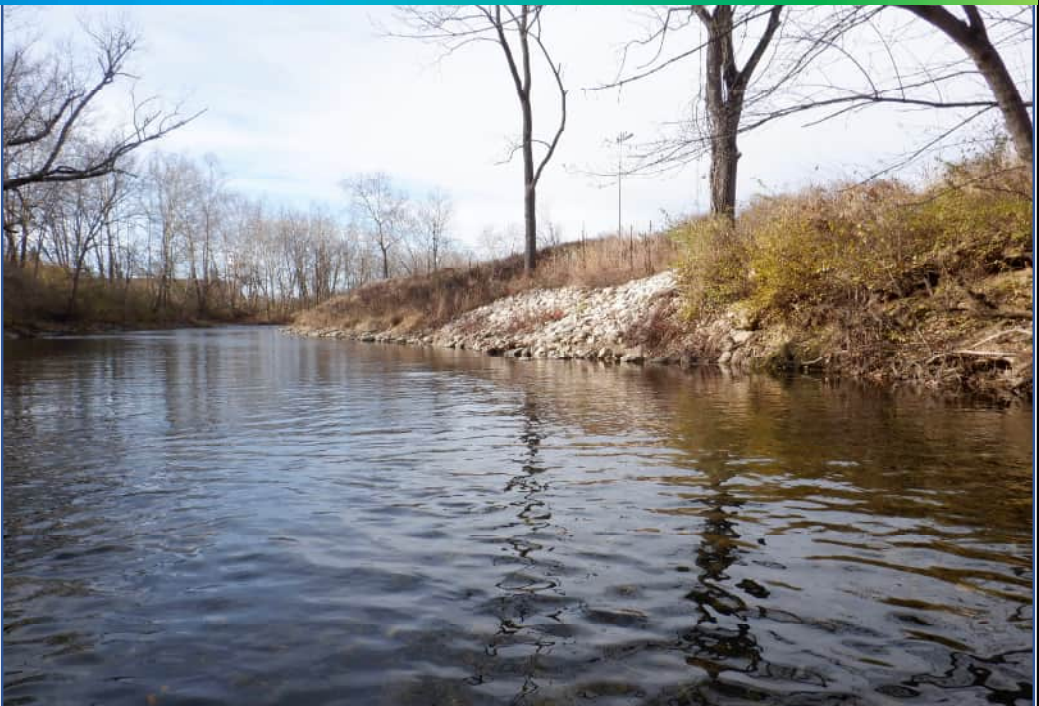
<b>Photo Number:</b> 74		<b>Location:</b> 00+2350'	
<b>Date:</b> 12/7/2021

<b>Direction:</b> West			
<b>Description:</b> Upstream view; undercutting at toe in non-remediated area; sparse vegetation cover.

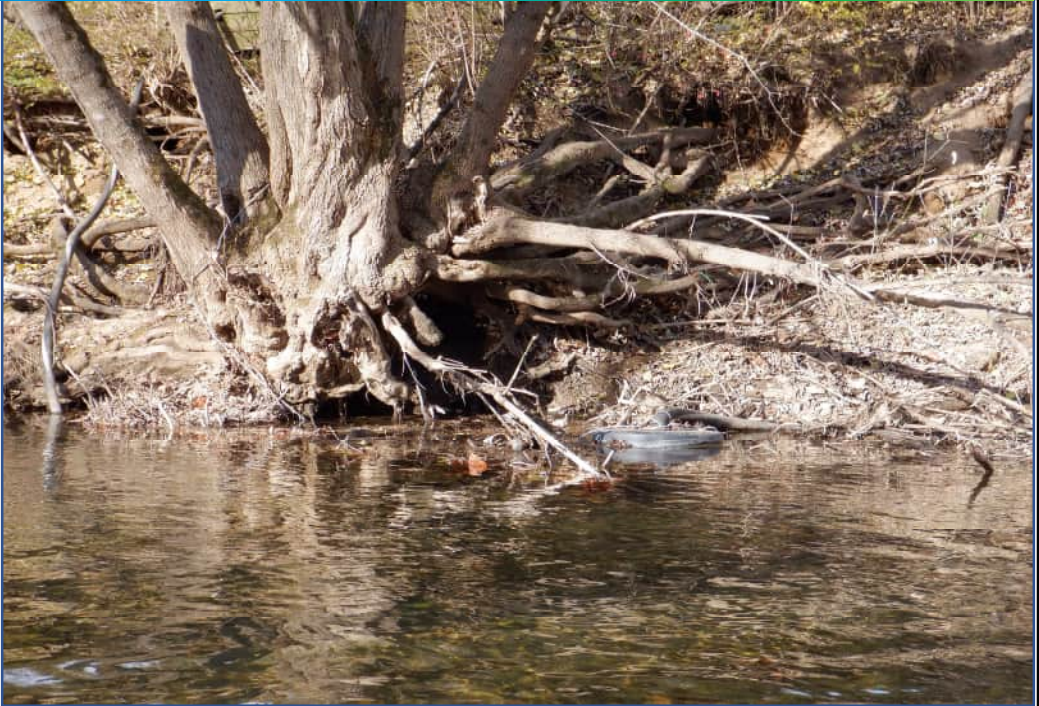
<b>Photo Number:</b> 75	<b>Location:</b> 00+2350'
<b>Date:</b> 12/7/2021

<b>Direction:</b> North	
<b>Description:</b> Significant erosion and scour around exposed roots of at-risk trees.

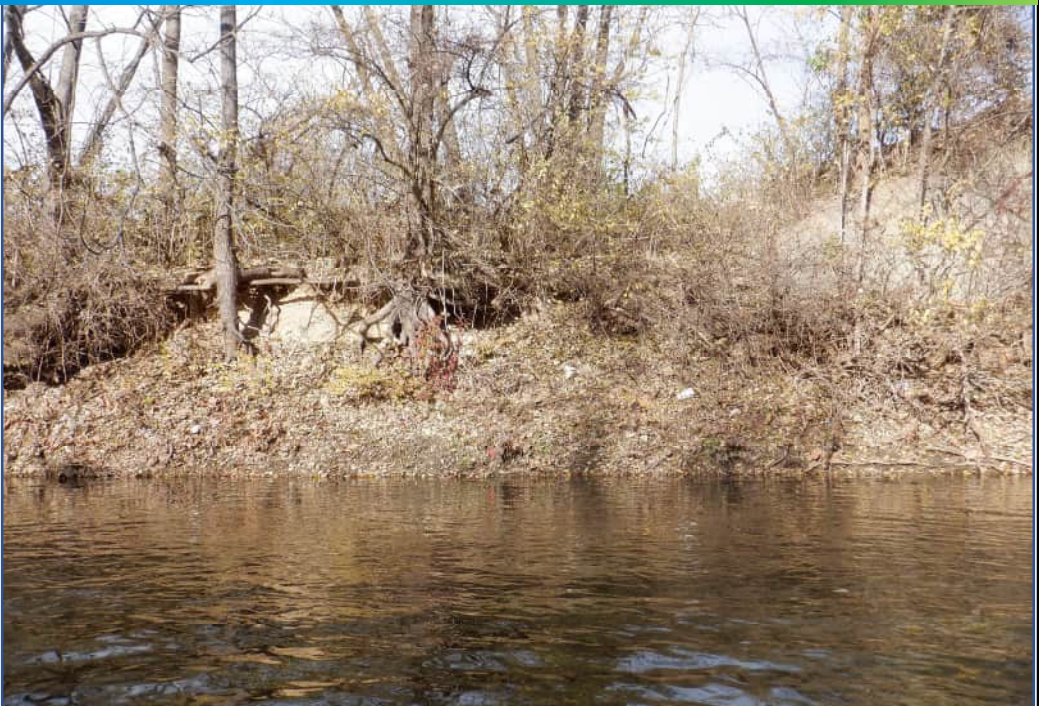
<b>Photo Number:</b> 76	<b>Location:</b> 00+2380'
<b>Date:</b> 12/7/2021

<b>Direction:</b> Northwest	
<b>Description:</b> lower bank ~90°; upper bank ~40°; woody vegetation throughout bank; moderate exposed roots mid to lower bank; sparse vegetation; roots severely exposed.
