**VIRGINIA DEPARTMENT OF ENVIRONMENTAL QUALITY**

**Re: 2021 Leaf-on and Leaf-off Maintenance Inspections  
Former DuPont Waynesboro Site AOC 4  
Waynesboro, Virginia  
EPA ID# VAD003114832**

Subject South River BMA - 2021 Leaf-Off Maintenance Inspection  
Former DuPont Waynesboro Site, Area of Concern 4

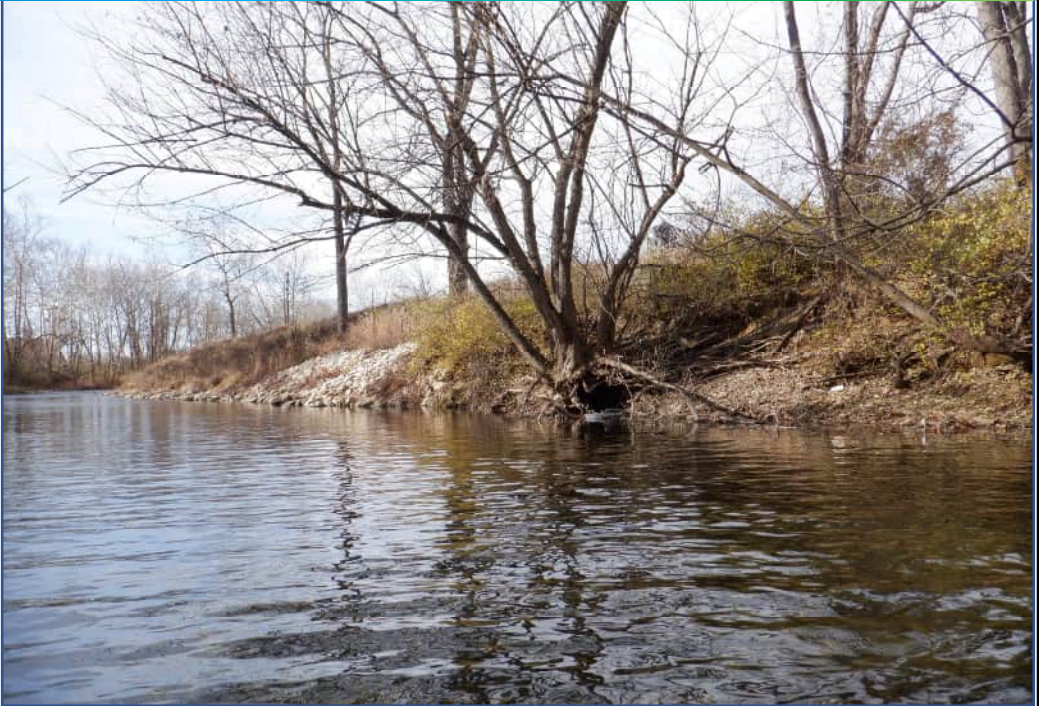
<b>Photo Number:</b> 77		<b>Location:</b> 00+2380'	
<b>Date:</b> 12/7/2021

<b>Direction:</b> West			
<b>Description:</b> Upstream view; undercutting at toe of bank in non-remediated area; sparse vegetation cover.

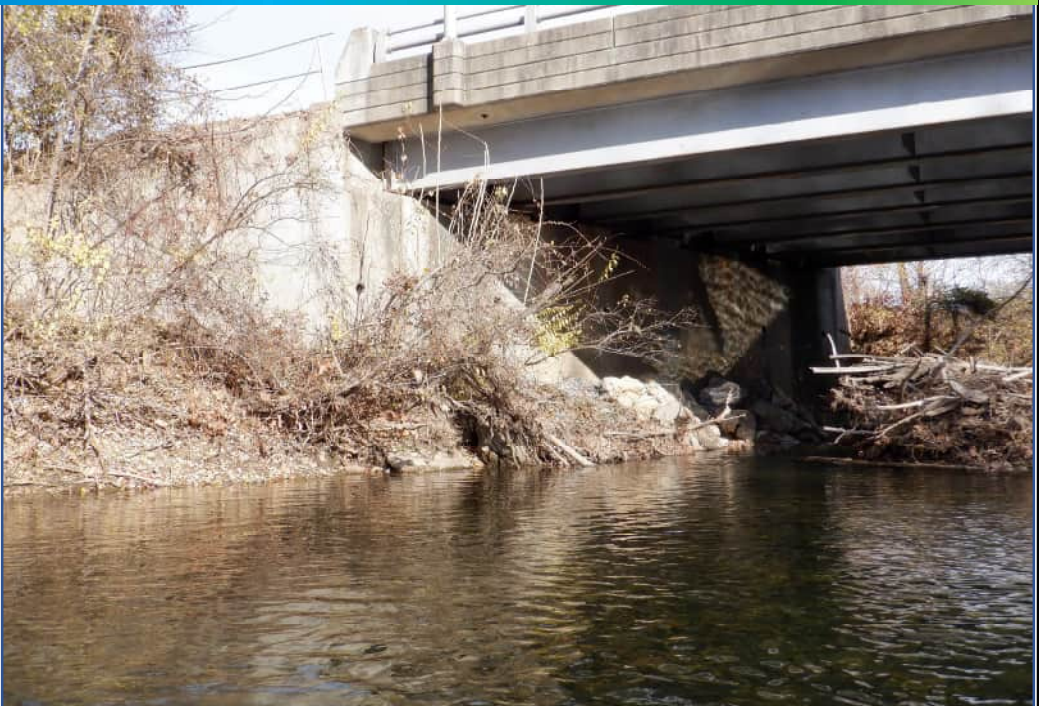
<b>Photo Number:</b> 78		<b>Location:</b> 00+2380'	
<b>Date:</b> 12/7/2021

<b>Direction:</b> North			
<b>Description:</b> Downstream view; minimal vegetation cover; erosion and scour by toe of slope.

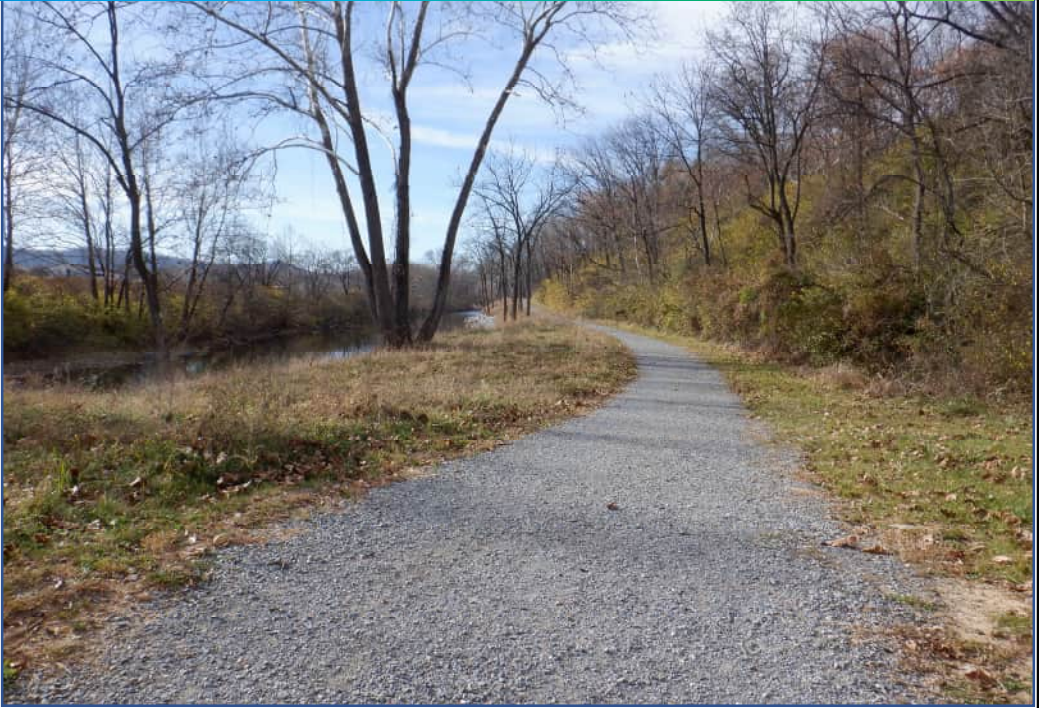
<b>Photo Number:</b> 79		<b>Location:</b> North Park	
<b>Date:</b> 12/7/2021

<b>Direction:</b> West			
<b>Description:</b> Trees present across greenspace in North Park along greenway in good condition; vegetation minimally established in greenspace; plantings establishing.

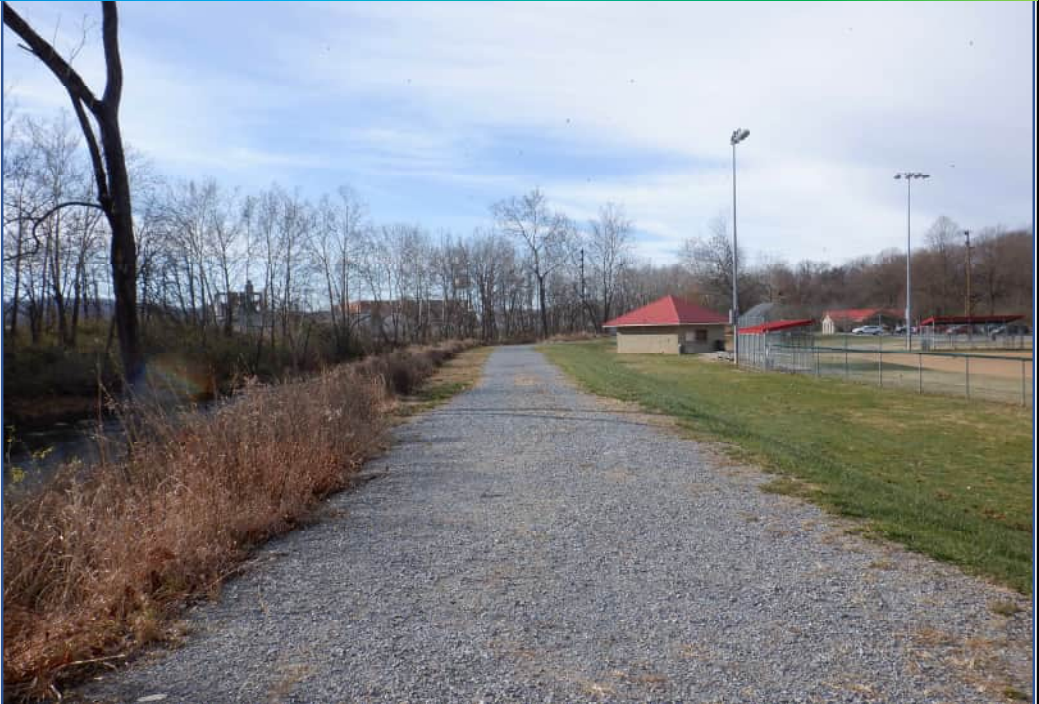
<b>Photo Number:</b> 80		<b>Location:</b> North Park	
<b>Date:</b> 12/7/2021

<b>Direction:</b> West			
<b>Description:</b> Greenway intact and ready for pavement; some ruts along greenway from vehicles; some erosion control fabric exposed by proposed pollinator garden area.
