RE: 2022 Leaf-off, 2022 Leaf-on and 2023 Leaf-on BMA Inspection Memos
Former DuPont Waynesboro Site AOC 4
Waynesboro, Virginia
EPA ID# VAD003114832

Memorandum

Subject 2022 Leaf-on Maintenance Inspection
Former DuPont Waynesboro Site, Area of Concern 4

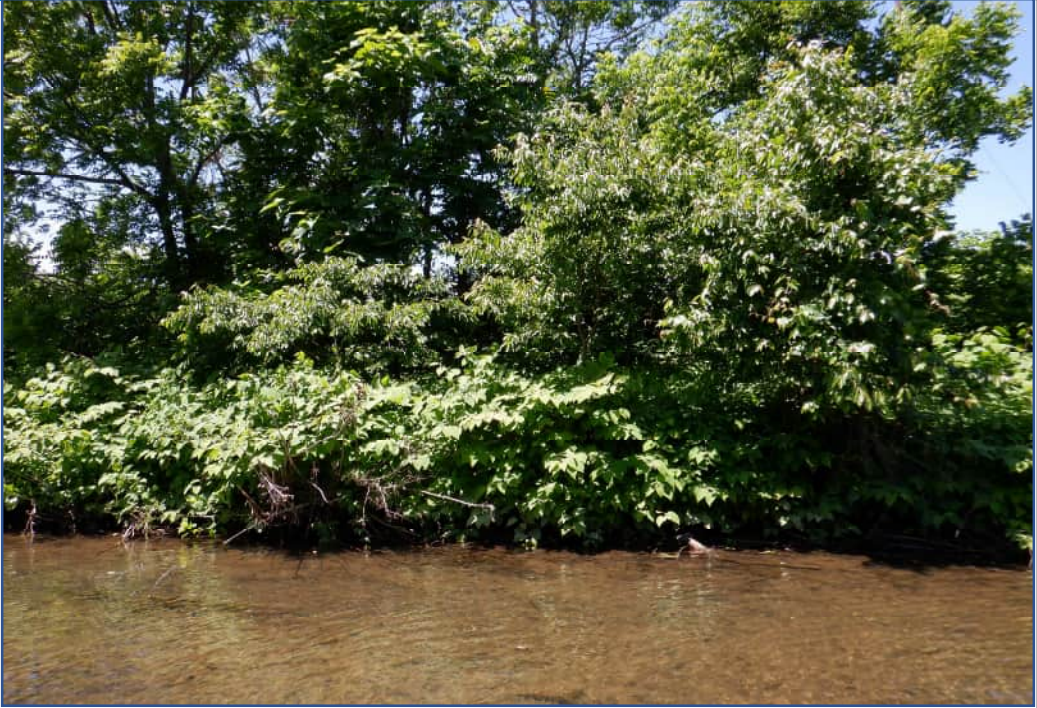
Photo Number: 01		Location: 00 – 25'	
Date: 6/9/2022

Direction: West			
Description: Lower bank ~20°; upper bank ~55°; no woody plants or trees adjacent to edge of water; large patch of invasive knotweed along water's edge

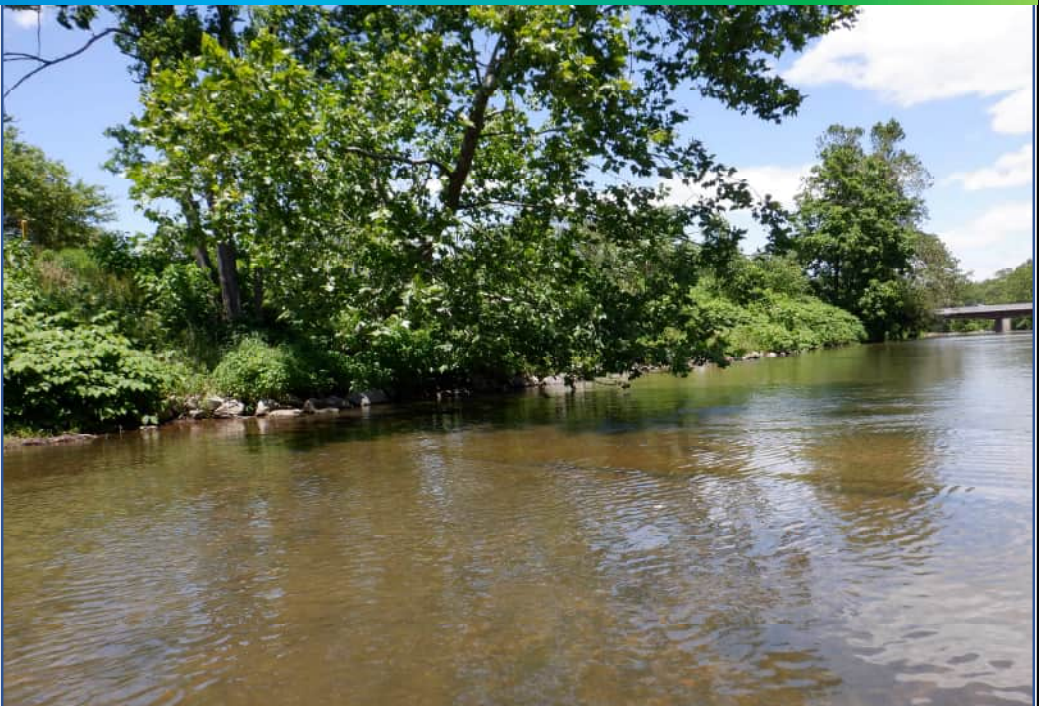
Photo Number: 06	Location: 00 + 50'
Date: 6/9/2022

Direction: West	
Description: Downstream view of at-risk sycamore at ~00+70'.

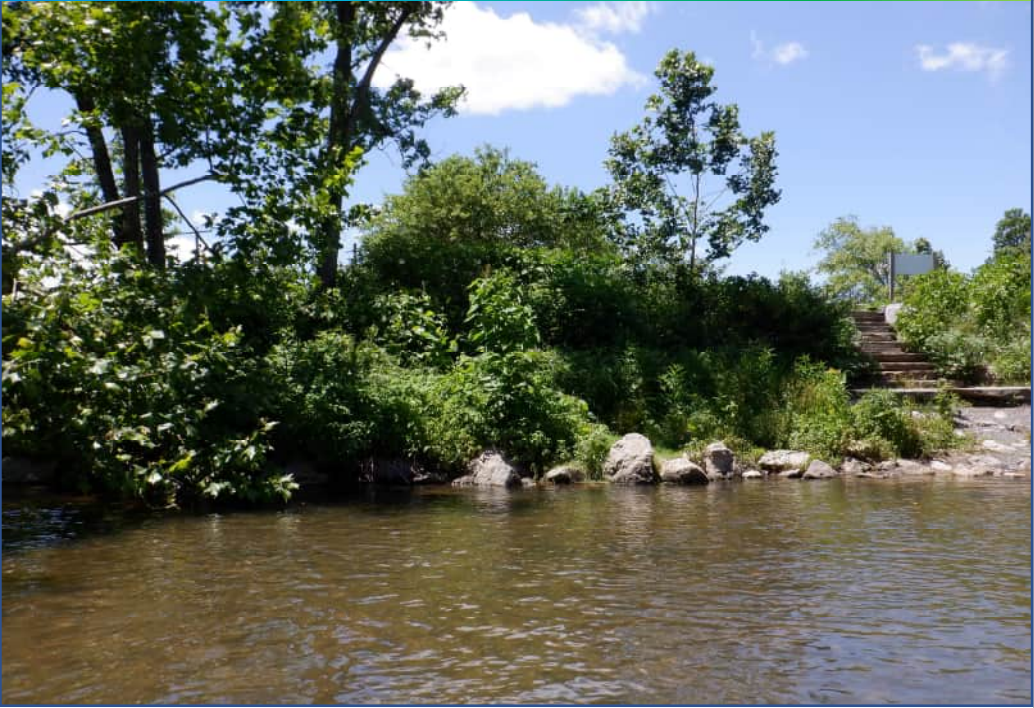
Photo Number: 07		Location: 00 + 100'	
Date: 6/9/2022

Direction: West			
Description: Lower bank ~20° (rock toe); upper bank ~50°; live stakes not visible; at-risk trees sycamore upstream at 00+70'; sediment deposition adjacent to rock toe boulders.

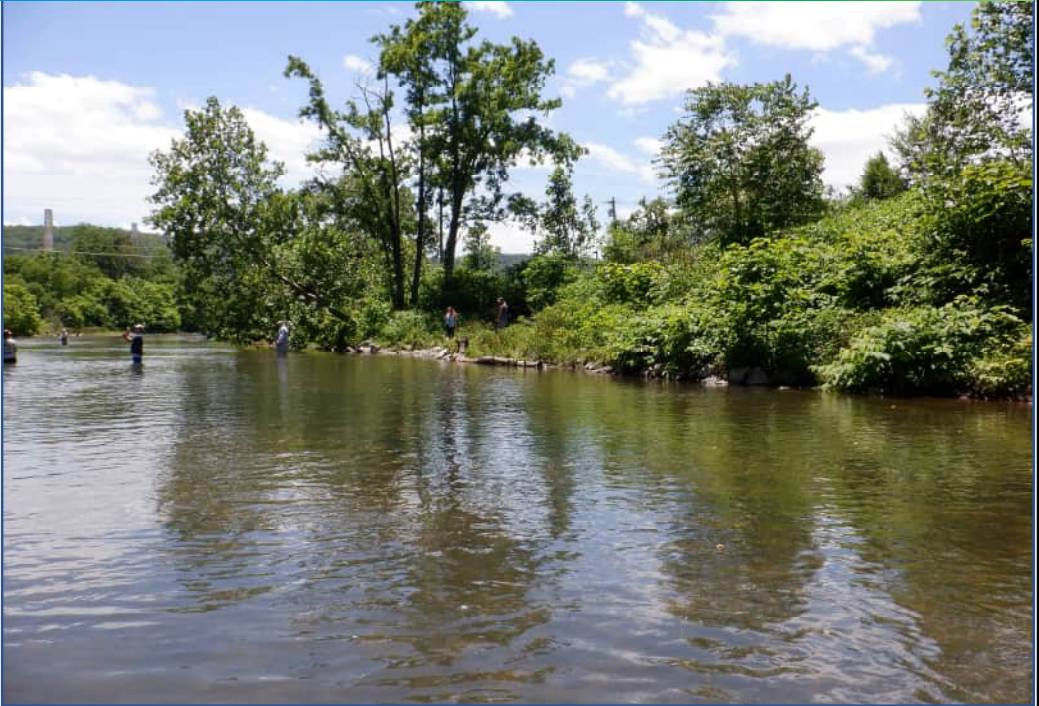
Photo Number: 13	Location: 00 + 250'
Date: 6/9/2022

Direction: West	
Description: Upstream view of remediated bank; patches of invasive knotweed present.

There are large and small patches of invasive knotweed throughout the BMA. Knotweed coverage has increased compared to previous years. Treatment with herbicide is recommended. Stakes designed to hold coir logs in place are visible on the edge of the water. Coir logs are decomposed so stakes can be removed.

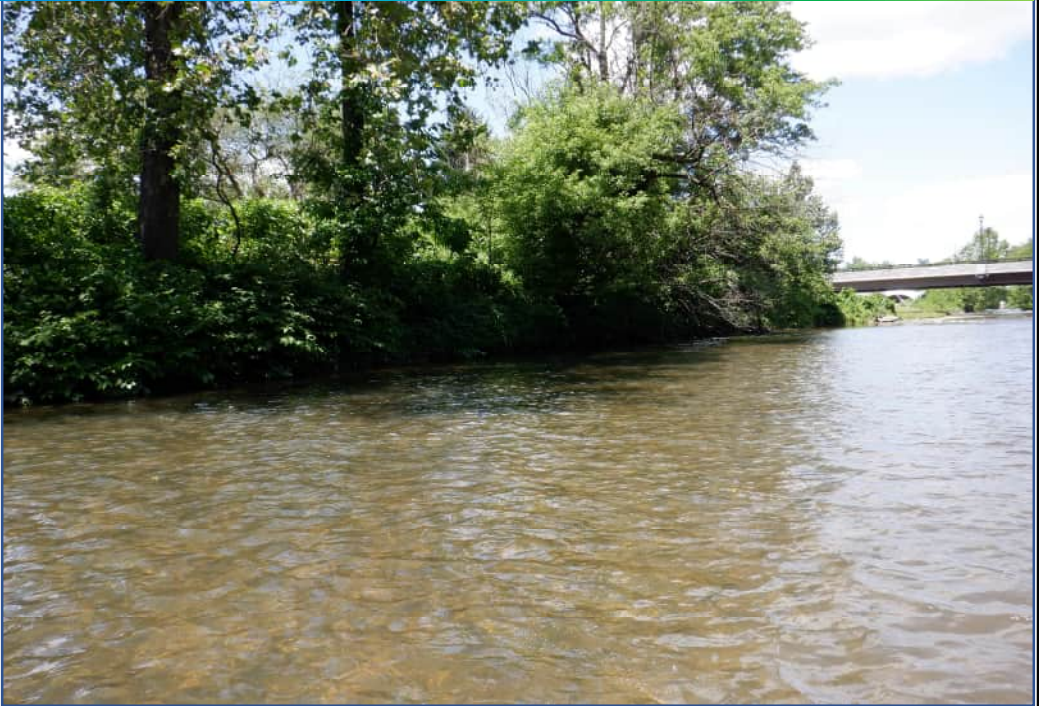
Photo Number: 17		Location: 00+350'	
Date: 6/9/2022

Direction: Northwest			
Description: Downstream view of remediated bank; scour at toe.

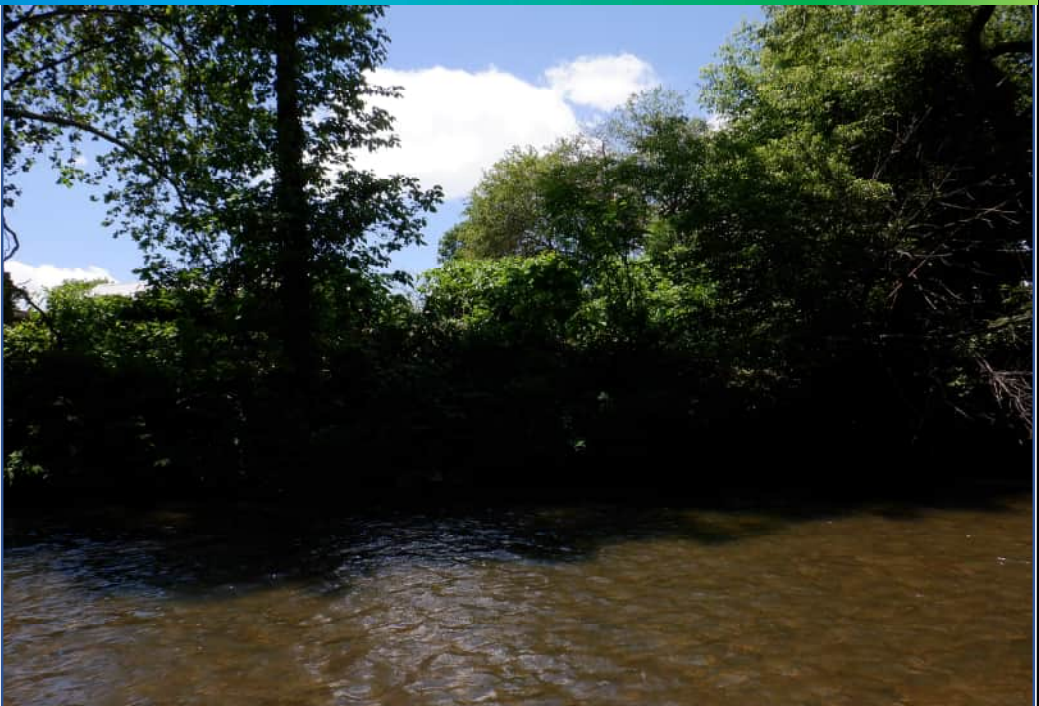
Photo Number: 18		Location: 00+400'	
Date: 6/9/2022

Direction: Southwest			
Description: ~60° bank angle; no live stakes visible; small patch of invasive knotweed; mostly native vegetation along bank.

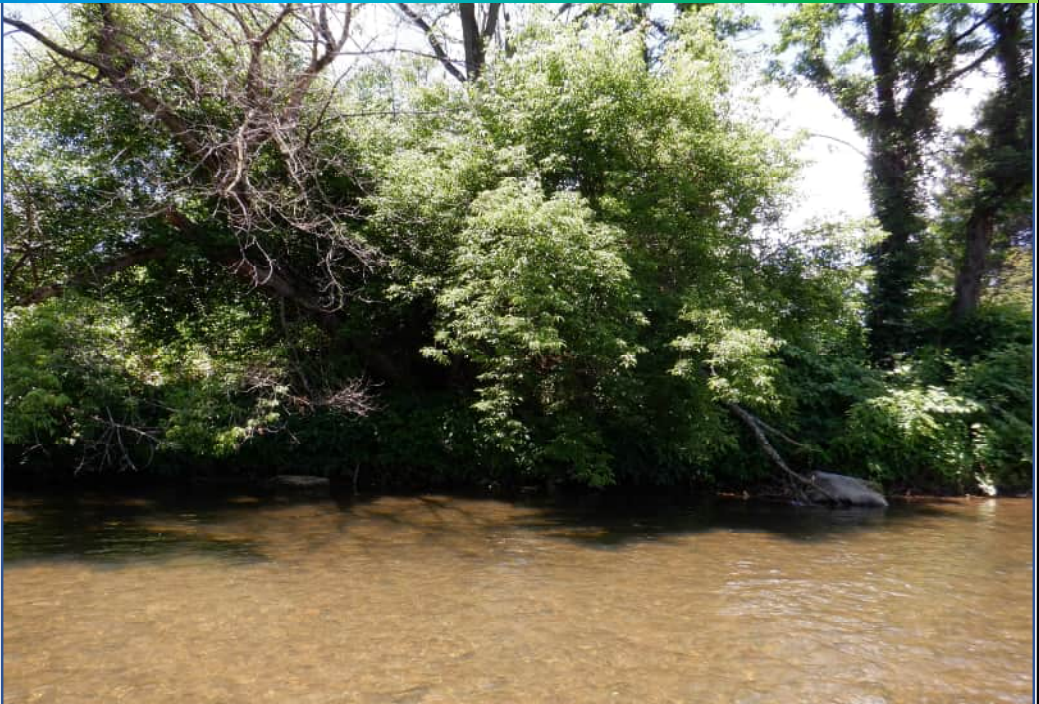
Photo Number: 20		Location: 00+450'	
Date: 6/9/2022

Direction: West			
Description: ~50° bank angle; native vegetation present along top of bank with small patches of invasive knotweed at toe of slope; at-risk Box Elder tree

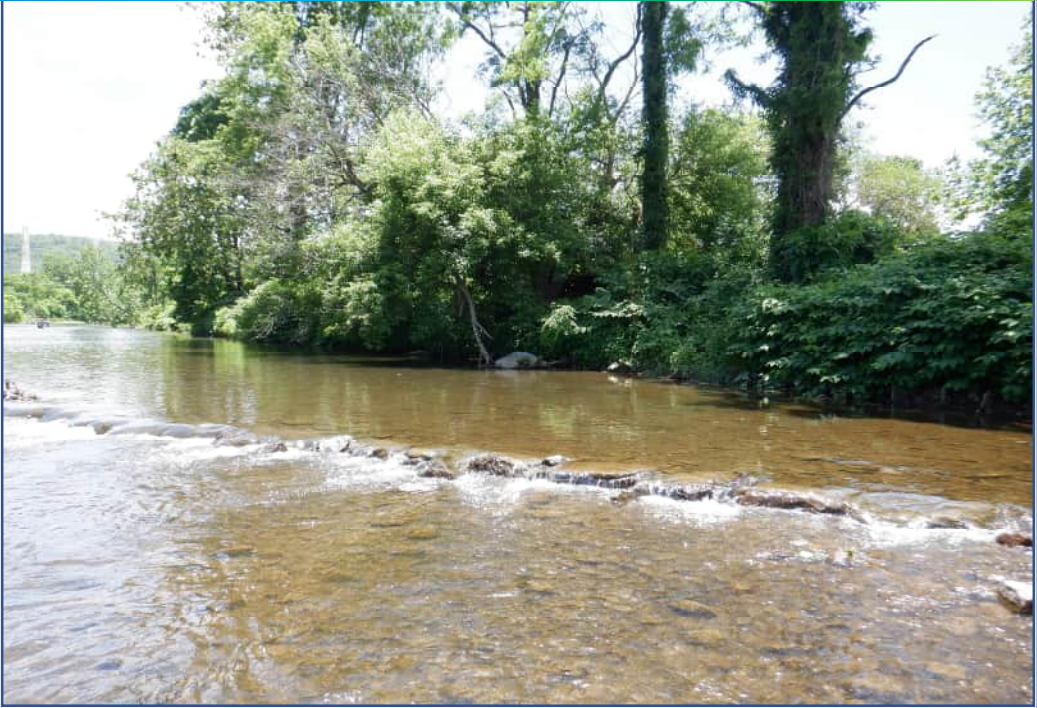
Photo Number: 25		Location: 00+525'	
Date: 6/9/2022

Direction: West			
Description: Upstream view from end of remediated section; at-risk tree and invasive knotweed present.

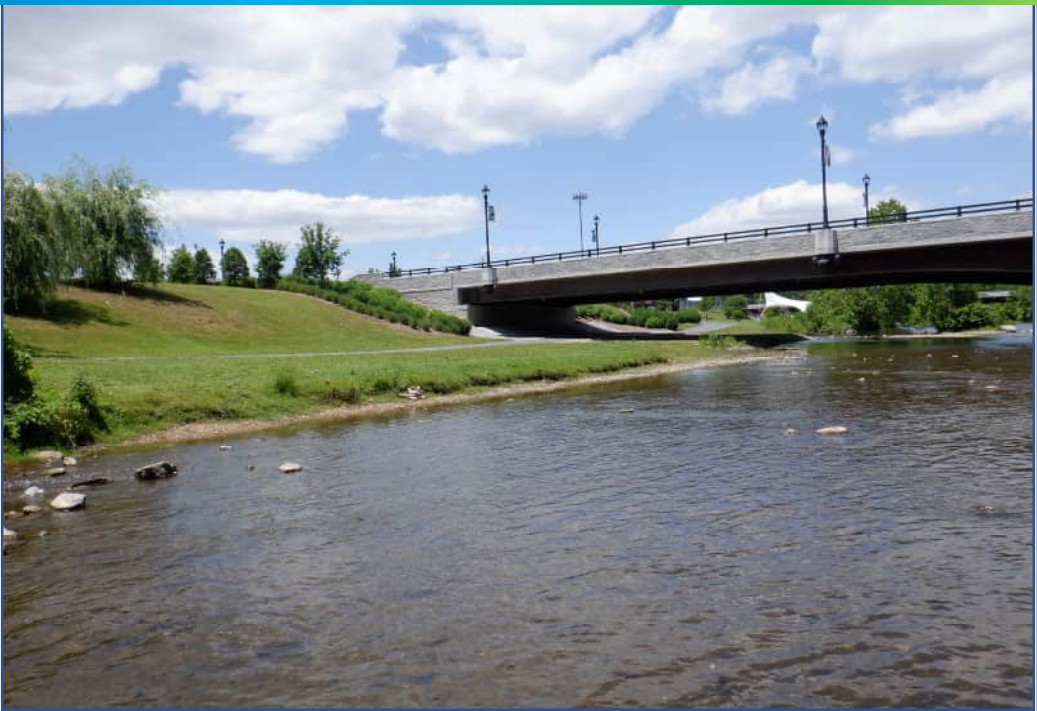
Photo Number: 26		Location: 00+525'	
Date: 6/9/2022

Direction: Southwest			
Description: Downstream view from end of remediated bank; no trees or vegetation along bank below remediated section.

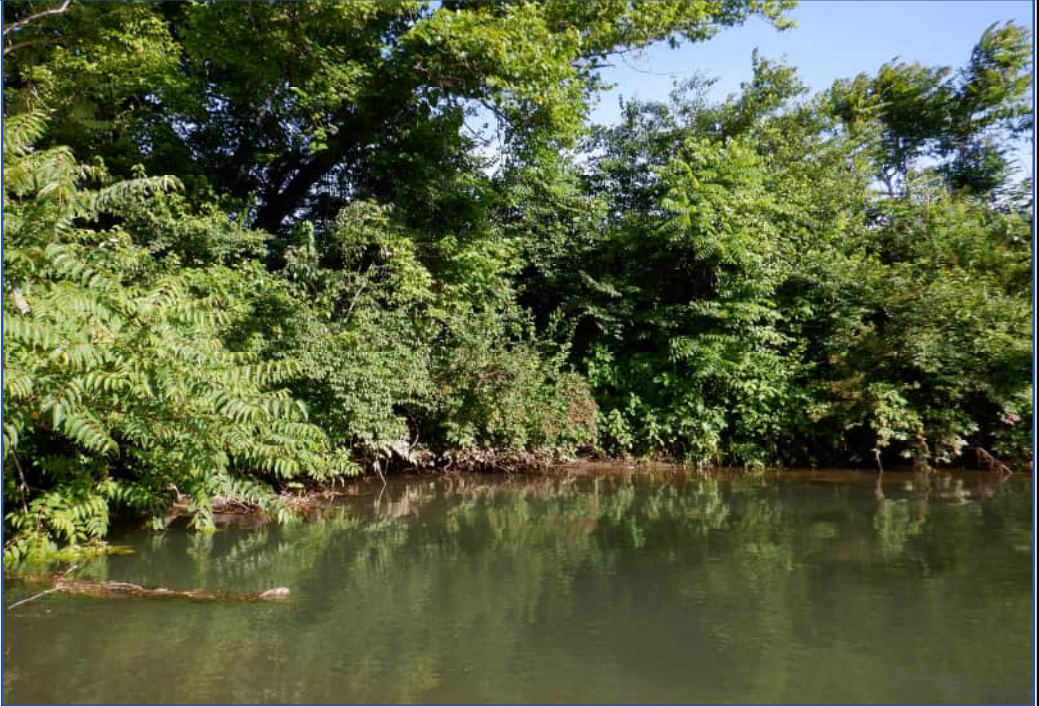
Photo Number: 01	Location: 00-25'
Date: 6/9/2022

Direction: Northwest	
Description: Upstream of remediate bank; ~85° bank angle; high quantity of exposed roots on the bank; at-risk tree; 80% vegetated; scour present throughout.

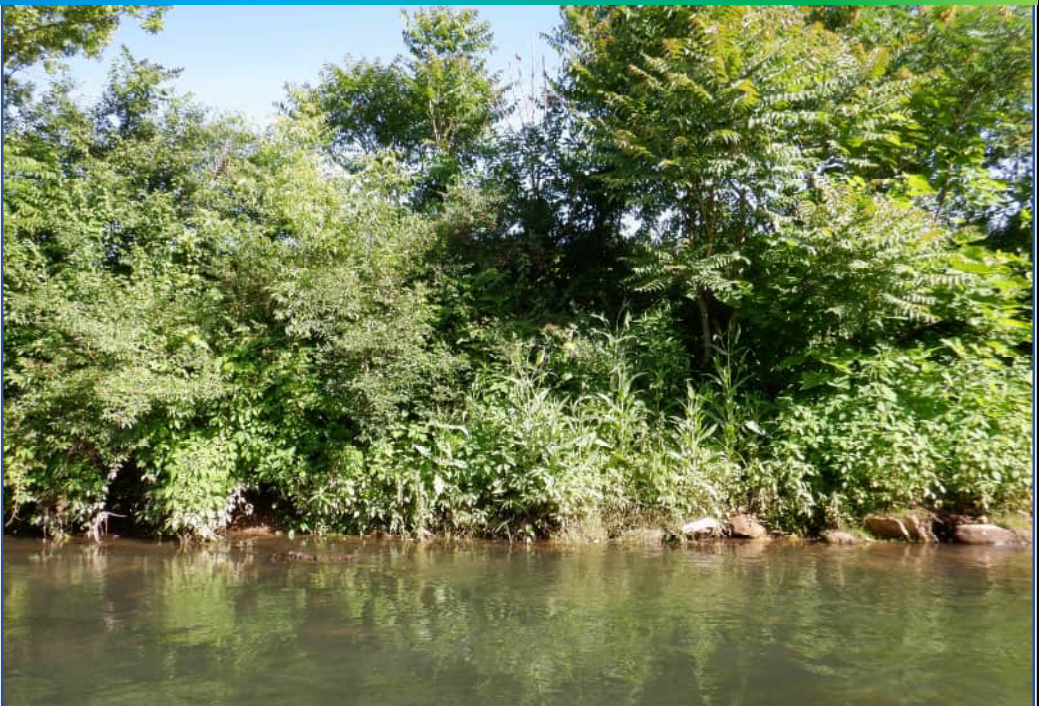
Photo Number: 02	Location: 00+00'
Date: 6/9/2022

Direction: Northeast	
Description: Beginning of 1 st remediated bank; lower bank ~60°; upper bank ~80°; vegetation fully established and grasses establishing by rock toe base; some scour present from rock toe to mid bank upstream of remediation.

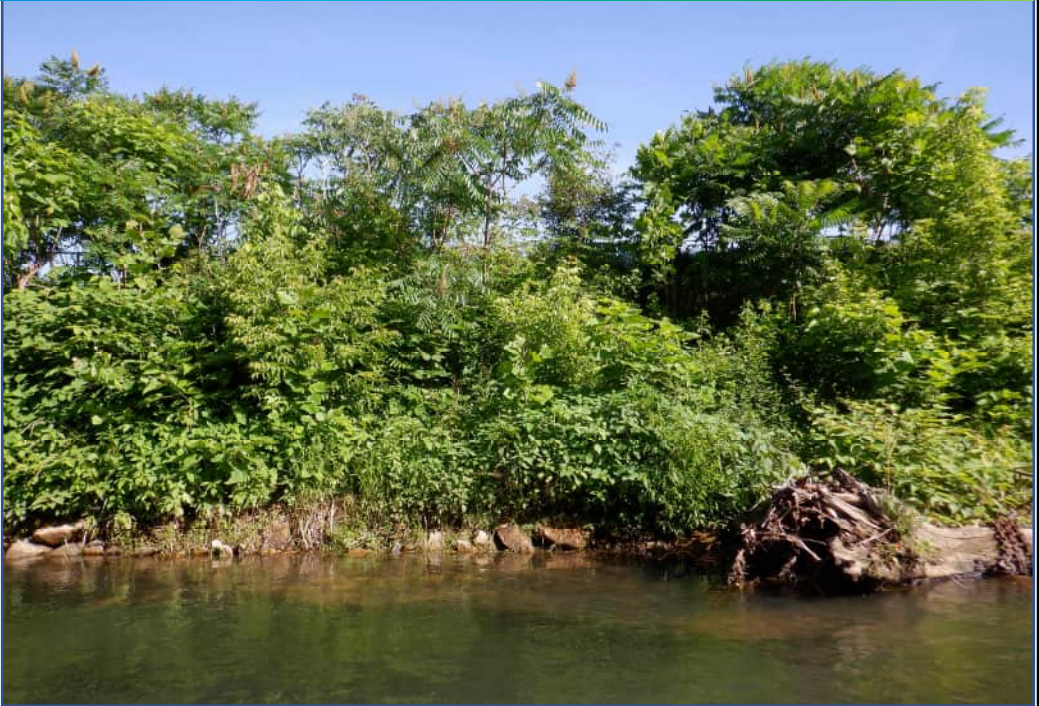
Photo Number: 03		Location: 00+50'	
Date: 6/9/2022

Direction: Northwest			
Description: ~45° bank angle; predominantly native vegetation along top of rock toe; vegetation fully established; grasses establishing by rock toe base; no woody plants adjacent to edge of water.

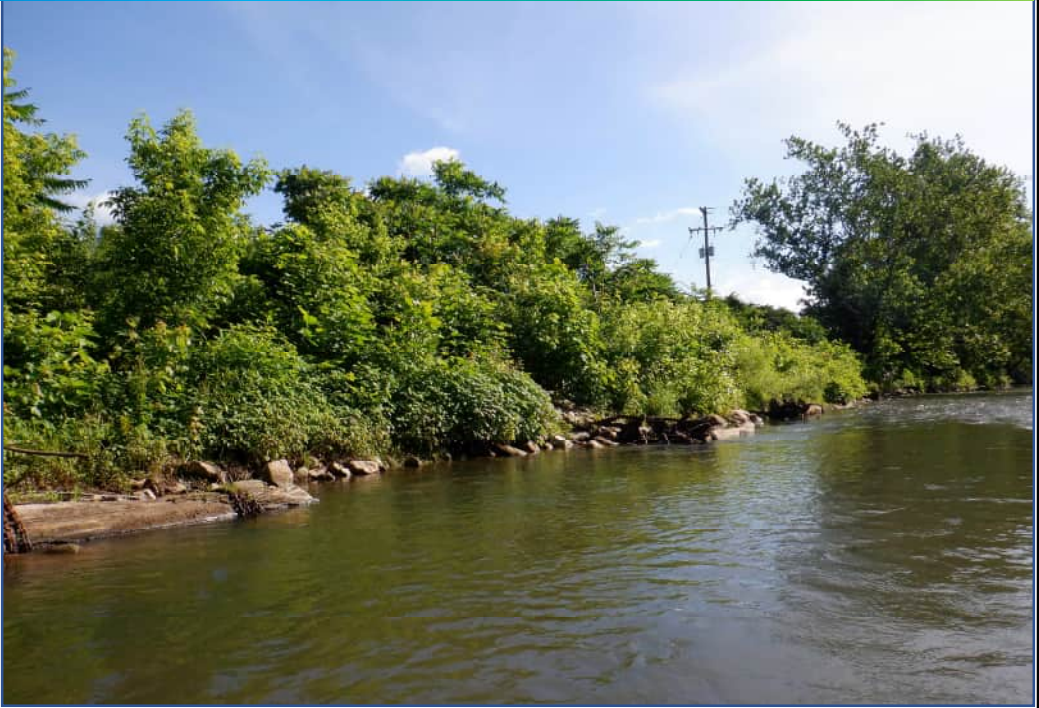
Photo Number: 05	Location: 00+50'
Date: 6/9/2022

Direction: Northeast	
Description: Downstream view of remediated bank; rock toe intact; LWD intact; sediment filling behind LWD; no scour present along rock toe.

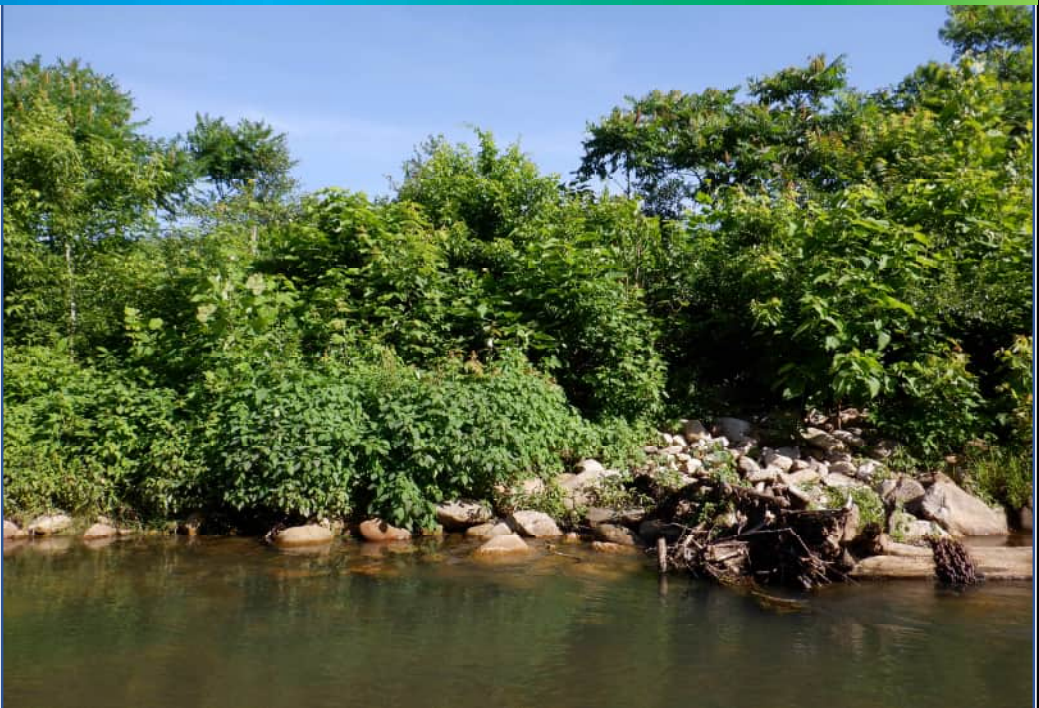
Photo Number: 06	Location: 00+100'
Date: 6/9/2022

Direction: Northwest	
Description: ~45° bank angle; predominantly native vegetation along top of rock toe; vegetation fully established; grasses establishing by rock toe base; no woody plants adjacent to edge of water; rock toe intact; LWD intact; no scour present along rock toe.

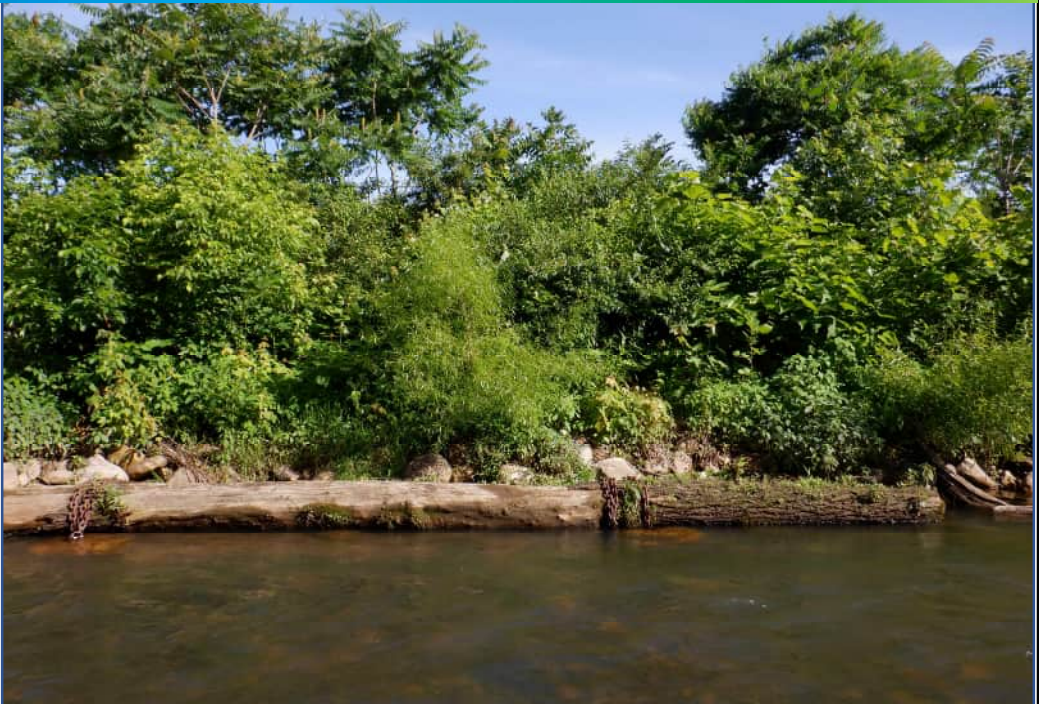
Photo Number: 08		Location: 00+150'	
Date: 6/9/2022

Direction: Northwest			
Description: ~45° bank angle; predominantly native vegetation; vegetation fully established and grasses establishing by rock toe base; no woody plants adjacent to edge of water; no scour present along rock toe and outfall pipe present within.

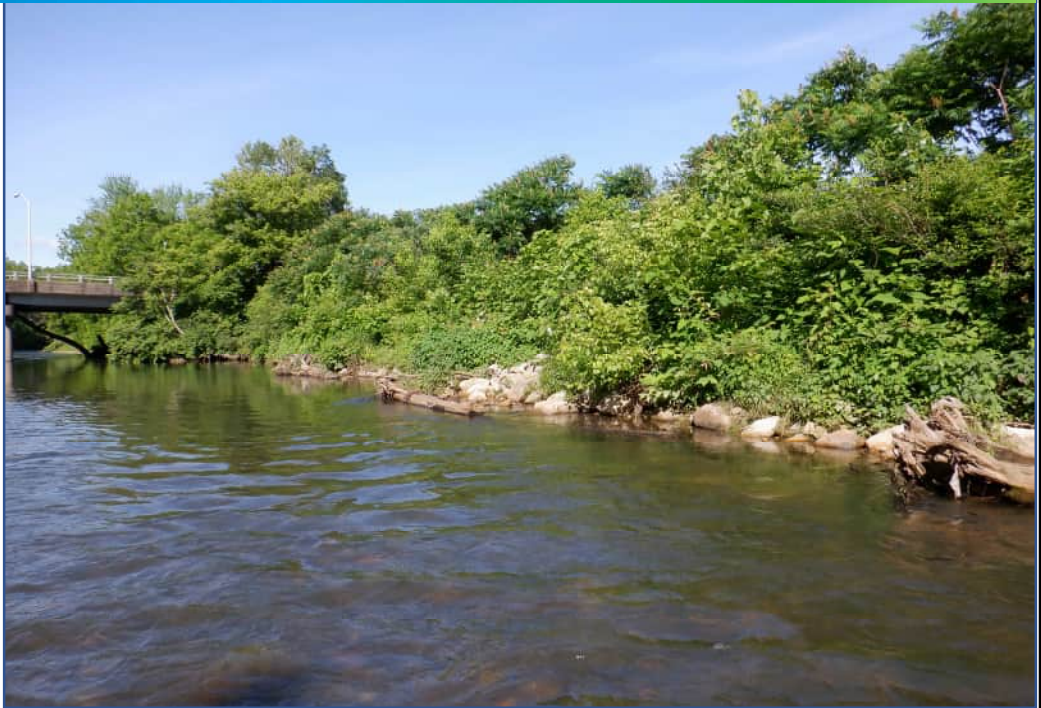
Photo Number: 09	Location: 00+150'
Date: 6/9/2022

Direction: Southwest	
Description: Upstream view of remediated bank; rock toe intact; LWD intact; sediment filling behind LWD; no scour present along rock toe.

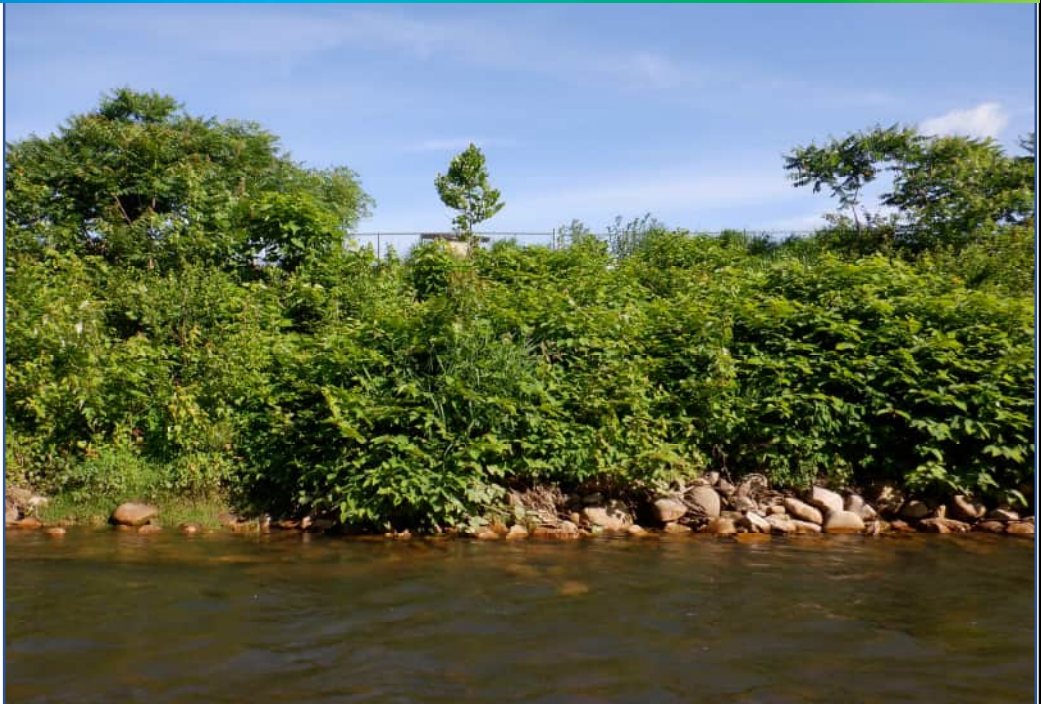
Photo Number: 10	Location: 00+200'
Date: 6/9/2022

Direction: Northwest	
Description: ~45° bank angle; Invasive Knotweed 90% cover, Knotweed completely covers rock stairs and gate present on upper half of bank; LWD intact; sediment filling behind LWD; no scour present along rock toe.

*Two LWD features shifted downstream from 350' to 400' and 850' to 880'. Herbicide treatment is recommended for areas with Japanese knotweed.

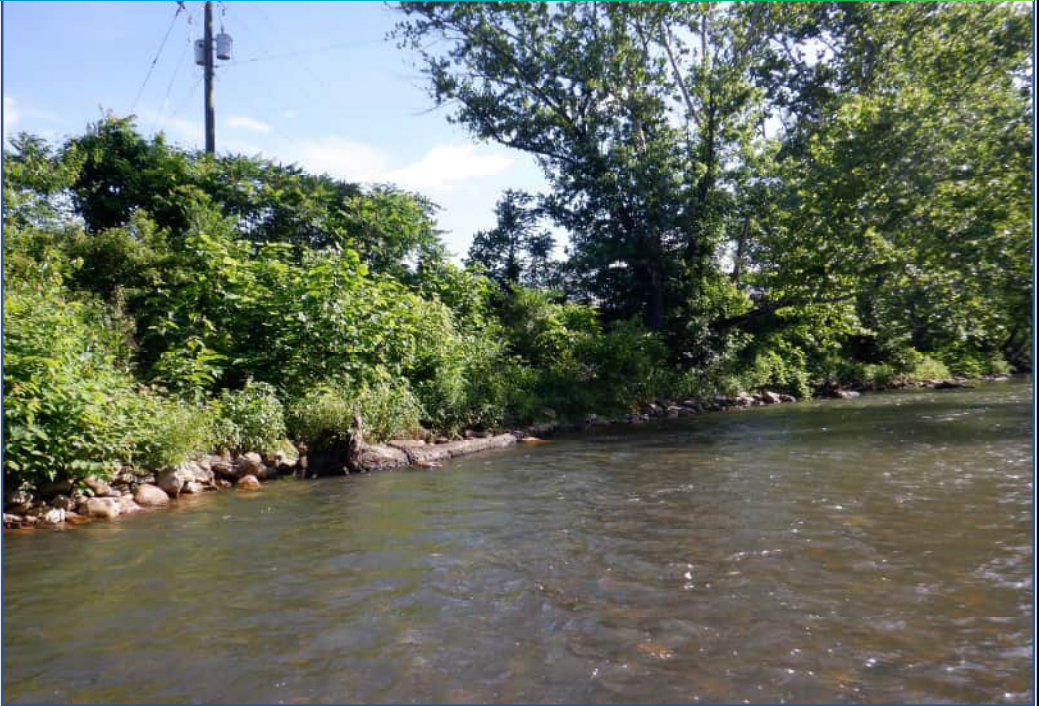
Photo Number: 11		Location: 00+200'	
Date: 6/9/2022

Direction: Northeast			
Description: Downstream view of remediated bank; rock toe intact; LWD intact; sediment filling behind LWD; no scour present along rock toe.

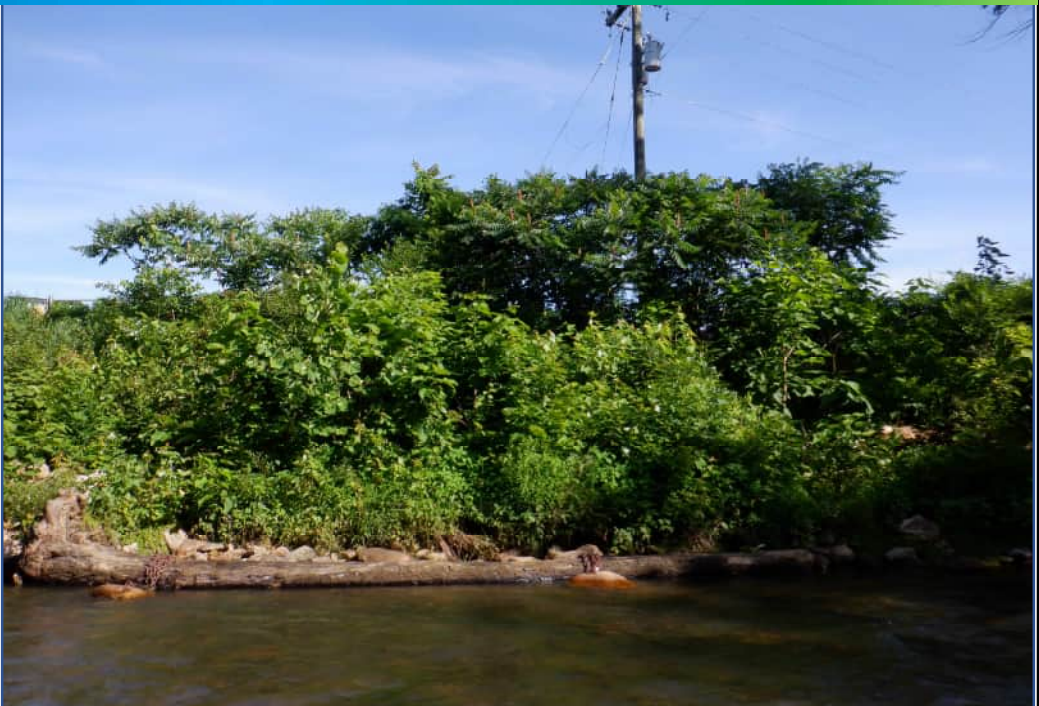
Photo Number: 12		Location: 00+250'	
Date: 6/9/2022

Direction: Northwest			
Description: ~45° bank angle; predominately native vegetation along top of Rock Toe; no woody plants adjacent to edge of water; LWD intact; sediment filling in behind LWD, no scour present along Rock Toe.

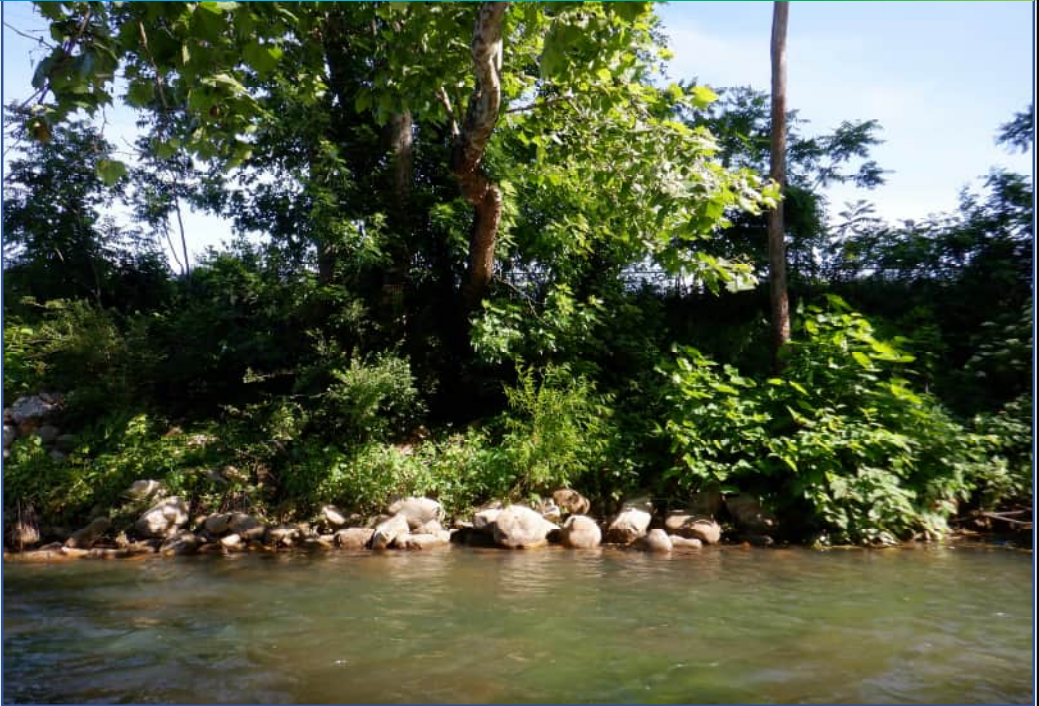
Photo Number: 13		Location: 00+300'	
Date: 6/9/2022

Direction: Northwest			
Description: ~45° bank angle; predominantly native vegetation along top of rock toe.

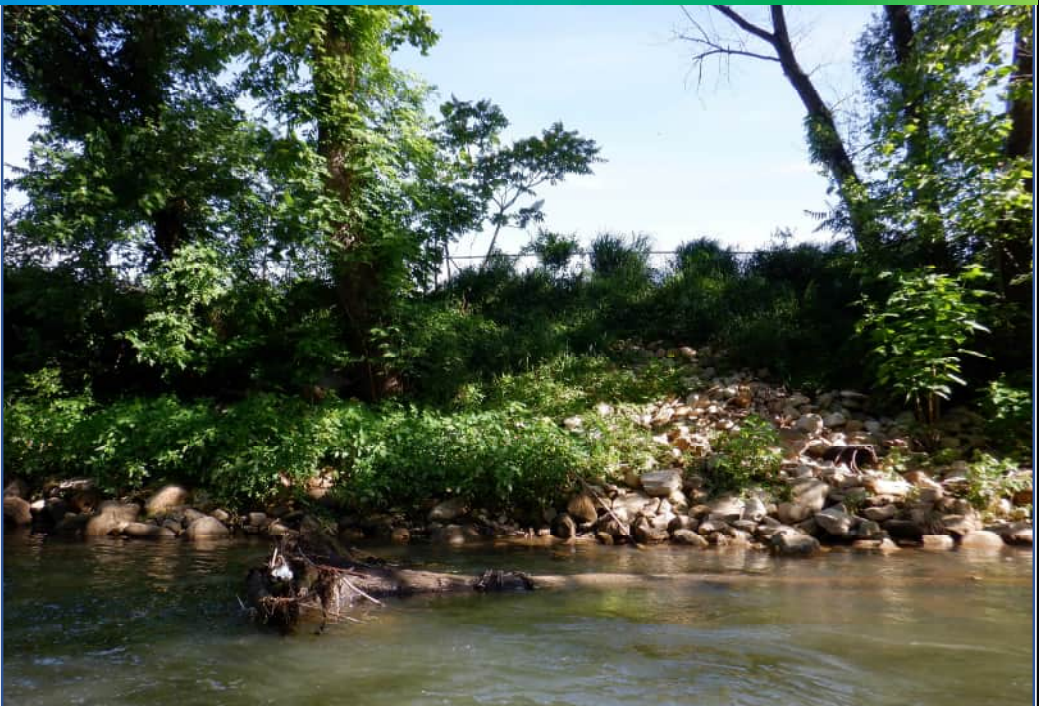
Photo Number: 14		Location: 00+350'	
Date: 6/9/2022

Direction: Northwest			
Description: ~45° bank angle; predominantly native vegetation with flood debris on top of intact rock toe; vegetation fully established; two outfall pipes present within rock toe, but no scour.

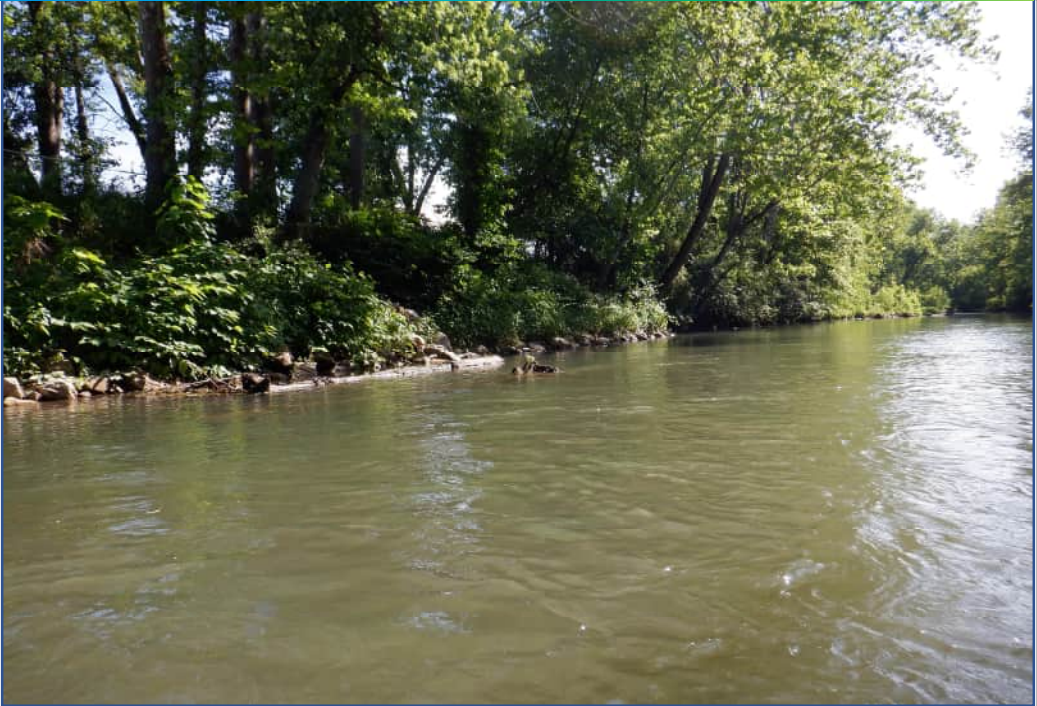
Photo Number: 17	Location: 00+400'
Date: 6/9/2022

Direction: Northeast	
Description: Downstream view of the end of the 1 st remediation bank; native vegetation along top of rock toe; vegetation fully established; some large trees present; small sycamore on mid-bank leaning over river at 45°; rock toe intact; no scour present along rock toe.

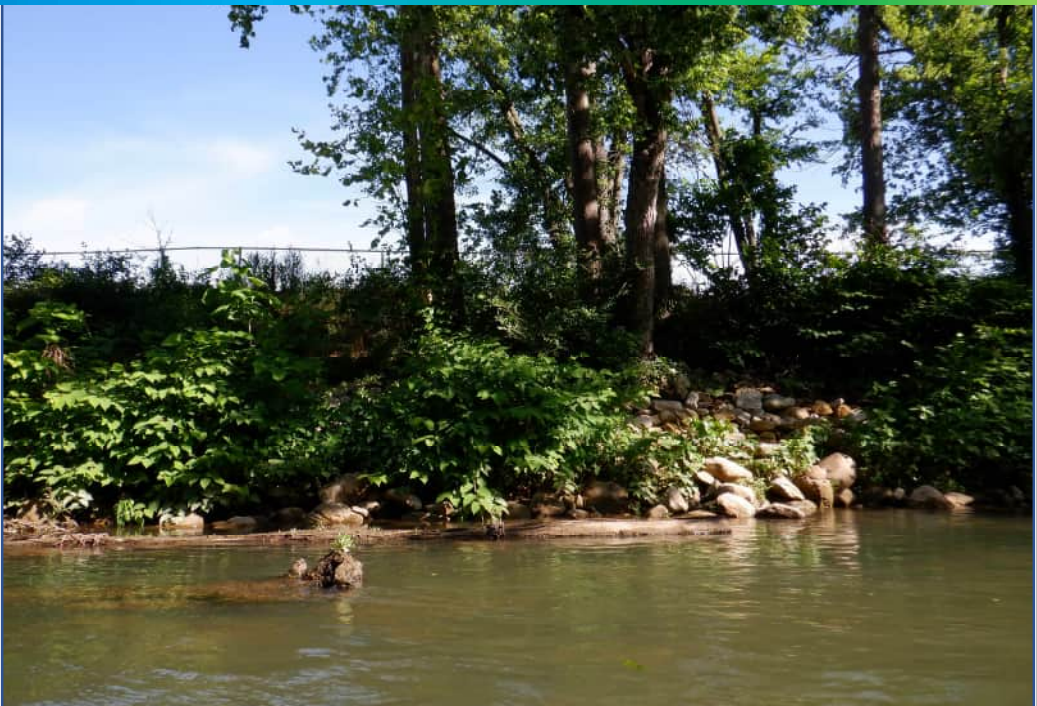
Photo Number: 18	Location: 00+450'
Date: 6/9/2022

Direction: Northwest	
Description: ~45° bank angle; native vegetation along top of rock toe; vegetation fully established; some large trees present; LWD from upstream shifted and is parallel to LWD; rock toe intact; no scour present along rock toe.

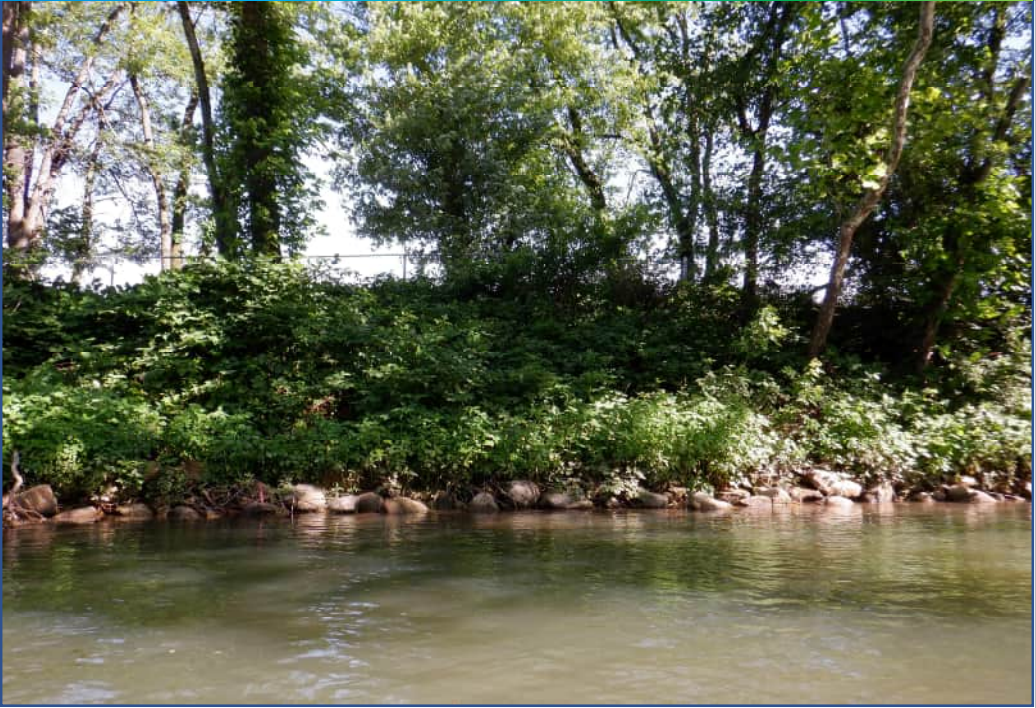
Photo Number: 19		Location: 00+500'	
Date: 6/9/2022

Direction: Northwest			
Description: End of 1 st remediation area; ~45° bank angle; native vegetation along top of rock toe; vegetation fully established; some large trees present; small sycamore on mid-bank leaning over river at 45°; rock toe intact; no scour present along rock toe.

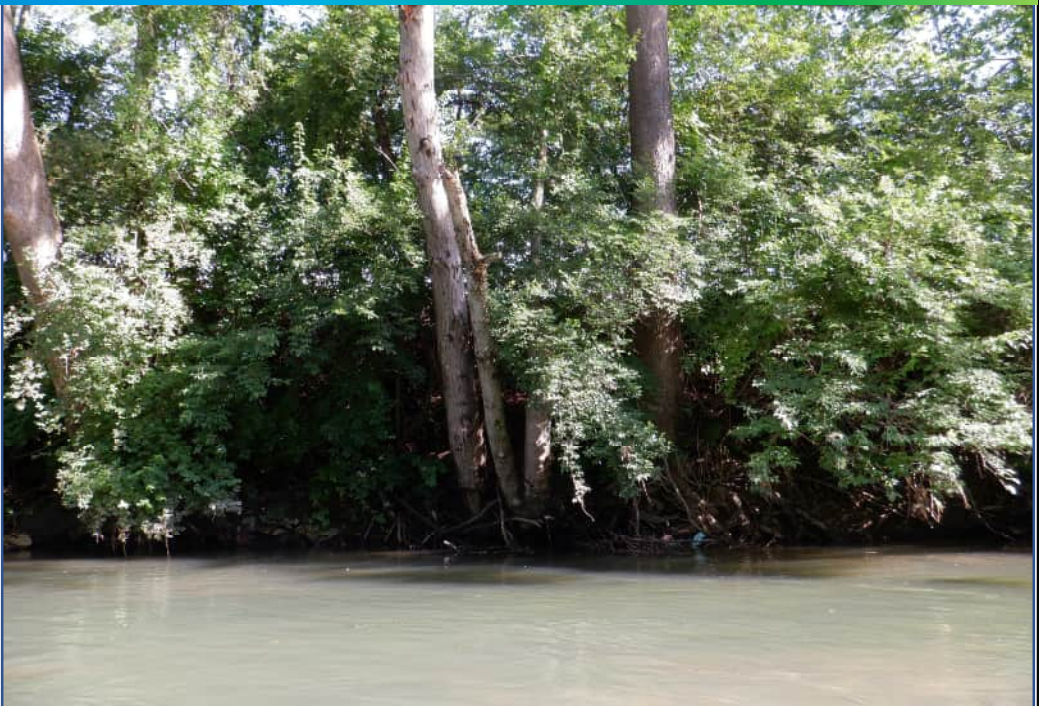
Photo Number: 22	Location: 00+550'
Date: 6/9/2022

Direction: Northwest	
Description: Start of non-remediated area; ~70° bank angle; significant bank erosion and undercutting; lower bank consists mostly of exposed roots; several large trees with exposed roots hanging over the river; entire lower bank shows large amounts of scour.

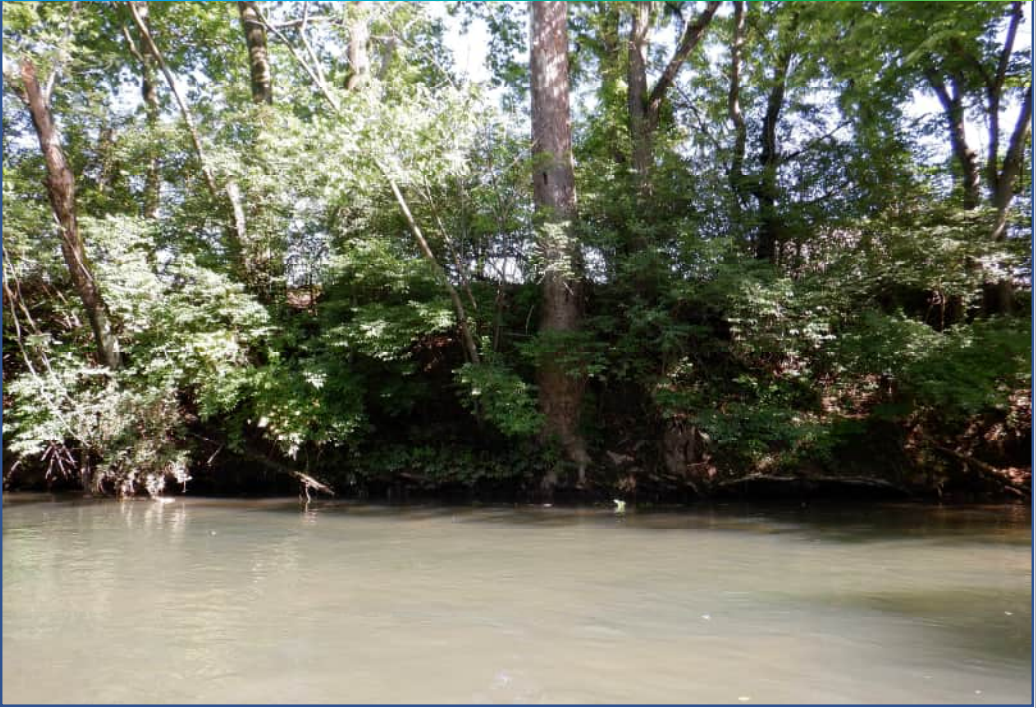
Photo Number: 23		Location: 00+600'
Date: 6/9/2022

Direction: Northwest		
Description: ~75° bank angle; severe bank erosion and undercutting; bank consists mostly of exposed roots; at risk trees present along the upper bank, some of them beginning to die; entire bank shows large amounts of scour.

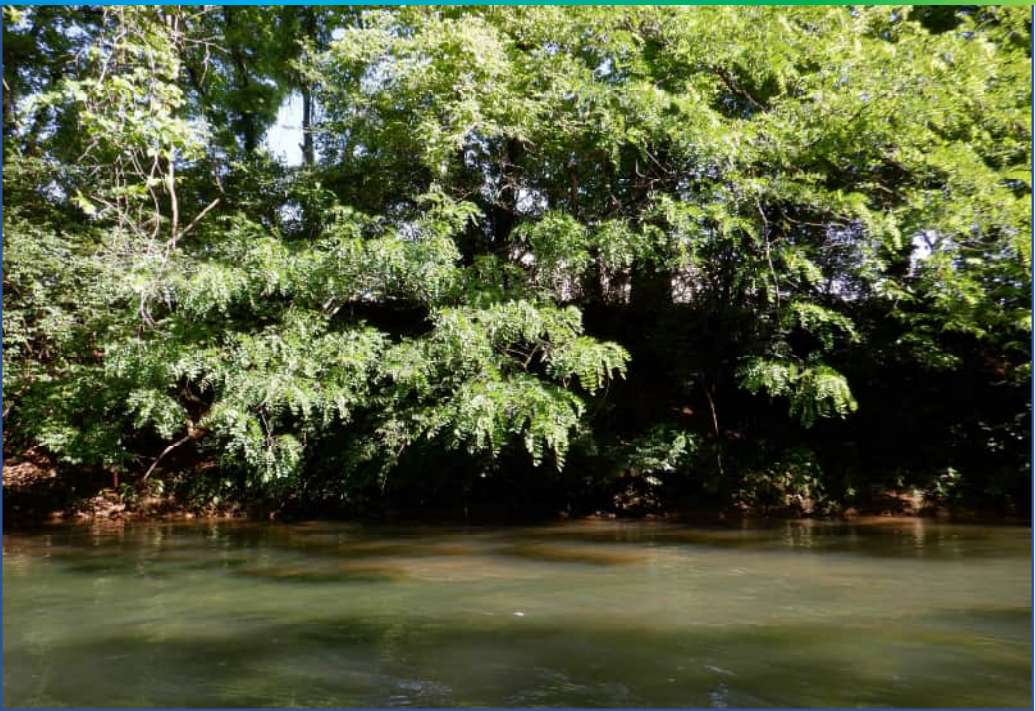
Photo Number: 24		Location: 00+650'
Date: 6/9/2022

Direction: Northwest		
Description: ~85° bank angle; severe bank erosion and undercutting; bank consists mostly of exposed roots; at risk trees present along the upper bank, some of them beginning to die; entire bank shows large amounts of scour.

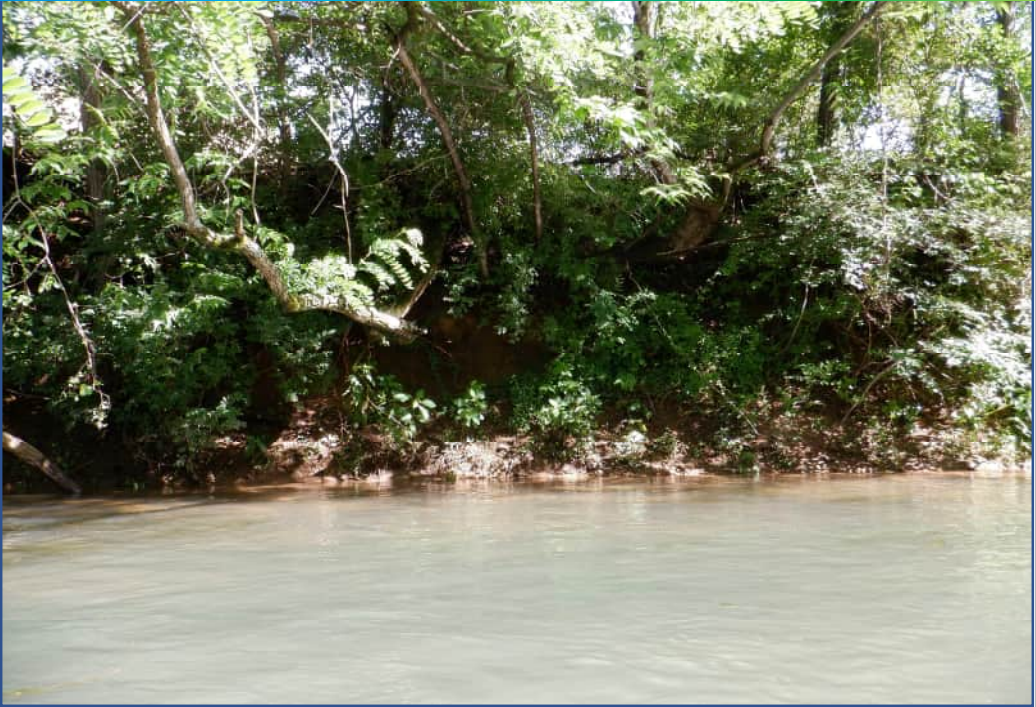
Photo Number: 26	Location: 00+700'
Date: 6/9/2022

Direction: Northwest	
Description: End of non-remediated section. ~85° bank angle; severe bank erosion and undercutting; bank consists mostly of exposed roots; at risk trees present along the upper bank, some of them beginning to die; entire bank shows large amounts of scour.
