RE: 2022 Leaf-off, 2022 Leaf-on and 2023 Leaf-on BMA Inspection Memos
Former DuPont Waynesboro Site AOC 4
Waynesboro, Virginia
EPA ID# VAD003114832

Memorandum

Subject 2022 Leaf-on Maintenance Inspection
Former DuPont Waynesboro Site, Area of Concern 4

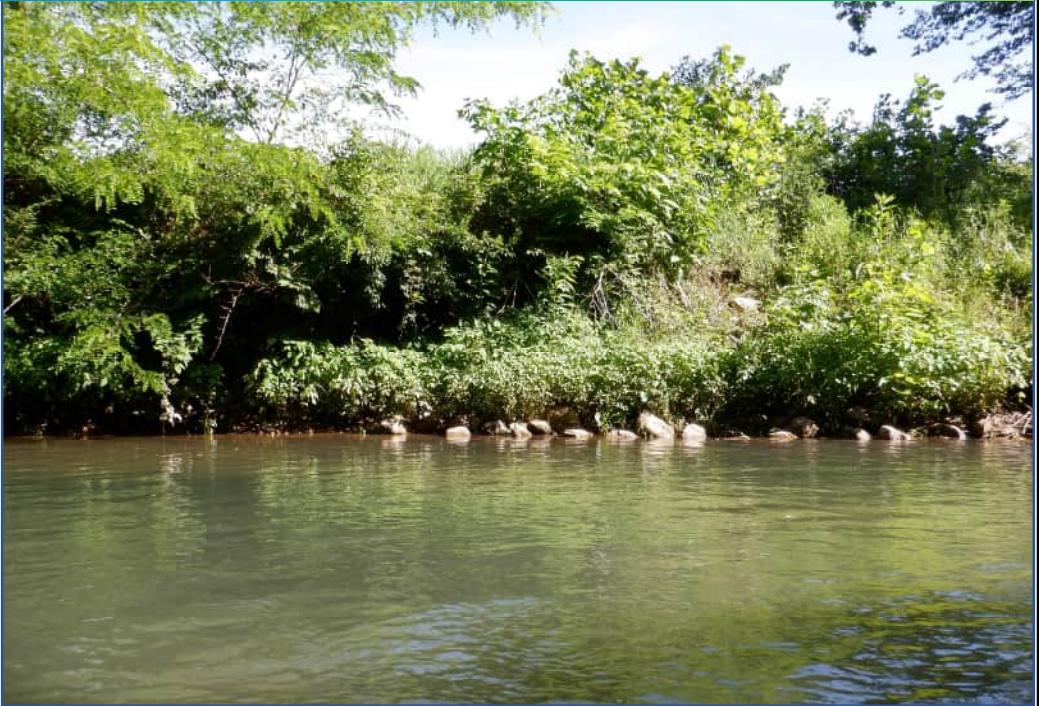
Photo Number: 27	Location: 00+750'
Date: 6/9/2022

Direction: Northwest	
Description: Beginning of second remediated section; ~45° bank angle; vegetation well established above rock toe; no at-risk trees present; rock toe intact; LWD intact; no scour present along rock toe.

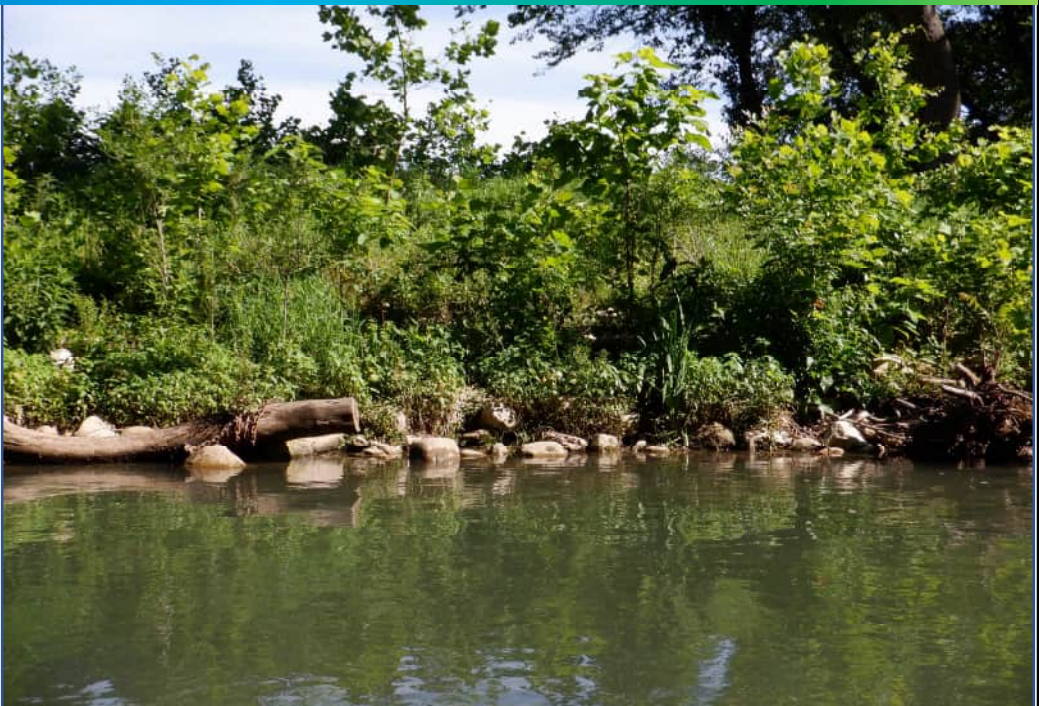
Photo Number: 30	Location: 00+800'
Date: 6/9/2022

Direction: Northwest	
Description: ~45° bank angle; vegetation well established above rock toe; no at-risk trees present; rock toe intact; LWD intact; no scour present along rock toe.

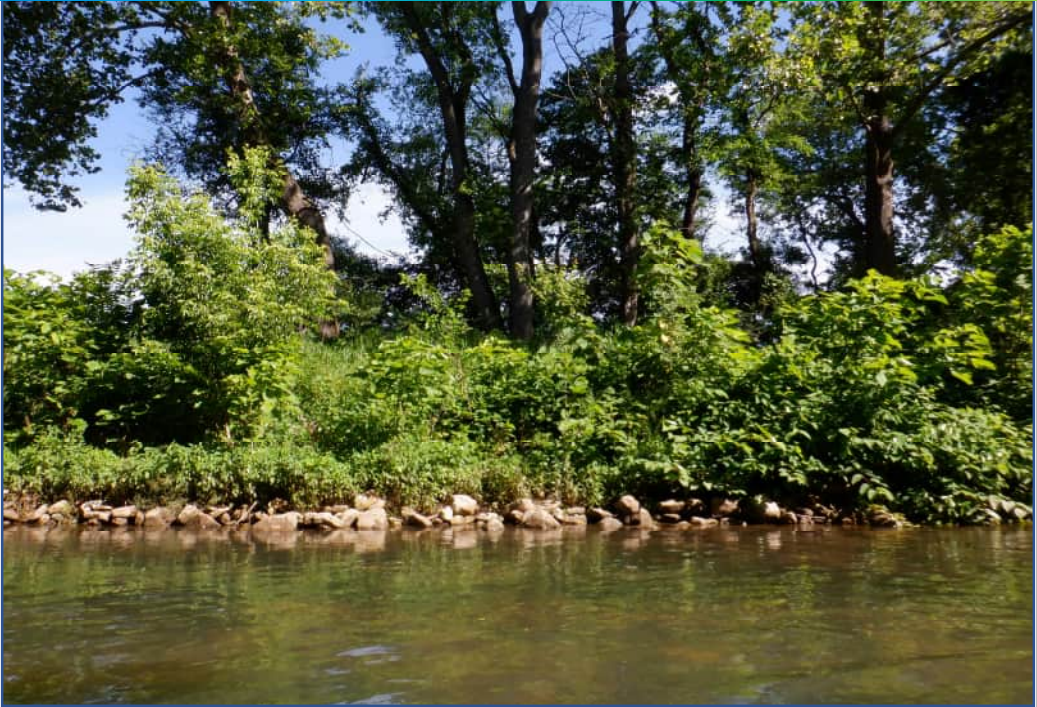
Photo Number: 32	Location: 00+850'
Date: 6/9/2022

Direction: Northwest	
Description: ~45° bank angle; vegetation established about and in rock toe; knotweed 20% cover; <i>Ailanthus altissima</i> saplings present; no at-risk trees present; rock toe intact; LWD shifted downstream; no scour present along rock toe.

*Two LWD features shifted downstream from 350' to 400' and 850' to 880'. Herbicide treatment is recommended for areas with Japanese knotweed.

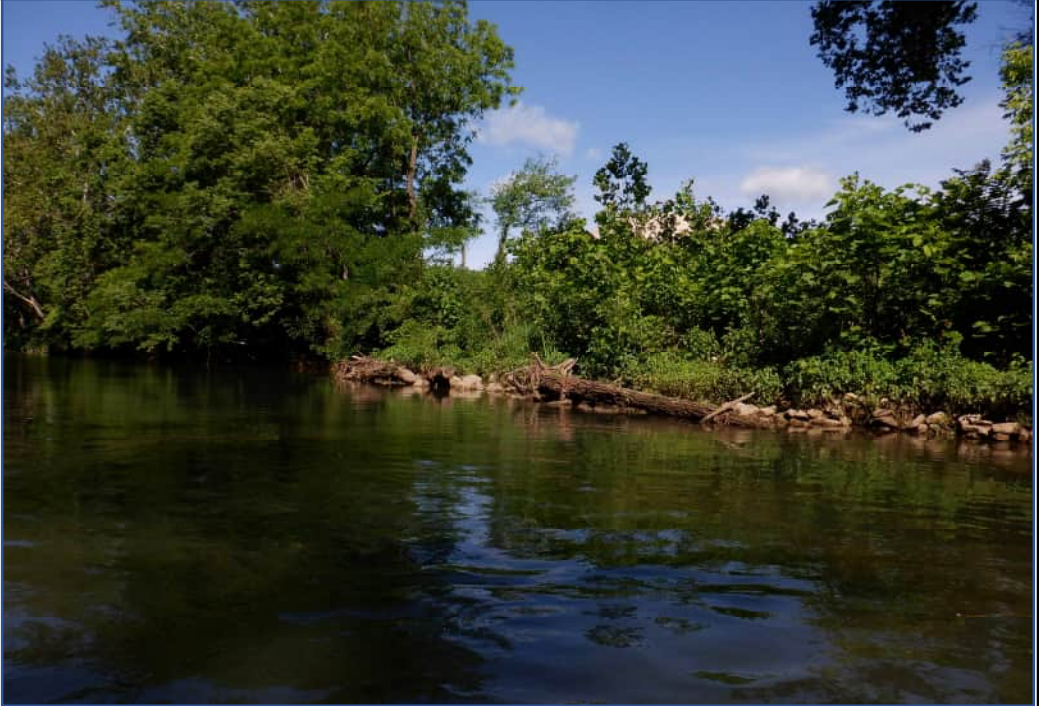
Photo Number: 33	Location: 00+850'
Date: 6/9/2022

Direction: Northwest	
Description: Upstream view of remediated bank.

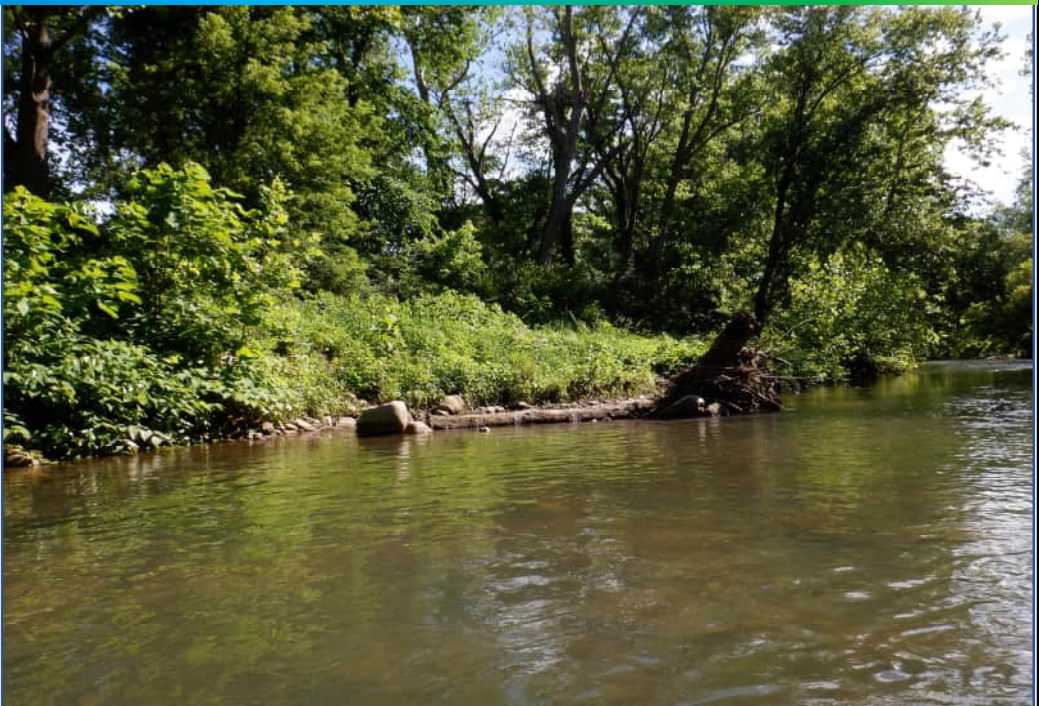
Photo Number: 34	Location: 00+850'
Date: 6/9/2022

Direction: Southeast	
Description: Downstream view of remediated bank; shifted LWD from 00+850 visible at 00+880.

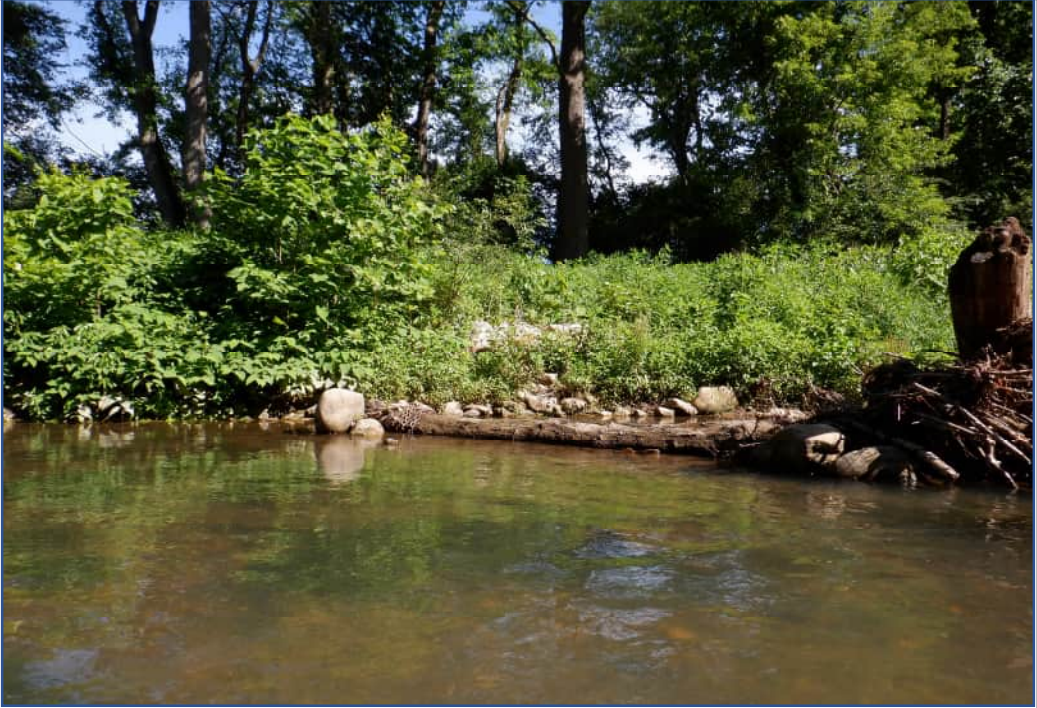
Photo Number: 35	Location: 00+880'
Date: 6/9/2022

Direction: Northwest	
Description: End of remediated bank; ~20° bank angle; LWD from 00+850 shifted here; vegetation well established above rock toe; no woody plants adjacent to edge of water; rock toe intact; no scour present along rock toe and lower bank.

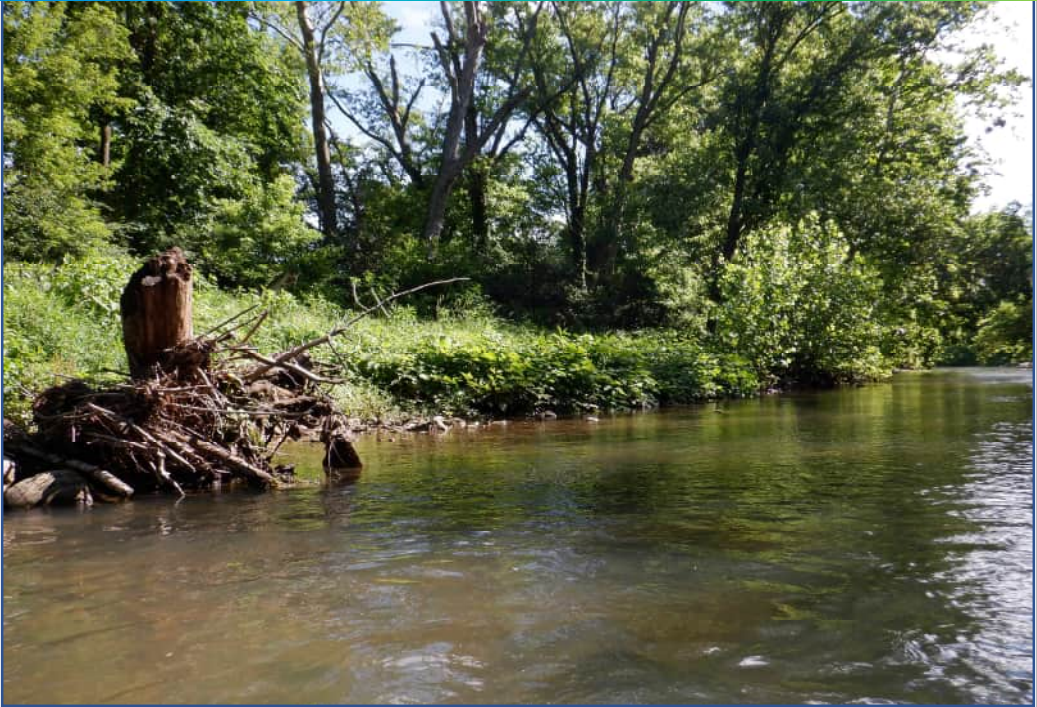
Photo Number: 36	Location: 00+880'
Date: 6/9/2022

Direction: Southeast	
Description: Downstream view of non-remediated bank below BMA.

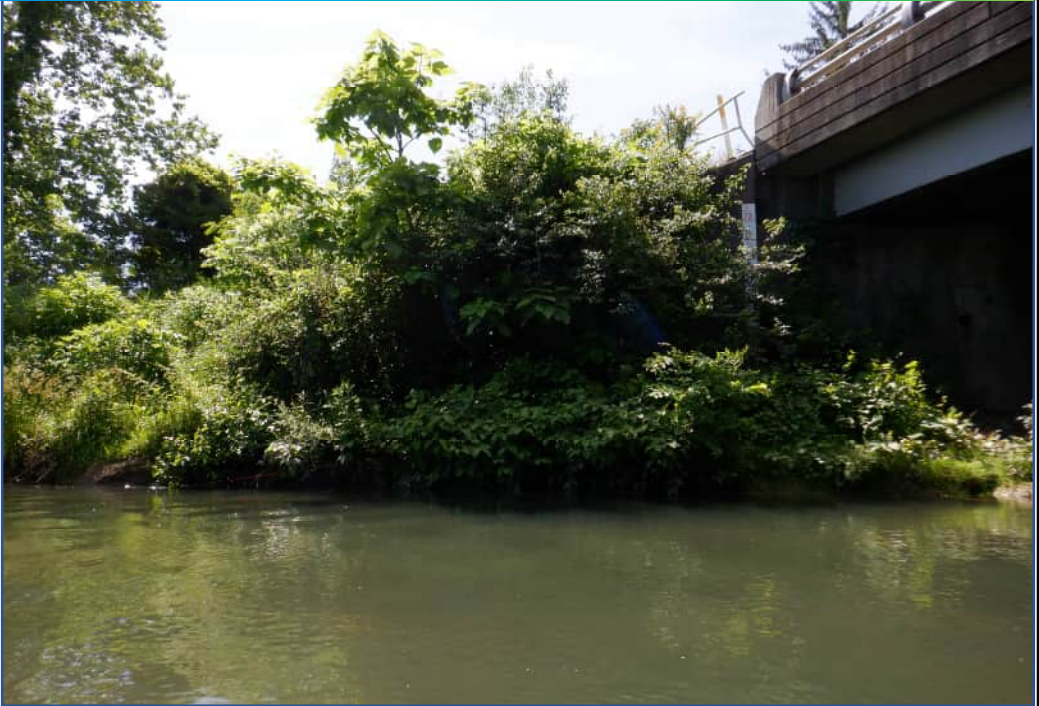
Photo Number: 01		Location: 00-20'	
Date: 6/9/2022

Direction: Southeast			
Description: Non-remediated section directly upstream of remediation; ~20° bank angle; invasive knotweed 40% cover; no woody plants adjacent to edge of water; no fabric or geocell installed; Some scour associated with foot traffic along bank.

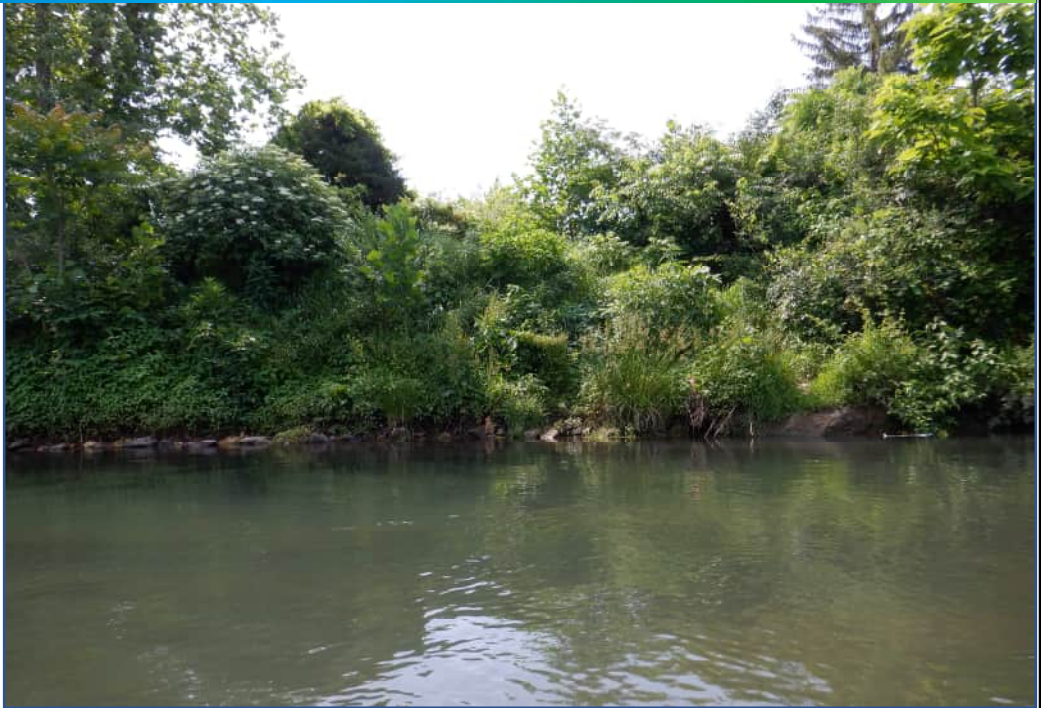
Photo Number: 03	Location: 00+00'
Date: 6/9/2022

Direction: Southeast	
Description: ~45° bank angle; start of 1 st remediation section; herbaceous vegetation fully established; no at-risk trees present; invasive <i>Ailanthus altissima</i> saplings; rock toe intact with sand deposition above; some scour associated with foot traffic along bank; erosion control fabric and geocell no longer exposed.

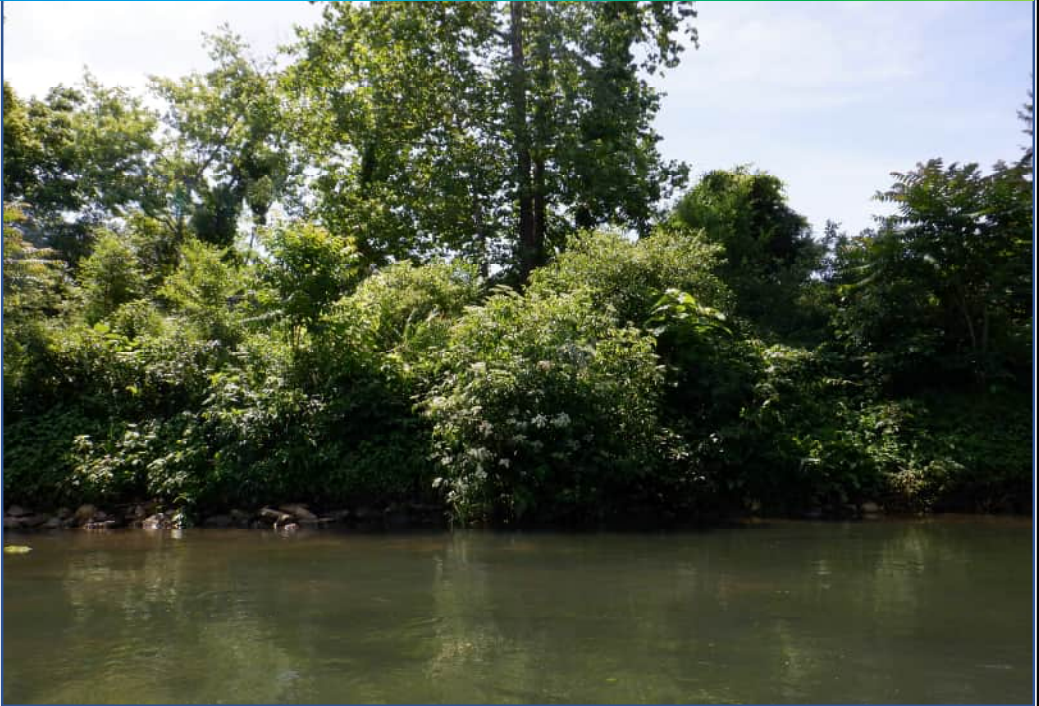
Photo Number: 05		Location: 00+50'	
Date: 6/9/2022

Direction: Southeast			
Description: ~50° bank angle; native herbaceous vegetation fully established; no at-risk trees present; rock toe intact; scour present where fabric is torn; sand deposition at toe of bank.

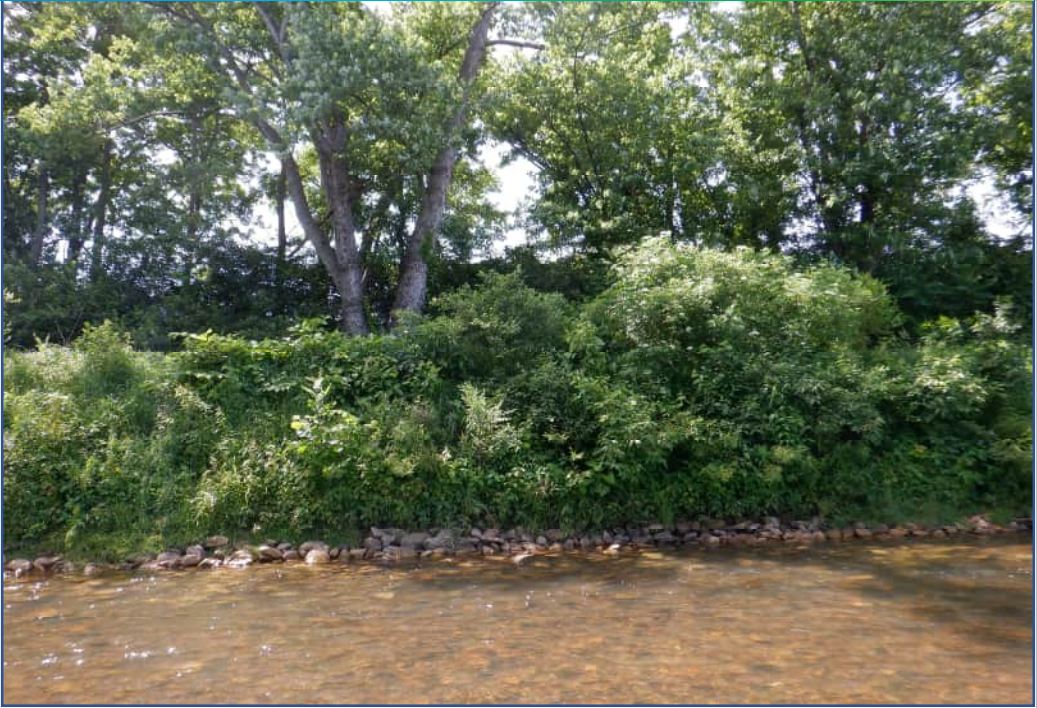
Photo Number: 11		Location: 00+200'	
Date: 6/9/2022

Direction: Southeast			
Description: ~50° bank angle; live stakes 70% established; native herbaceous vegetation fully established; no at-risk trees present; rock toe intact; sand deposition at toe of bank; erosion control fabric no longer exposed.

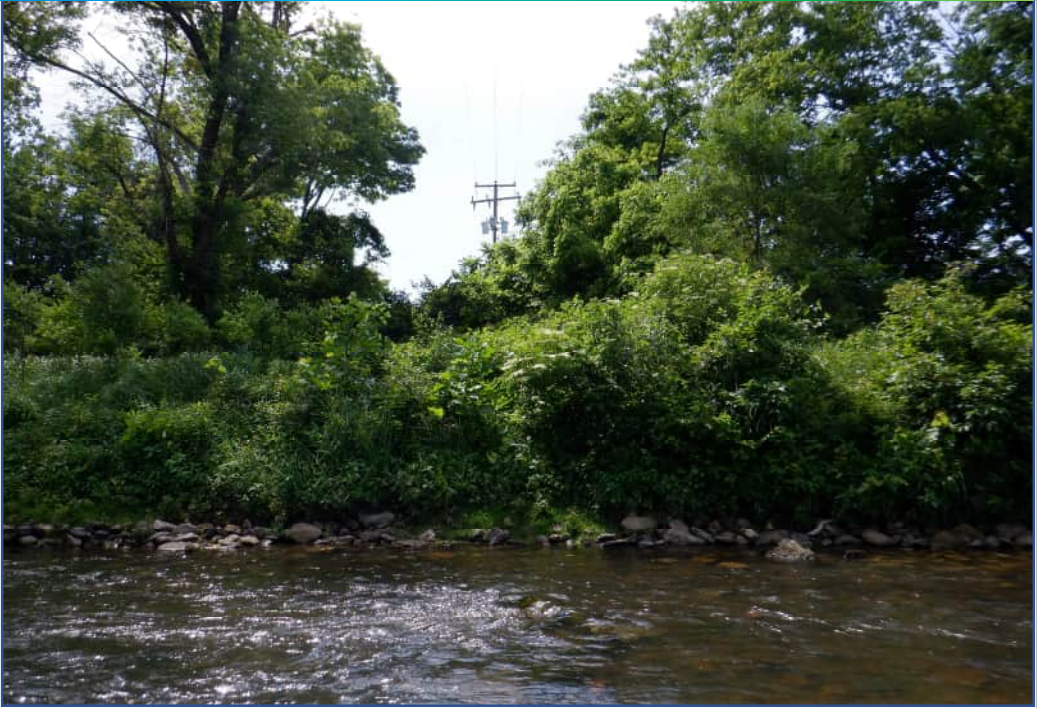
Photo Number: 13	Location: 00+300'
Date: 6/9/2022

Direction: Southeast	
Description: ~50° bank angle; live stakes 40% established; native herbaceous vegetation fully established; no at-risk trees present; rock toe intact; sand deposition at toe of bank.

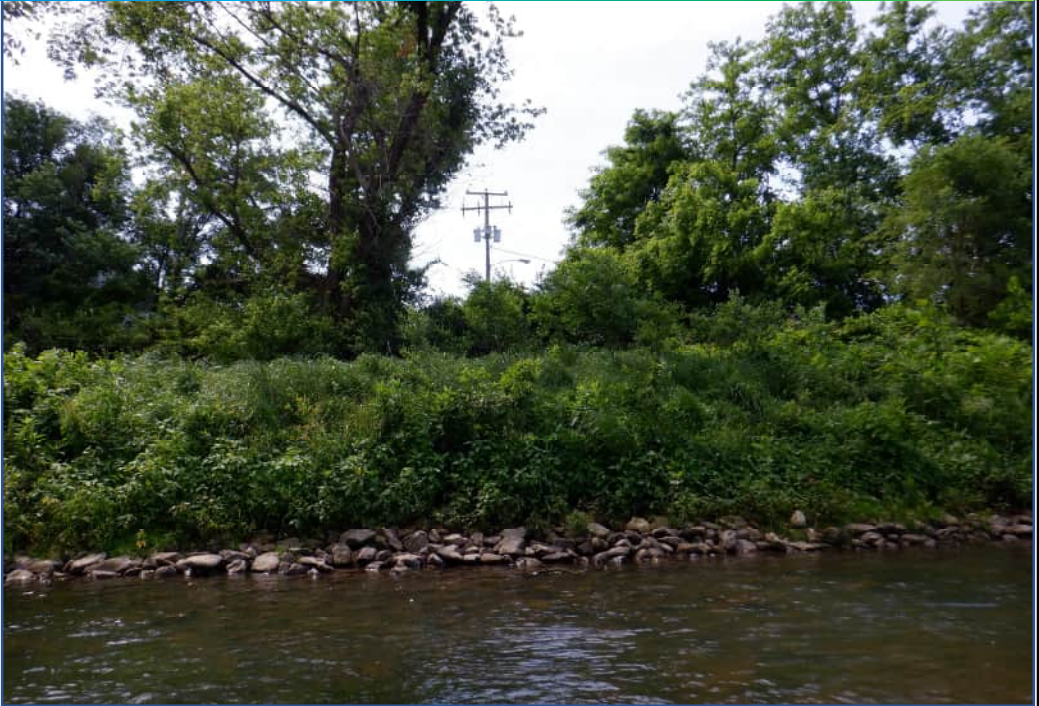
Photo Number: 15		Location: 00+350'	
Date: 6/9/2022

Direction: Southeast			
Description: ~50° bank angle; native herbaceous vegetation fully established; no at-risk trees present; rock toe intact; footpath; sand deposition at toe of bank.

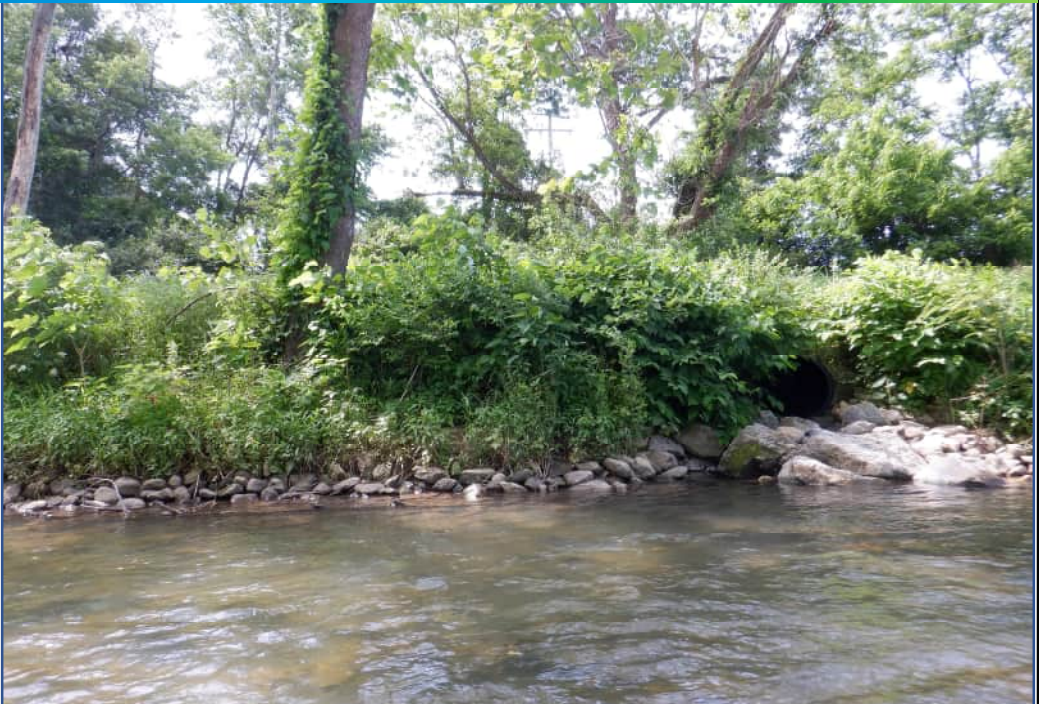
Photo Number: 16		Location: 00+400'	
Date: 6/9/2022

Direction: Southeast			
Description: ~50° bank angle; large patches of invasive knotweed surrounding outfall; native herbaceous vegetation established; no at-risk trees present; rock toe intact; sand deposition at toe of bank.

Comments: Herbicide treatment is recommended for the areas with Japanese knotweed

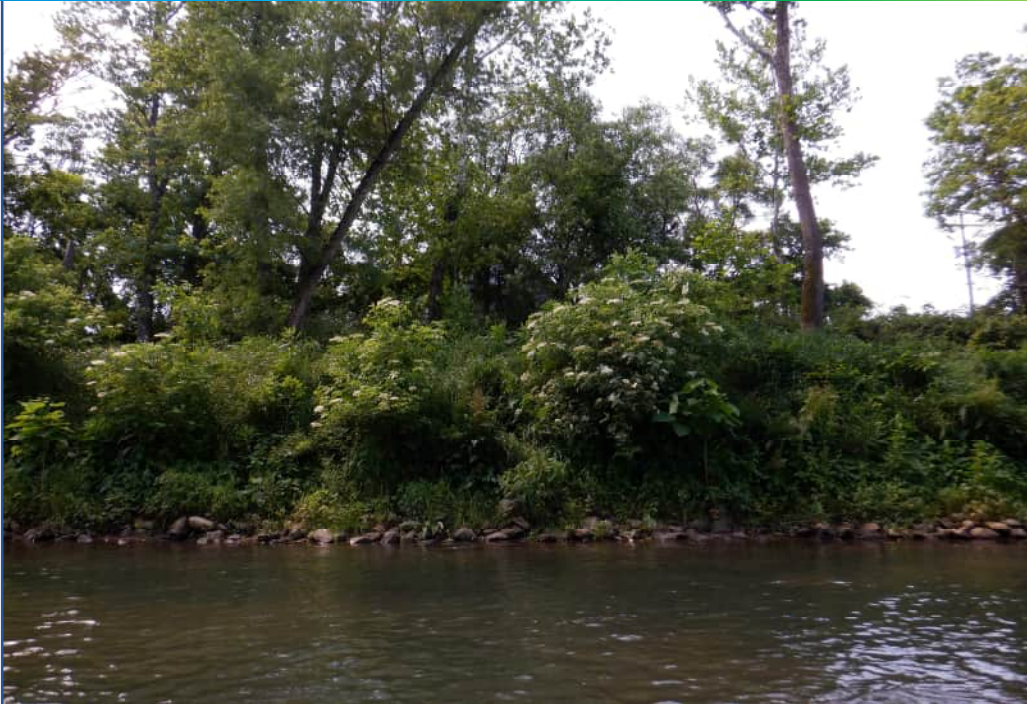
Photo Number: 17		Location: 00+450'	
Date: 6/9/2022

Direction: Southeast			
Description: ~60° bank angle; native herbaceous vegetation fully established; no at- risk trees present; rock toe intact; sand deposition at toe of bank.

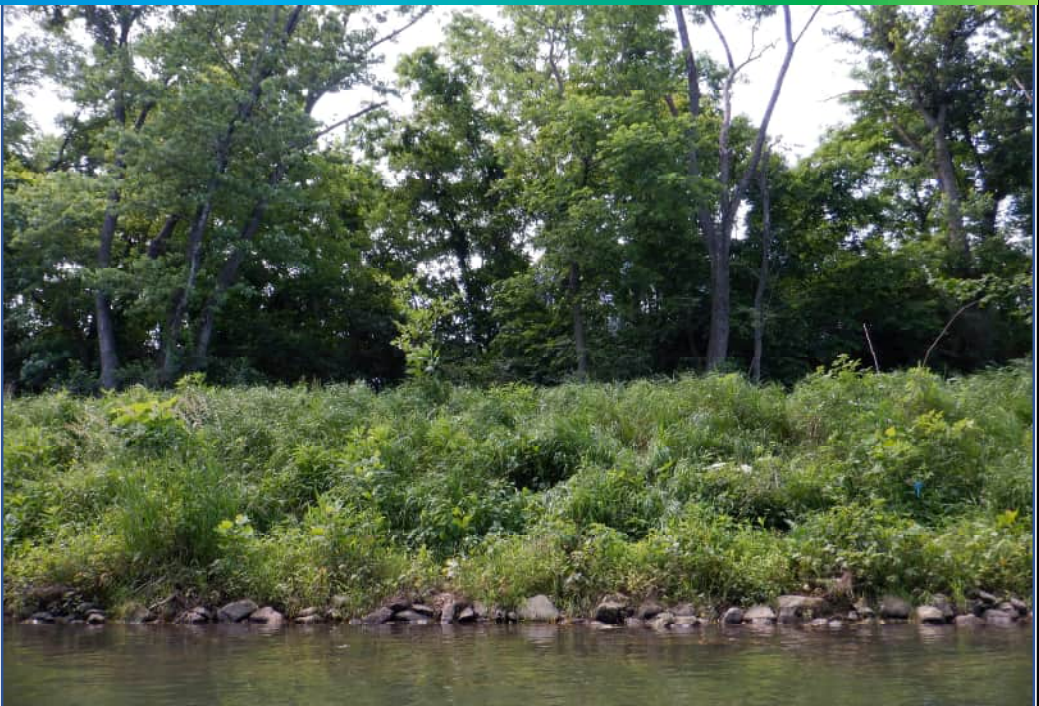
Photo Number: 22	Location: 00+600'
Date: 6/9/2022

Direction: Southeast	
Description: Lower bank ~30°; upper bank ~45°; native herbaceous vegetation fully established; no at-risk trees present; rock toe intact; sand deposition at toe of bank.

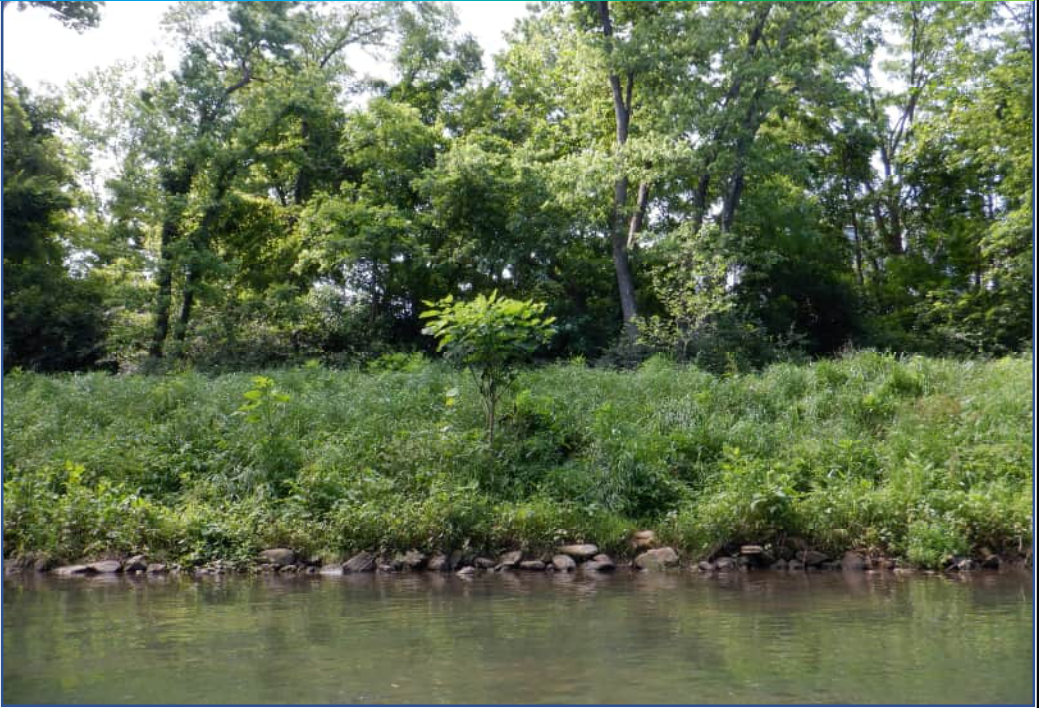
Photo Number: 23		Location: 00+650'	
Date: 6/9/2022

Direction: Southeast			
Description: Lower bank ~30°; upper bank ~45°; native herbaceous vegetation fully established; no at-risk trees present; rock toe intact; sand deposition at toe of bank.

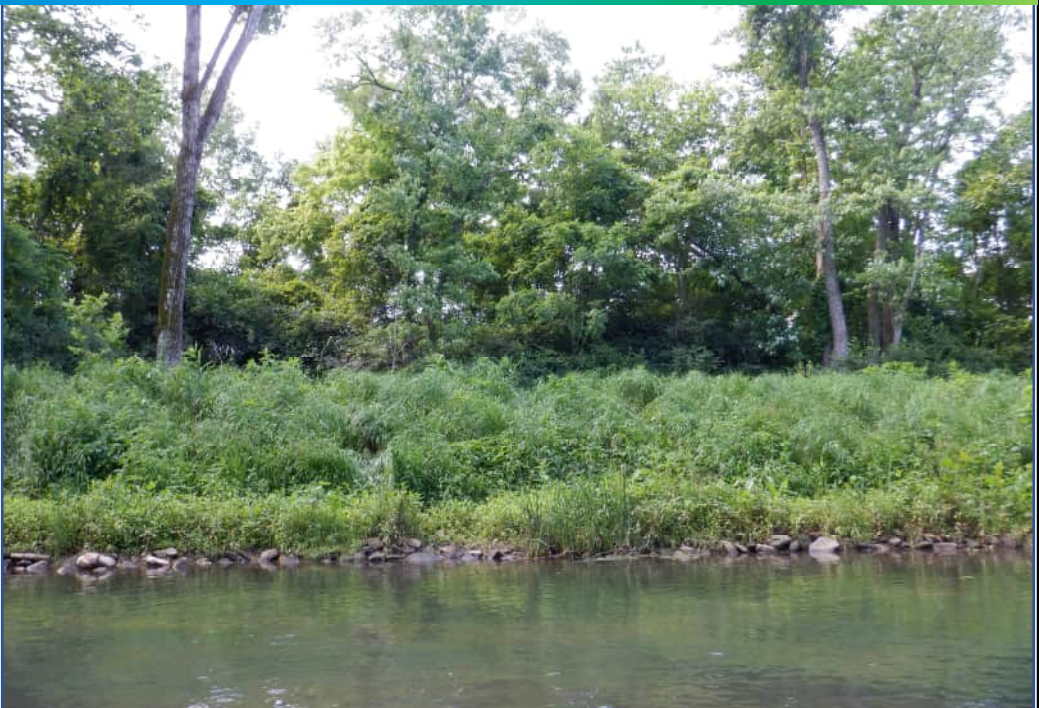
Photo Number: 24		Location: 00+700'	
Date: 6/9/2022

Direction: Southeast			
Description: Lower bank ~30°; upper bank ~45°; native herbaceous vegetation fully established; no at-risk trees present; rock toe intact; sand deposition at toe of bank.

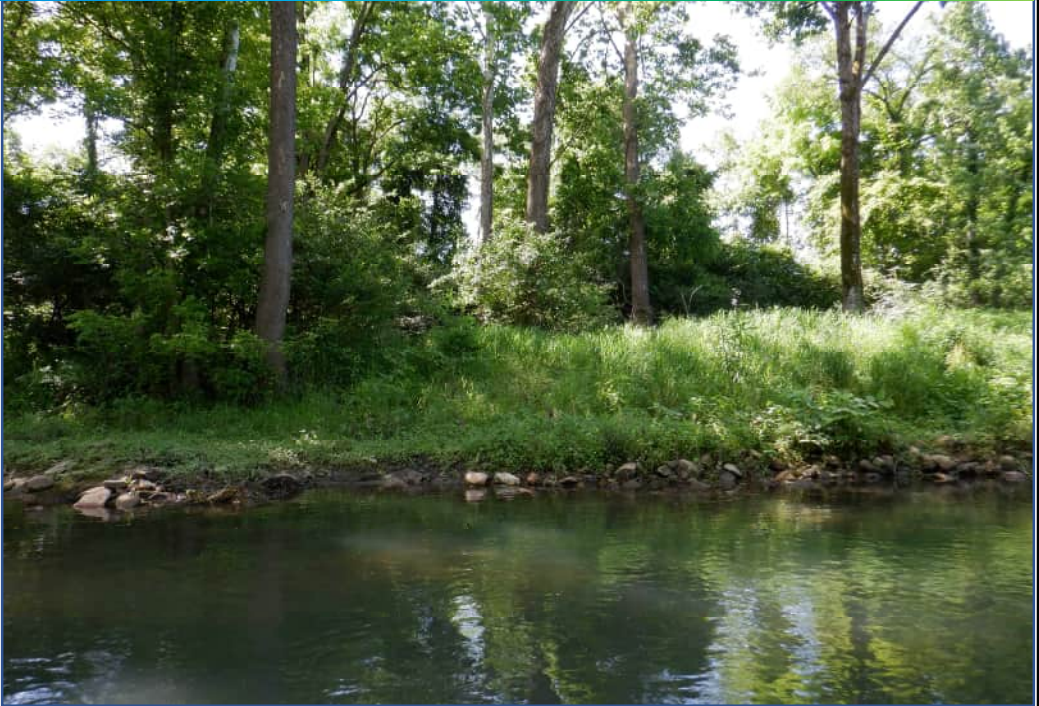
Photo Number: 27	Location: 00+750'
Date: 6/9/2022

Direction: Southeast	
Description: End of first remediated section; lower bank ~30°; upper bank ~45°; native herbaceous vegetation fully established; no at-risk trees in remediated area; rock toe intact; sand deposition at toe of bank; footpath present.

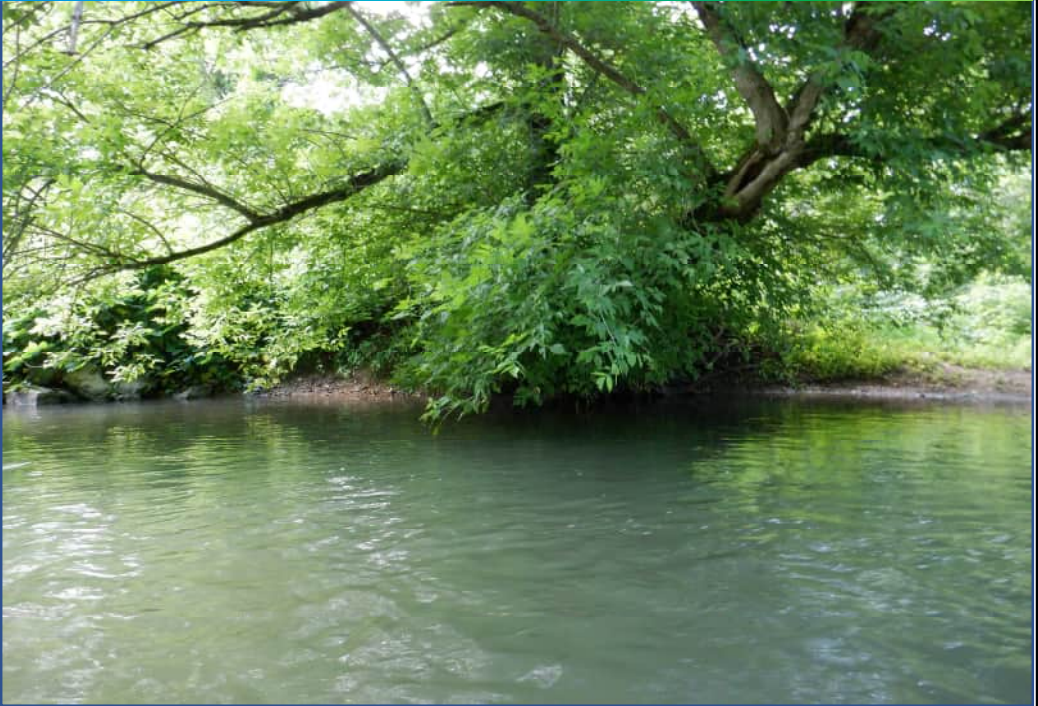
Photo Number: 29	Location: 00+1250'
Date: 6/9/2022

Direction: Southeast	
Description: Start of 2 nd remediated section; bank angle non-remediated upstream section ~80°; remediated section ~40°; exposed roots just upstream of remediated bank; native herbaceous vegetation fully established; one large at-risk tree just upstream of remediated bank.

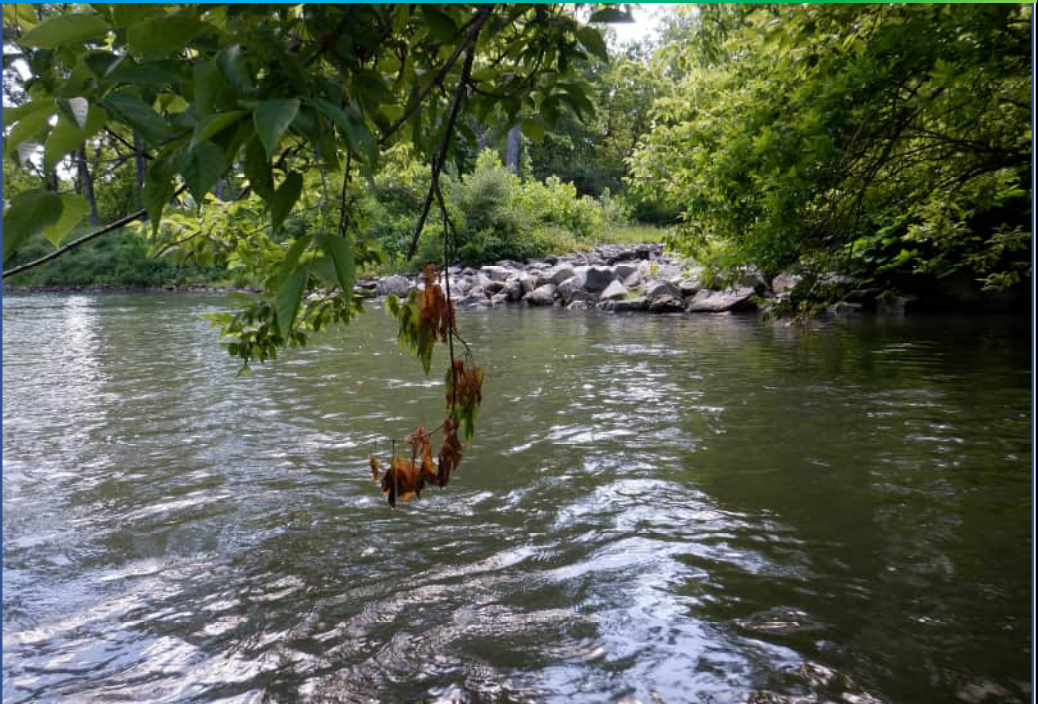
Photo Number: 30	Location: 00+1250'
Date: 6/9/2022

Direction: Northeast	
Description: Downstream view from beginning of second remediated area; entirely rip-rap portion of bank at start of second remediated section.

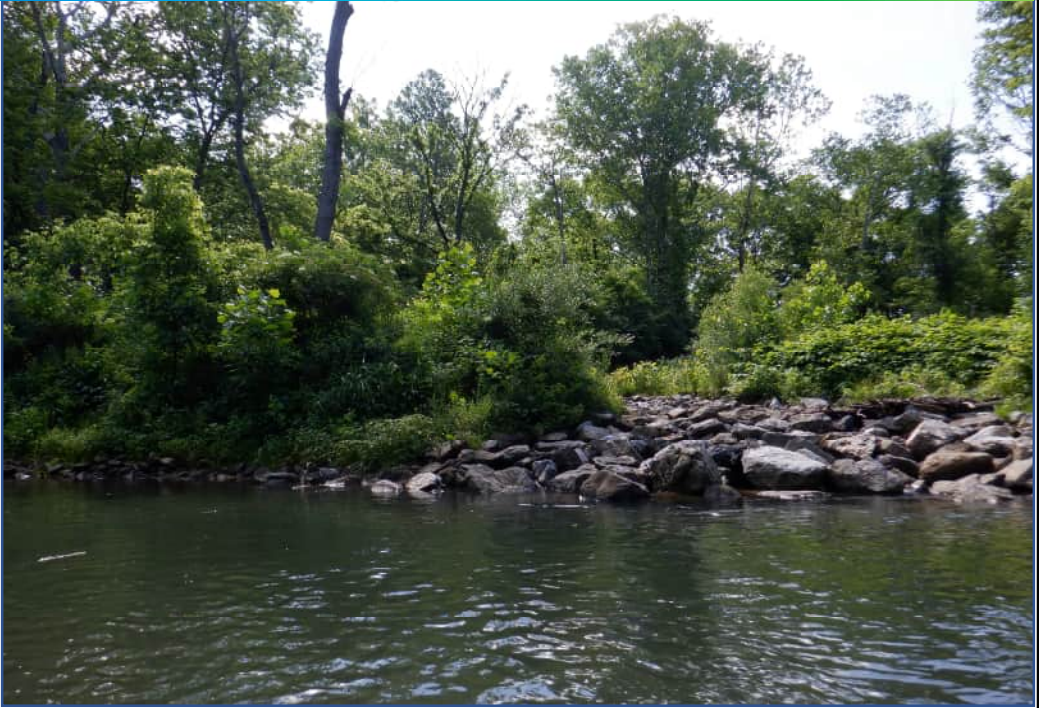
Photo Number: 31	Location: 00+1300'
Date: 6/9/2022

Direction: Southeast	
Description: ~30° bank angle; fortified tributary channel; entirely rip-rap portion of bank; large patches of invasive knotweed along rip-rap section; vegetation established around rock toe; sediment deposition by rock toe.

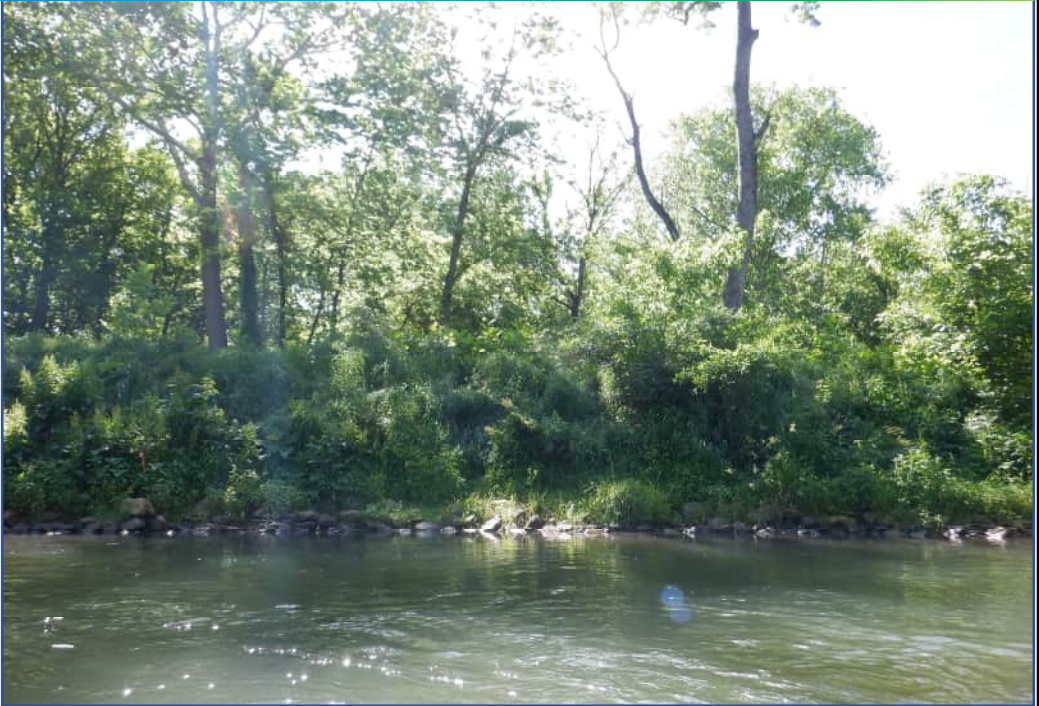
Photo Number: 33		Location: 00+1350'	
Date: 6/9/2022

Direction: East			
Description: ~50° bank angle; native herbaceous vegetation fully established; no at-risk trees present; rock toe intact.

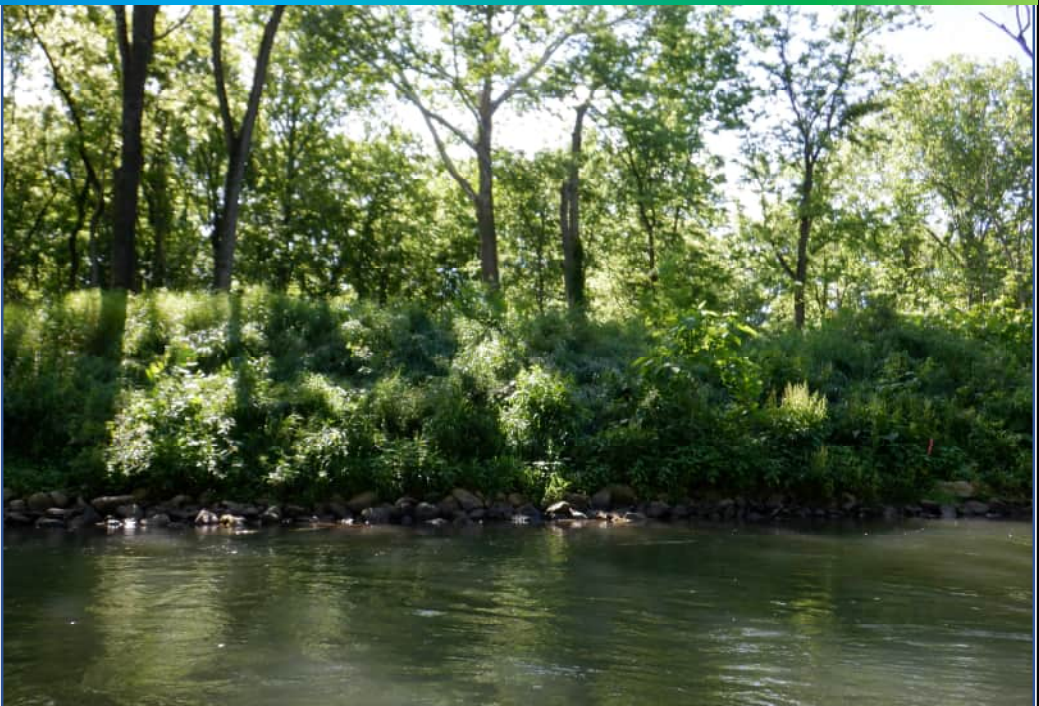
Photo Number: 34		Location: 00+1400'	
Date: 6/9/2022

Direction: Southeast			
Description: ~50° bank angle; native herbaceous vegetation fully established; no at-risk trees present; rock toe intact.

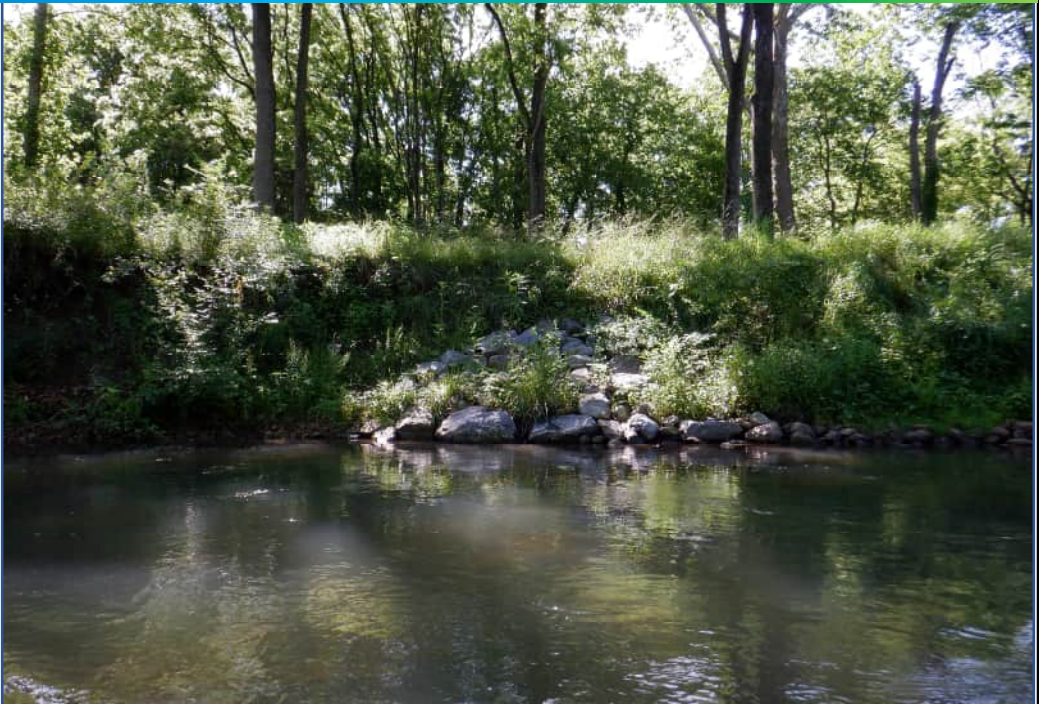
Photo Number: 36		Location: 00+1450'	
Date: 6/9/2022

Direction: East			
Description: ~80° bank angle; end of 2 nd remediation section; rip-rap fortified bank abutment intact; native herbaceous vegetation fully established and starting to grow in rip-rap section; heavy erosion present downstream of remediated BMA.

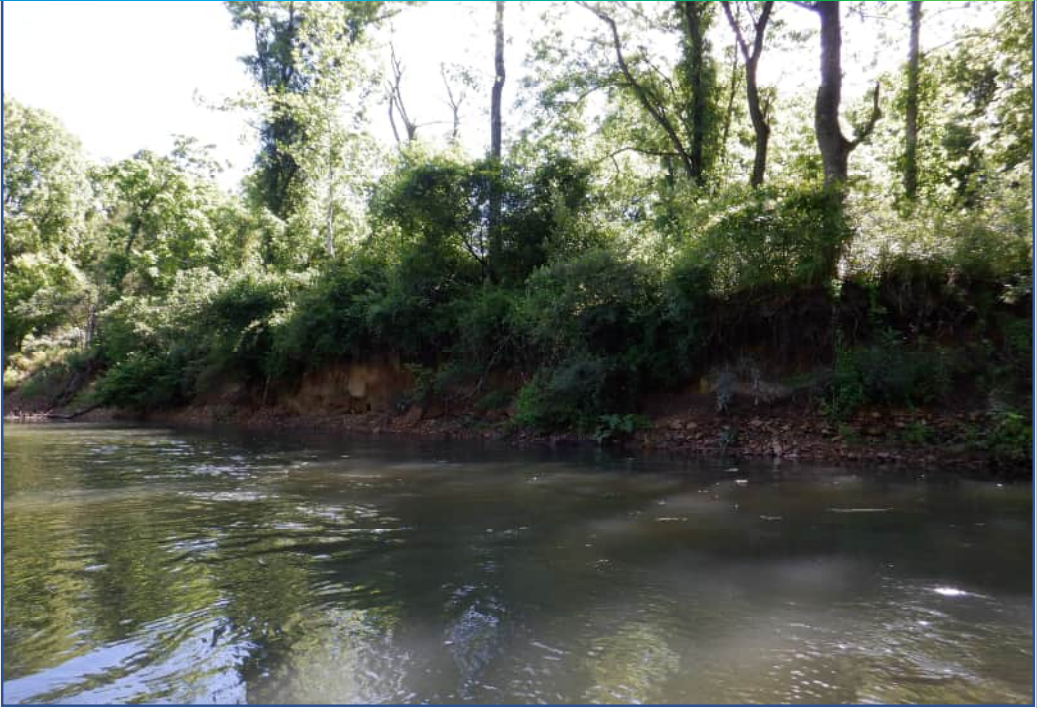
Photo Number: 37		Location: 00+1450'	
Date: 6/9/2022

Direction: Southeast			
Description: Downstream view of end of 2 nd remediated section; bank heavily undercut downstream of remediation; severe root exposure downstream of remediated bank; high density of at-risk trees downstream of remediated bank.

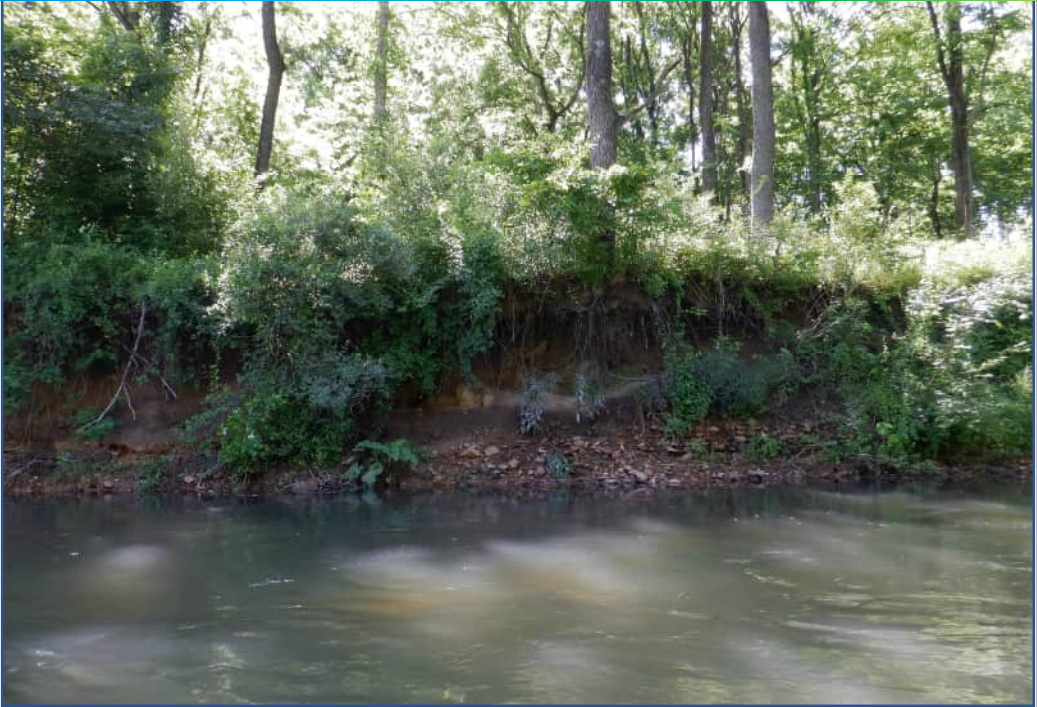
Photo Number: 38		Location: 00+1500'	
Date: 6/9/2022

Direction: East			
Description: ~90° bank angle; non-remediated section at end remediated bank; native herbaceous vegetation fully established; severe erosion present downstream of remediated BMA; severe root exposure downstream of remediated bank; high density of at-risk trees downstream of remediated bank.

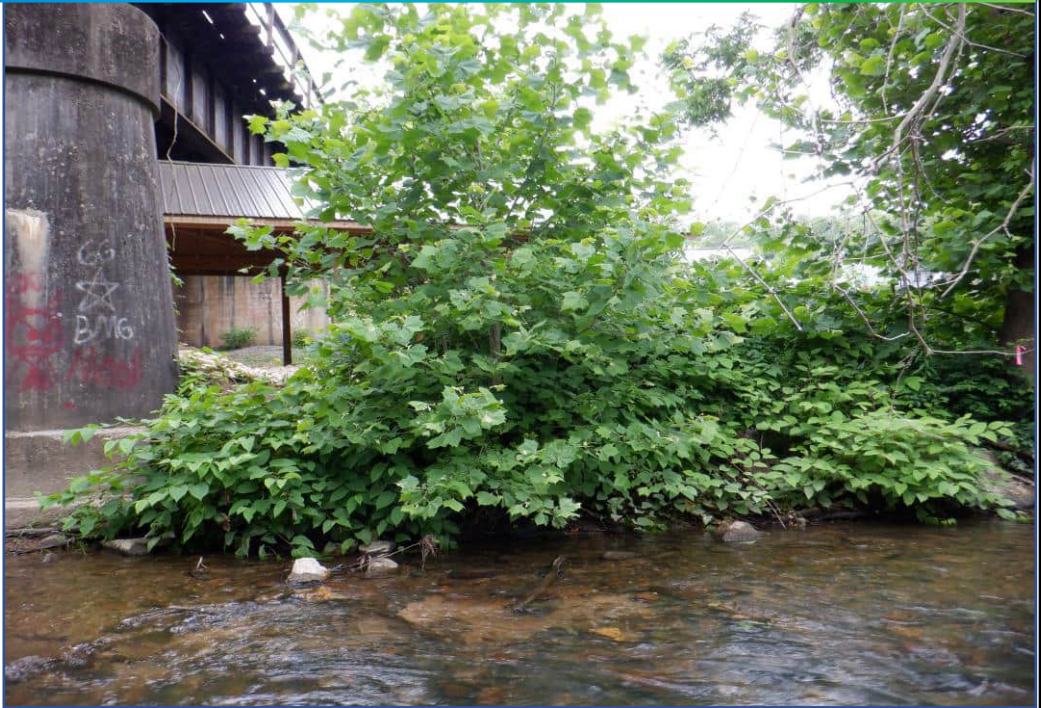
Photo Number: 01	Location: 00-25'
Date: 6/7/2022

Direction: West	
Description: ~ 30° bank angle; level shelf mid-bank but grade above and below are the same; some vegetation; exposed roots along bank; access pathways present; invasive knotweed 30% cover; small sycamore at-risk; upstream of remediation; minimal scour present.
