RE: 2022 Leaf-off, 2022 Leaf-on and 2023 Leaf-on BMA Inspection Memos
Former DuPont Waynesboro Site AOC 4
Waynesboro, Virginia
EPA ID# VAD003114832

Memorandum

Subject 2022 Leaf-on Maintenance Inspection
Former DuPont Waynesboro Site, Area of Concern 4

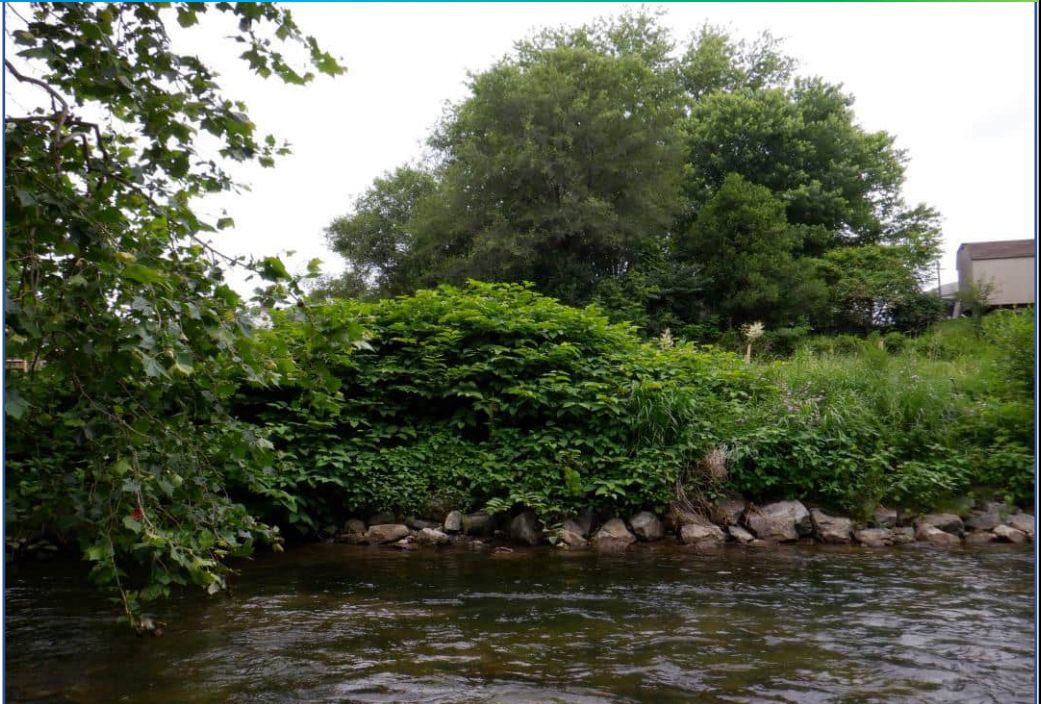
Photo Number: 02	Location: 00+00'
Date: 6/7/2022

Direction: West	
Description: ~ 45° bank angle; minimal grasses established; invasive knotweed 50% cover; top half of Slippery Elm adjacent to river upstream is dead; culvert just upstream of remediation; evidence of sediment deposition in rock toe under concrete by culvert.

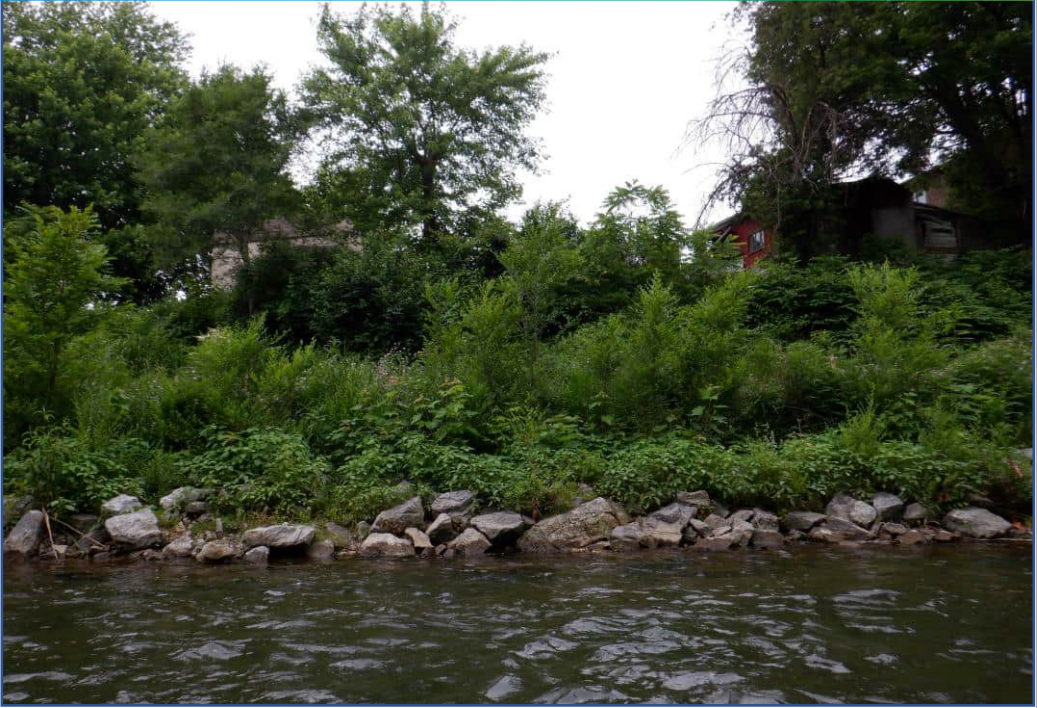
Photo Number: 07	Location: 00+100'
Date: 6/7/2022

Direction: West	
Description: ~ 50° bank angle; lower bank ~40°; upper bank ~60°; vegetation 95% cover; several elm saplings establishing on bank; rock toe intact; footpath present; evidence of sediment deposition in rock toe.

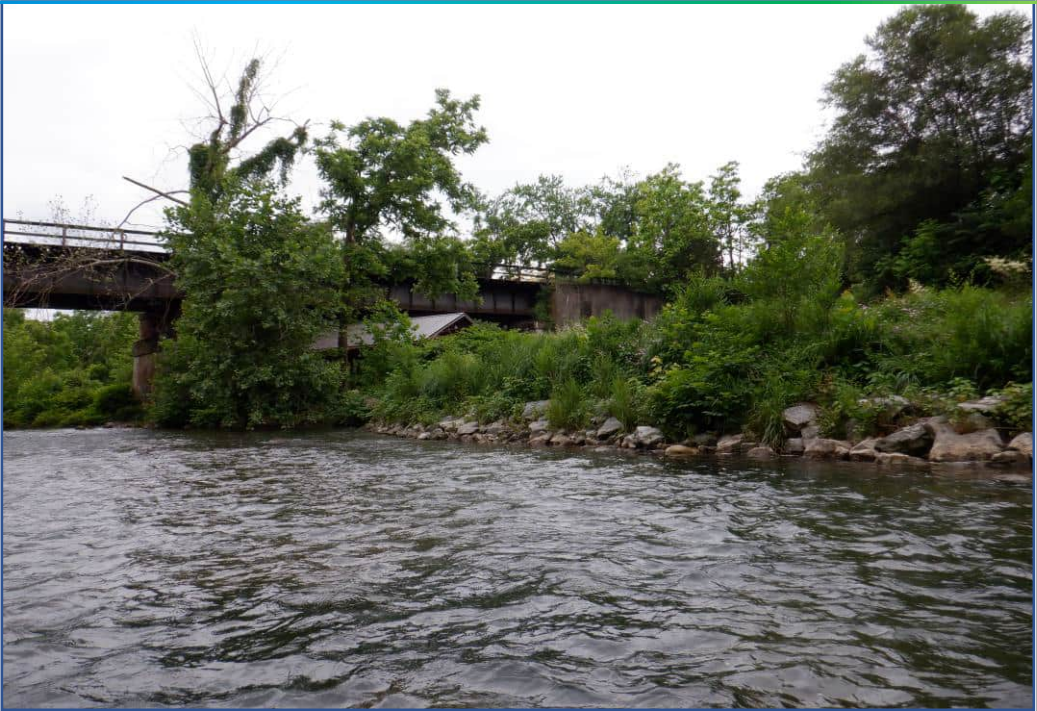
Photo Number: 08	Location: 00+100'
Date: 6/7/2022

Direction: South	
Description: Upstream view of remediated bank.

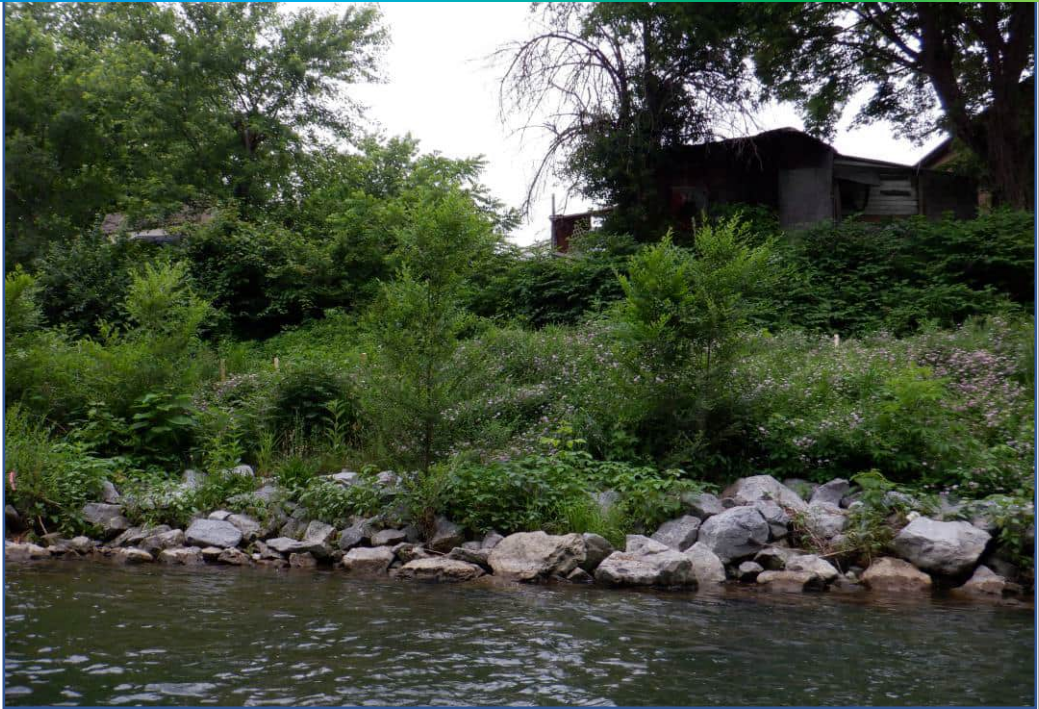
Photo Number: 10	Location: 00+150'
Date: 6/7/2022

Direction: West	
Description: ~ 50° bank angle; lower bank ~40°; upper bank ~60°; Above GW ~60°; large patches of knotweed completely cover bank above GW; vegetation 95% cover; several elm saplings adjacent to edge of water; evidence of sediment deposition in rock toe.

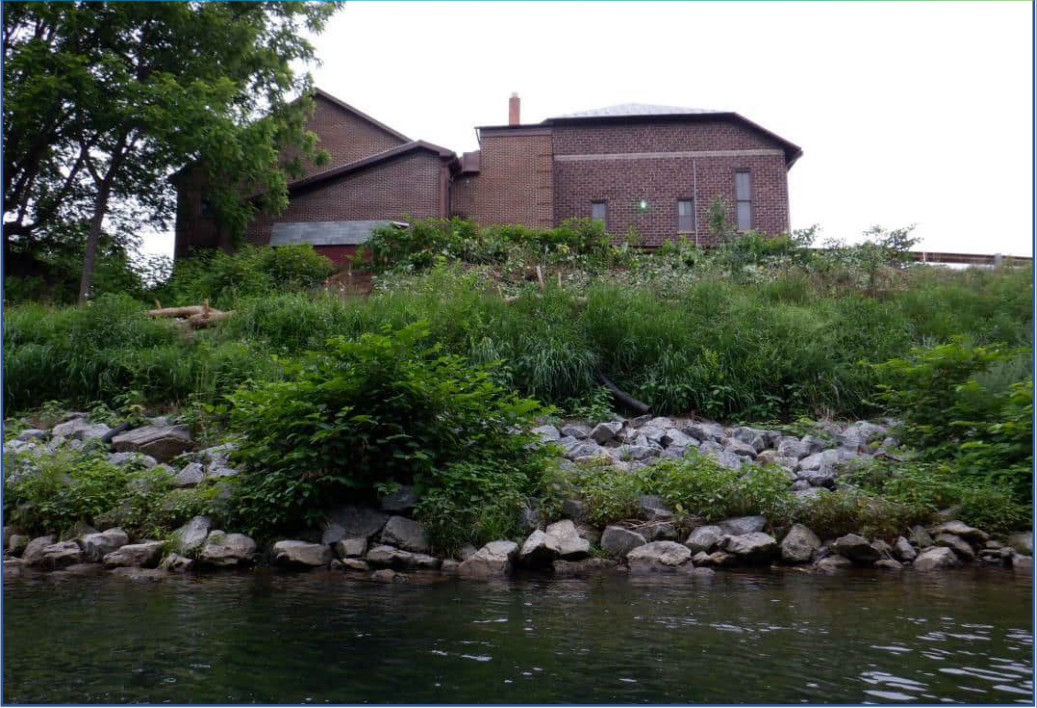
Photo Number: 13		Location: 00+250'	
Date: 6/7/2022

Direction: West			
Description: ~ 65° bank angle; lower bank ~45°; upper bank ~65°; above GW ~70°; vegetation 95% cover; invasive knotweed establishing in rock toe; vegetation above GW impacted by construction; rock toe intact; plastic corrugated pipe exposed on bank above GW.

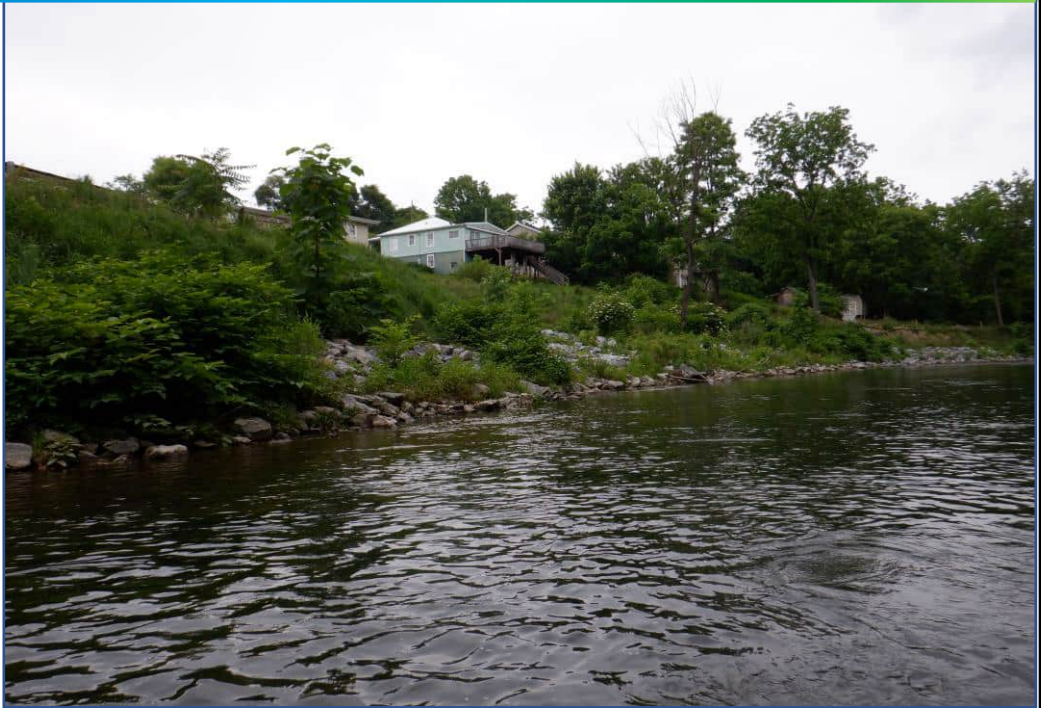
Photo Number: 15		Location: 00+250'	
Date: 6/7/2022

Direction: North			
Description: Downstream view of remediated bank; knotweed and princess tree visible.

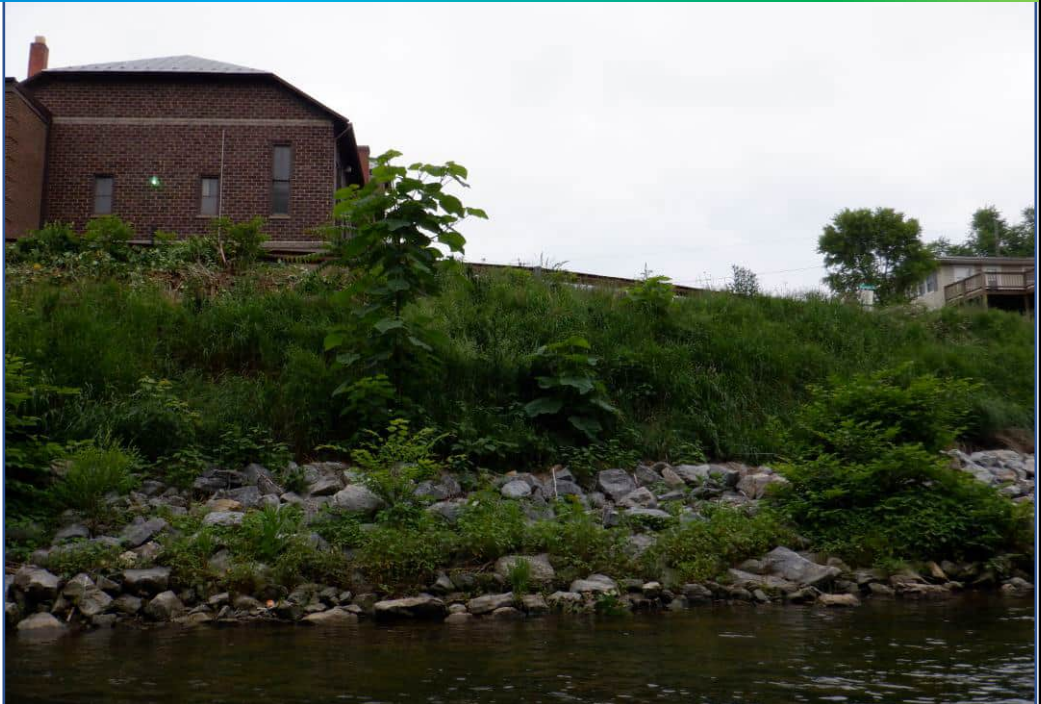
Photo Number: 16		Location: 00+300'	
Date: 6/7/2022

Direction: West			
Description: ~ 65° bank angle; lower bank ~45°; upper bank ~80°; above GW ~70°; vegetation 90% cover; invasive knotweed establishing in rock toe 3% cover; vegetation above GW impacted by vegetation; drainage pipe across GW cut; rock toe intact with evidence of sediment deposition.

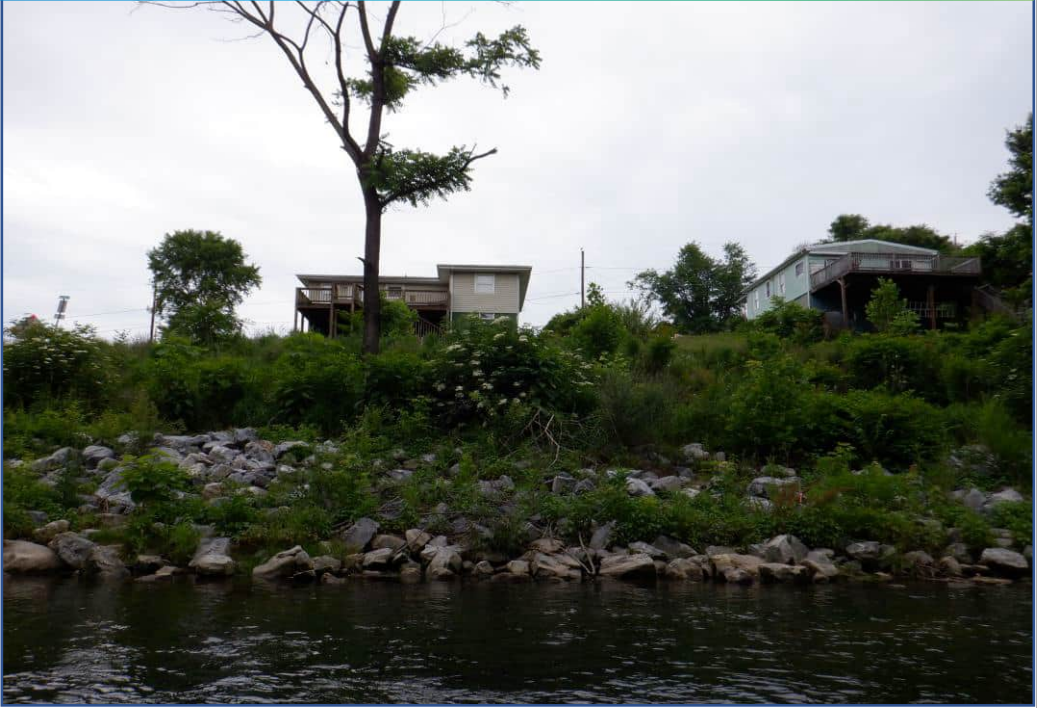
Photo Number: 19	Location: 00+400'
Date: 6/7/2022

Direction: West	
Description: ~ 50° bank angle; lower bank ~45°; upper bank ~50°; some grasses established; vegetation 95% cover; dying Black Walnut near top of bank; rock toe intact; evidence of sediment deposition in rock toe.

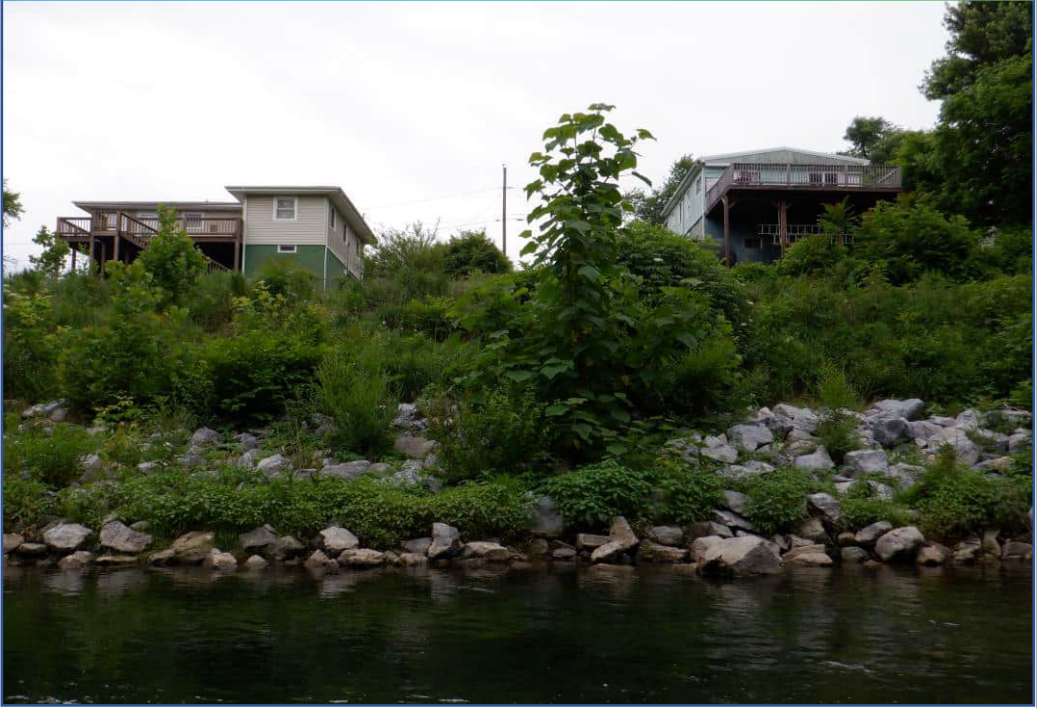
Photo Number: 21		Location: 00+450'	
Date: 6/7/2022

Direction: West			
Description: ~ 50° bank angle; lower bank ~45°; upper bank ~55°; some grasses established; vegetation 95% cover; invasive princess tree growing in rock toe; vegetation and sapling growth in rock toe; rock toe intact.

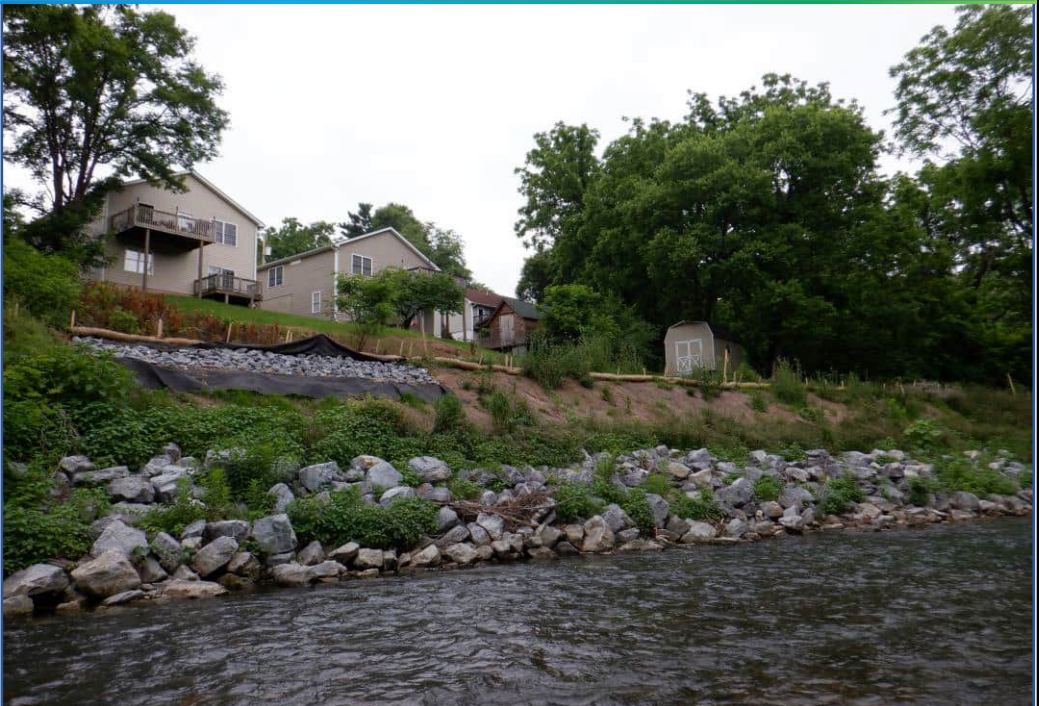
Photo Number: 24 Location: 00+500'	
<p>Date: 6/7/2022</p> <hr/> <p>Direction: Northwest</p> <hr/> <p>Description: Downstream view of remediated bank, including the section that was repaired due to construction damage. Grass did not establish on previously restored bank, few herbaceous vegetation growing in its place.</p>

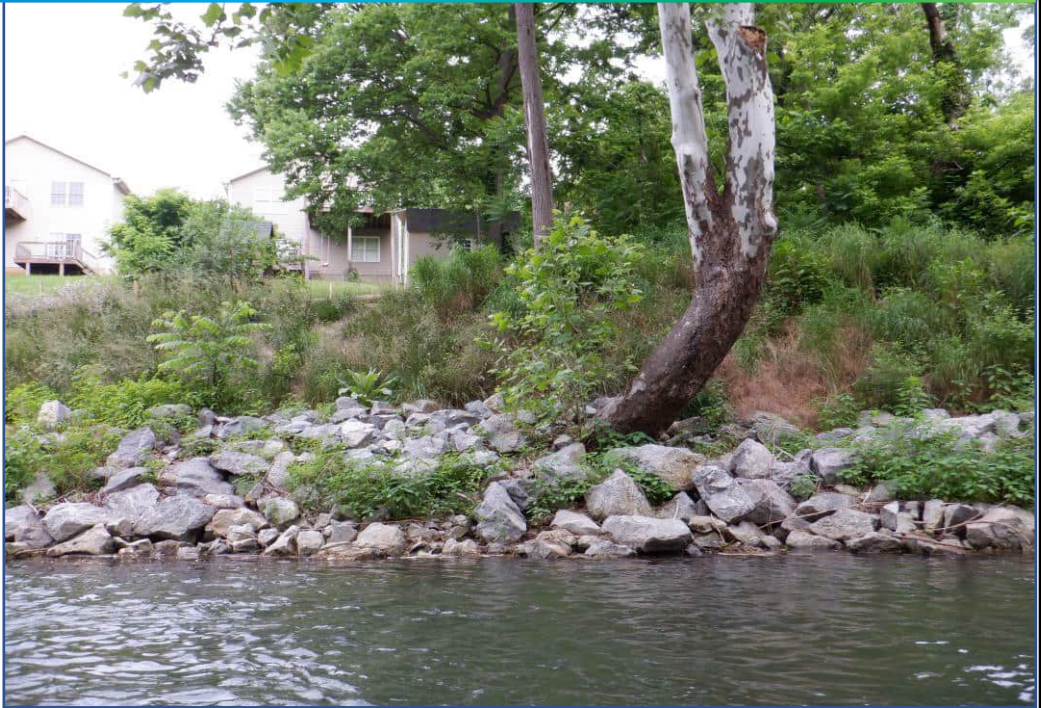
Photo Number: 29	Location: 00+650'
Date: 6/7/2022

Direction: West	
Description: ~ 65° bank angle; lower bank ~45°; upper bank ~50°; end of restored bank; herbaceous vegetation establishing with patches of thick mats of dead grasses on restored bank where grass did not establish; vegetation 75% cover; bank 25% exposed; large sycamore potentially at-risk.

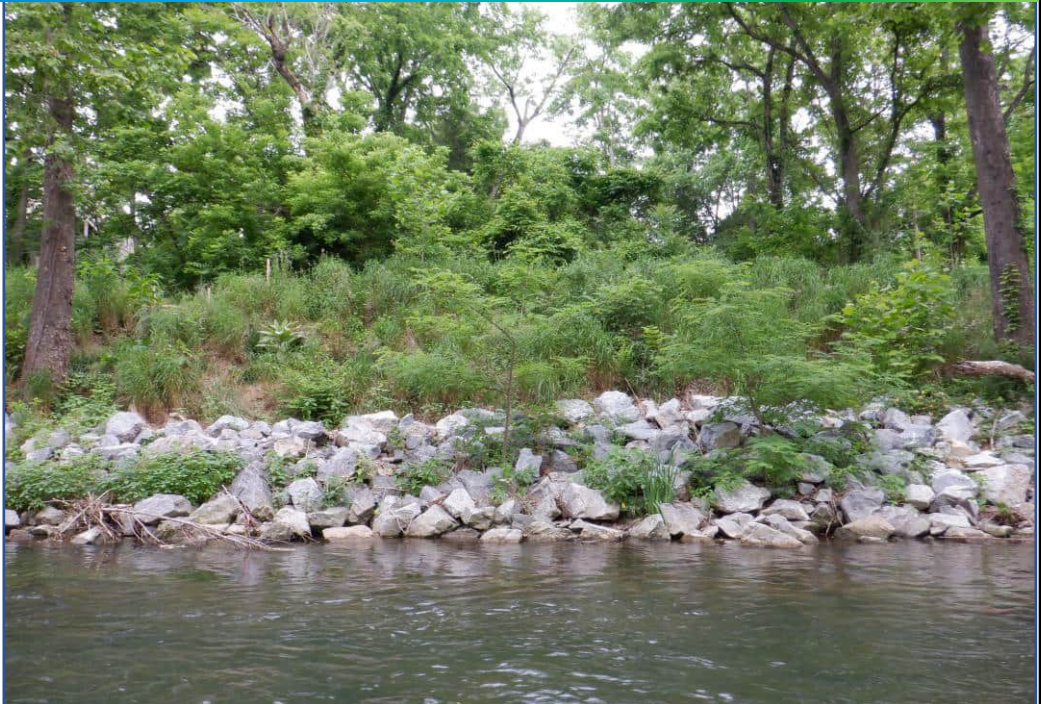
Photo Number: 30	Location: 00+700'
Date: 6/7/2022

Direction: West	
Description: ~ 50° bank angle; herbaceous vegetation established ; locust saplings established in rock toe not yet at risk; several patches of bare soil exposed.

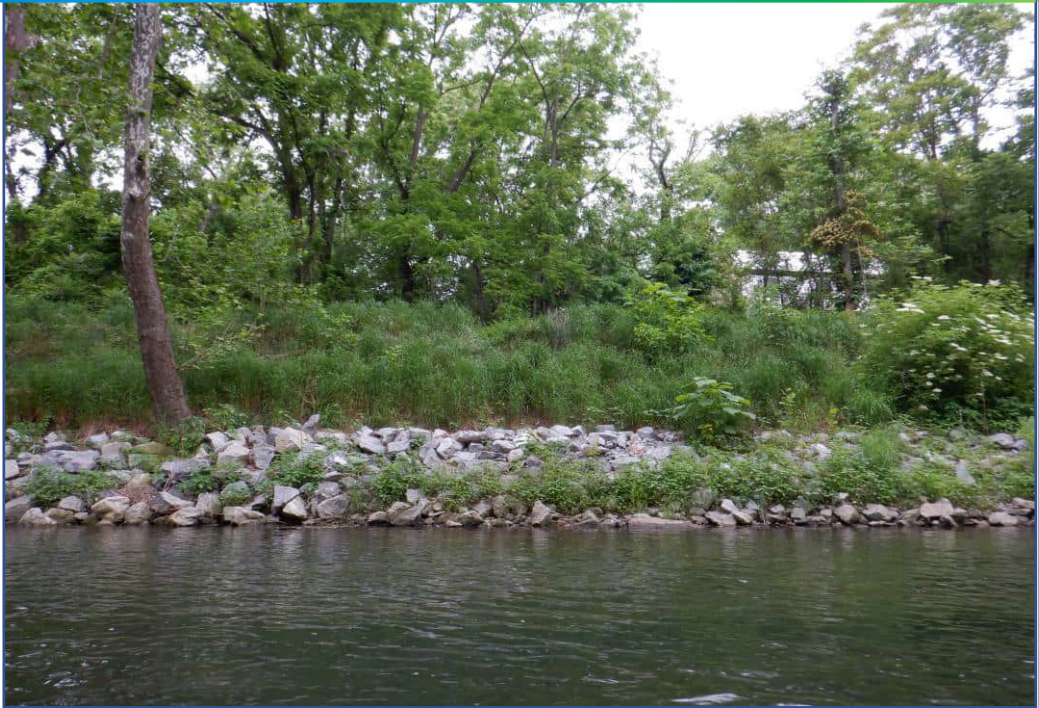
Photo Number: 33	Location: 00+750'
Date: 6/7/2022

Direction: West	
Description: ~ 60° bank angle; grasses and herbaceous vegetation established; vegetation 80% cover; no trees adjacent to edge of water; rock toe intact; evidence of sediment deposition in rock toe.

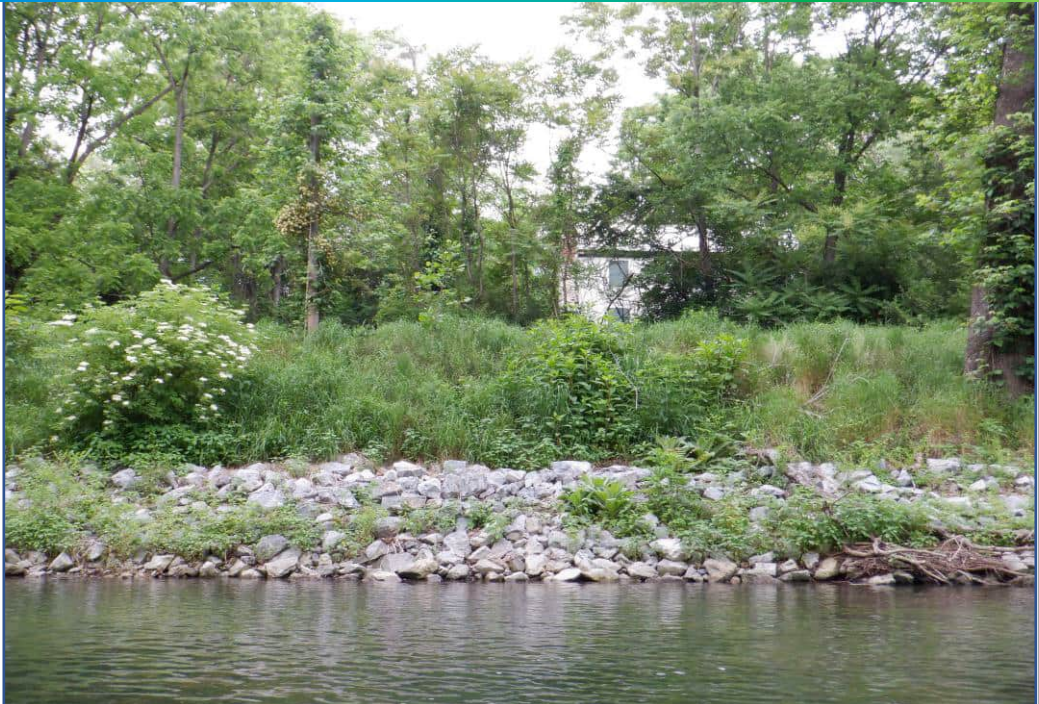
Photo Number: 34	Location: 00+800'
Date: 6/7/2022

Direction: West	
Description: ~ 65° bank angle; grasses and herbaceous vegetation established; vegetation 80% cover; no trees adjacent to edge of water; rock toe intact; evidence of sediment deposition in rock toe.

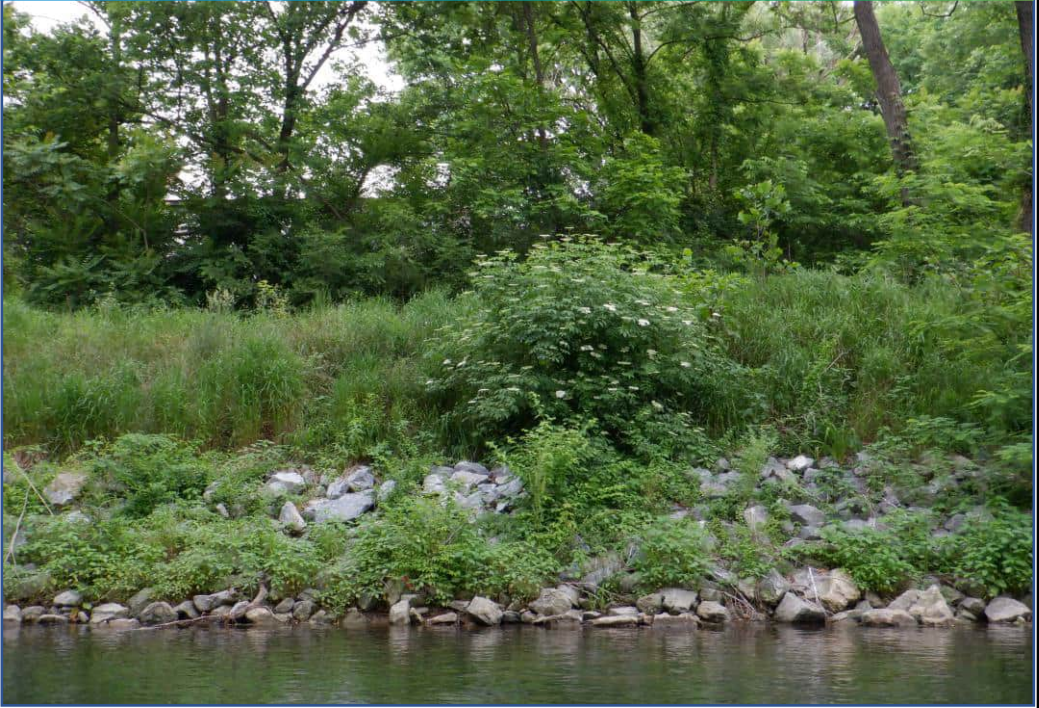
Photo Number: 35		Location: 00+850'	
Date: 6/7/2022

Direction: West			
Description: ~ 75° bank angle; grasses and herbaceous vegetation established; vegetation 90% cover; no trees adjacent to edge of water; rock toe intact; evidence of sediment deposition in rock toe

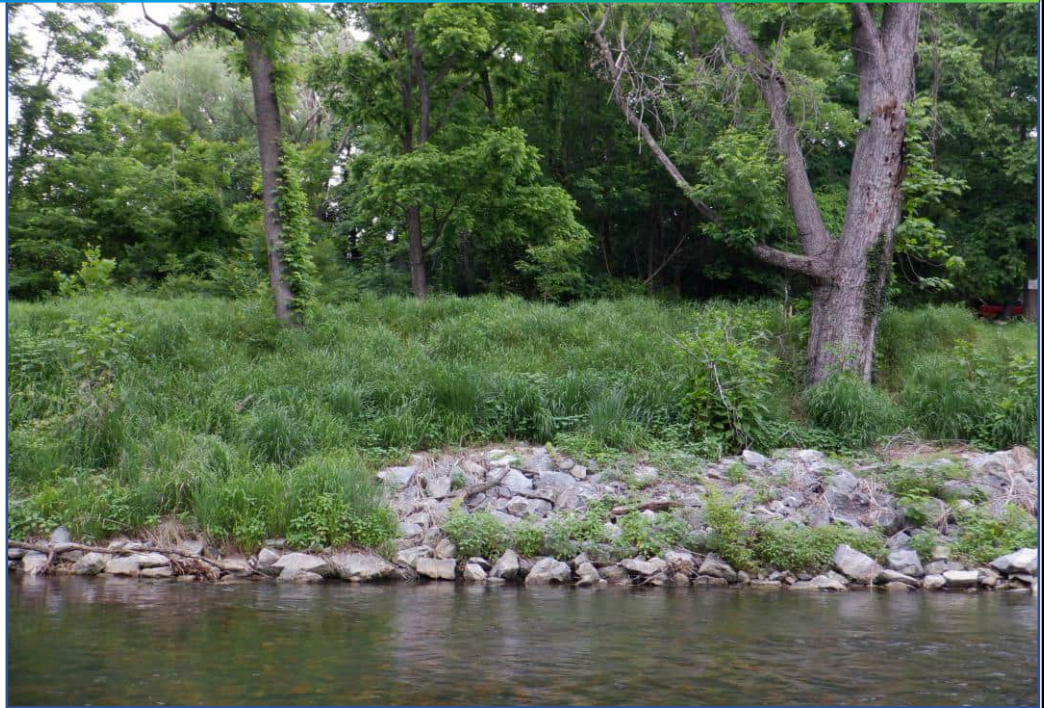
~ 65° bank angle;
lower bank ~70°;
upper bank ~60°;
grasses established
along upper bank;
vegetation 90% cover;
no at-risk trees
present; rock toe
intact; evidence of
sediment deposition
in rock toe.

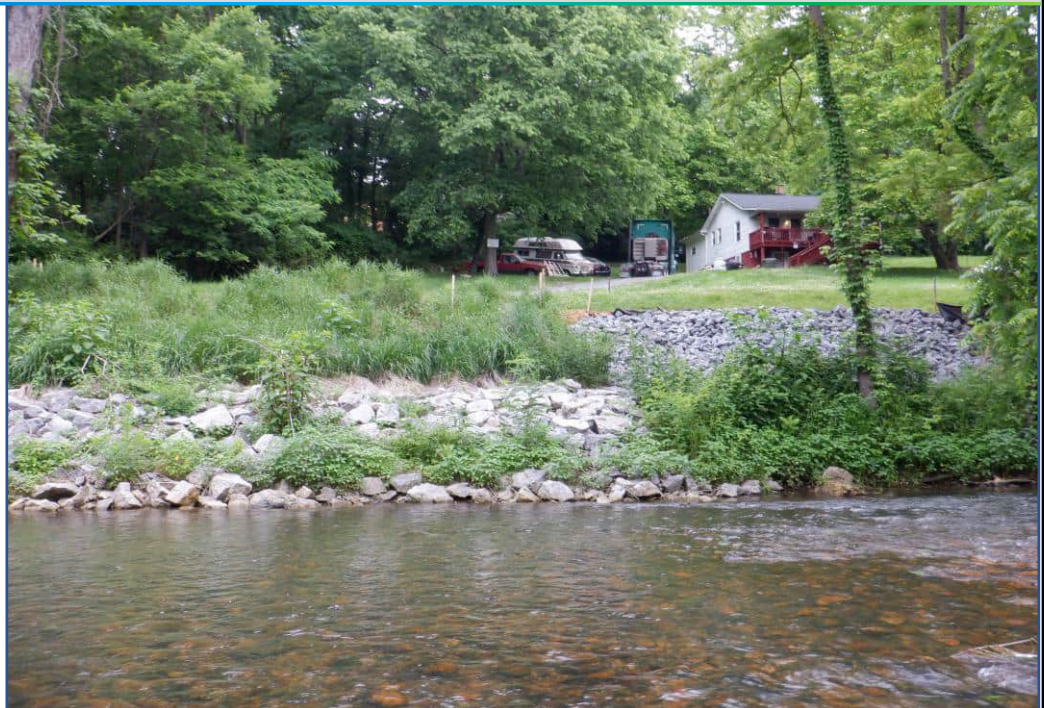
~ 60° bank angle; end
of remediation;
grasses established
along upper bank;
vegetation 90%
cover; new cobbles
added on top of bank
after remediated
section due to GW
construction; rock
toe intact; evidence
of sediment
deposition.

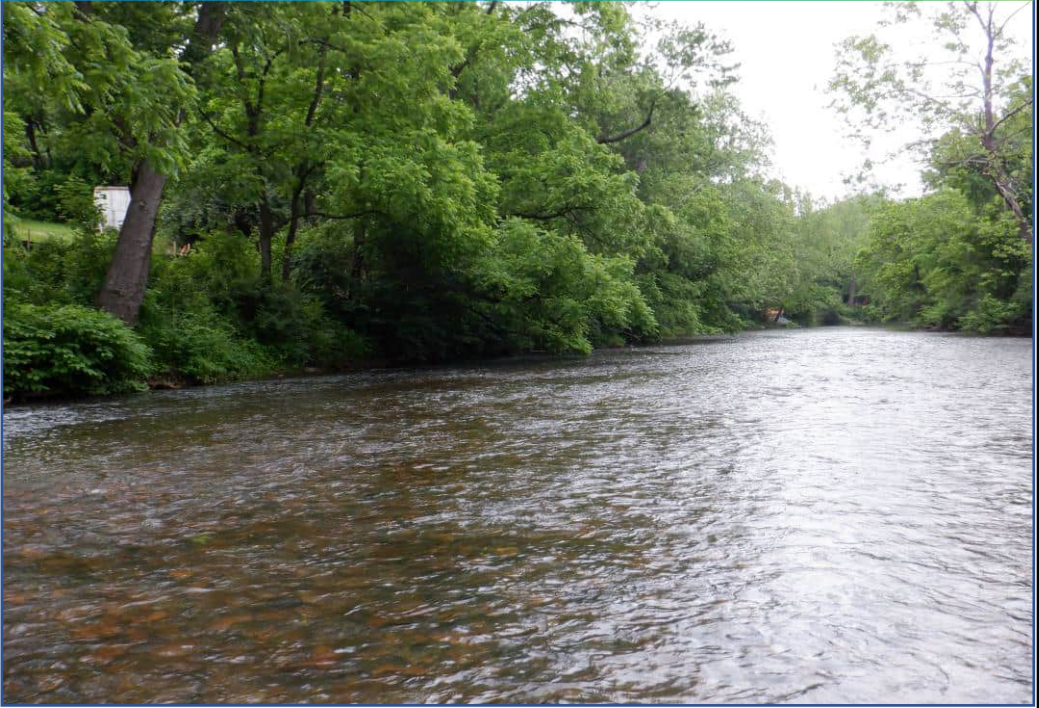
Photo Number: 41	Location: 00+975'
Date: 6/7/2022

Direction: North	
Description: Downstream view from end of remediated bank; exposed roots and at-risk trees present downstream of remediation; evidence of sediment deposition; scour present downstream of remediation.

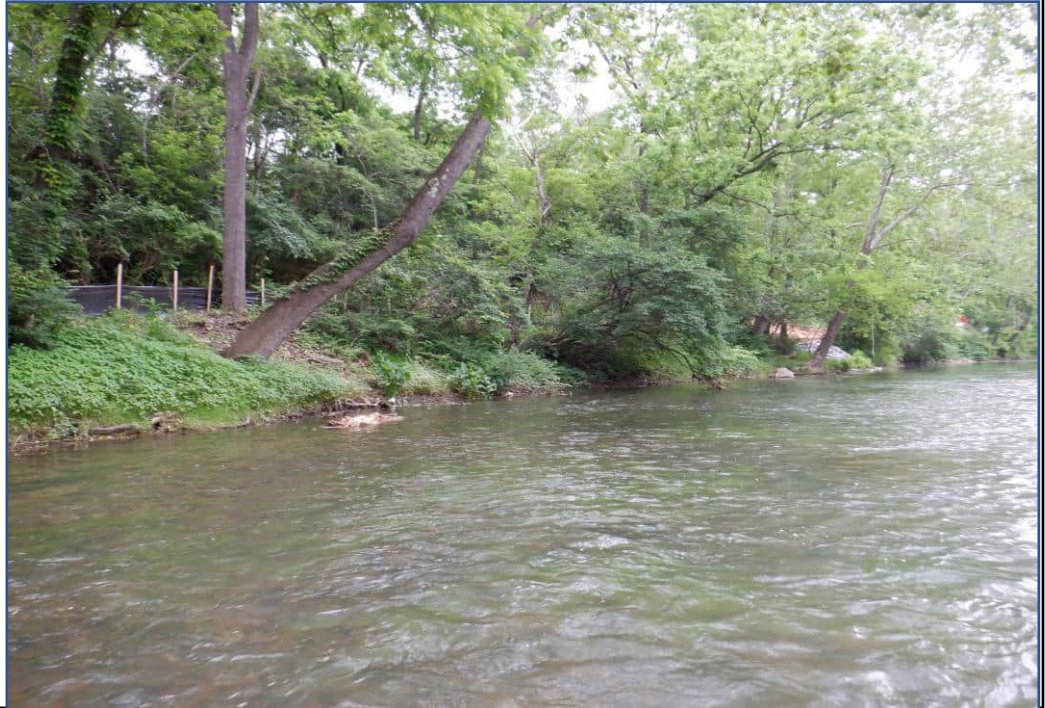
Description:
At-risk tree in non-remediated section of bank downstream of remediated section.

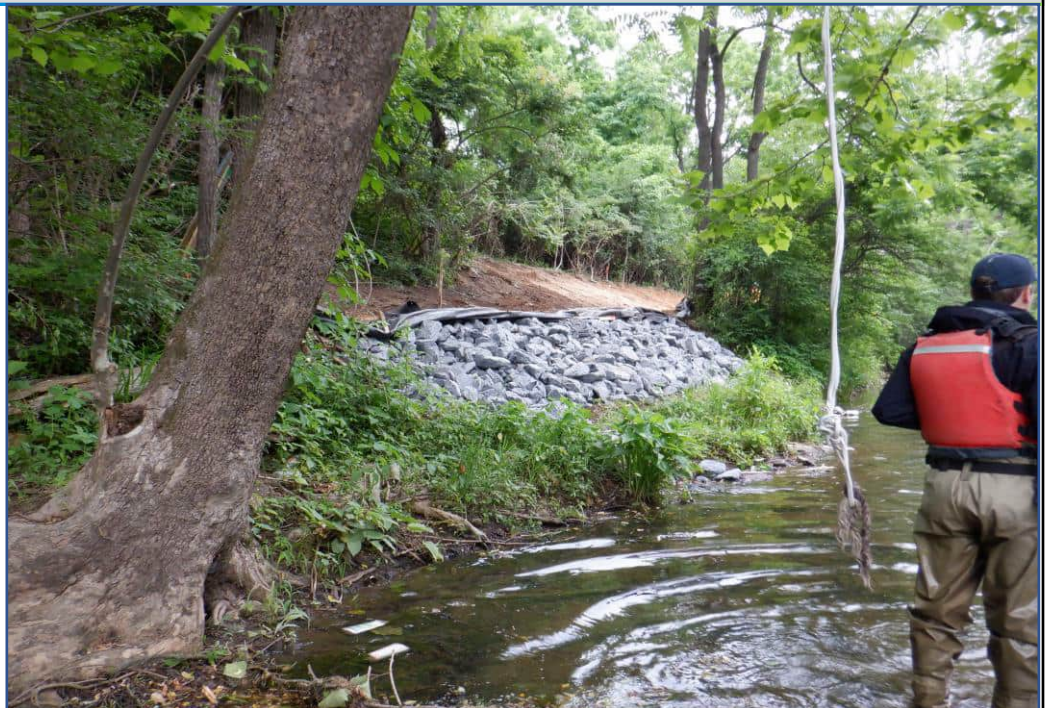
Description:
Rip rap cobble added to bank due to construction damage downstream of remediated bank.

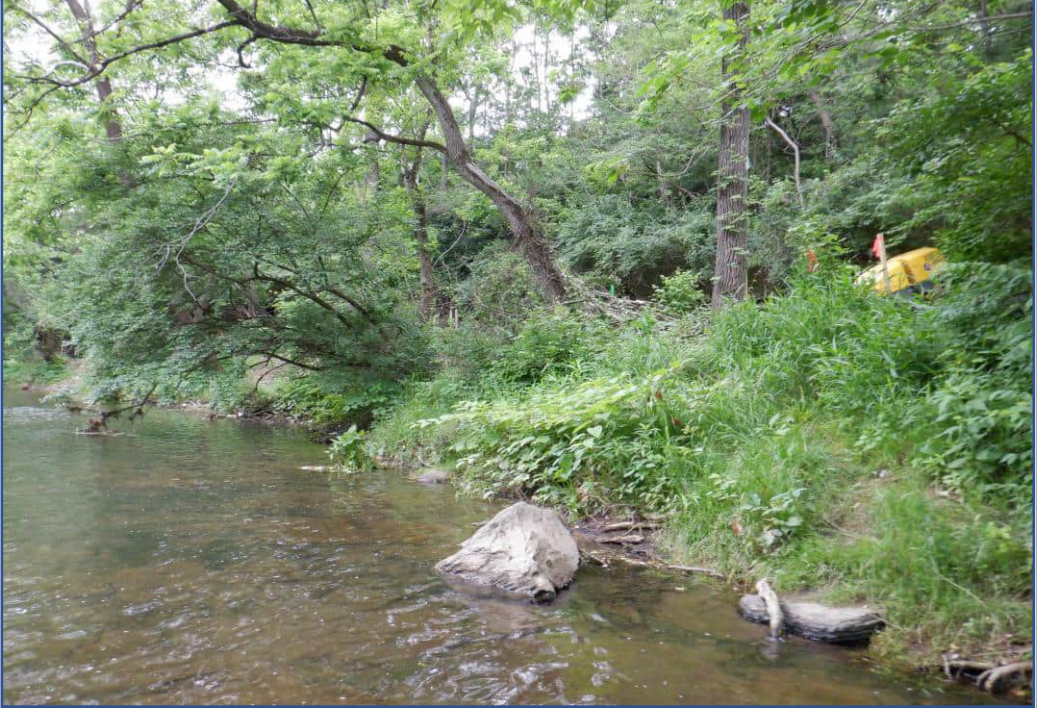
Photo Number: 49	Location: Downstream
Date: 6/7/2022

Direction: South	
Description: At-risk trees in the non-remediated section downstream of the remediated bank.

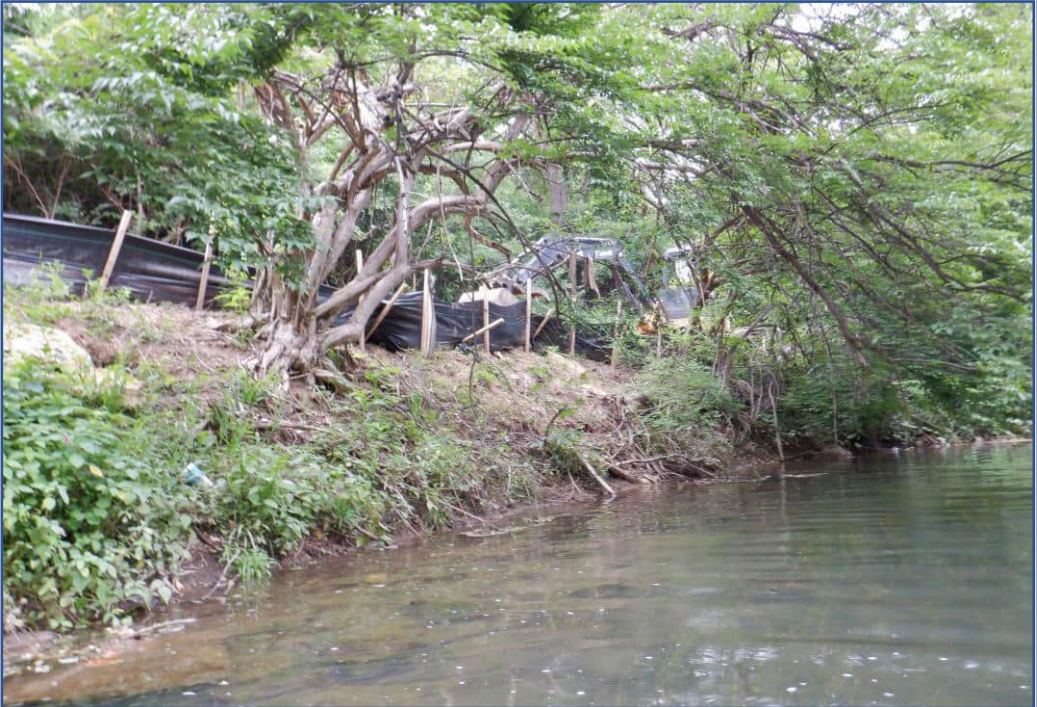
Photo Number: 50	Location: Downstream
Date: 6/7/2022

Direction: North	
Description: Ongoing construction and at-risk trees present in non-remediated bank downstream of remediated area. Silt fencing is helping prevent erosion.

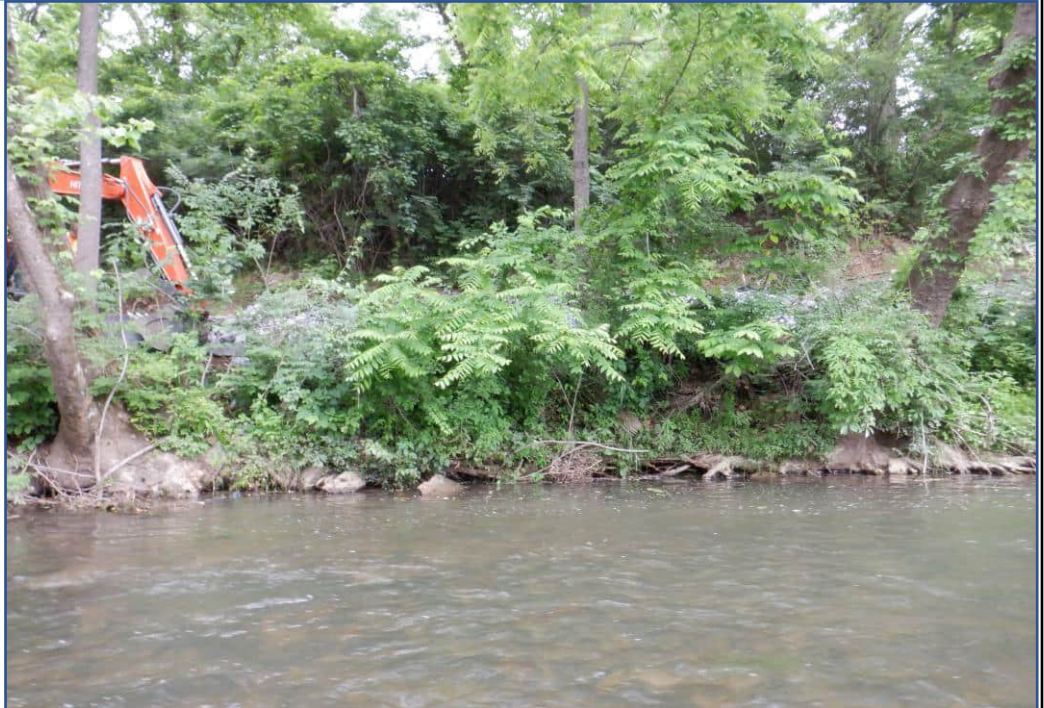
Description:
Ongoing construction and at-risk trees present in non-remediated bank downstream of remediated area.

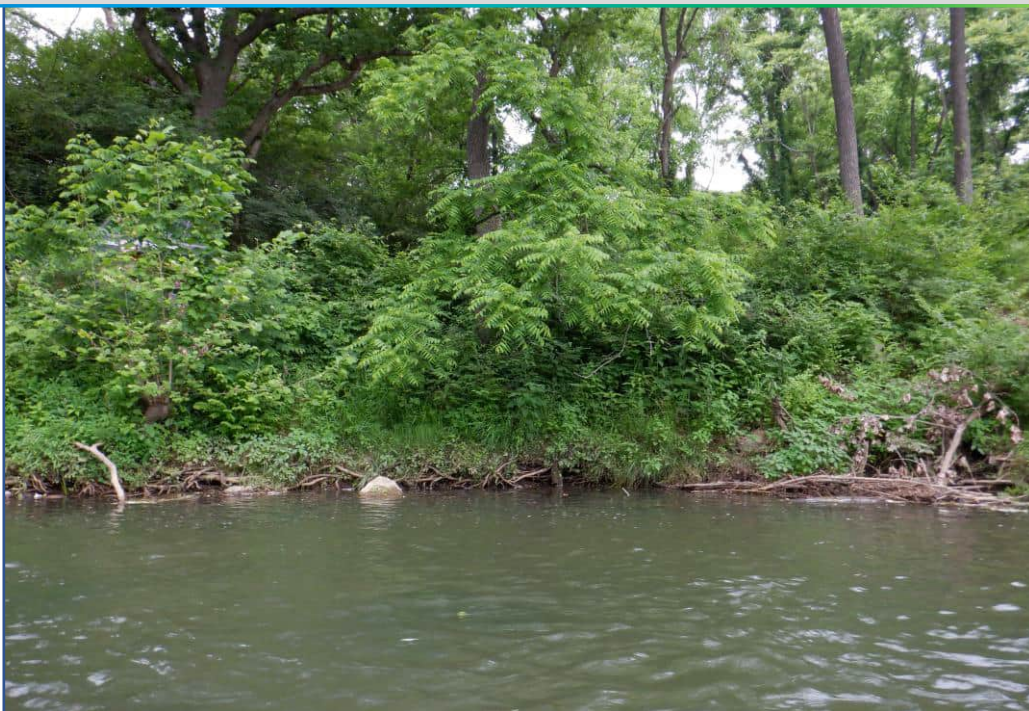
Photo Number: 01	Location: 00-25'
Date: 6/7/2022

Direction: Northwest	
Description: Upstream of remediation; ~ 60° bank angle; vertical drop at toe; undercut bank with exposed roots; no woody vegetation; minimal scour present; bank undercut.

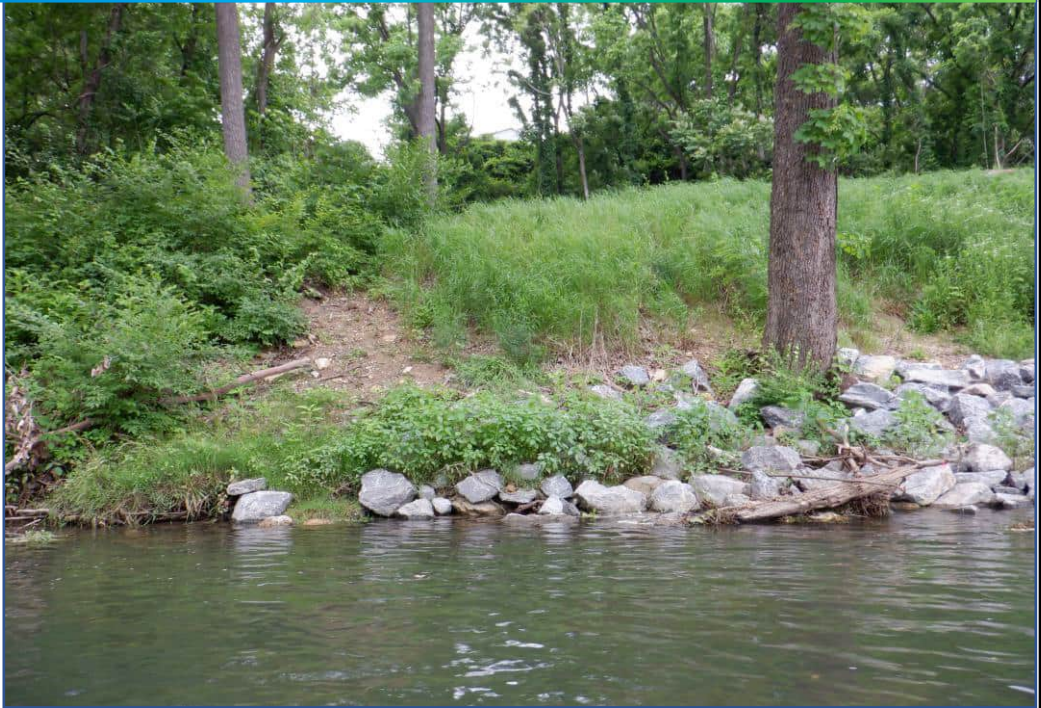
Photo Number: 03	Location: 00-00'
Date: 6/7/2022

Direction: Northwest	
Description: Start of 1 st remediated section; ~ 60° bank angle; vegetation 60% cover; bare soil at beginning of remediated section, no at-risk trees present; footpath at edge of remediation;

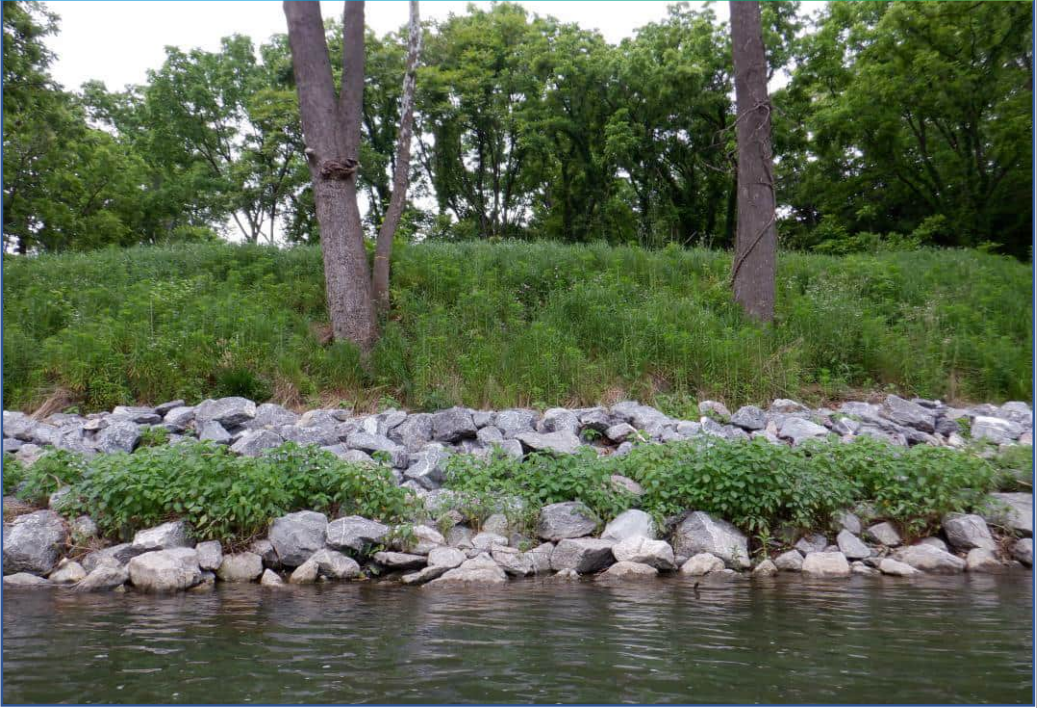
Photo Number: 05	Location: 00+50'
Date: 6/7/2022

Direction: Northwest	
Description: ~ 50° bank angle; vegetation 85% cover; no at-risk trees present; fine sediment deposition.

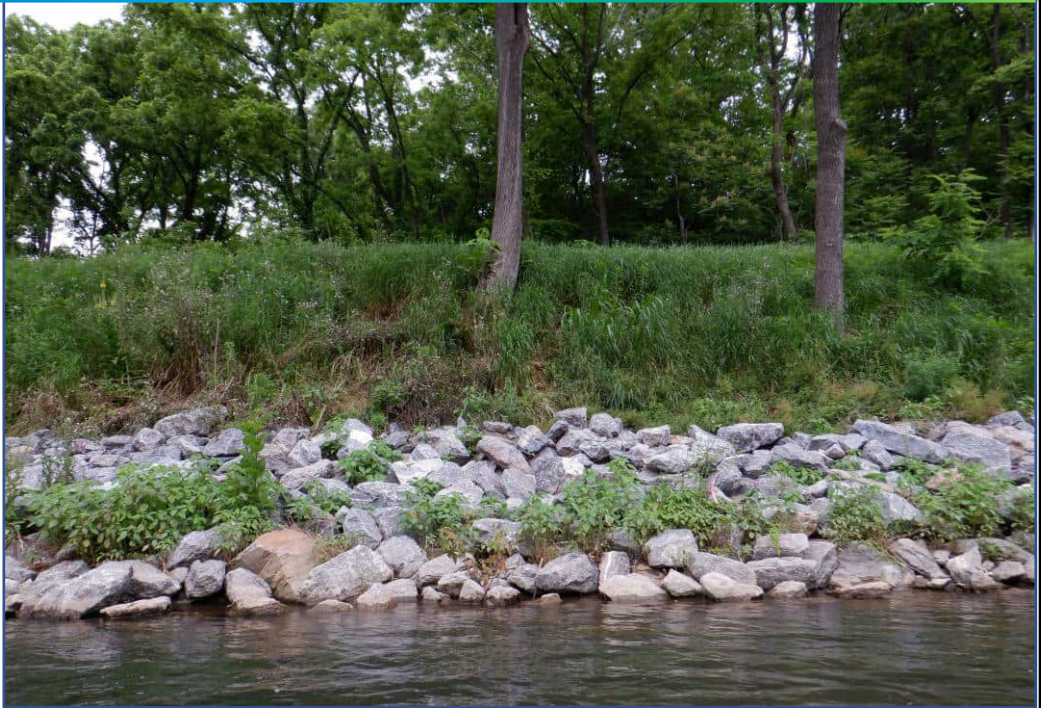
Photo Number: 09	Location: 00+150'
Date: 6/7/2022

Direction: Northwest	
Description: ~ 60° bank angle; vegetation 80% cover; jewelweed establishing in rock toe; rock toe intact; moderate sediment deposition.

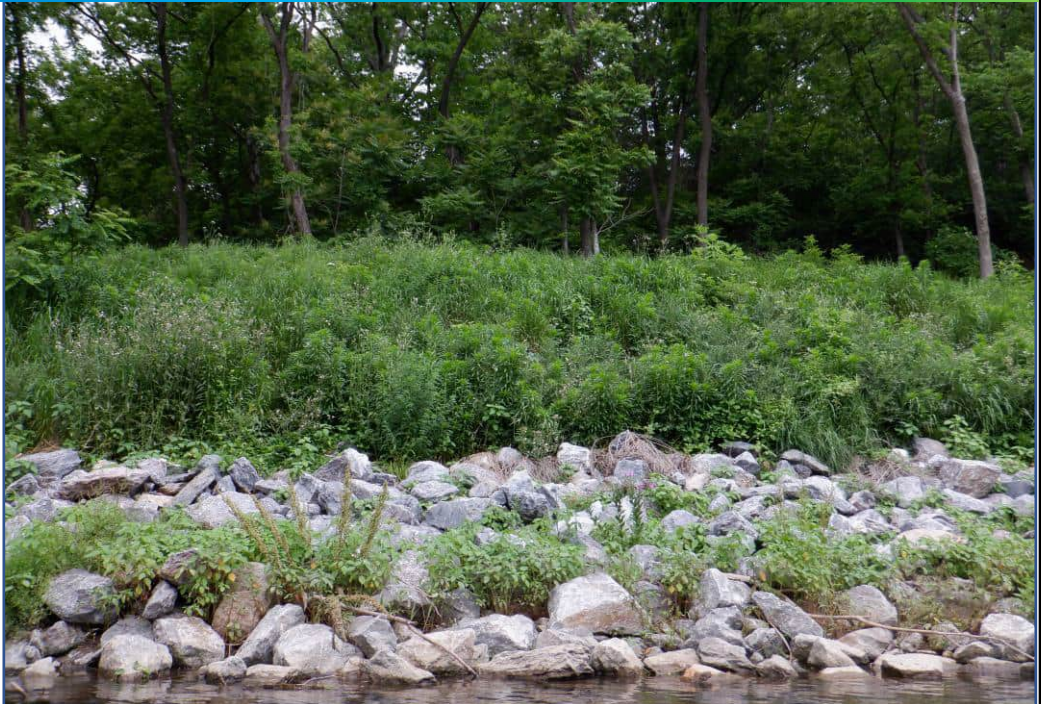
Photo Number: 10	Location: 00+200'
Date: 6/7/2022

Direction: Northwest	
Description: ~ 60° bank angle; vegetation 95% cover; trees present mid bank; rock toe intact, plants establishing in rock toe; moderate sediment deposition.
