RE: 2022 Leaf-off, 2022 Leaf-on and 2023 Leaf-on BMA Inspection Memos
Former DuPont Waynesboro Site AOC 4
Waynesboro, Virginia
EPA ID# VAD003114832

Memorandum

Subject 2022 Leaf-on Maintenance Inspection
Former DuPont Waynesboro Site, Area of Concern 4

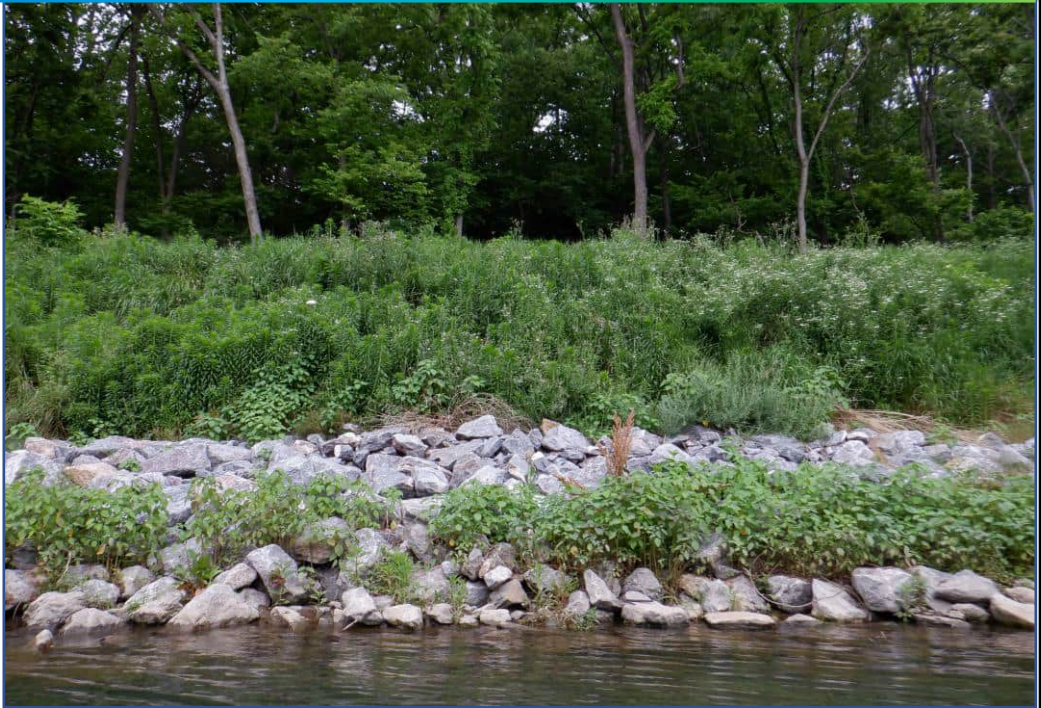
Photo Number: 11	Location: 00+250'
Date: 6/7/2022

Direction: Northwest	
Description: ~ 70° bank angle; vegetation 90% cover; rock toe intact; ; moderate sediment deposition.

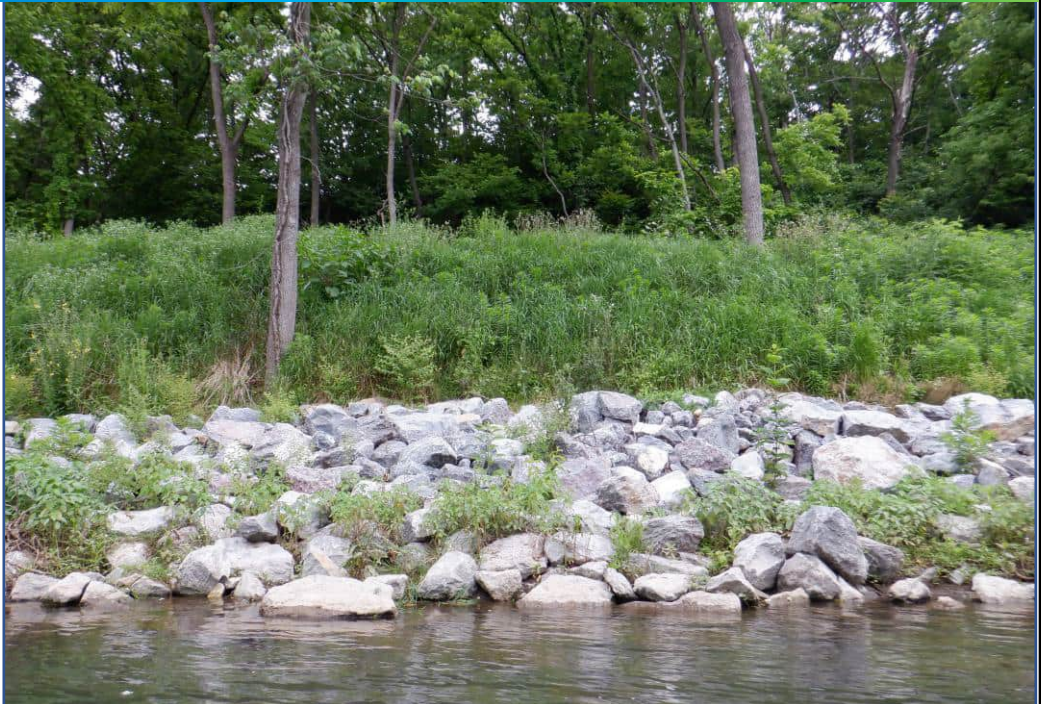
Photo Number: 12	Location: 00+300'
Date: 6/7/2022

Direction: Northwest	
Description: ~ 70° bank angle; vegetation 95% cover; trees present mid bank; rock toe intact; moderate sediment deposition.

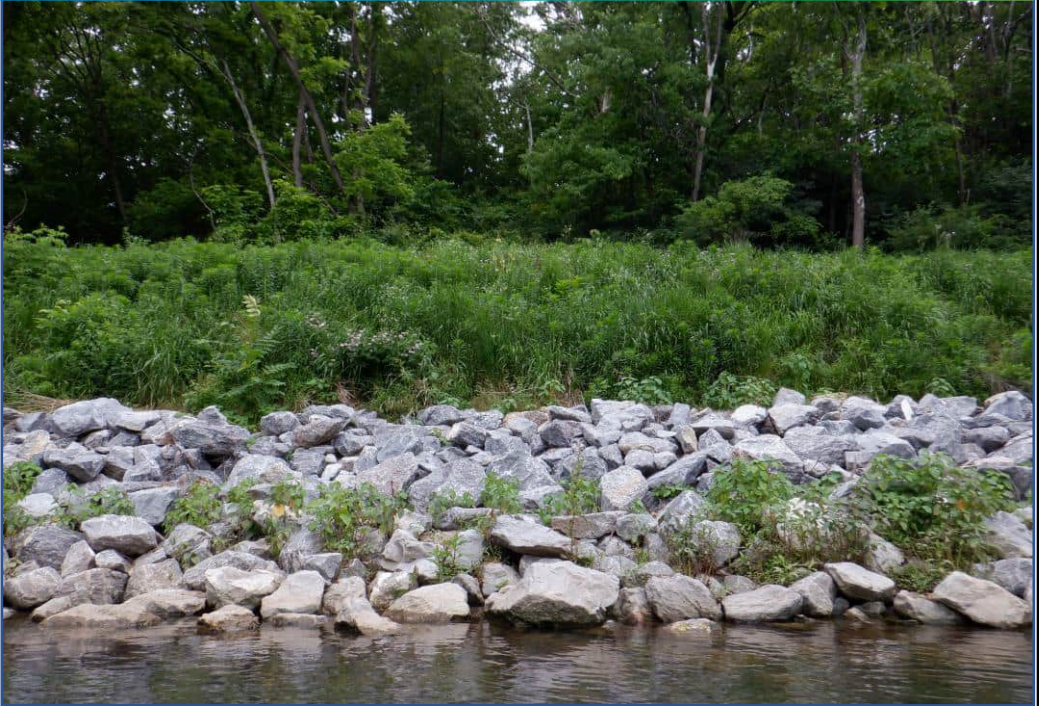
Photo Number: 15	Location: 00+350'
Date: 6/7/2022

Direction: Northwest	
Description: ~ 70° bank angle; vegetation 95% cover; rock toe intact, jewelweed establishing in rock toe; minimal sediment deposition.

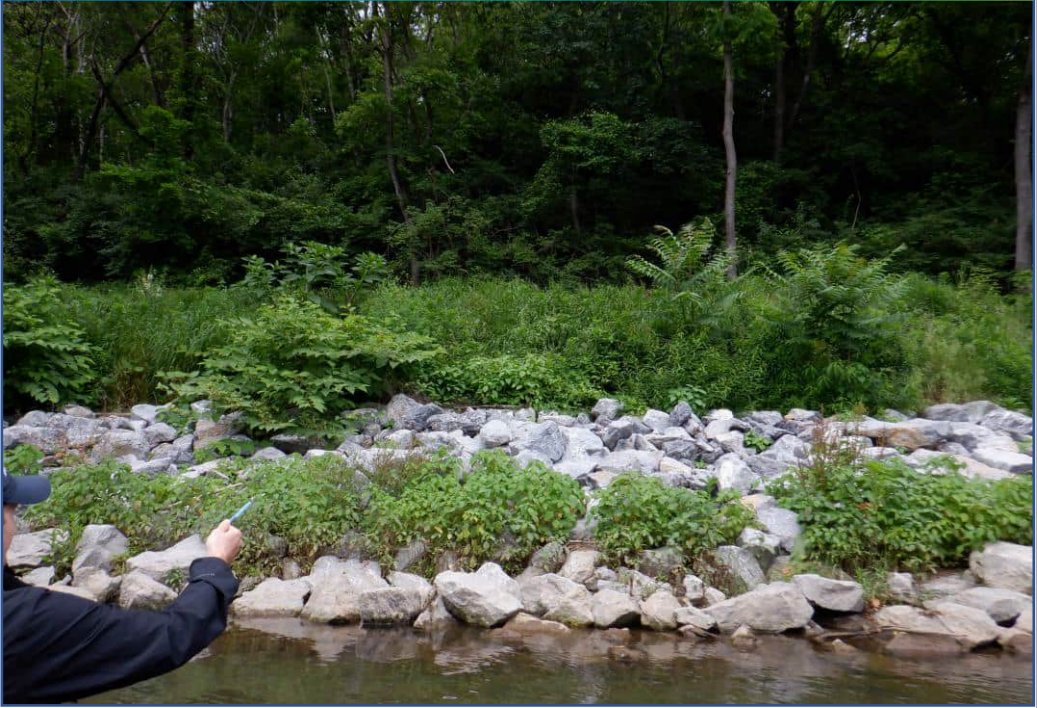
Photo Number: 17	Location: 00+450'
Date: 6/7/2022

Direction: Northwest	
Description: ~ 50° bank angle; vegetation 95% cover; invasive knotweed 5% cover; rock toe intact, jewelweed establishing in rock toe; minimal sediment deposition.

Comments: Recommended herbicide treatment for areas of Japanese knotweed. Continue to monitor pathway and rock toe for erosion along river.

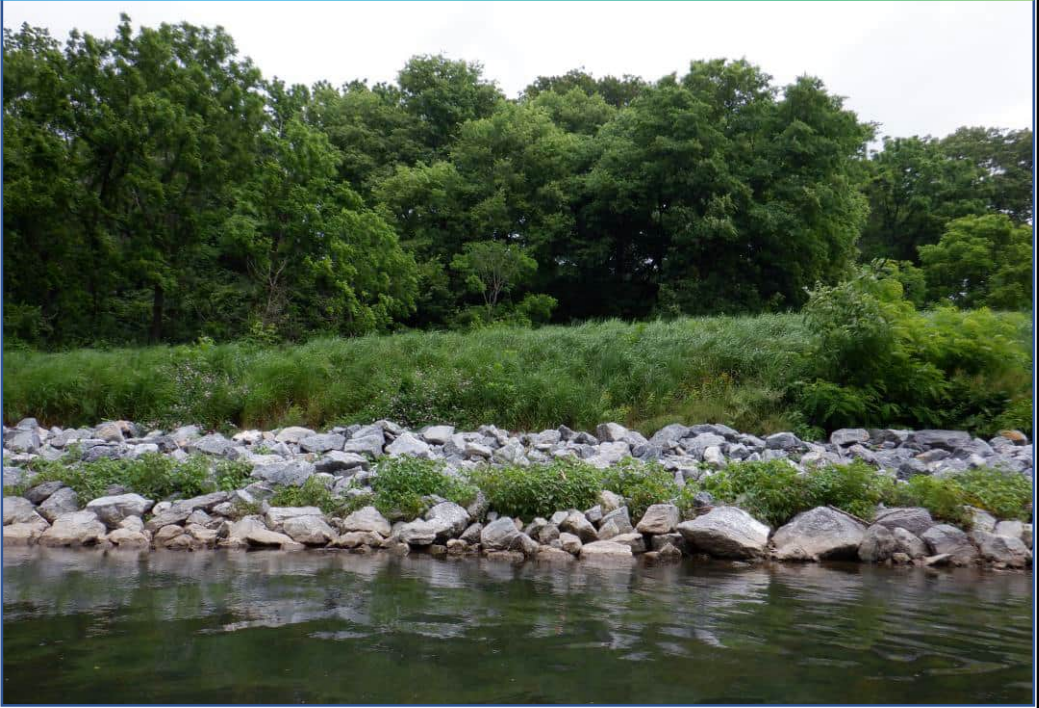
Photo Number: 29		Location: 00+950'	
Date: 6/7/2022

Direction: Northwest			
Description: ~ 50° bank angle, vegetation 95% cover; rock toe intact, jewelweed establishing in rock toe; minimal sediment deposition.

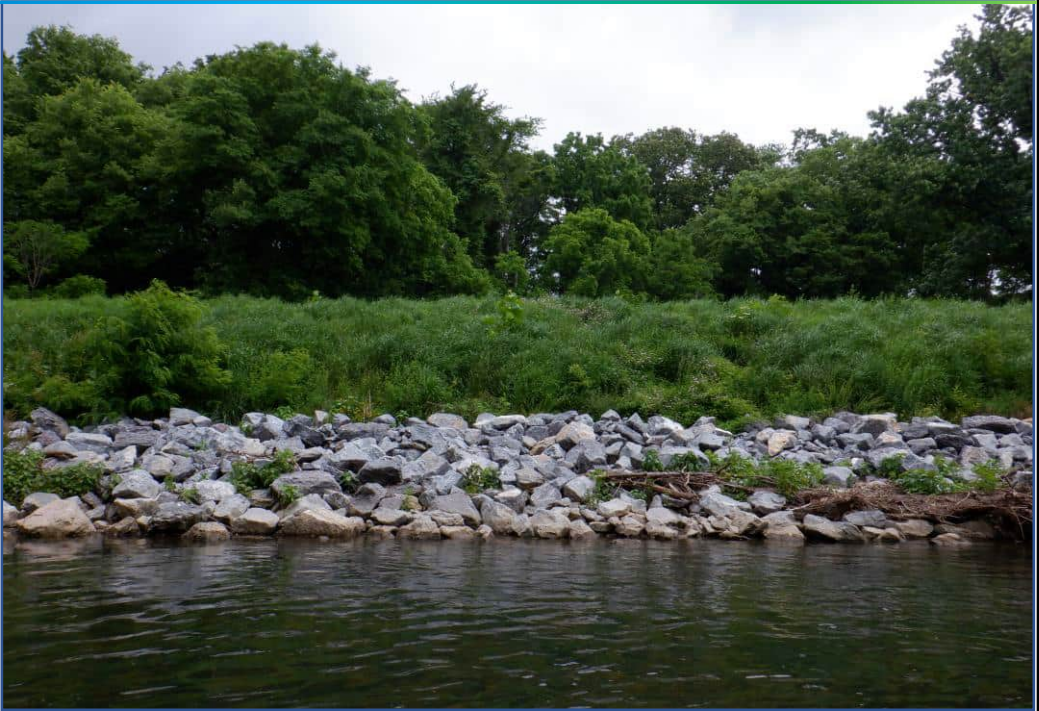
Photo Number: 30		Location: 00+1000'	
Date: 6/7/2022

Direction: Northwest			
Description: ~ 50° bank angle vegetation 95% cover; rock toe intact; minimal sediment deposition.

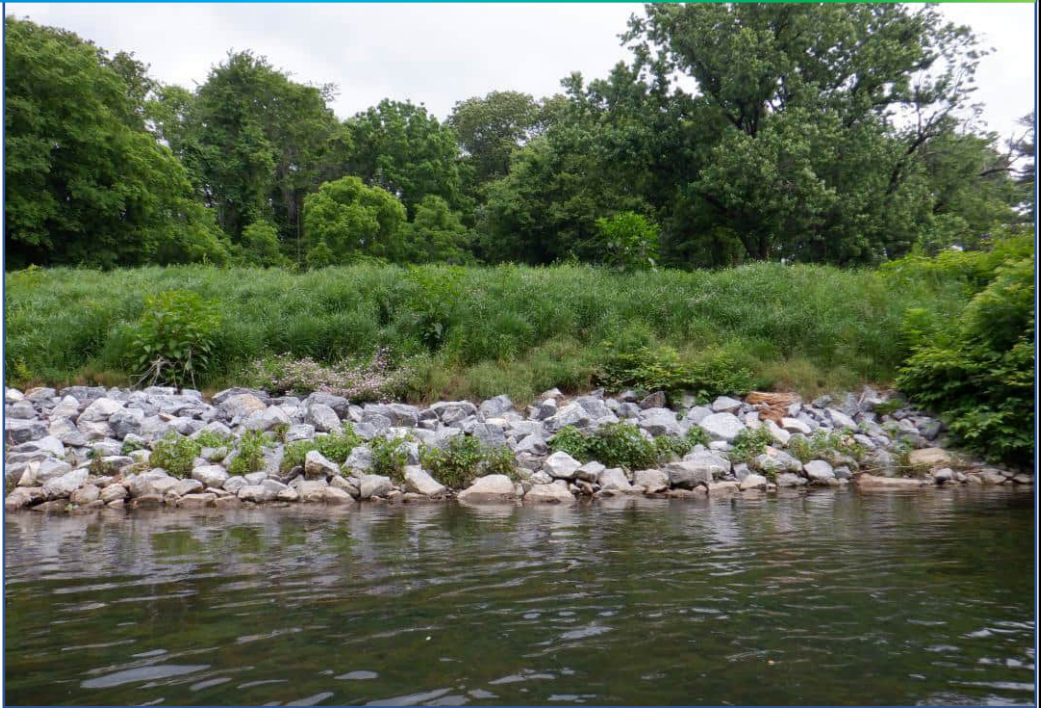
Photo Number: 31	Location: 00+1050'
Date: 6/7/2022

Direction: Northwest	
Description: ~ 45° bank angle; end of 1 st remediation area; vegetation 90% cover; rock toe intact; minimal sediment deposition.

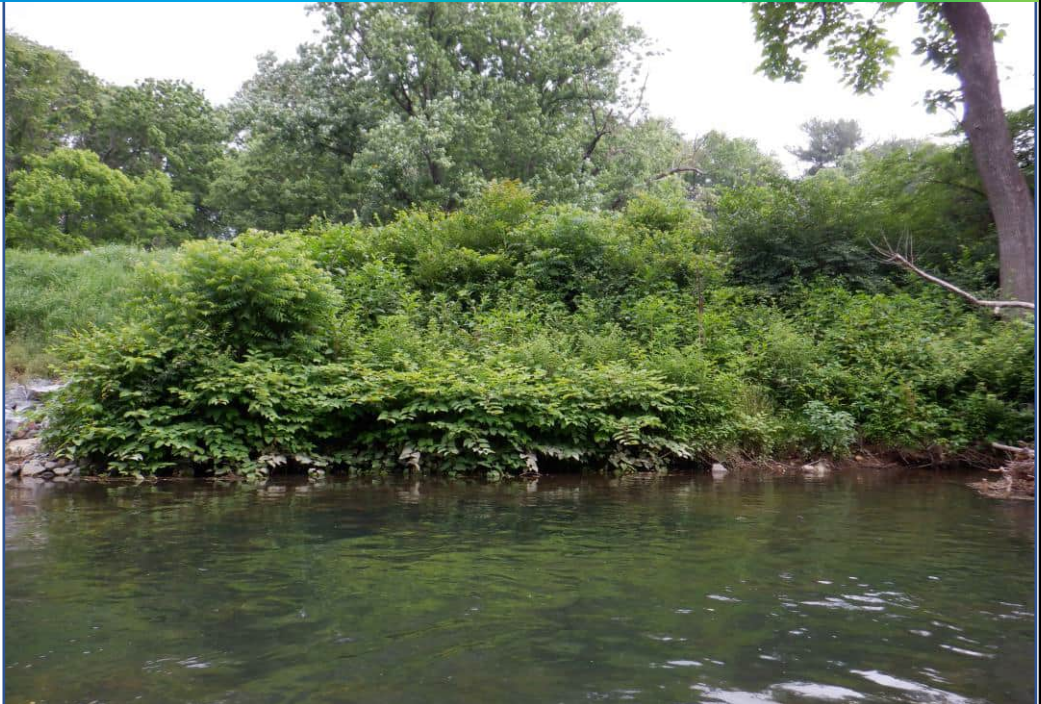
Photo Number: 34		Location: 00+1100'
Date: 6/7/2022

Direction: North		
Description: Start of non-remediated section; ~ 65° bank angle; vegetation 70% cover; invasive knotweed 60% cover; minimal undercutting at toe of bank; minimal scour at end of remediation.

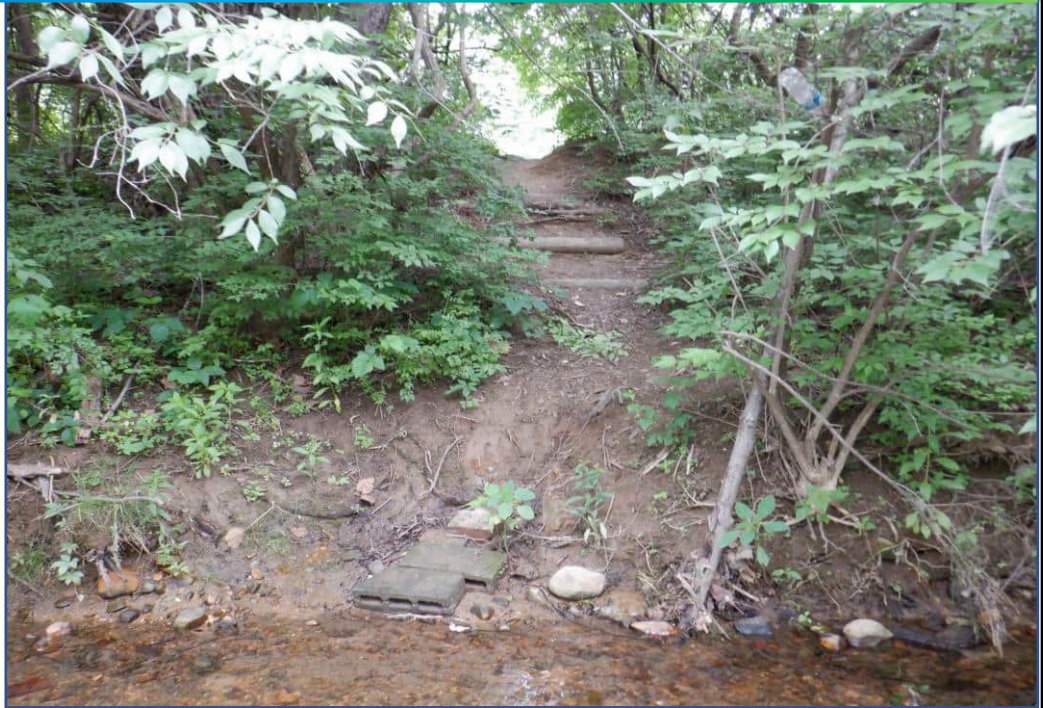
**South River Photolog
North Park BMA
Bank Monitoring Memo****Photo Number:** 39**Location:** 00+1250'**Date:** 6/7/2022**Direction:** North**Description:**

View of access path and wooden steps present from top of bank to mid bank then a mostly vertical drop from scour and erosion at the base of steps.

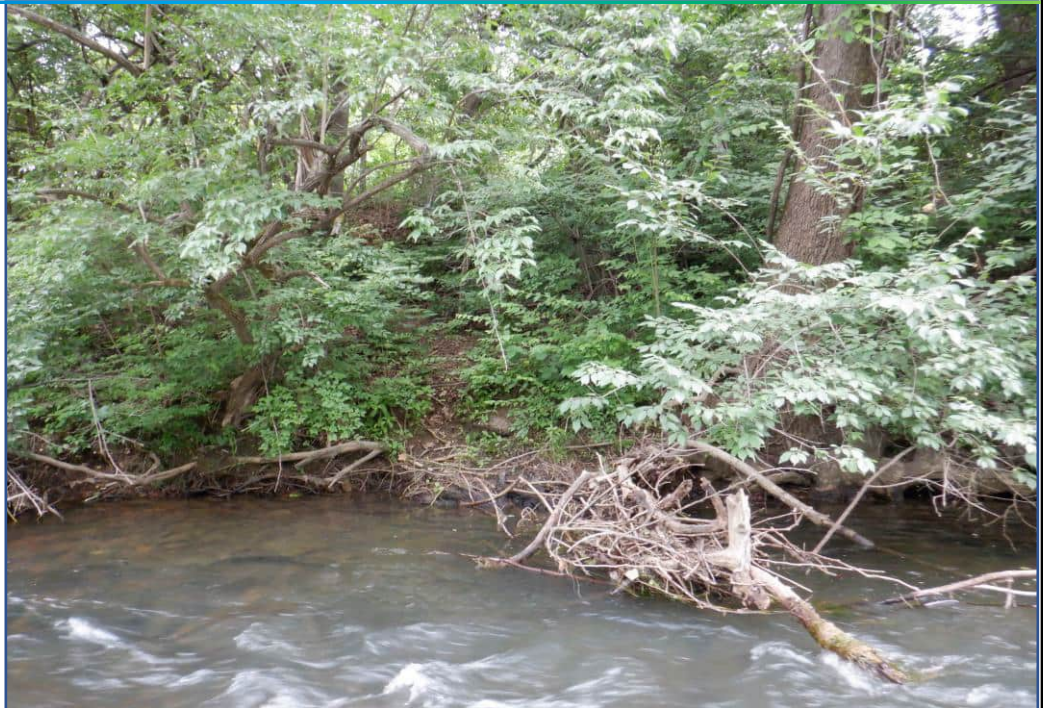
**Photo Number:** 40**Location:** 00+1300'**Date:** 6/7/2022**Direction:** North**Description:**

Non-remediated section; ~ 45° bank angle; exposed roots on tree at toe; vegetation 60% cover; improvised access path present, leading to exposed soil; 1 tree at toe and 1 at mid bank; tree mid bank appears to be dead; significant undercutting mostly at toe of bank; some scour at exposed roots at toe of bank.

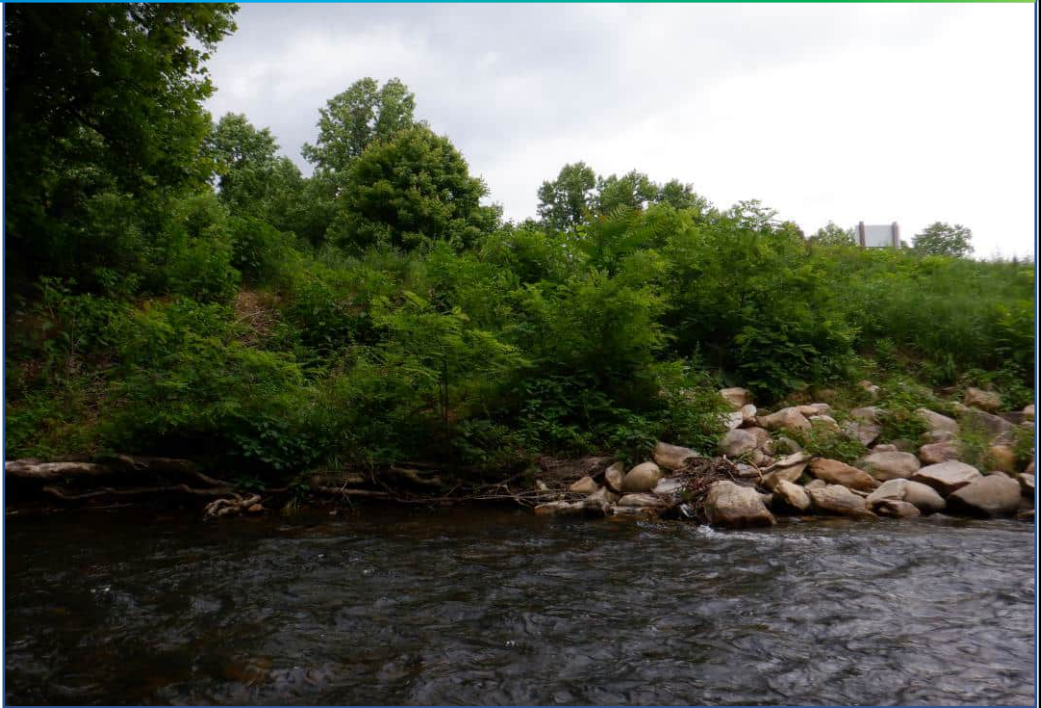
Photo Number: 45	Location: 00+1550'
Date: 6/7/2022

Direction: North	
Description: Start of 2 nd section of bank remediation; ~60° bank angle; vegetation 90% cover; rock toe intact, significant undercutting, with large exposed root, and bare ground just upstream of remediated section.

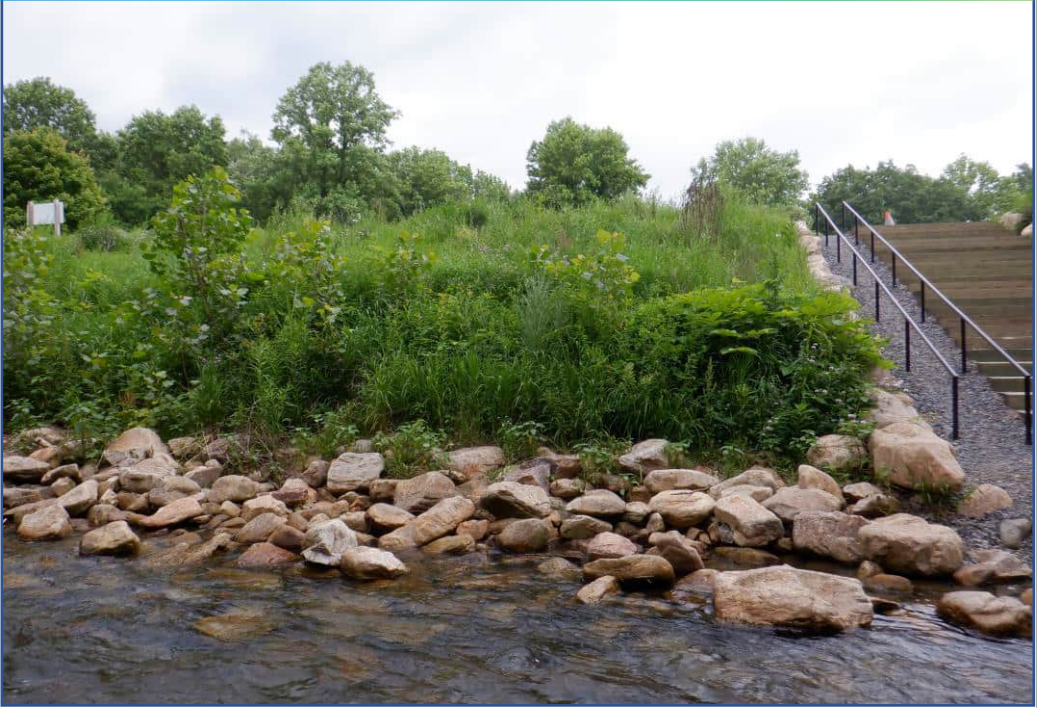
**South River Photolog
North Park BMA
Bank Monitoring Memo**

Direction: North			
Description: ~ 45° bank angle; live stakes and plantings not established; vegetation 95% cover; no at-risk trees present; erosion control fabric 5% exposed; kayak launch and steps intact; path not level, gravel dust eroded away revealing larger blue gravel, small boulders tumbled into water; minimal sediment deposition.

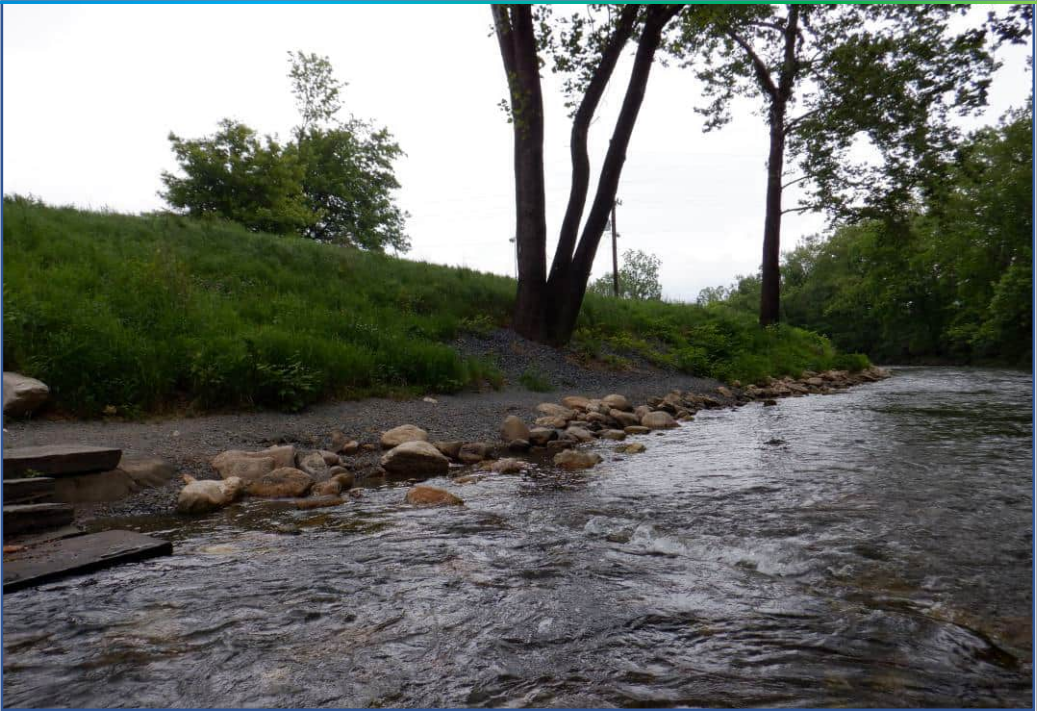
Photo Number: 52		Location: 00+1650'	
Date: 6/7/2022

Direction: East			
Description: Upstream view of remediated bank,, small boulders tumbled into water, path beginning to slant due to erosion.

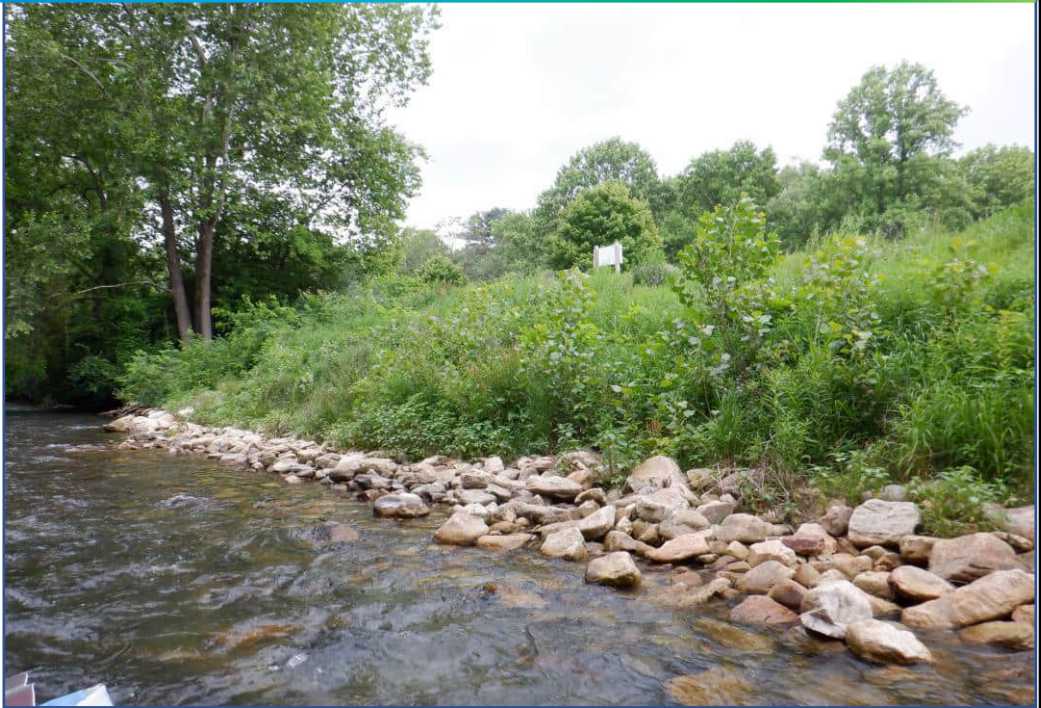
Photo Number: 53	Location: 00+1650'
Date: 6/7/2022

Direction: West	
Description: Downstream view of remediated bank; small boulders tumbled into water.

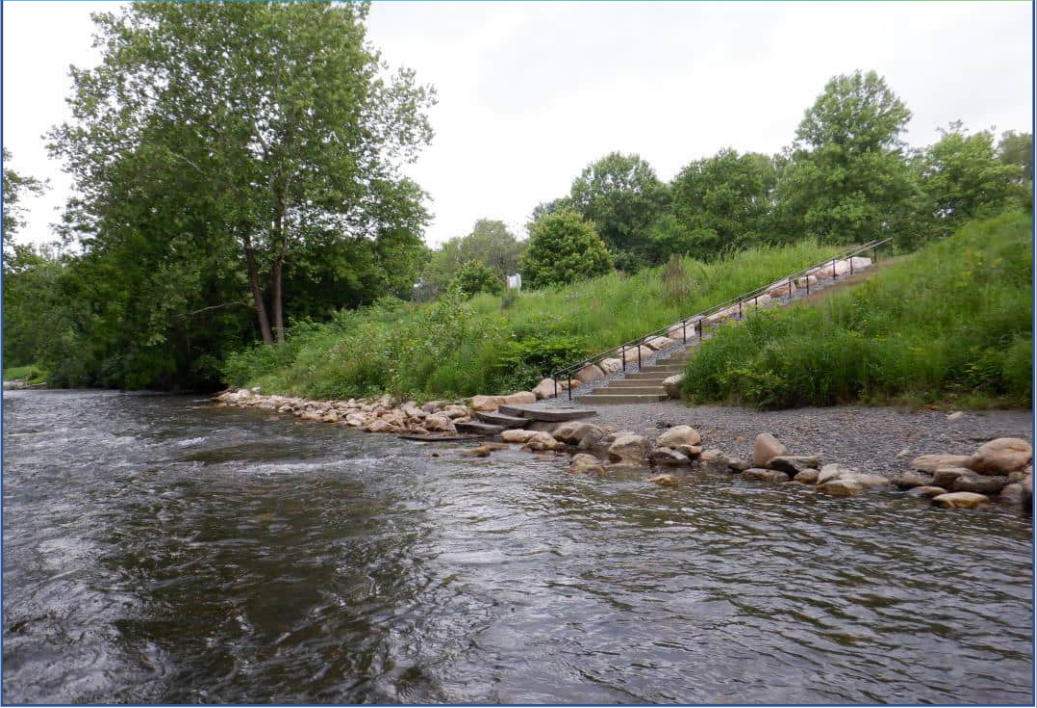
Photo Number: 55		Location: 00+1700'	
Date: 6/7/2022

Direction: West			
Description: Upstream view of remediated bank; path slanted, gravel dust eroded away revealing larger blue gravel, small boulders tumbled into water.

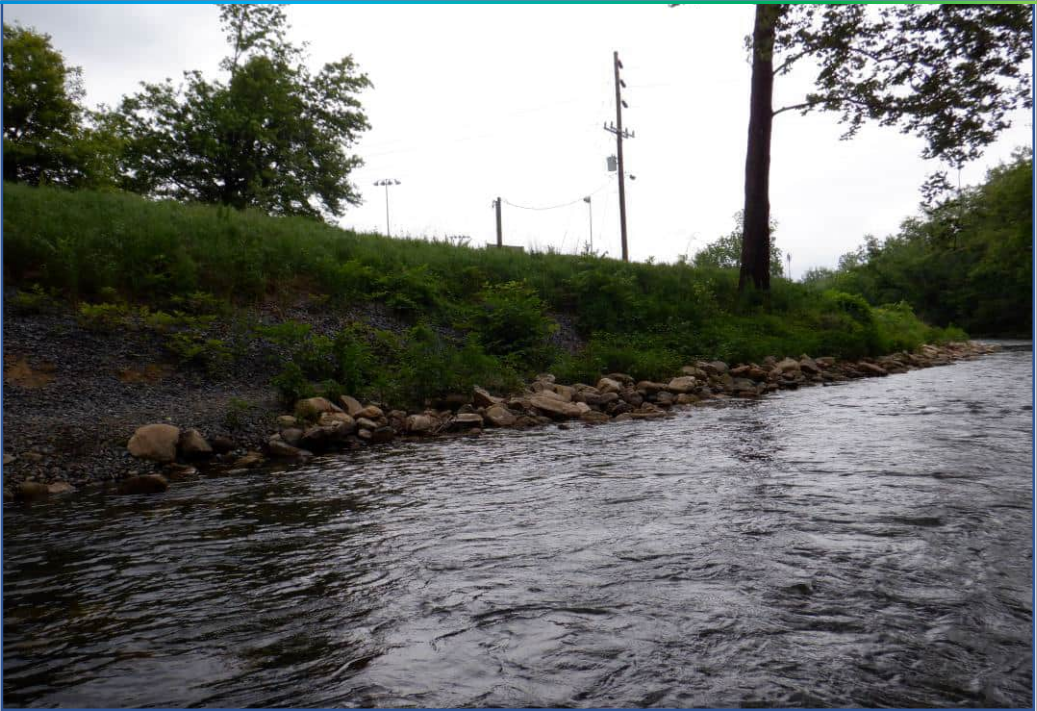
Photo Number: 56		Location: 00+1700'	
Date: 6/7/2022

Direction: East			
Description: Downstream view of remediated bank; path slanted, gravel dust eroded away revealing larger blue gravel, small boulders tumbled into water.

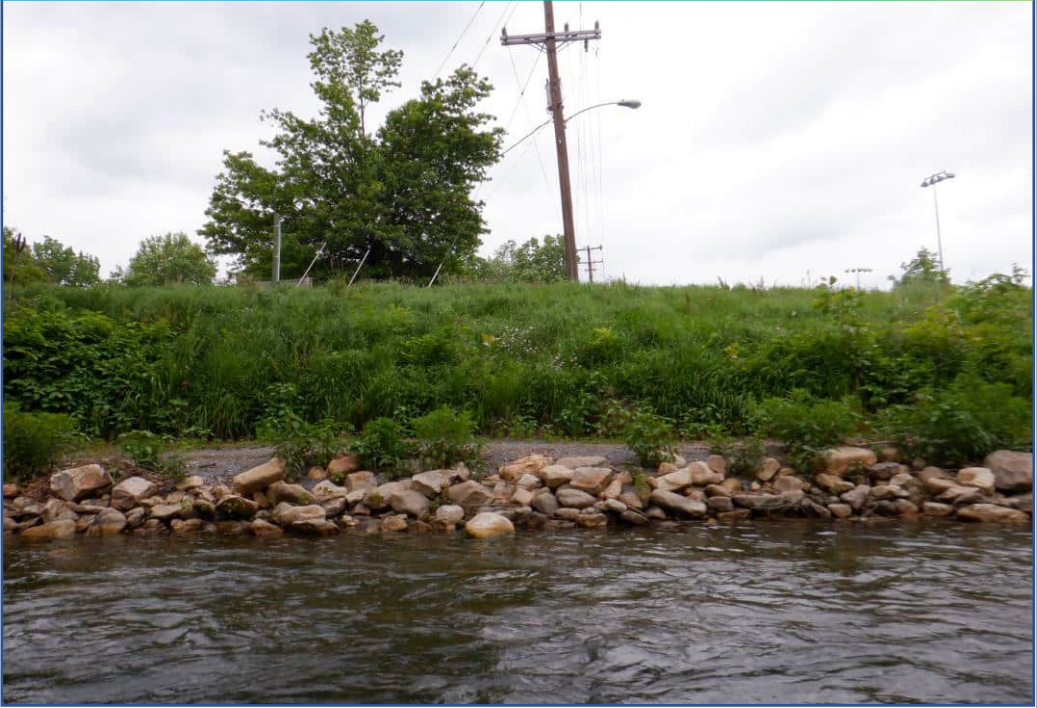
Photo Number: 59		Location: 00+1850'	
Date: 6/7/2022

Direction: North			
Description: ~ 45° bank angle; vegetation 95% cover; no at-risk trees present; rock toe intact; walking path above rock toe, gravel dust visible, small boulders tumbled into water; minimal sediment deposition; boulders tumbled into water.

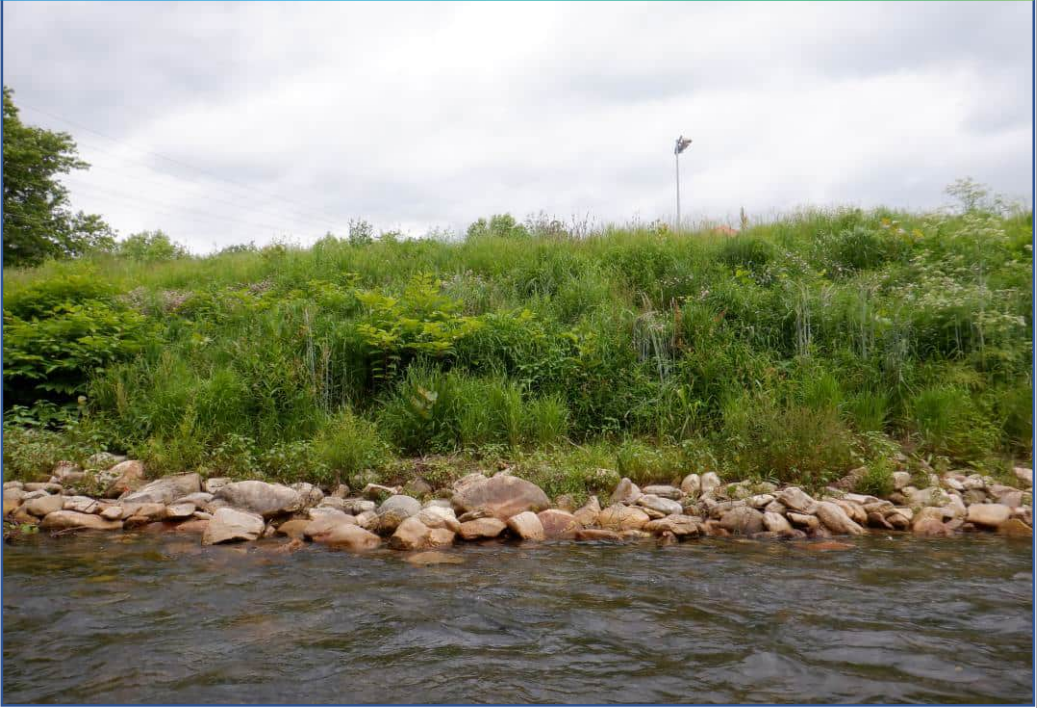
Photo Number: 63		Location: 00+1950'
Date: 6/7/2022

Direction: North		
Description: ~ 70° bank angle; vegetation 95% cover; concrete outfall pipe above rock toe intact; rock toe intact; minimal sediment deposition.

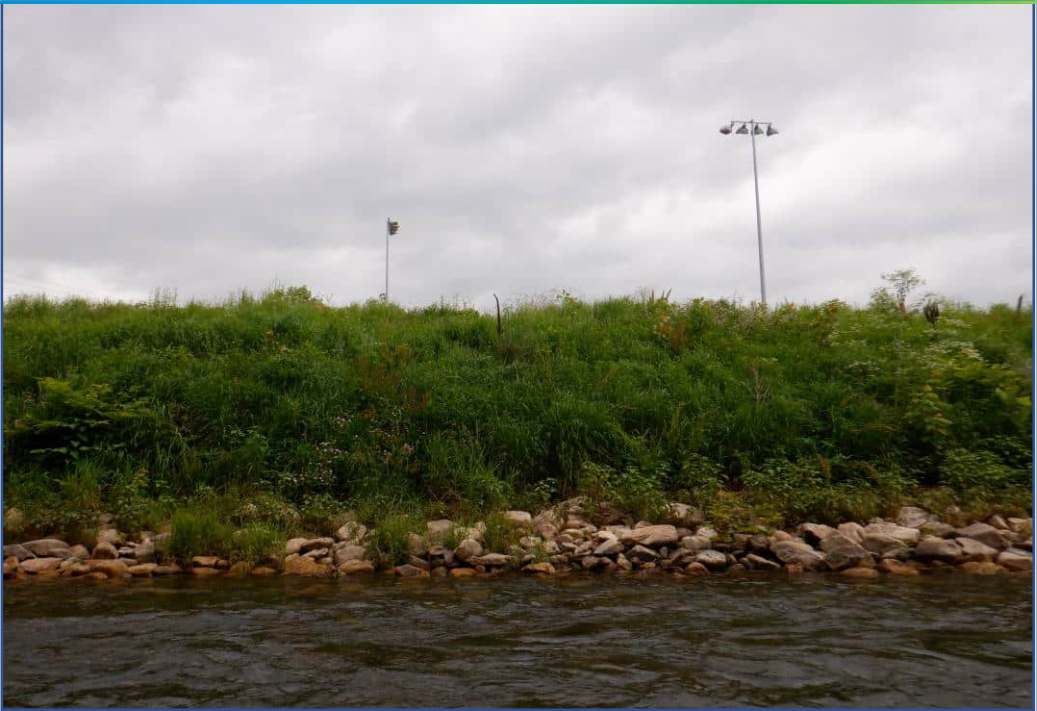
Photo Number: 64		Location: 00+2000'
Date: 6/7/2022

Direction: North		
Description: ~ 75° bank angle; vegetation 95% cover; rock toe intact; minimal sediment deposition.

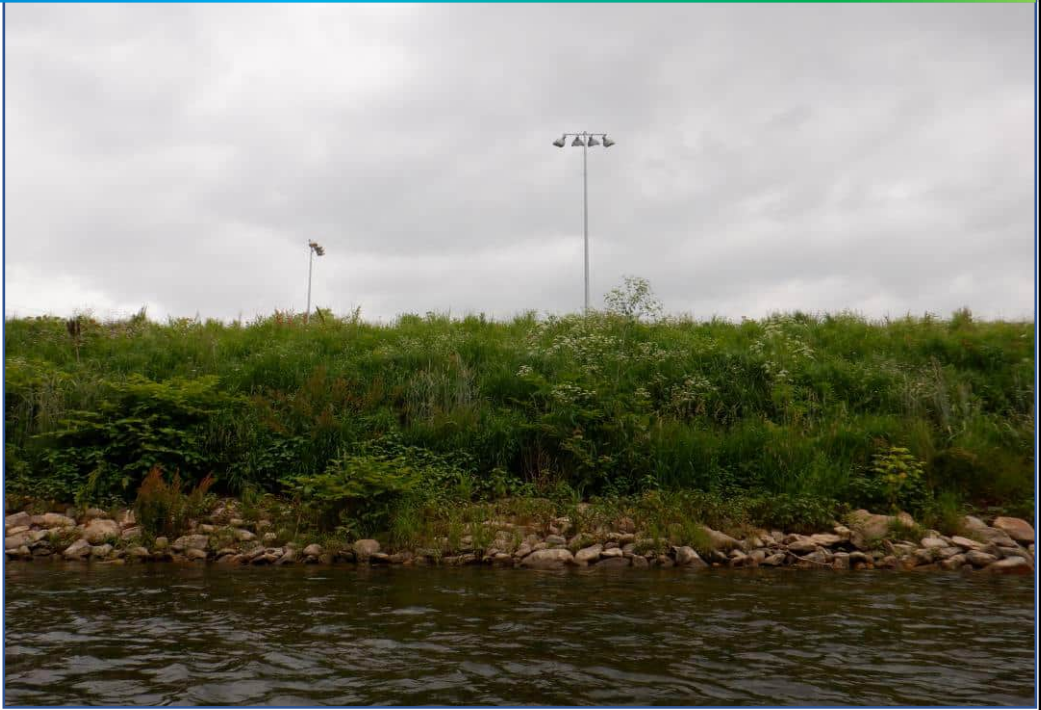
Photo Number: 65		Location: 00+2050'	
Date: 6/7/2022

Direction: North			
Description: ~ 60° bank angle; vegetation 95% cover; rock toe intact; minimal sediment deposition.

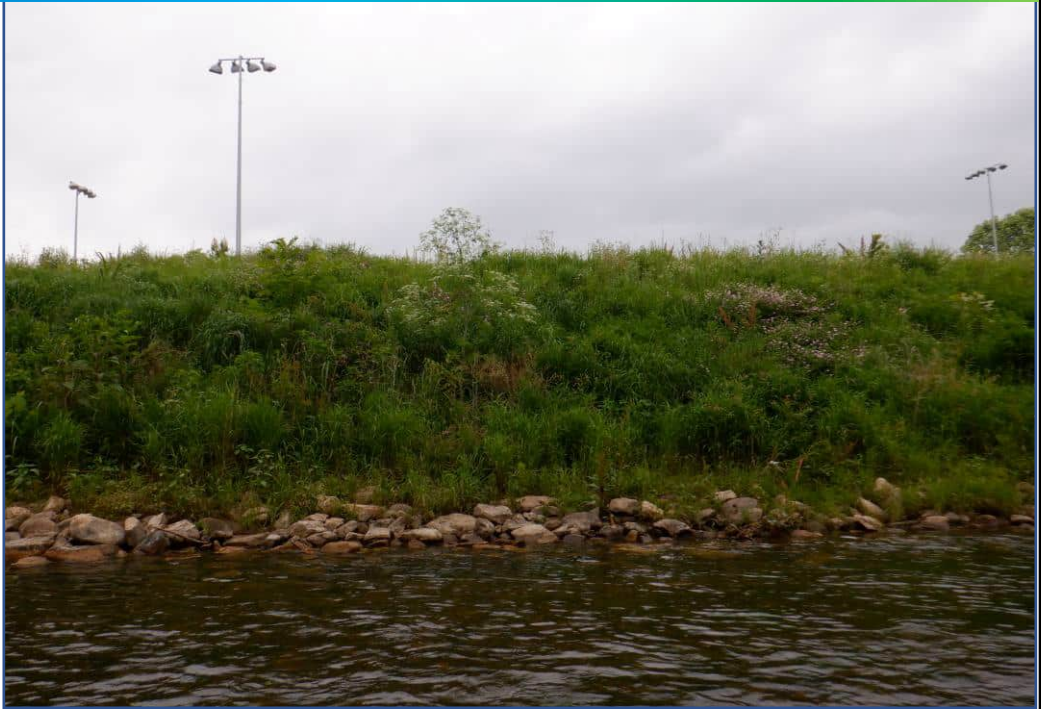
Photo Number: 66		Location: 00+2100'	
Date: 6/7/2022

Direction: North			
Description: ~ 70° bank angle; vegetation 95% cover; rock toe intact; minimal sediment deposition.

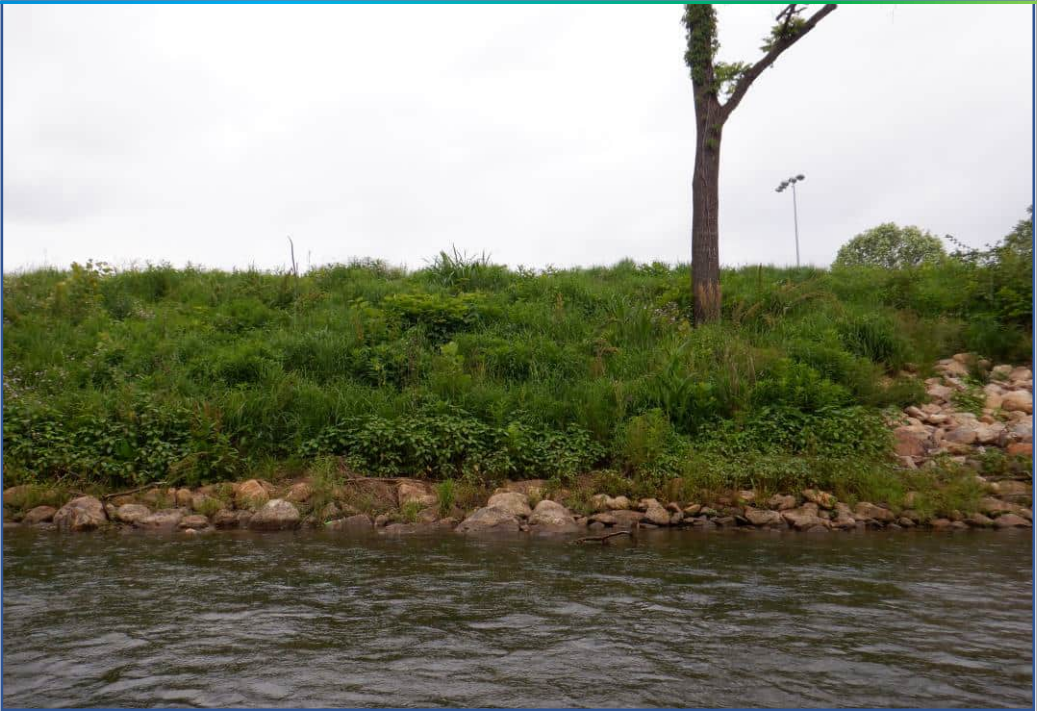
Photo Number: 68		Location: 00+2200'	
Date: 6/7/2022

Direction: Northwest			
Description: ~ 60° bank angle; vegetation 95% cover; one tree mid bank in good condition; rock toe intact; minimal sediment deposition.

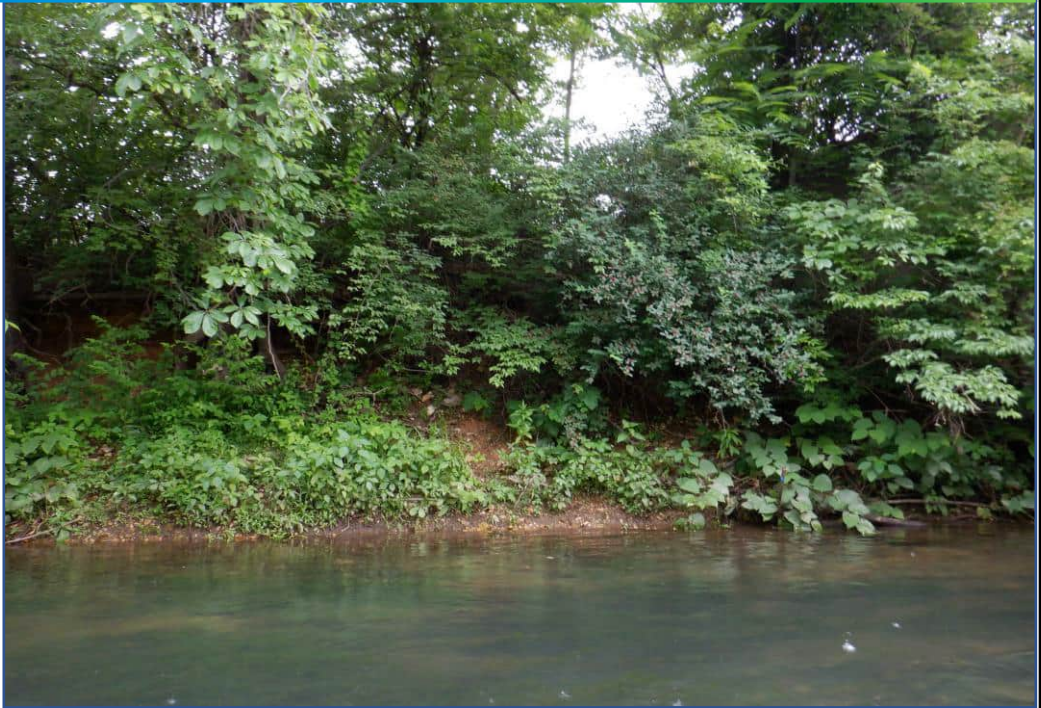
Photo Number: 75	Location: 00+2380'
Date: 6/7/2022

Direction: North	
Description: ~ 65° bank angle; woody vegetation throughout bank; medium exposed roots mid to lower bank; sparse vegetation; several trees on upper bank in good condition; at-risk elm saplings and ailanthus; roots severely exposed.

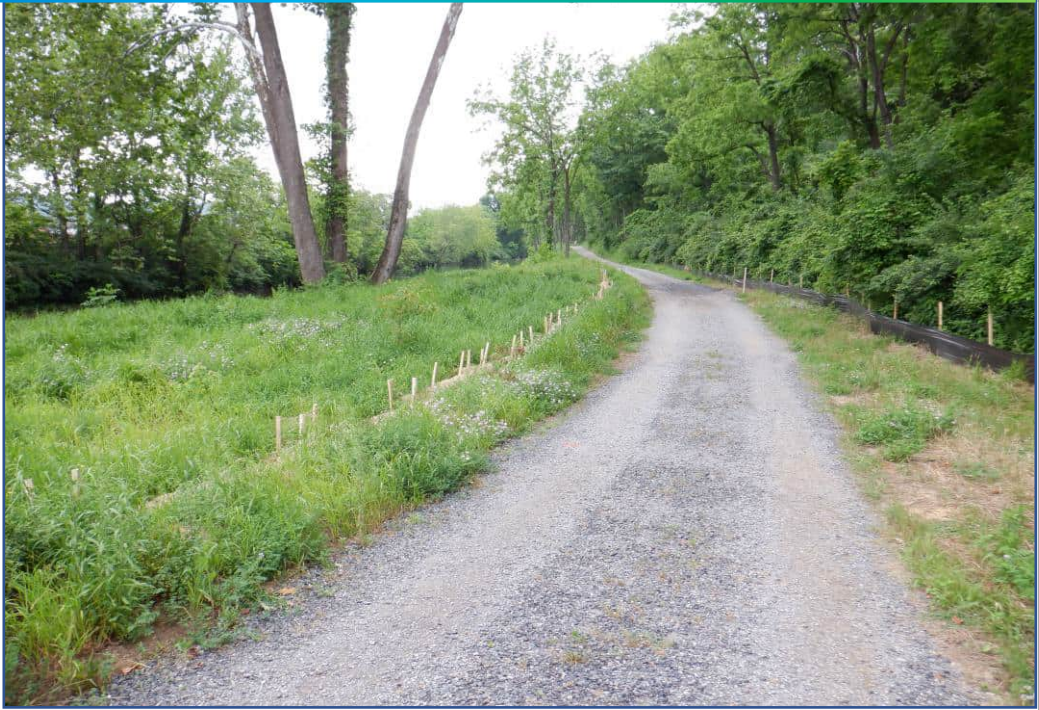
Photo Number: 81	Location: North Park
Date: 6/7/2022

Direction: West	
Description: Greenway above remediated bank in North Park; Greenway intact and ready for pavement; some ruts along GW from vehicles; construction to connect North Park and Shiloh section of GW underway.

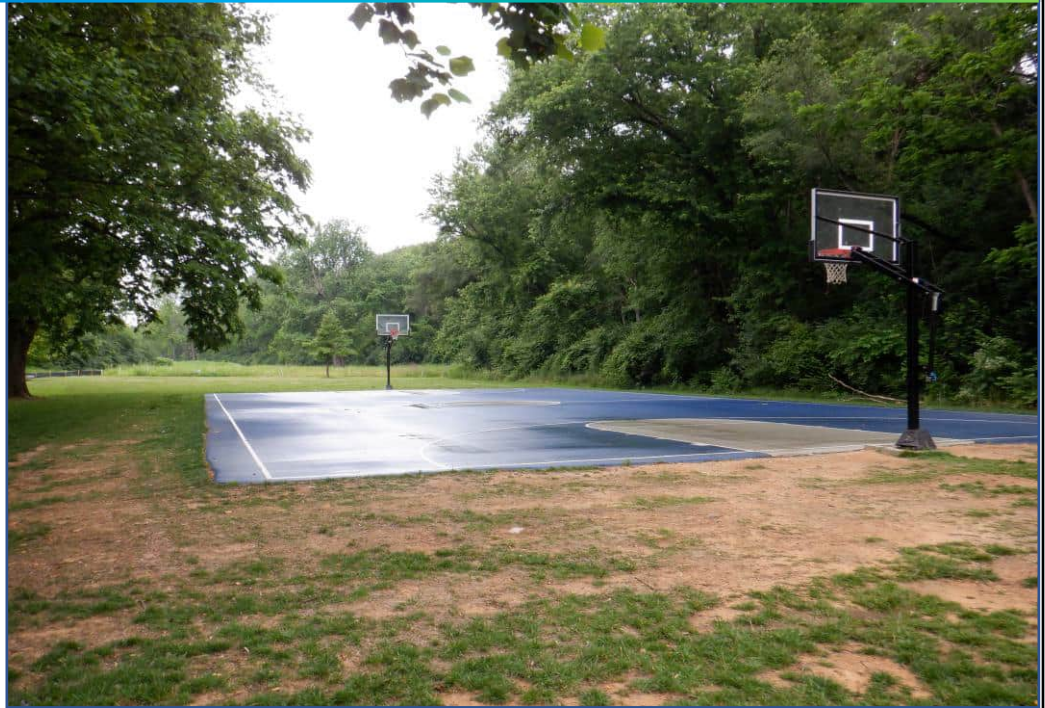
Basketball court in North Park in good condition; bare soil exposed in areas around court.
