RE: 2022 Leaf-off, 2022 Leaf-on and 2023 Leaf-on BMA Inspection Memos
Former DuPont Waynesboro Site AOC 4
Waynesboro, Virginia
EPA ID# VAD003114832

Subject 2023 Leaf-on Maintenance Inspection
Former DuPont Waynesboro Site, Area of Concern 4

Constitution Park BMA 2023 Leaf-on Inspection

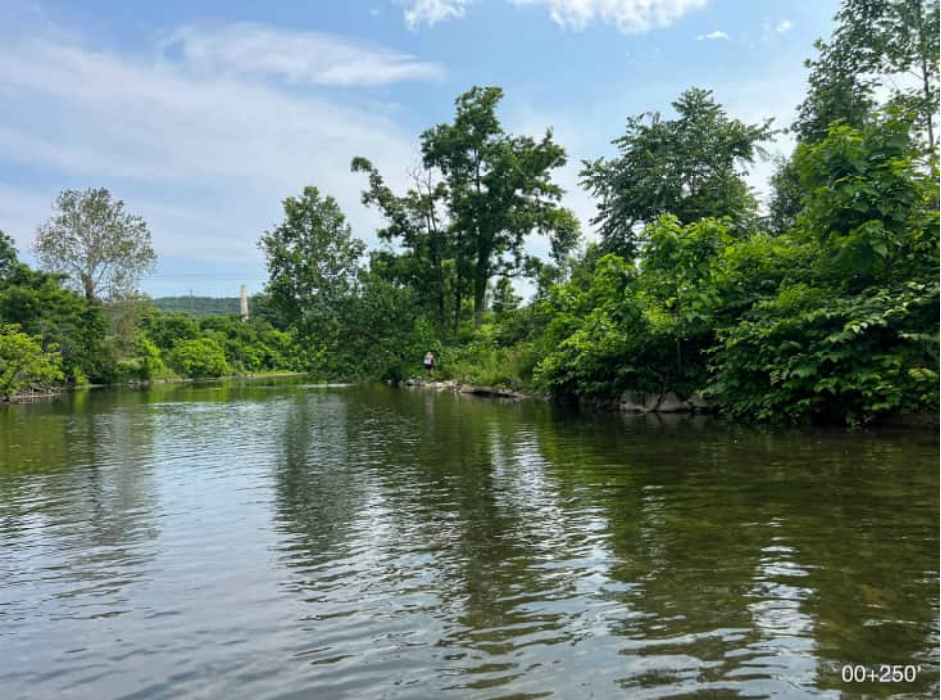
Photo Number: 14	Location: 00 + 250'
Date: 6/5/2023

Direction: West	
Description: Upstream view of remediated bank

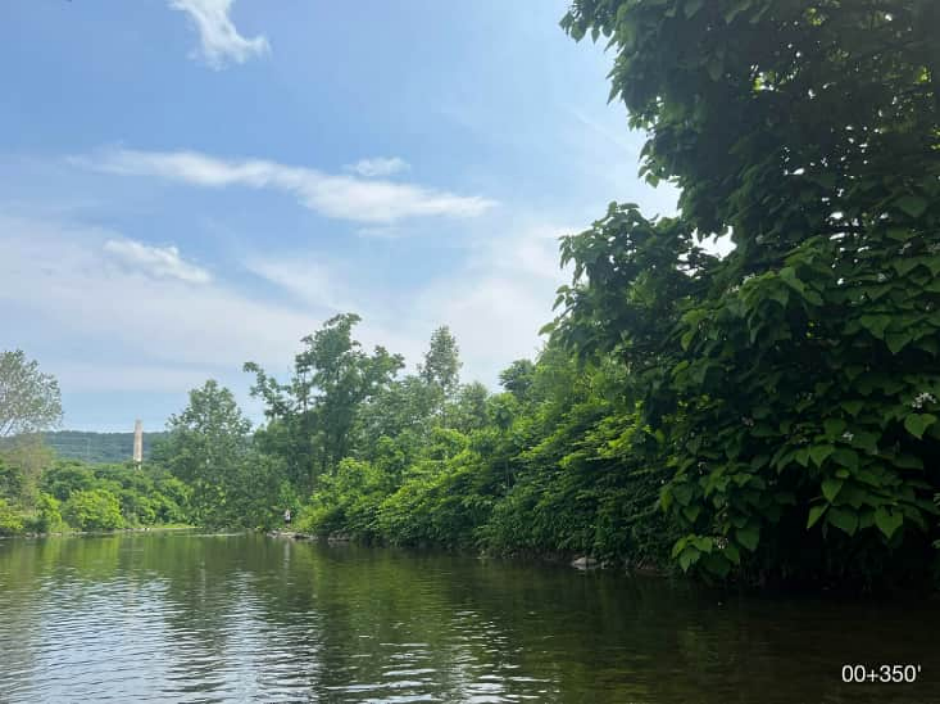
Photo Number: 17	Location: 00 + 350'
Date: 6/5/2023

<p>00+350'</p>
Direction: West	
Description: Upstream view of remediated bank

- Recommended herbicide treatment of Japanese knotweed in late summer/early fall.
- Recommended stabilization of eroded and undercut geocell at 00+350'.

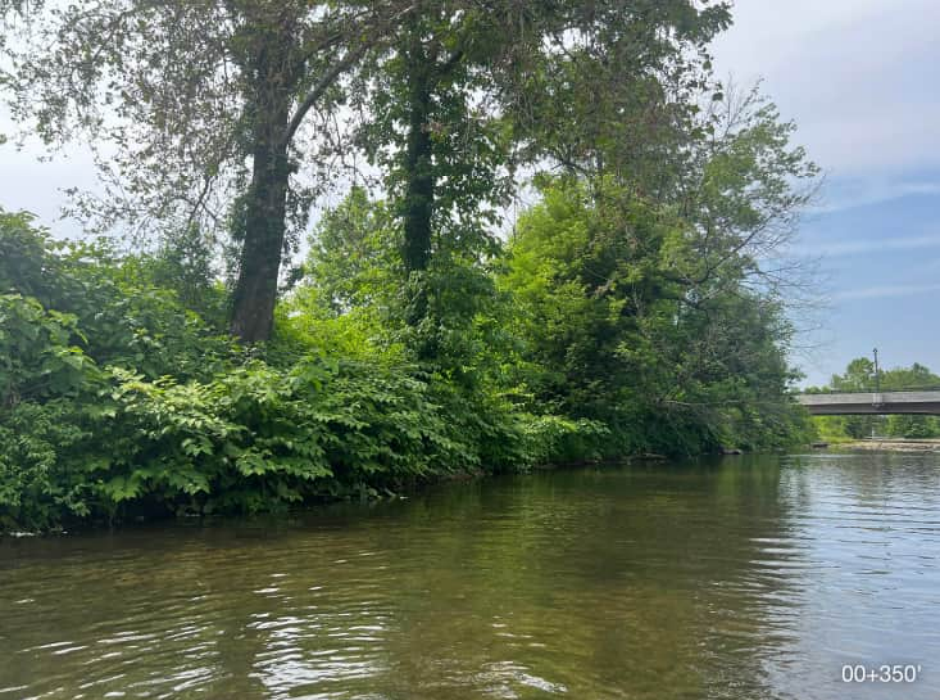
Photo Number: 18	Location: 00 + 350'
Date: 6/5/2023

<p>00+350'</p>
Direction: Northwest	
Description: Downstream view of remediated bank (Main St. bridge to right of picture in the distance)

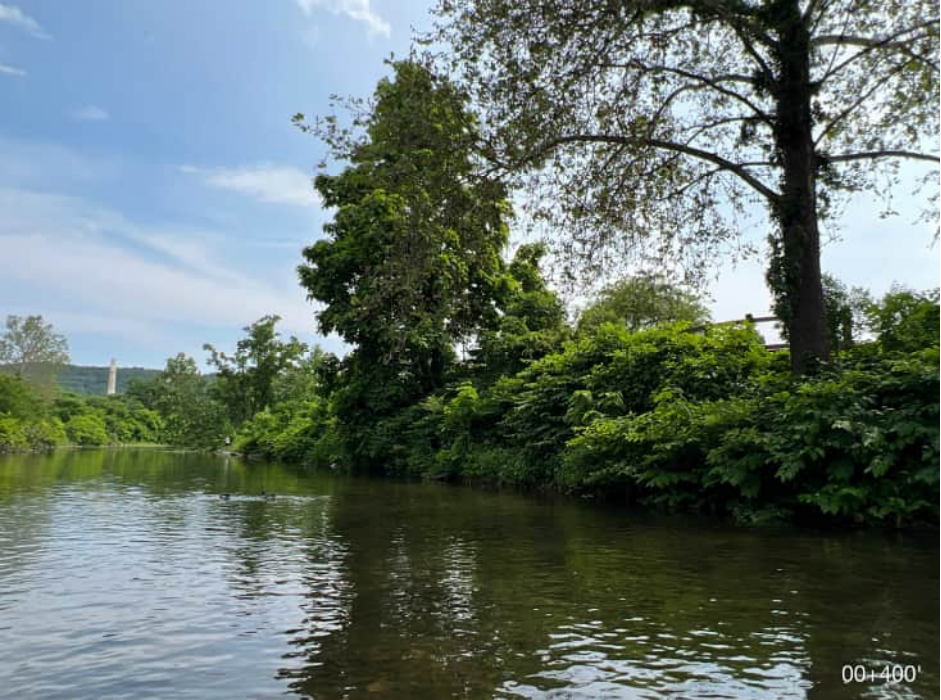
Photo Number: 20	Location: 00 + 400'
Date: 6/5/2023

Direction: Southwest	
Description: Upstream view of remediated bank with smokestack of former DuPont facility in the distance

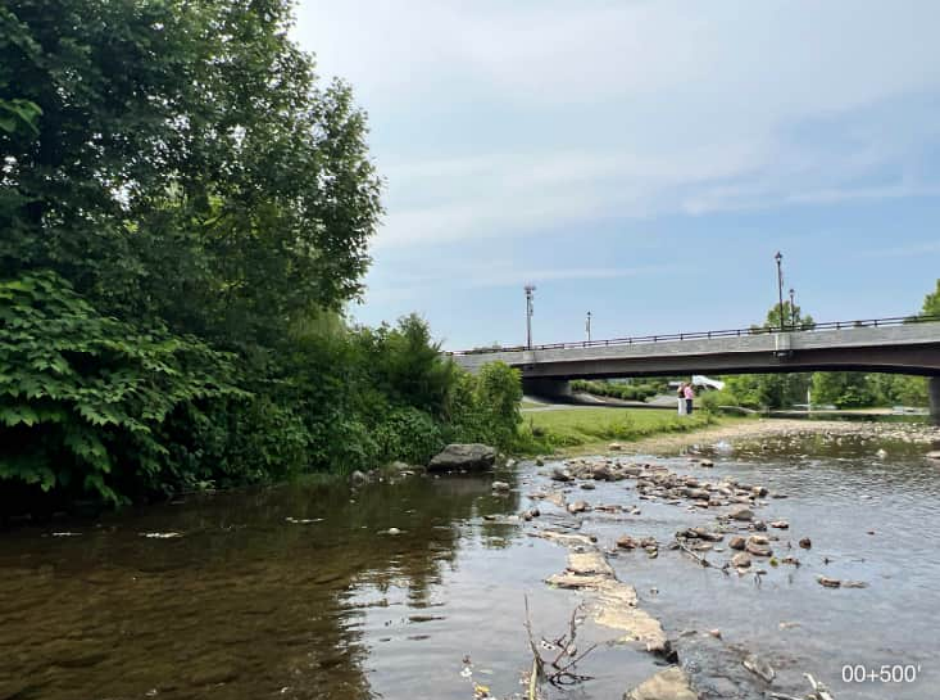
Photo Number: 24	Location: 00 + 500'
Date: 6/5/2023

Direction: Northwest	
Description: Downstream view from end of remediated bank; no trees or vegetation adjacent to water after remediated section

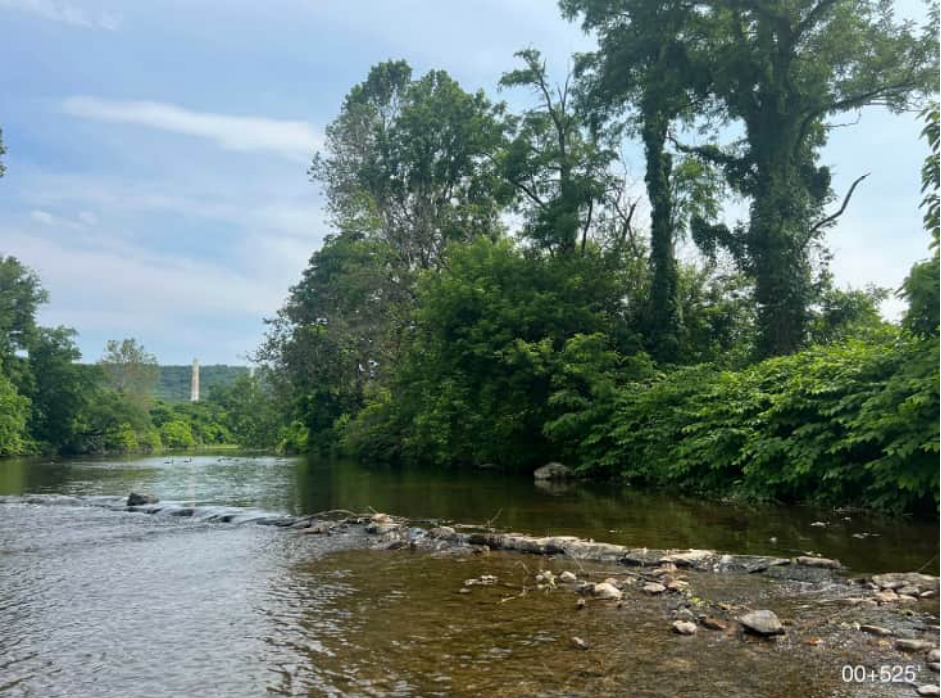
Photo Number: 26	Location: 00 + 525'
Date: 6/5/2023

Direction: South	
Description: Upstream view from the end of the remediated section

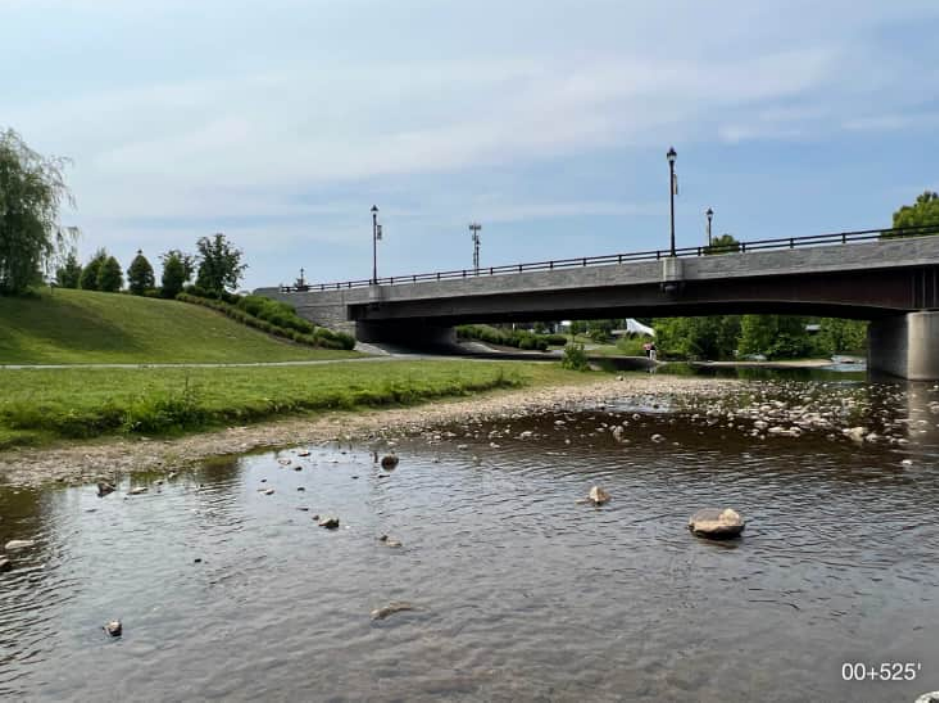
Photo Number: 27	Location: 00 + 525'
Date: 6/5/2023

Direction: Northwest	
Description:	
Downstream view looking toward Main St. bridge from end of remediated bank Greenway path, grass, and depositional bar remain in good condition

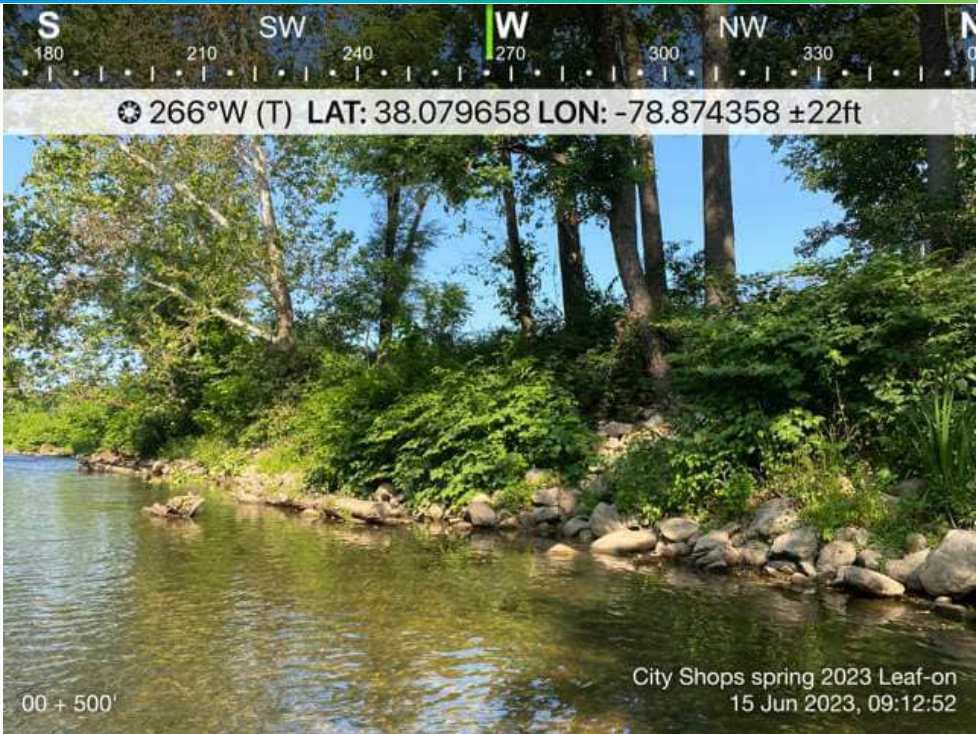
Photo Number: 23	Location: 00 + 500'
Date: 6/15/2023

Direction: West	
Description: Upstream view of remediated bank from end of first remediated section	
00 + 500' City Shops spring 2023 Leaf-on 15 Jun 2023, 09:12:52

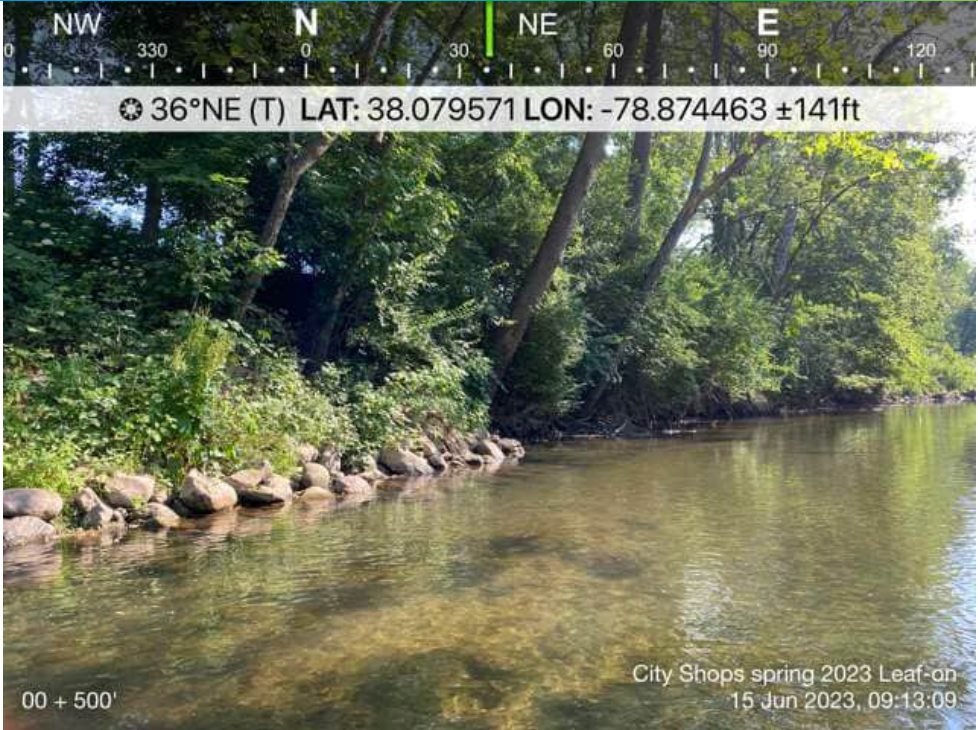
Photo Number: 24	Location: 00 + 500'
Date: 6/15/2023

Direction: Northeast	
Description: Downstream view of non-remediated bank from end of first remediated section	
00 + 500' City Shops spring 2023 Leaf-on 15 Jun 2023, 09:13:09

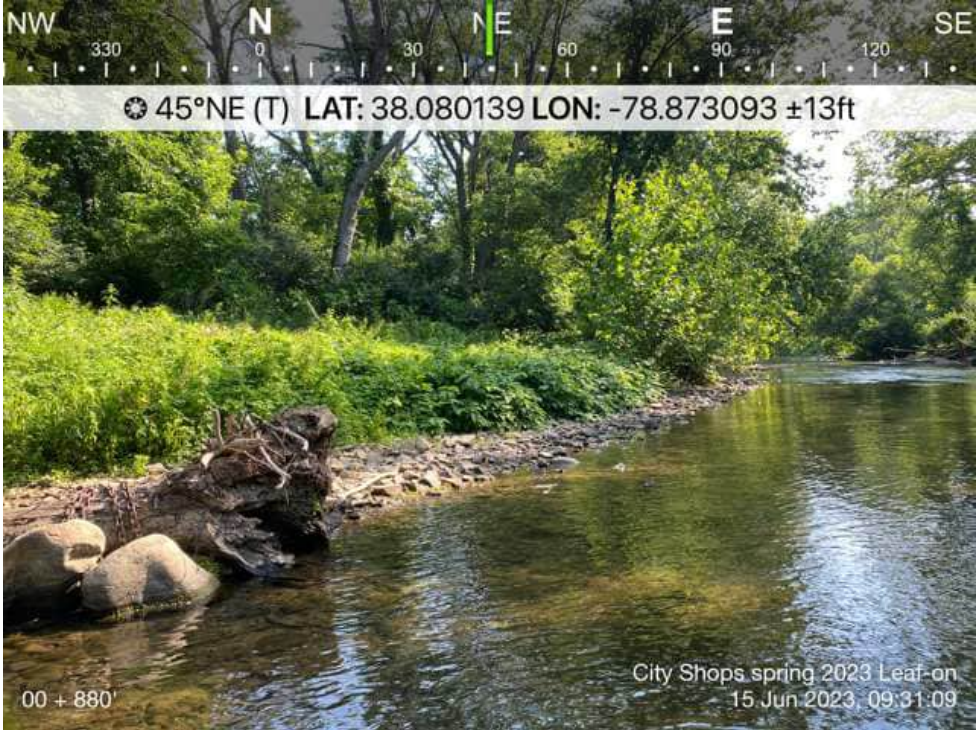
Photo Number: 39	Location: 00 + 880'
Date: 6/15/2023

Direction: Northeast	
Description: Downstream view of non-remediated bank	
	00 + 880' City Shops spring 2023 Leaf-on 15 Jun 2023, 09:31:09

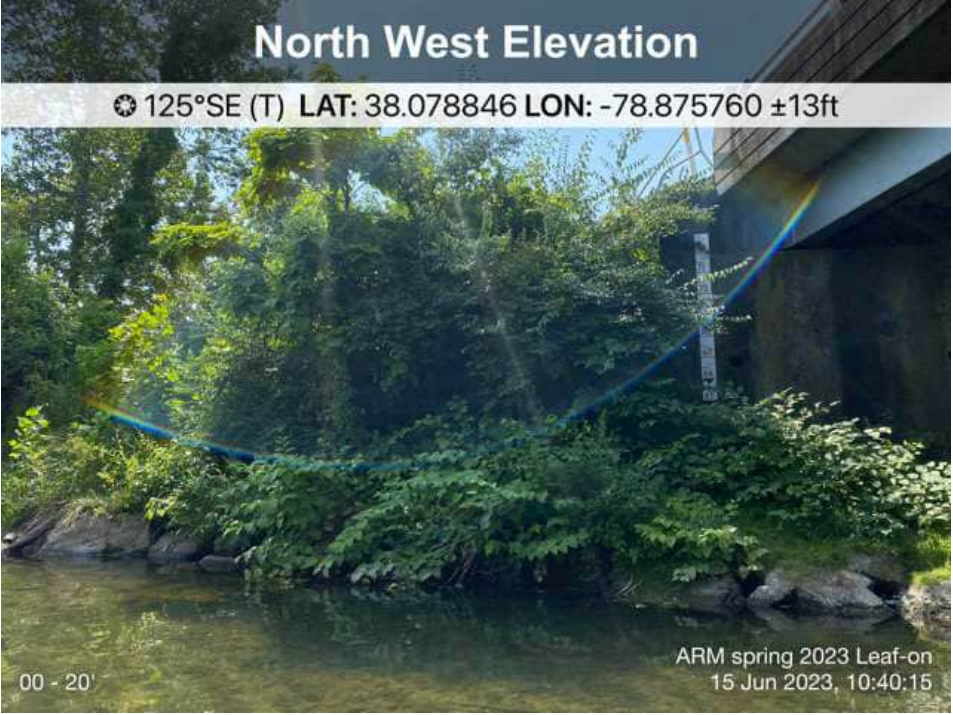
Photo Number: 1		Location: 00 – 20'	
Date: 6/15/2023

Direction: Southeast	☉ 125°SE (T) LAT: 38.078846 LON: -78.875760 ±13ft		
Description: ~20° bank angle; Non-remediated section directly upstream of remediation (2 nd St. bridge pictured) Invasive knotweed 50% cover; no fabric or geocell installed; Some scour associated with foot traffic along bank	ARM spring 2023 Leaf-on 15 Jun 2023, 10:40:15

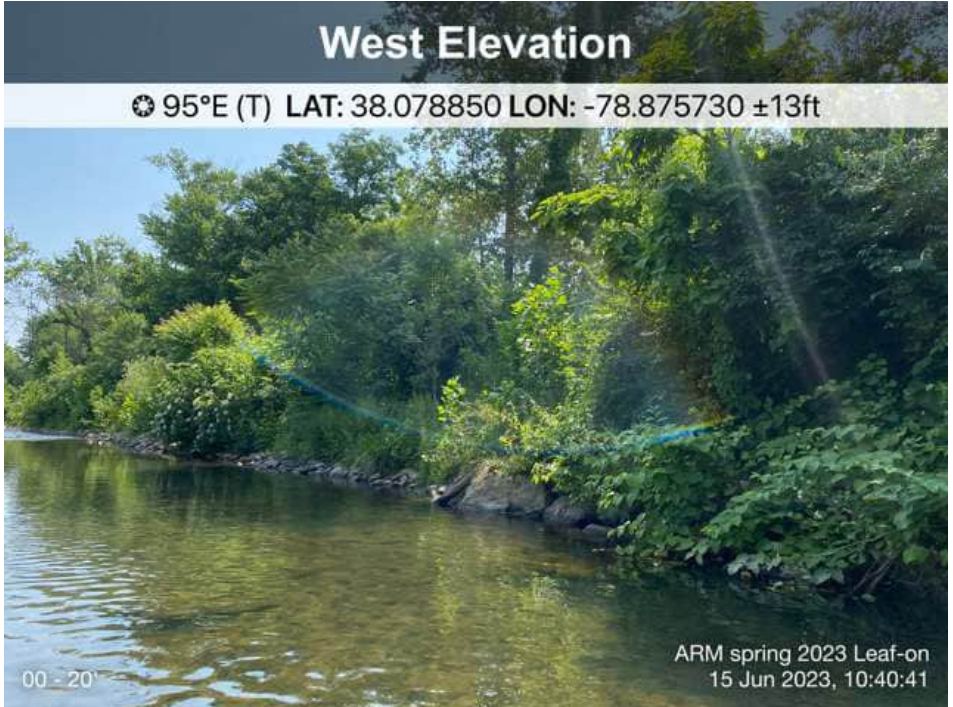
Photo Number: 2		Location: 00 – 20'	
Date: 6/15/2023

Direction: East	☉ 95°E (T) LAT: 38.078850 LON: -78.875730 ±13ft		
Description: Downstream view from non-remediated section under 2 nd St. overpass	ARM spring 2023 Leaf-on 15 Jun 2023, 10:40:41

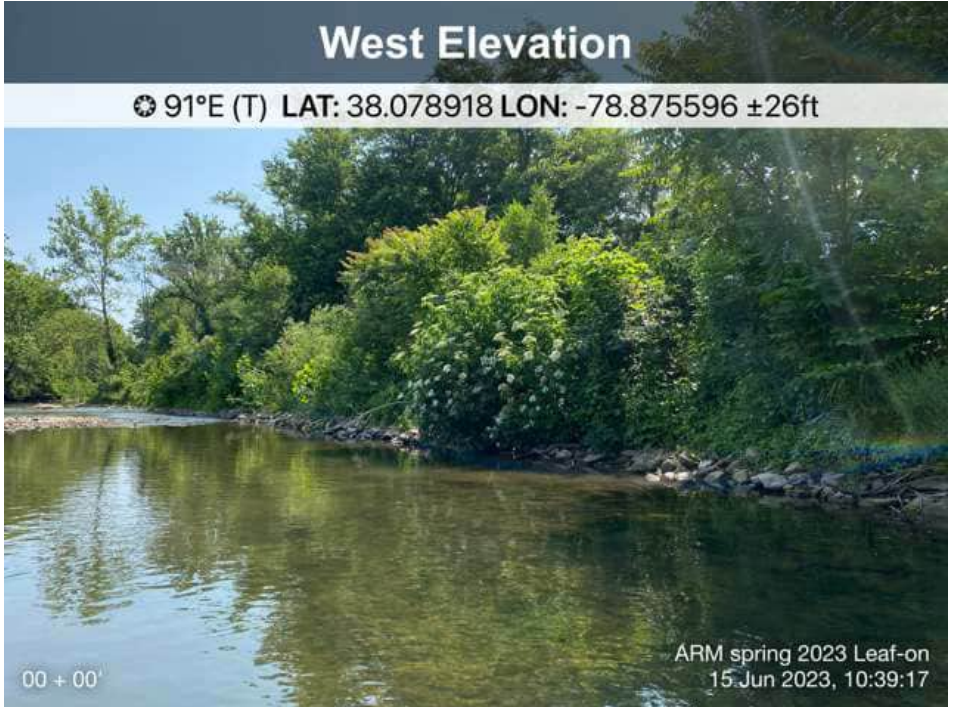
Photo Number: 4		Location: 00 + 00'	
Date: 6/15/2023

Direction: East	☉ 91°E (T) LAT: 38.078918 LON: -78.875596 ±26ft		
Description: Downstream view from beginning of remediated area	ARM spring 2023 Leaf-on 15 Jun 2023, 10:39:17

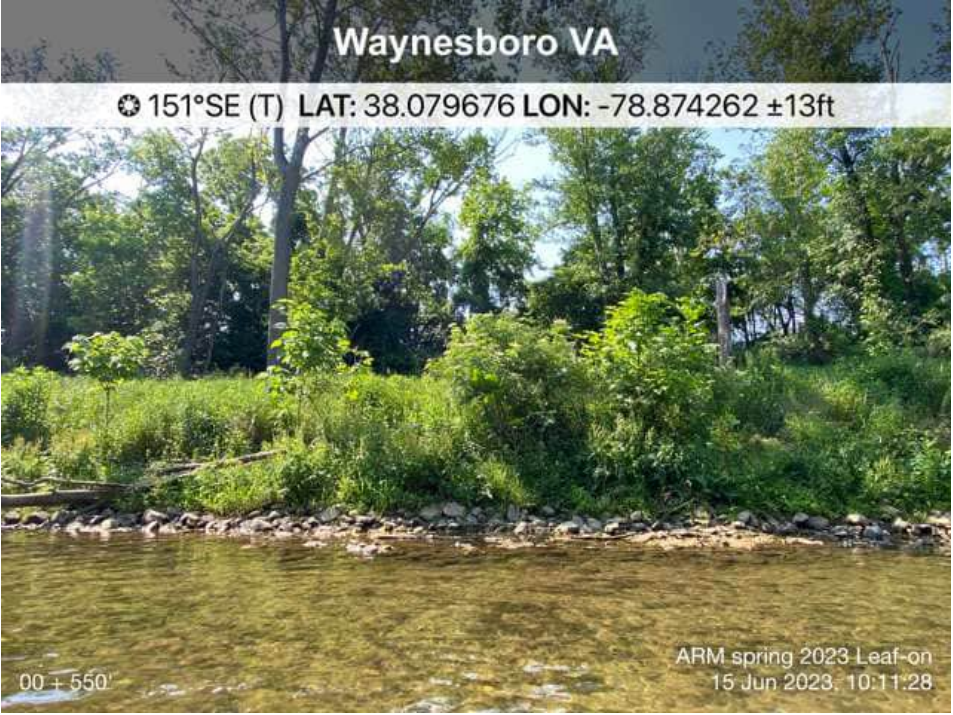
Photo Number: 21	Location: 00 + 550'
Date: 6/15/2023

Direction: Southeast	
Description: Lower bank ~30° Upper bank ~50° Native herbaceous vegetation fully established, grasses covering ~90%; no at-risk trees present; rock toe intact with sand deposition observed

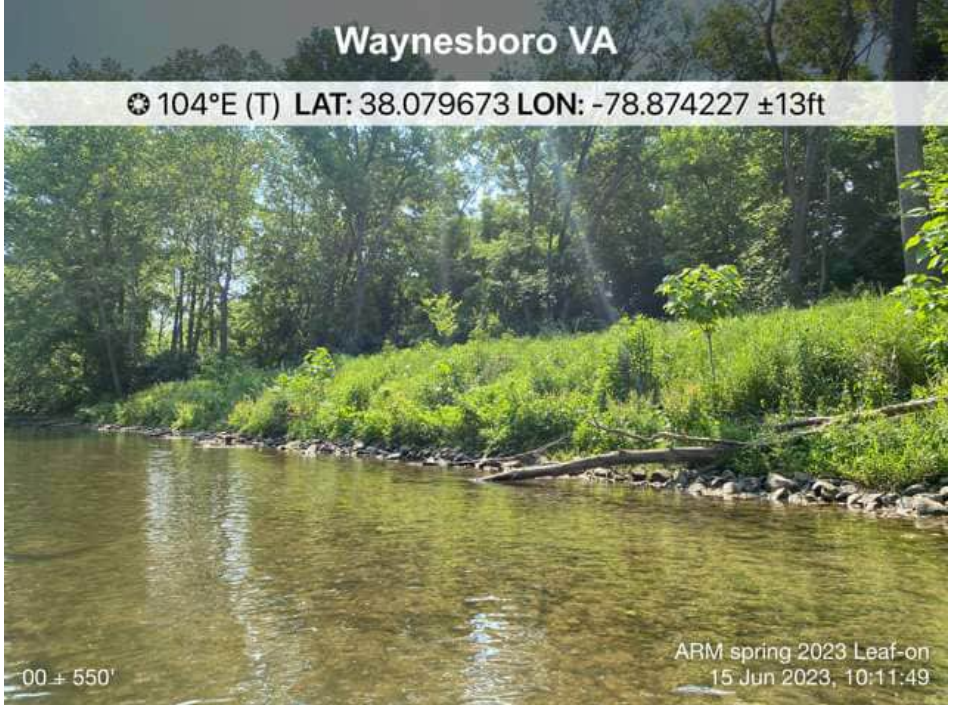
Photo Number: 22	Location: 00 + 550'
Date: 6/15/2023

Direction: East	
Description: Downstream view of remediated bank

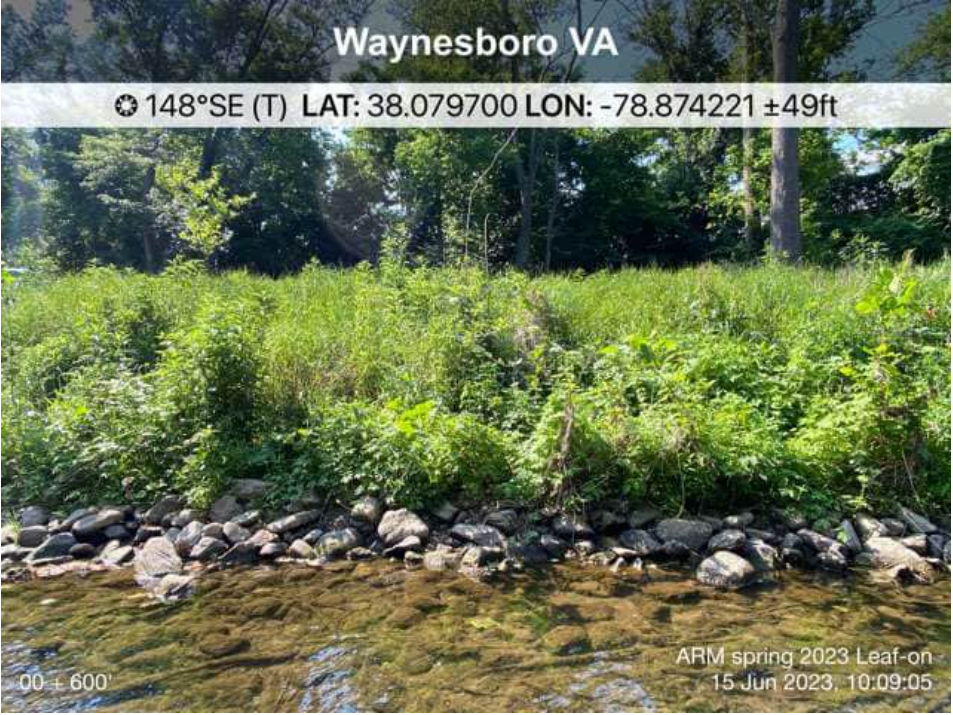
Photo Number: 23	Location: 00 + 600'
Date: 6/15/2023

Direction: Southeast	
Description: Lower bank ~30° Upper bank ~45° Native herbaceous vegetation fully established; no at-risk trees present; rock toe intact; sand deposition at toe of bank

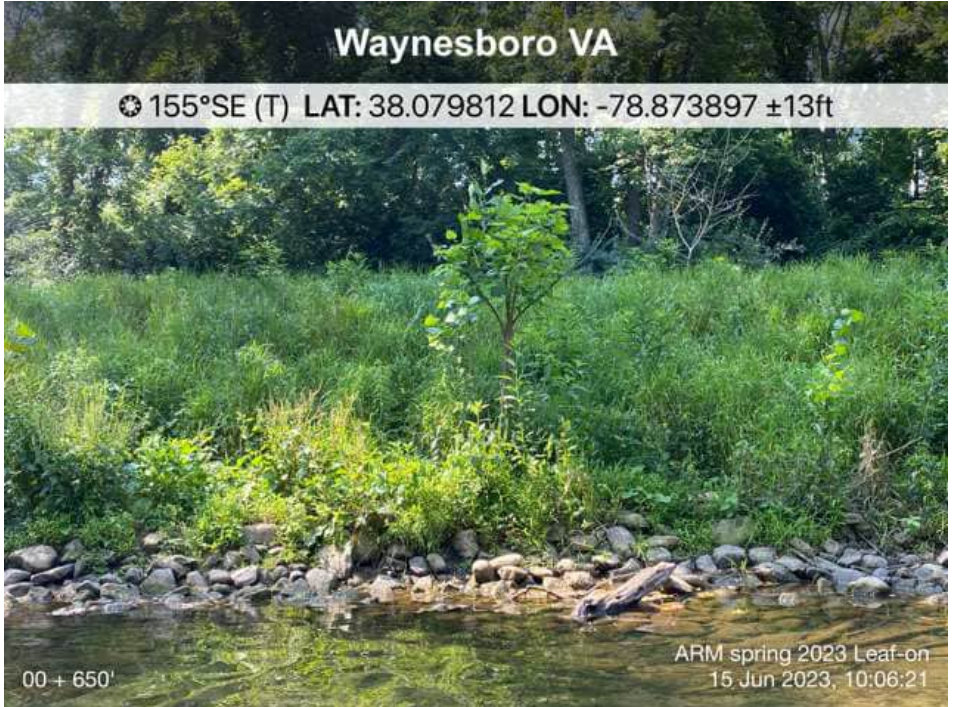
Photo Number: 24	Location: 00 + 650'
Date: 6/15/2023

Direction: Southeast	
Description: Lower bank ~30° Upper bank ~45° Native herbaceous vegetation fully established; no at-risk trees present; rock toe intact; sand deposition at toe of bank

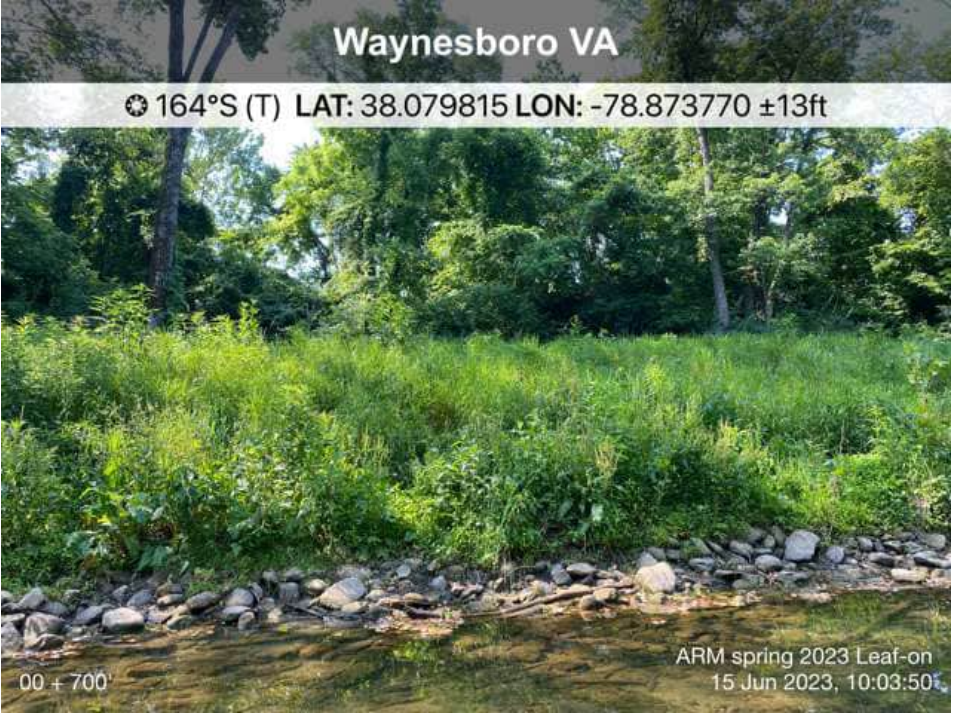
Photo Number: 25	Location: 00 + 700'
Date: 6/15/2023

<p>Waynesboro VA 164°S (T) LAT: 38.079815 LON: -78.873770 ±13ft</p> <p>ARM spring 2023 Leaf-on 15 Jun 2023, 10:03:50</p>
Direction: South	
Description: Lower bank ~30° Upper bank ~45° Native herbaceous vegetation fully established; no at-risk trees present; rock toe intact; sediment deposition in rock toe

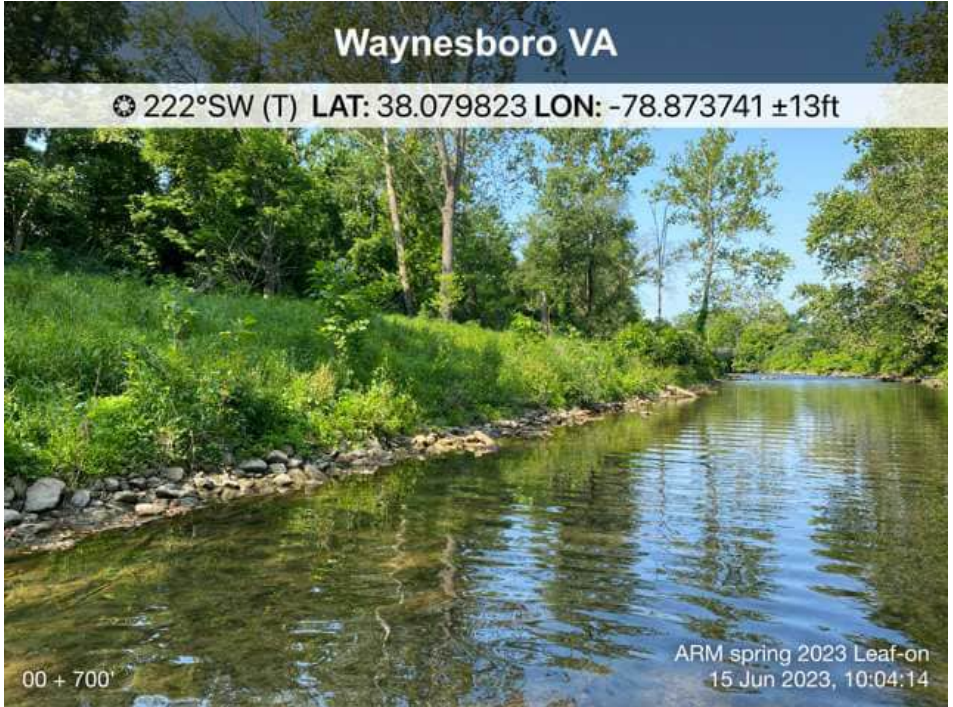
Photo Number: 26	Location: 00 + 700'
Date: 6/15/2023

<p>Waynesboro VA 222°SW (T) LAT: 38.079823 LON: -78.873741 ±13ft</p> <p>ARM spring 2023 Leaf-on 15 Jun 2023, 10:04:14</p>
Direction: Southwest	
Description: Upstream view of remediated bank

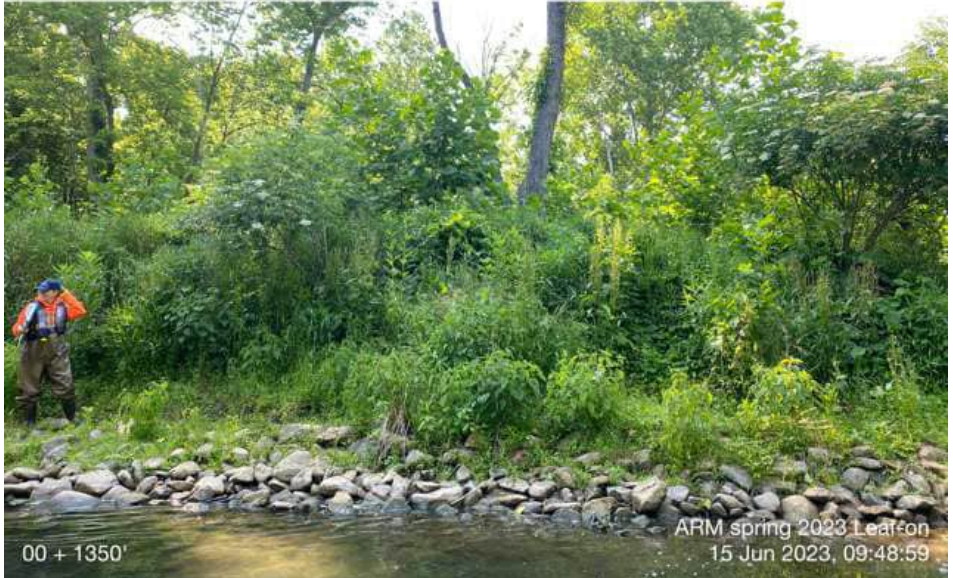
Photo Number: 32	Location: 00 + 1350'
Date: 6/15/2023

Direction: Southeast	
Description: ~50° bank angle; Native herbaceous vegetation fully established; no at-risk trees present; rock toe intact

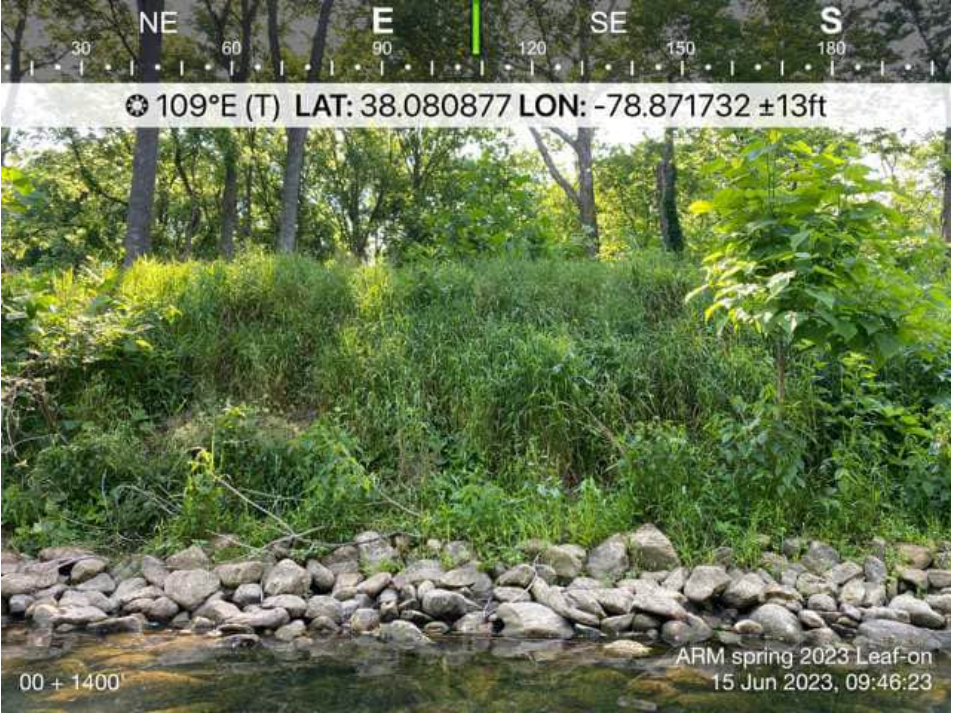
Photo Number: 33	Location: 00 + 1400'
Date: 6/15/2023

Direction: East	
Description: ~50° bank angle Native herbaceous vegetation fully established; no at-risk trees present; rock toe intact

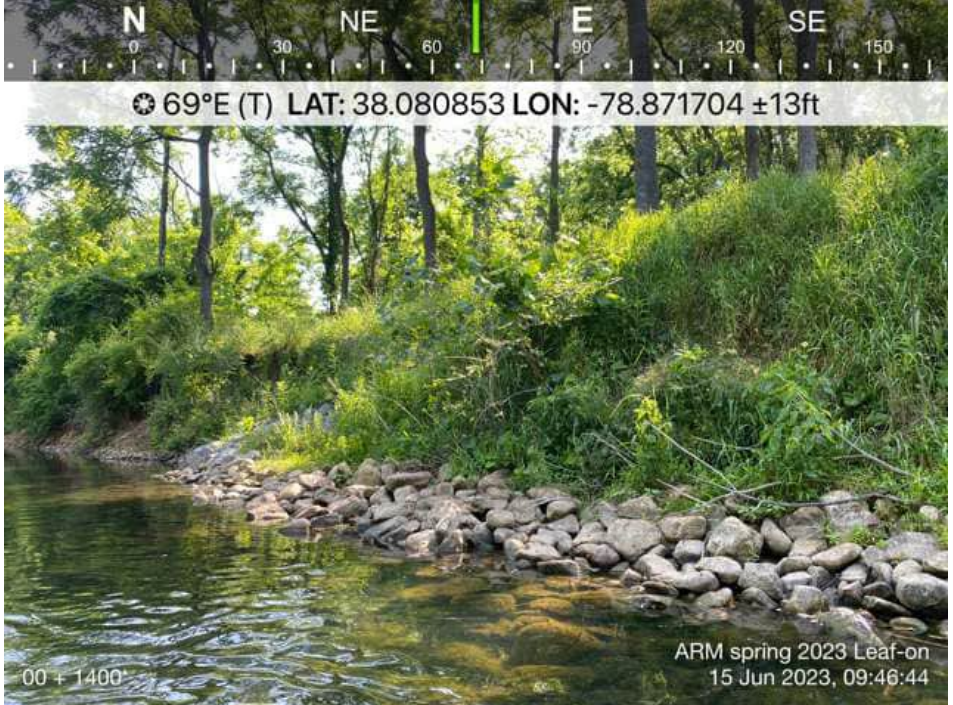
Photo Number: 34	Location: 00 + 1400'
Date: 6/15/2023

Direction: East	
Description: Downstream view of the end of remediated bank and start of non-remediated section

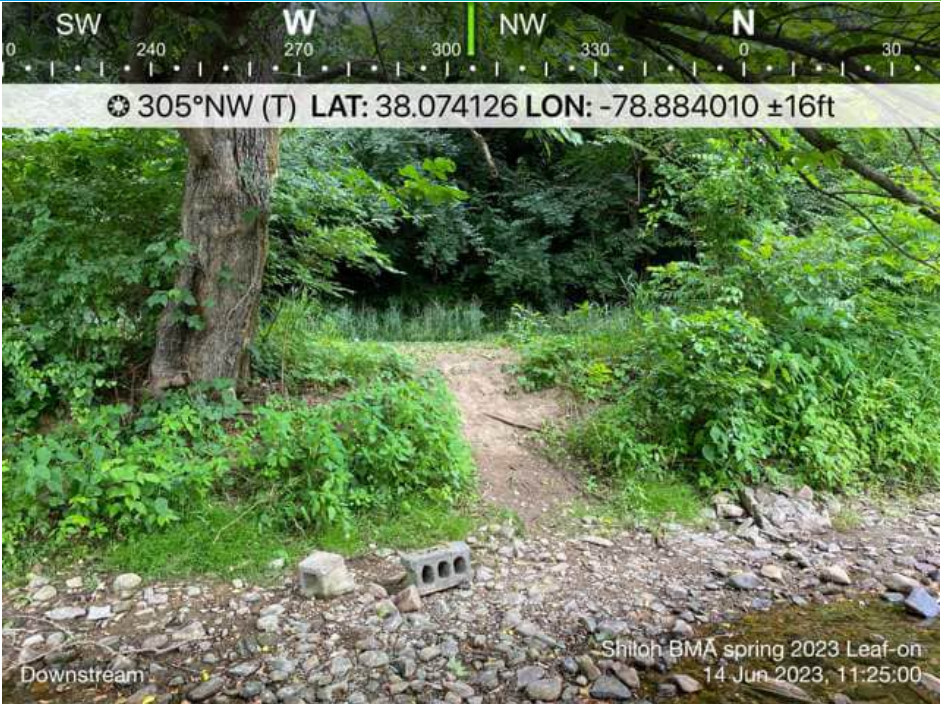
Photo Number: 45	Location: Downstream
Date: 6/14/2023

Direction: Northwest	
Description: Footpath from greenway path to river just downstream of BMA

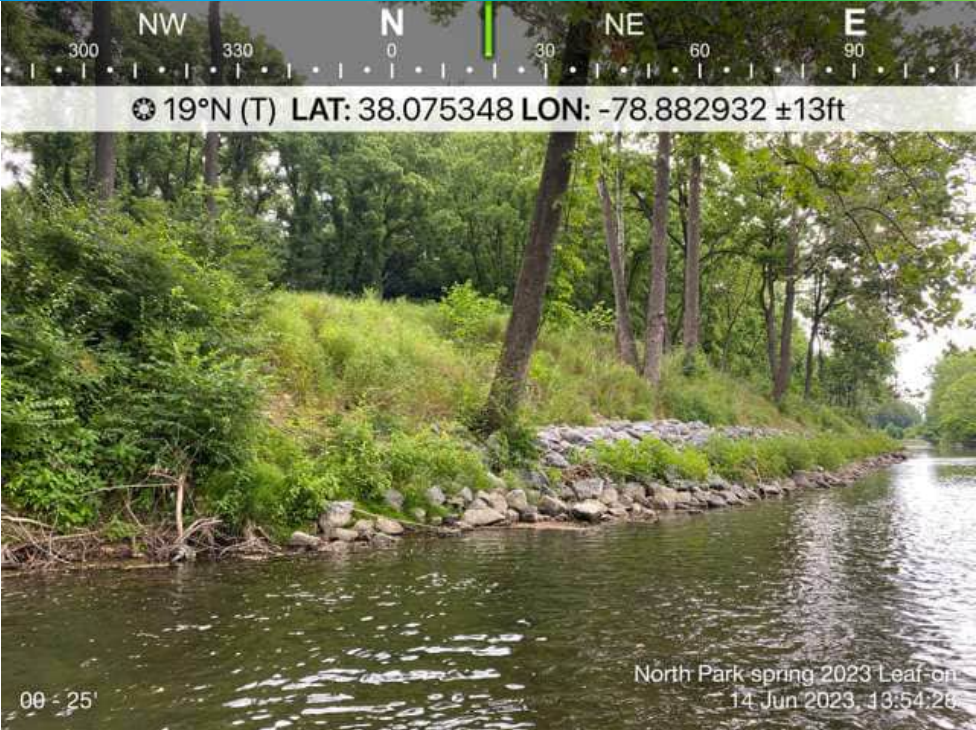
Photo Number: 2	Location: 00 – 25'
Date: 6/14/2023

Direction: North	
Description: Downstream view from start of remediated section

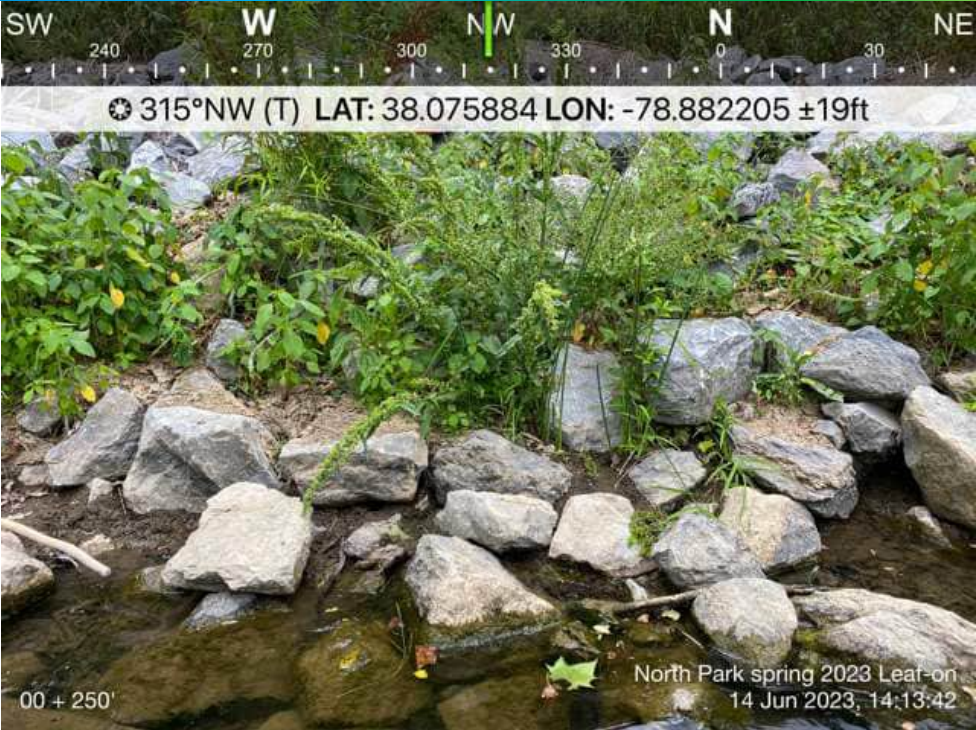
Photo Number: 12	Location: 00 + 250'
Date: 6/14/2023

Direction: Northwest	
Description: View of sediment deposition along rock toe with Jewelweed and other herbaceous vegetation colonizing

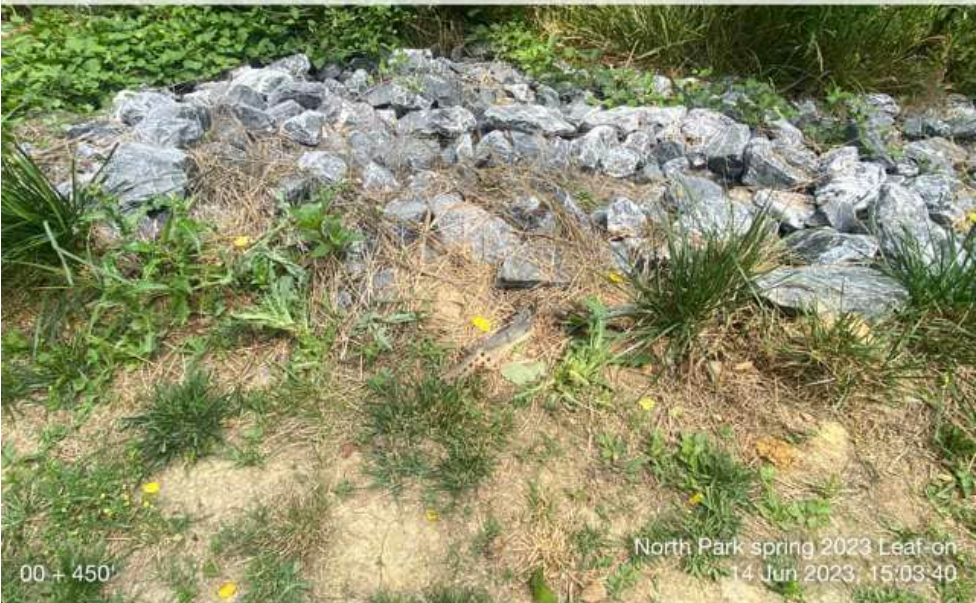
Photo Number: 20	Location: 00 + 450'
Date: 6/14/2023

Direction: Southeast	
Description: Rip rap fortified upper bank with protruding geocell along upper perimeter

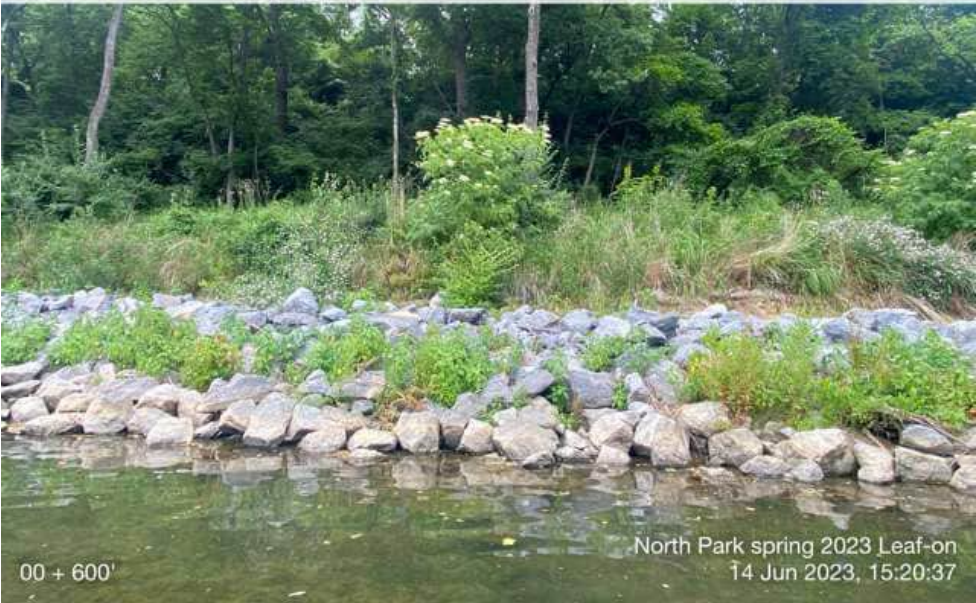
Photo Number: 28	Location: 00 + 650'
Date: 6/14/2023

Direction: Northwest	
<p>Description:</p> <p>~45° lower bank; ~60° upper bank</p> <p>Minimal sediment deposition; geocell slightly exposed; note the difference in color between upper and lower rock toe indicating sediment deposition is occurring</p>

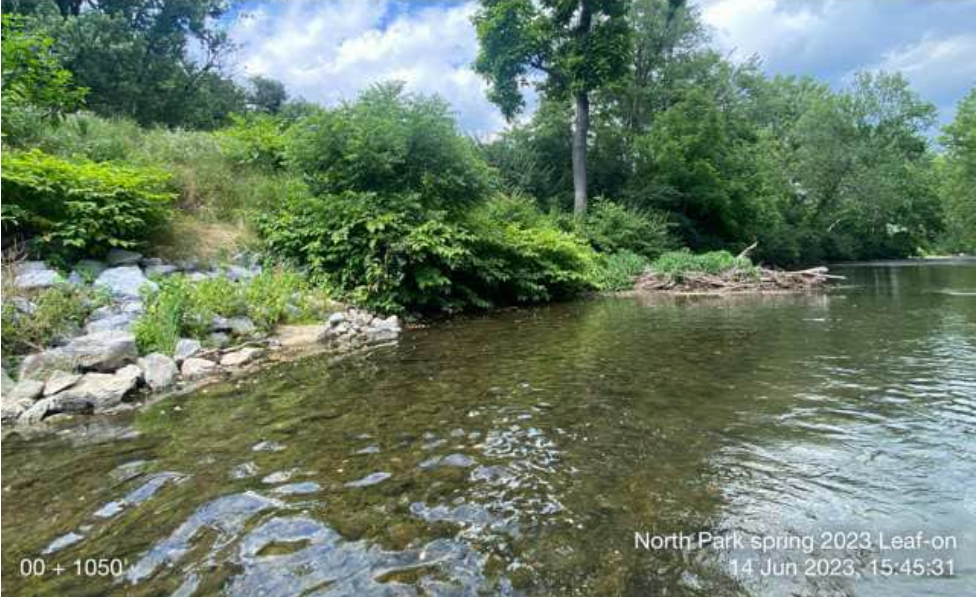
Photo Number: 42	Location: 00 + 1050'
Date: 6/14/2023

Direction: Northeast	☀ 36°NE (T) LAT: 38.077326 LON: -78.880207 ±13ft
Description: Downstream view of non-remediated section from end of first remediated section

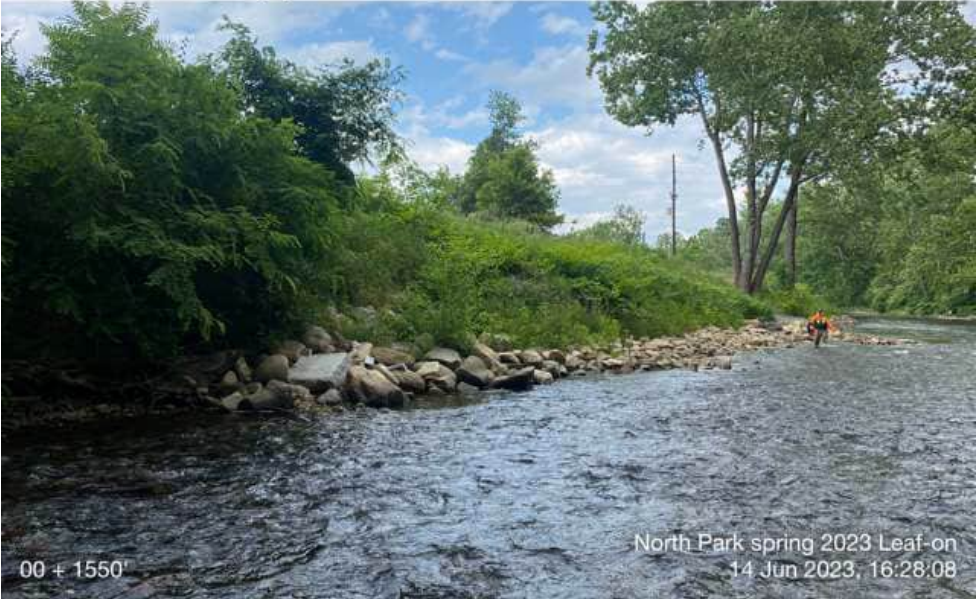
Direction: Northeast

Description: Downstream view of remediated bank from beginning of second remediated section	00 + 1550' North Park spring 2023 Leaf-on 14 Jun 2023, 16:28:08

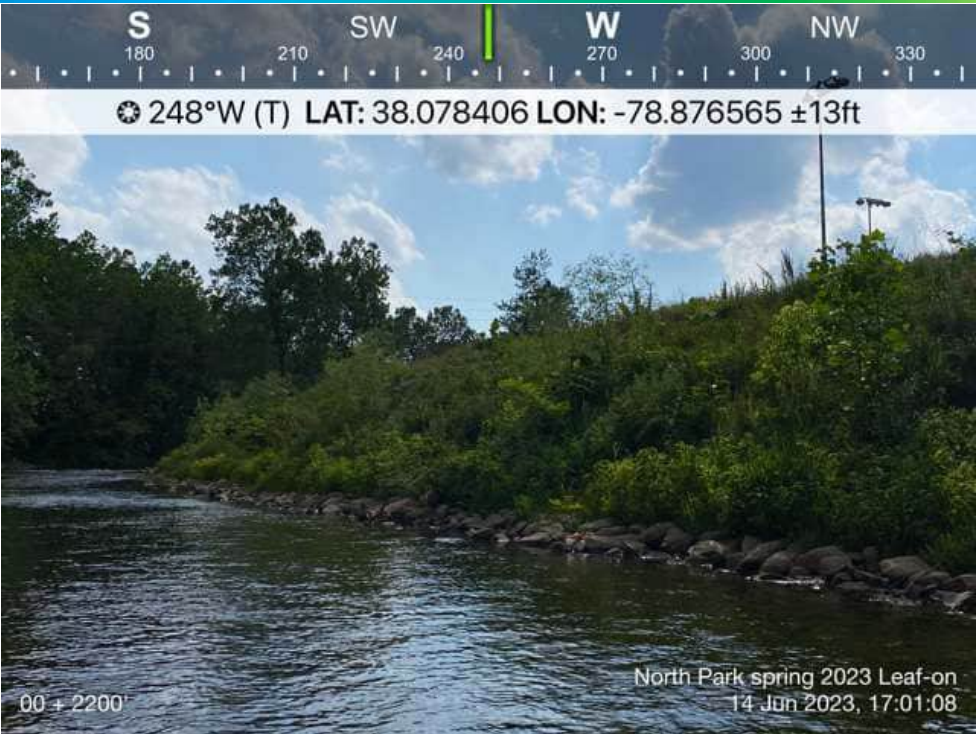
Photo Number: 79	Location: 00 + 2200'
Date: 6/14/2023

Direction: West	
Description: Upstream view of remediated bank	
00 + 2200' North Park spring 2023 Leaf-on 14 Jun 2023, 17:01:08

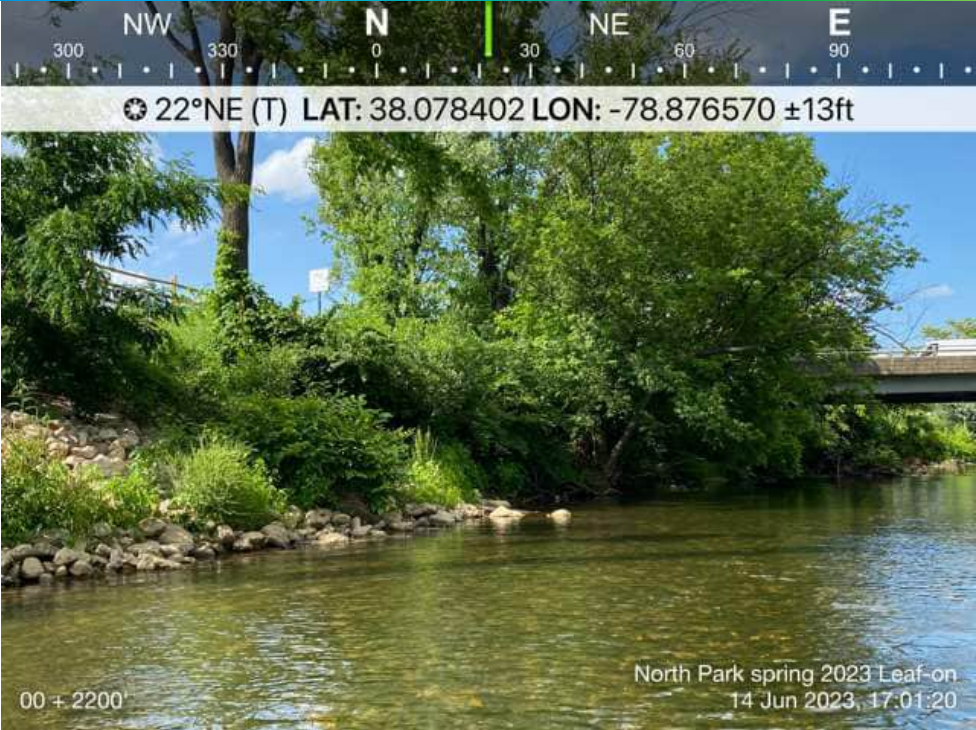
Photo Number: 80	Location: 00 + 2200'
Date: 6/14/2023

Direction: Northeast	
Description: Downstream view of remediated bank	
00 + 2200' North Park spring 2023 Leaf-on 14 Jun 2023, 17:01:20

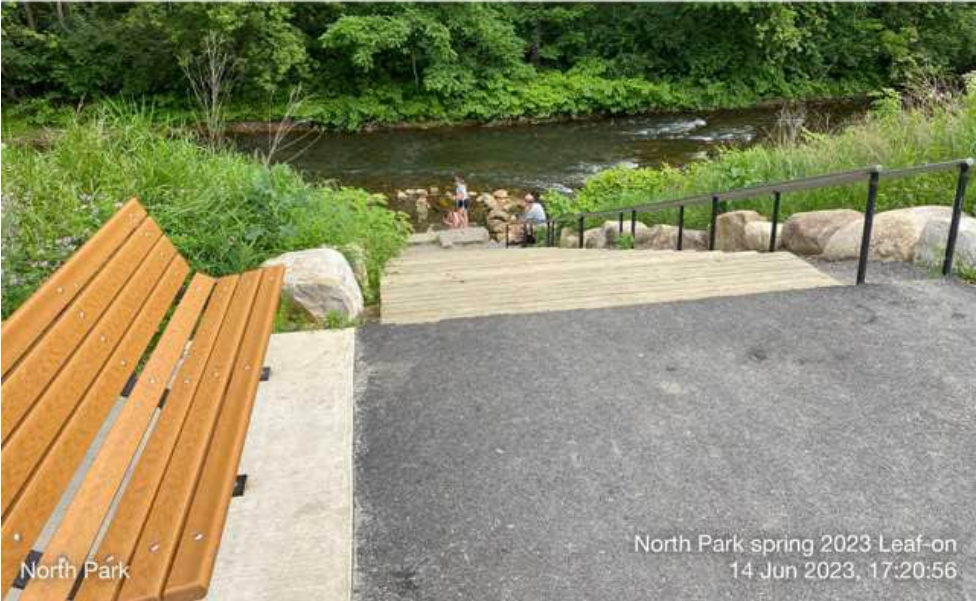
Direction: South	☀ 175°S (T) LAT: 38.077896 LON: -78.878274 ±13ft
Description: Public river access: stairs and kayak launch are in good condition
