RE: 2022 Leaf-off, 2022 Leaf-on and 2023 Leaf-on BMA Inspection Memos
Former DuPont Waynesboro Site AOC 4
Waynesboro, Virginia
EPA ID# VAD003114832

Subject 2023 Leaf-on Maintenance Inspection
Former DuPont Waynesboro Site, Area of Concern 4

Constitution Park BMA 2023 Leaf-on Inspection

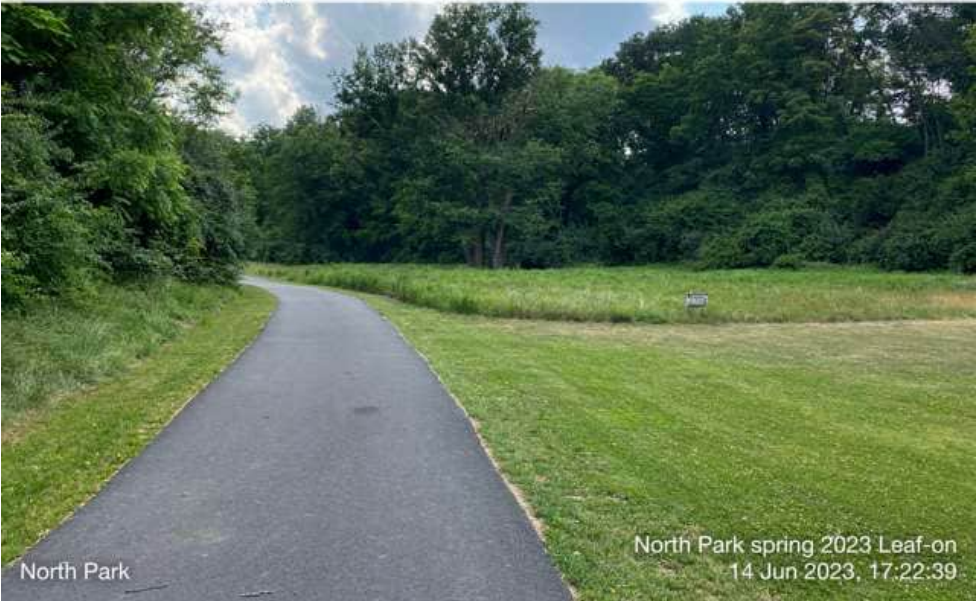
Photo Number: 88	Location: North Park
Date: 6/14/2023

Direction: West	☀ 266°W (T) LAT: 38.077899 LON: -78.879380 ±19ft
Description: Greenway above the non-remediated bank segment in North Park in good condition. Thick riparian buffer to the left is in good condition

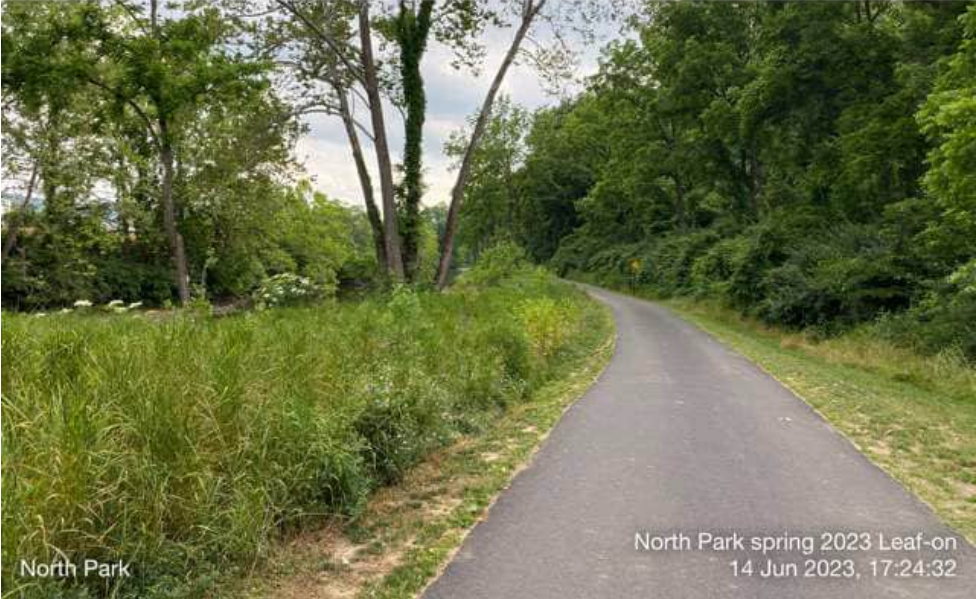
Direction: Southwest	☀ 217°SW (T) LAT: 38.077423 LON: -78.880574 ±13ft
Description: Paved greenway path looking Southwest towards the Shiloh Baptist Church BMA

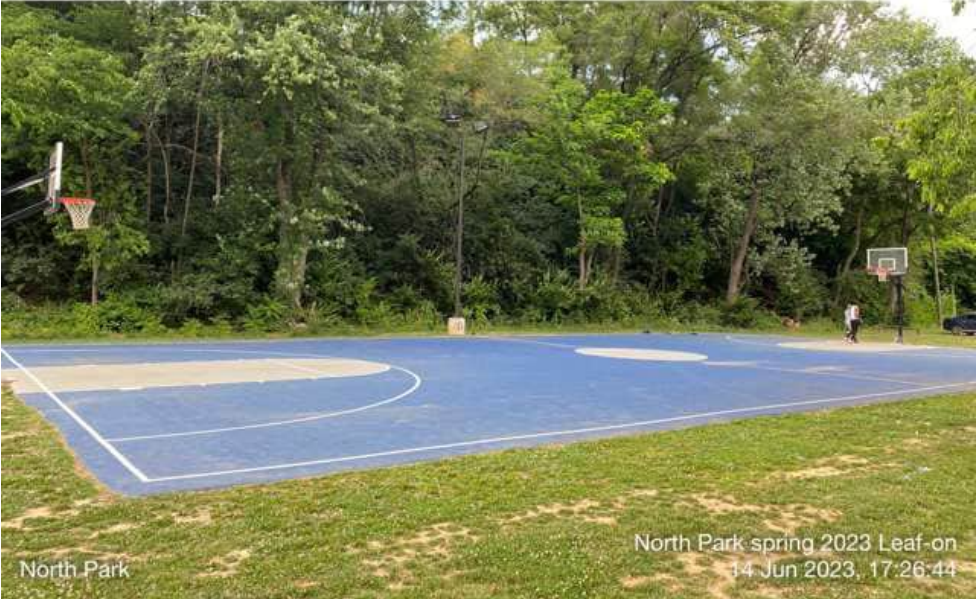
Photo Number: 90	Location: North Park
Date: 6/14/2023

Direction: North	☀ 1°N (T) LAT: 38.078154 LON: -78.879098 ±13ft
Description: Basketball court remains in good condition; grasses have grown in around the edge of the court
