## Memorandum

| Subject | Spring 2017 Short-term Monitoring Field Summary Memo<br>Former DuPont Waynesboro Site, Area of Concern 4 | |
| Date | August 31, 2017 | |

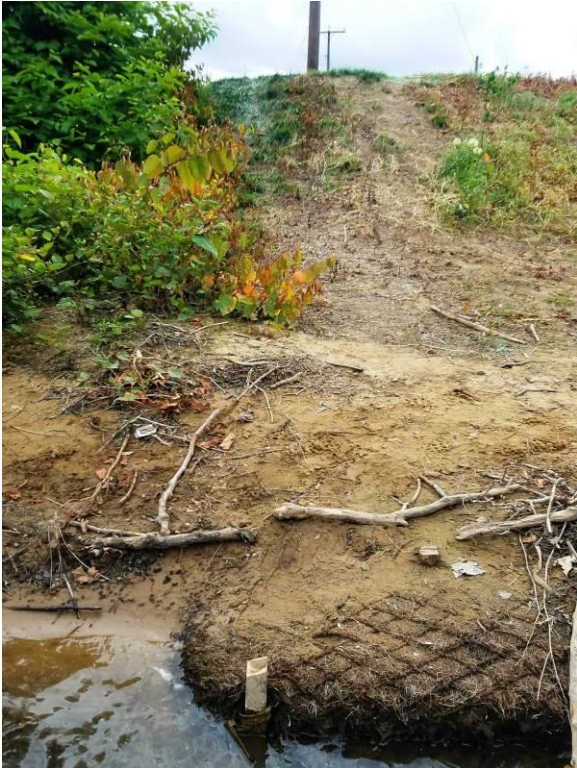
| <b>Photo No.</b><br>4 | <b>Date:</b><br>6/8/2017 | |

| <b>Description:</b><br><br>Station 00 + 00'<br><br>~40 degree bank angle;<br>no at-risk trees present;<br>limited vegetation present;<br>coir logs intact;<br>no scour present | | |

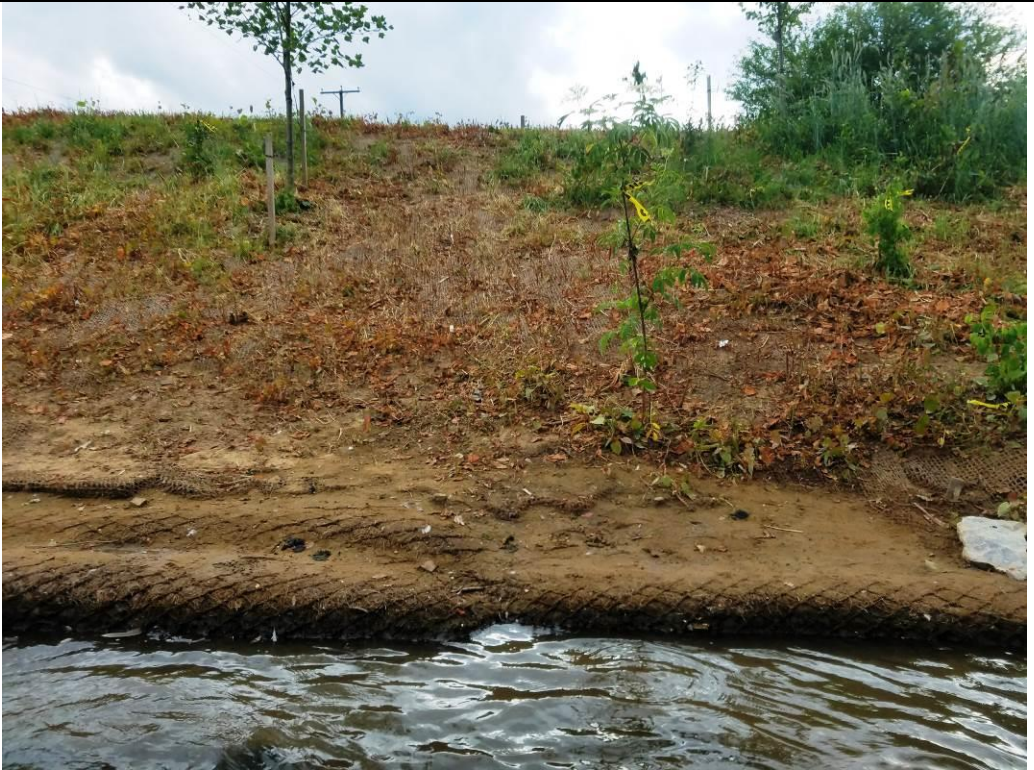
| <b>Description:</b><br><br>Station 00 + 50'<br><br>~45 degree consistent bank angle; no at-risk trees present; no exposed roots; coir logs intact; no scour present; evidence of recent vegetative maintenance, including cut stakings; evidence of foot traffic along toe of slope, along coir logs | | |

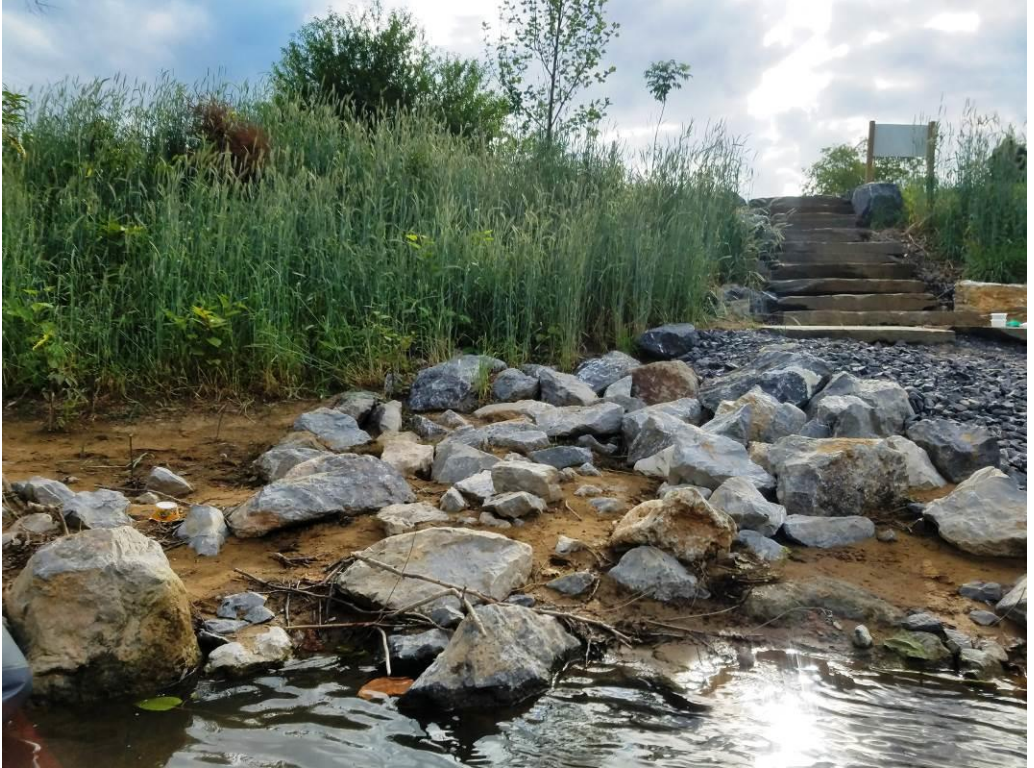
| <b>Description:</b><br><br>Station 00 + 100'<br><br>~40 degree bank angle; no at-risk trees present; no exposed roots; no scour present; installed rock toe intact with evidence of sediment deposition; installed river access steps intact; well-established planted rye grass on bank | | |

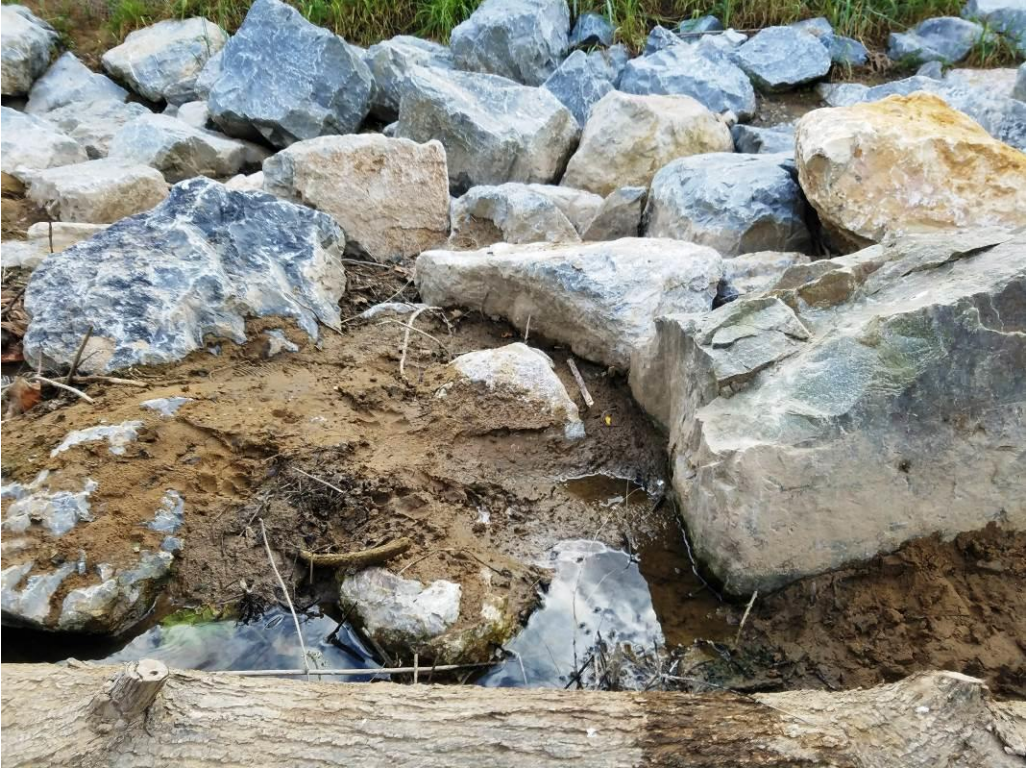
| <b>Photo No.</b><br>16 | <b>Date:</b><br>6/8/2017 | |

| <b>Description:</b><br><br>Station 00 + 150'<br><br>Installed rock toe and large woody debris (LWD) intact with evidence of sediment deposition | | |

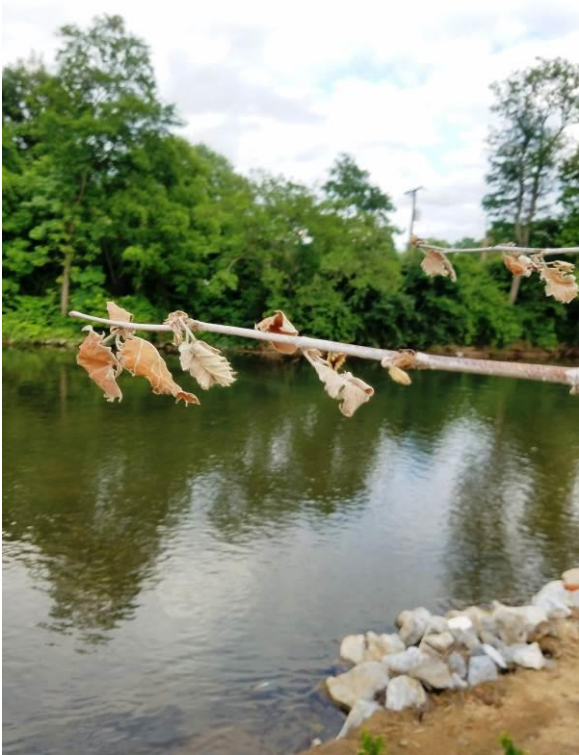
| <b>Photo No.</b><br>18 | <b>Date:</b><br>6/8/2017 | |

| <b>Description:</b><br>Station 00 + 200'<br><br>Evidence of recent vegetative maintenance, including cut stakings and dead sycamore sapling | | |

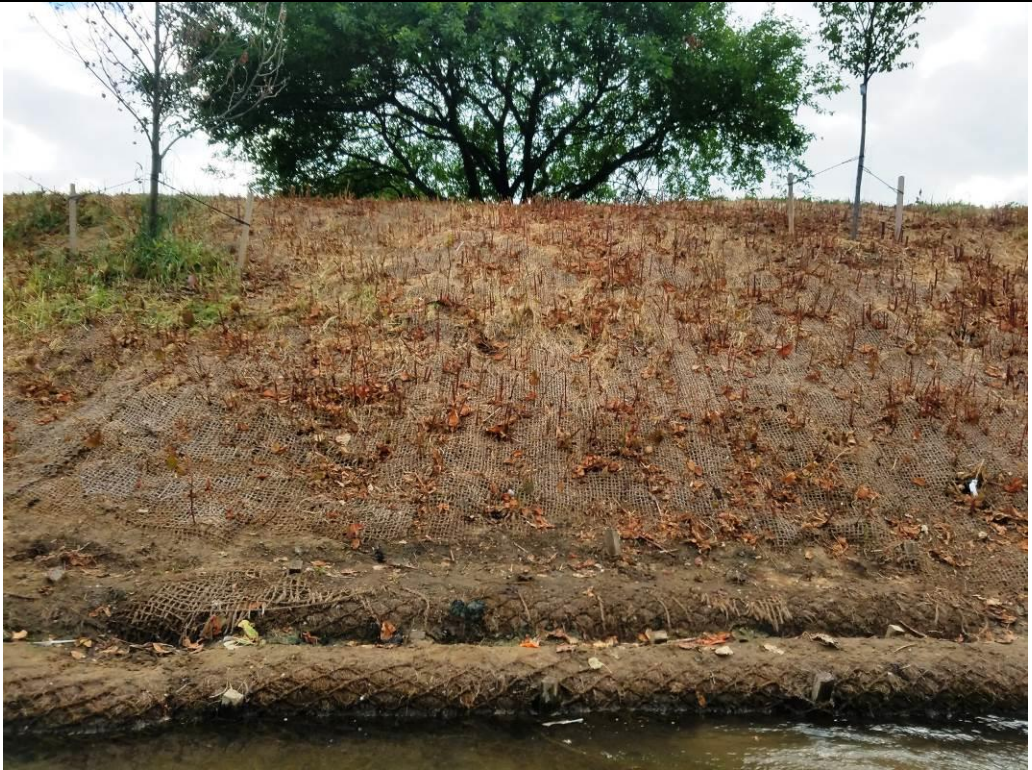
| <b>Photo No.</b><br>20 | <b>Date:</b><br>6/8/2017 | |

| <b>Description:</b><br><br>Station 00 + 200'<br><br>~55 degree consistent bank angle; no exposed roots; no scour present; recent vegetative maintenance, exposing erosion control fabric; installed coir logs, geocell and erosion control fabric intact | | |

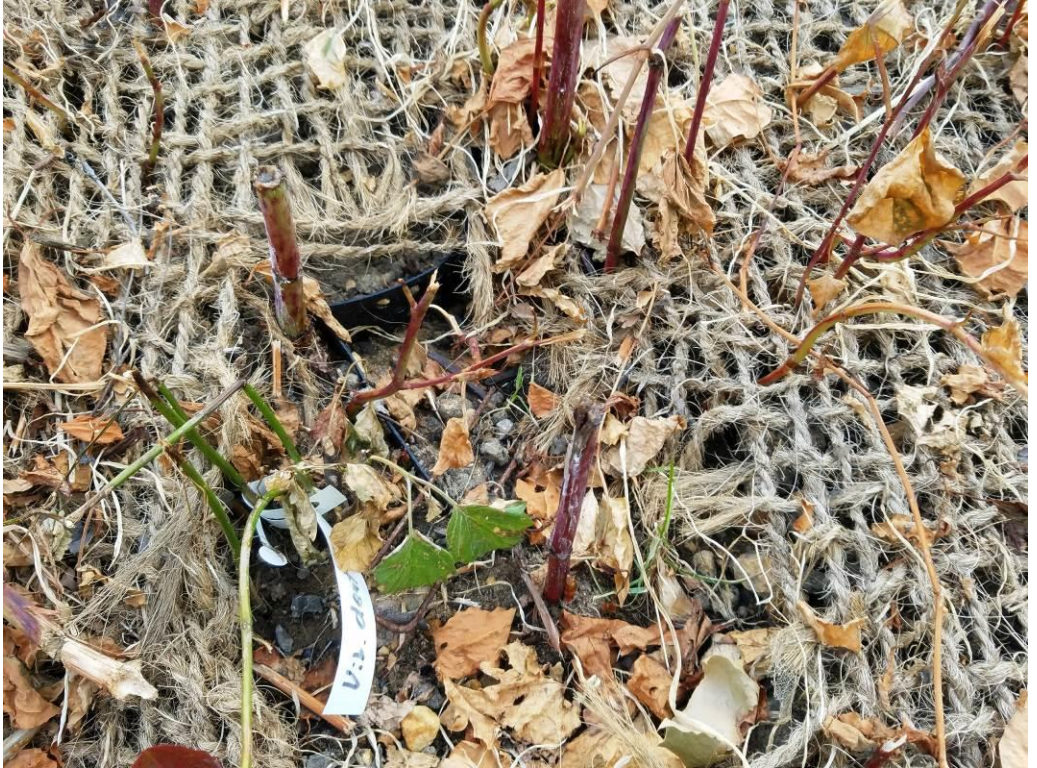
| <b>Photo No.</b><br>22 | <b>Date:</b><br>6/8/2017 | |

| <b>Description:</b><br><br>Station 00 + 250'<br><br>Evidence of recent vegetative maintenance, including cut stakings; minimal exposed geocell around planted vegetation | | |

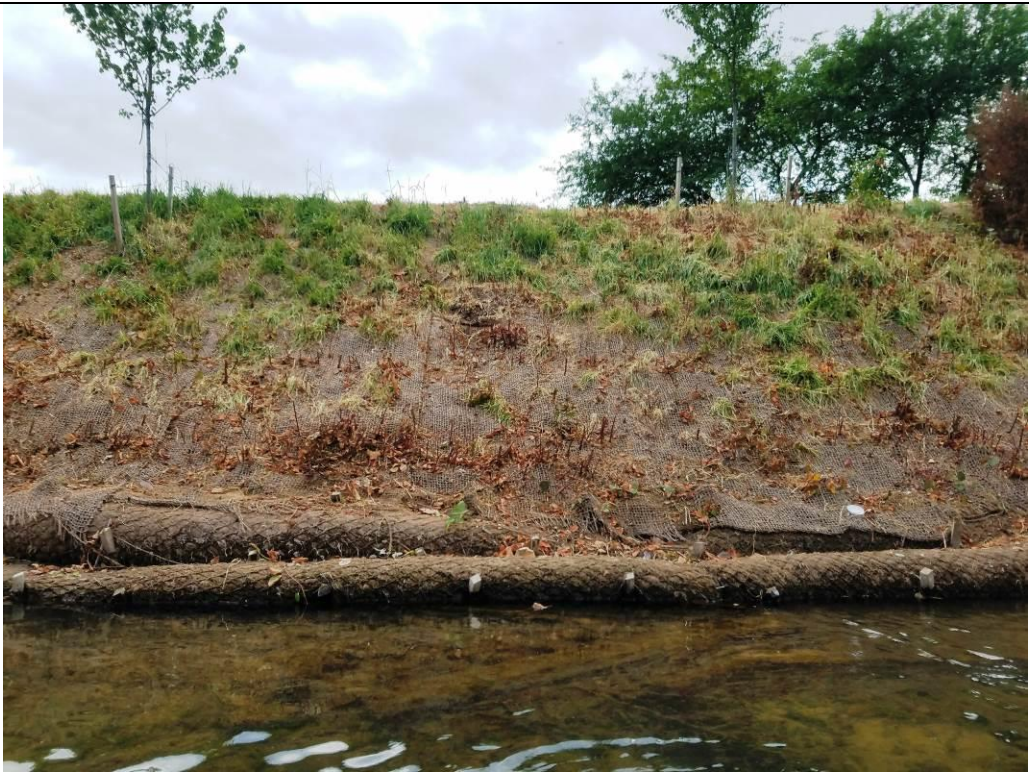
| <b>Photo No.</b><br>24 | <b>Date:</b><br>6/8/2017 | |

| <b>Description:</b><br><br>Station 00 + 250'<br><br>~55 degree consistent bank angle; no exposed roots; no scour present; evidence of recent vegetative maintenance; installed coir logs and geocell intact; edge of erosion control fabric exposed near toe of slope | | |

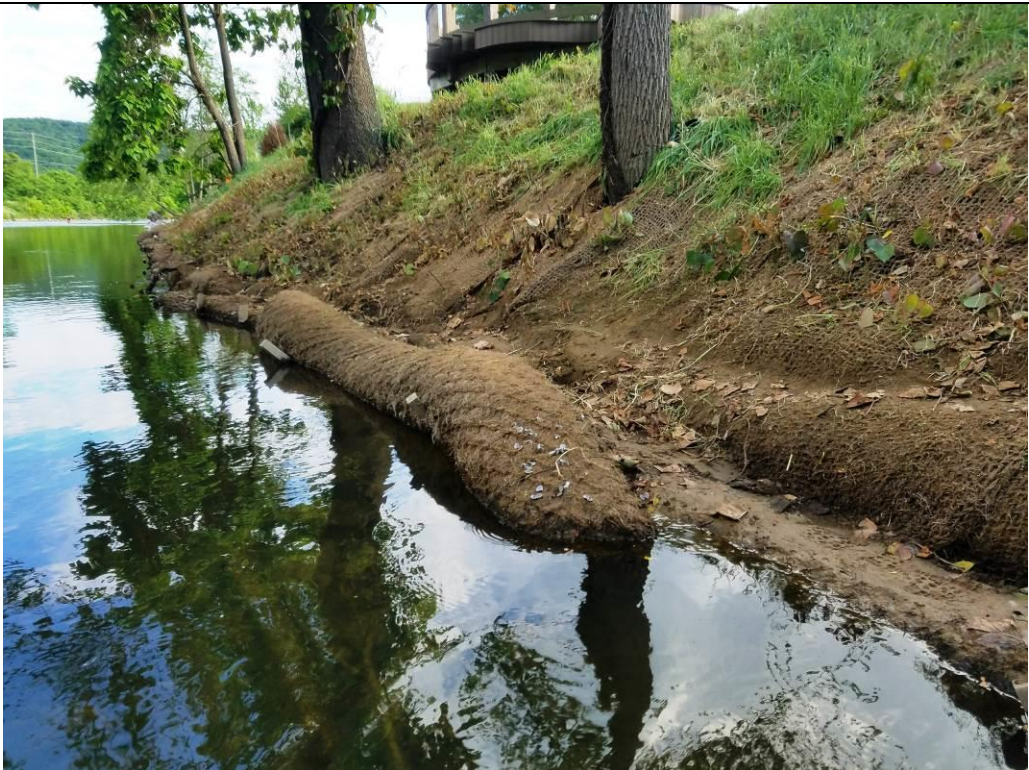
| <b>Photo No.</b><br>30 | <b>Date:</b><br>6/8/2017 | |

| <b>Description:</b><br>Station 00 + 400'<br><br>Installed coir logs intact; erosion control fabric exposed near bottom of bank | | |

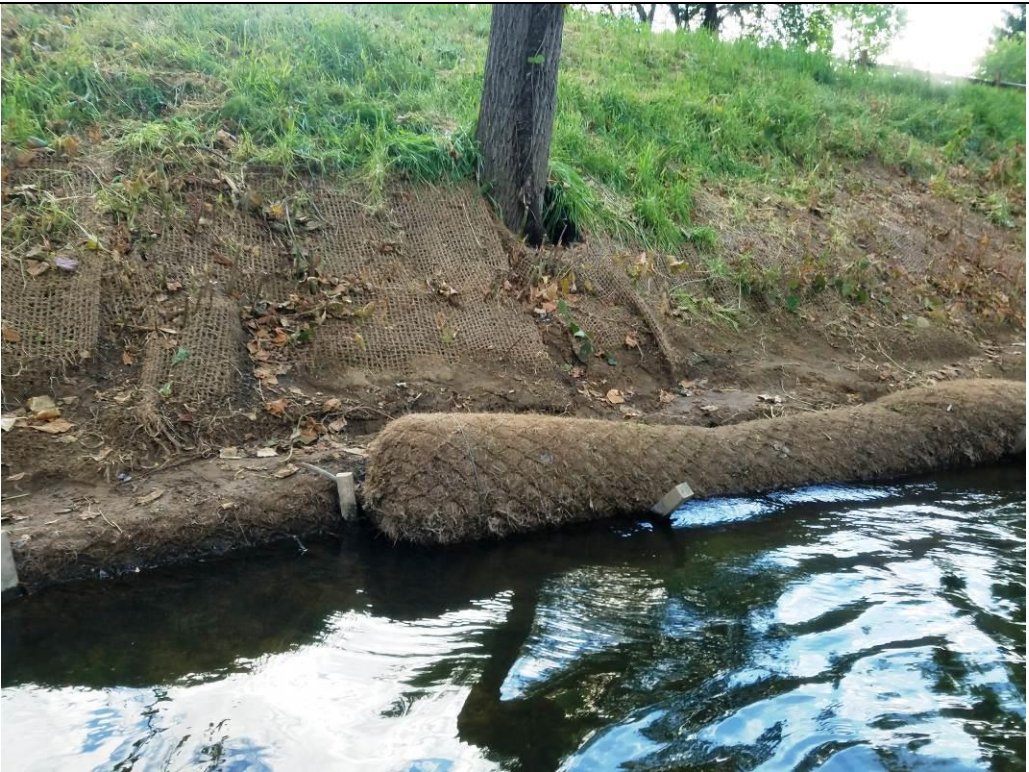
| <b>Photo No.</b><br>32 | <b>Date:</b><br>6/8/2017 | |

| <b>Description:</b><br>Station 00 + 400'<br><br>Installed coir logs intact; erosion control fabric exposed near; some geocell and edge of erosion control fabric exposed around base of black walnut tree unvegetated | | |

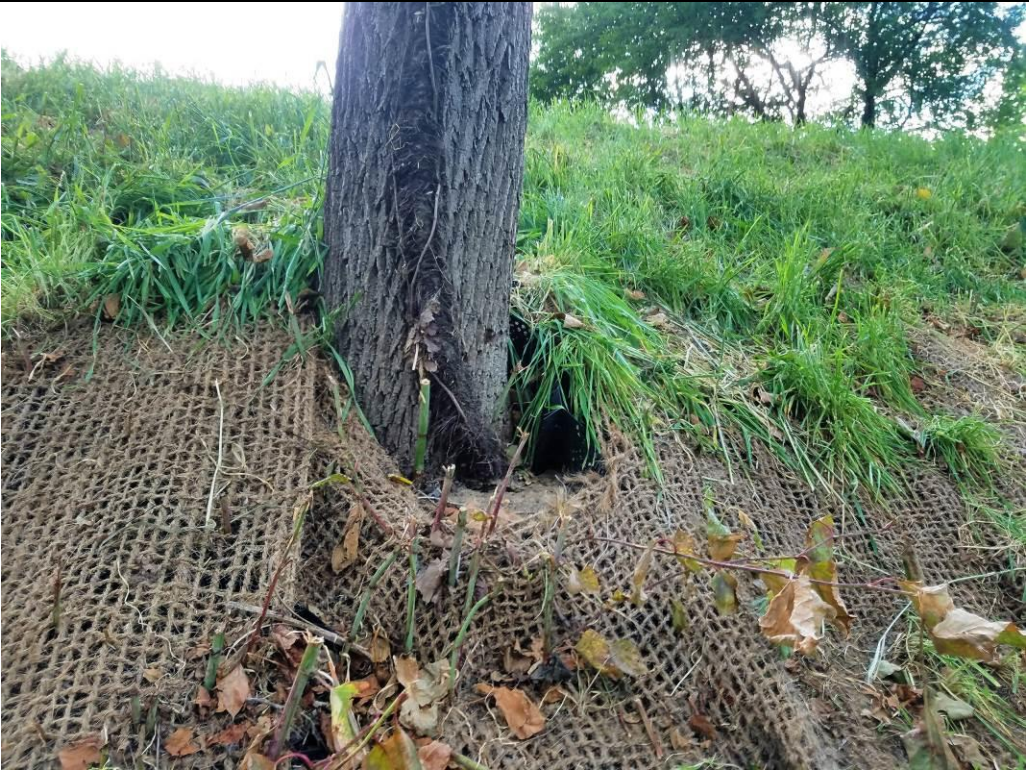
| <b>Photo No.</b><br>34 | <b>Date:</b><br>6/8/2017 | |

| <b>Description:</b><br>Station 00 + 400'<br><br>Some geocell and edge of erosion control fabric exposed around base of black walnut tree | | |

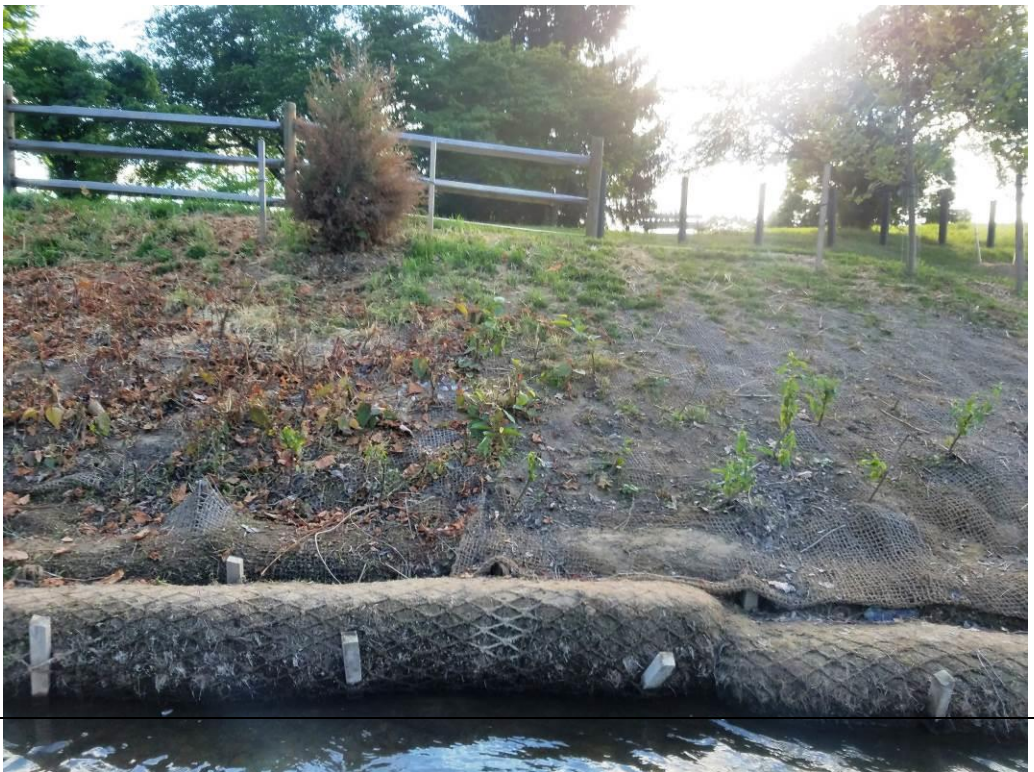
| <b>Photo No.</b><br>36 | <b>Date:</b><br>6/8/2017 | |

| <b>Description:</b><br>Station 00 + 500'<br><br>~40 degree consistent bank angle; no exposed roots; no at-risk trees; no scour present; evidence of vegetative maintenance for most of the bank | | |
