**Re: 2018/2019 Allied Ready Mix Bank Management Area - Leaf-off Maintenance Inspection  
Area of Concern 4, Former DuPont Waynesboro Plant  
Waynesboro, Virginia  
EPA ID# VAD003114832**

| Subject | 2018/2019 Allied Ready Mix BMA – Leaf-off Maintenance Inspection<br>Former DuPont Waynesboro Site, Area of Concern 4 | | |

Table 1  
Winter 2018/2019 Allied Ready Mix BMA Maintenance Inspection  
Former DuPont Waynesboro Site, Area of Concern 4

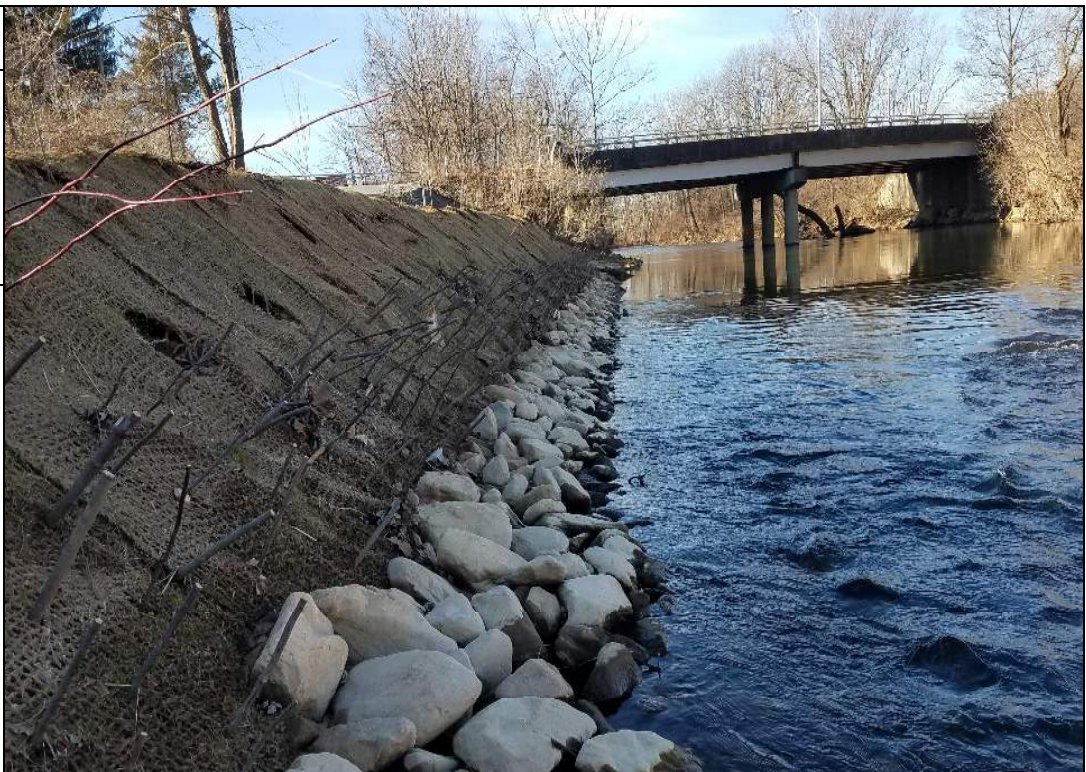
| <b>Description:</b><br><br>Station PCM5<br><br>Installed live stakes upstream of PCM5. | | |

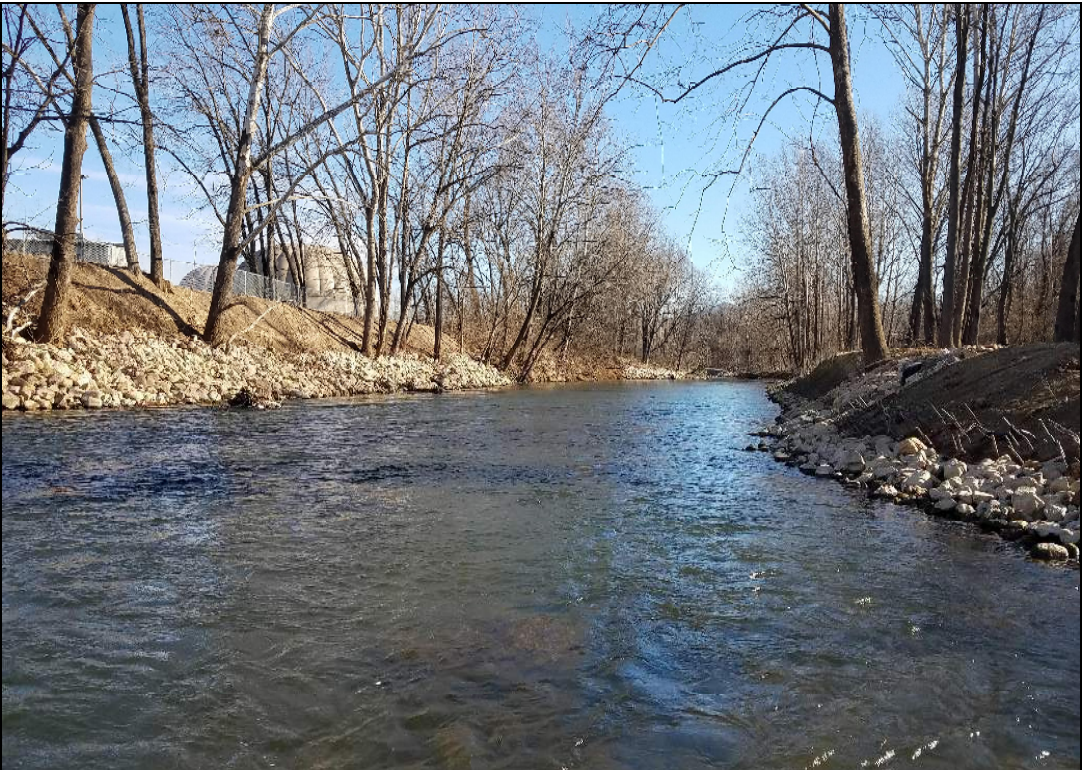
| <b>Description:</b><br>Station PCM8<br><br>Downstream view of newly constructed bank and installed live stakes. | | |

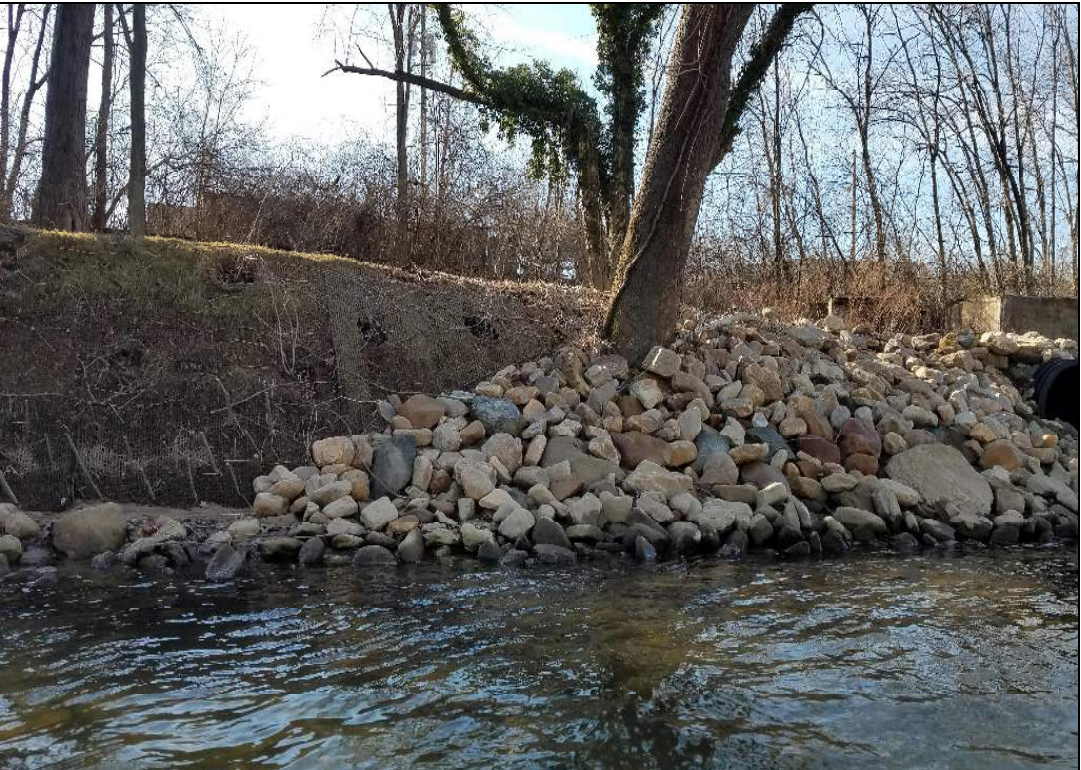
| <b>Description:</b><br><br>Station PCM10<br><br>~50 degree bank angle;<br>outfall and drainage<br>structure intact; live<br>stakes planted on lower<br>bank; saplings planted<br>along bank; erosion<br>fabric exposed<br>throughout; sand<br>deposition at toe of<br>bank. | | |

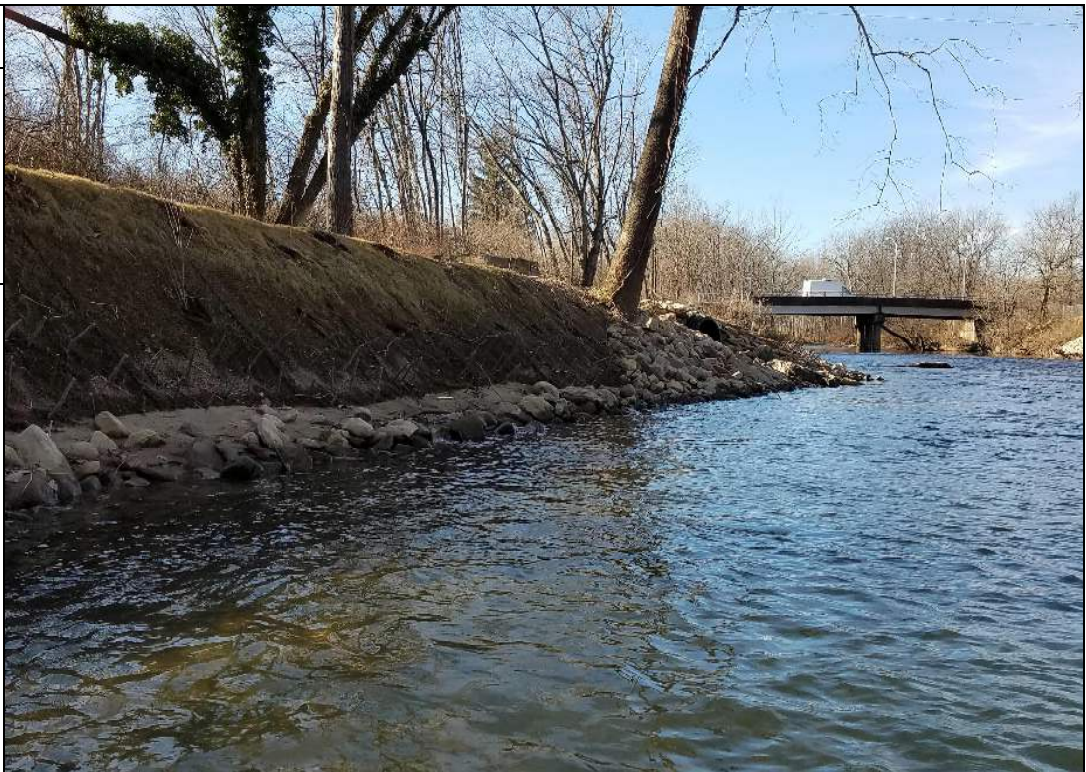
| <b>Description:</b><br><br>Station PCM11<br><br>Upstream view of newly constructed bank and installed live stakes; mid-bank plantings downstream of the outfall structure were generally intact. | | |

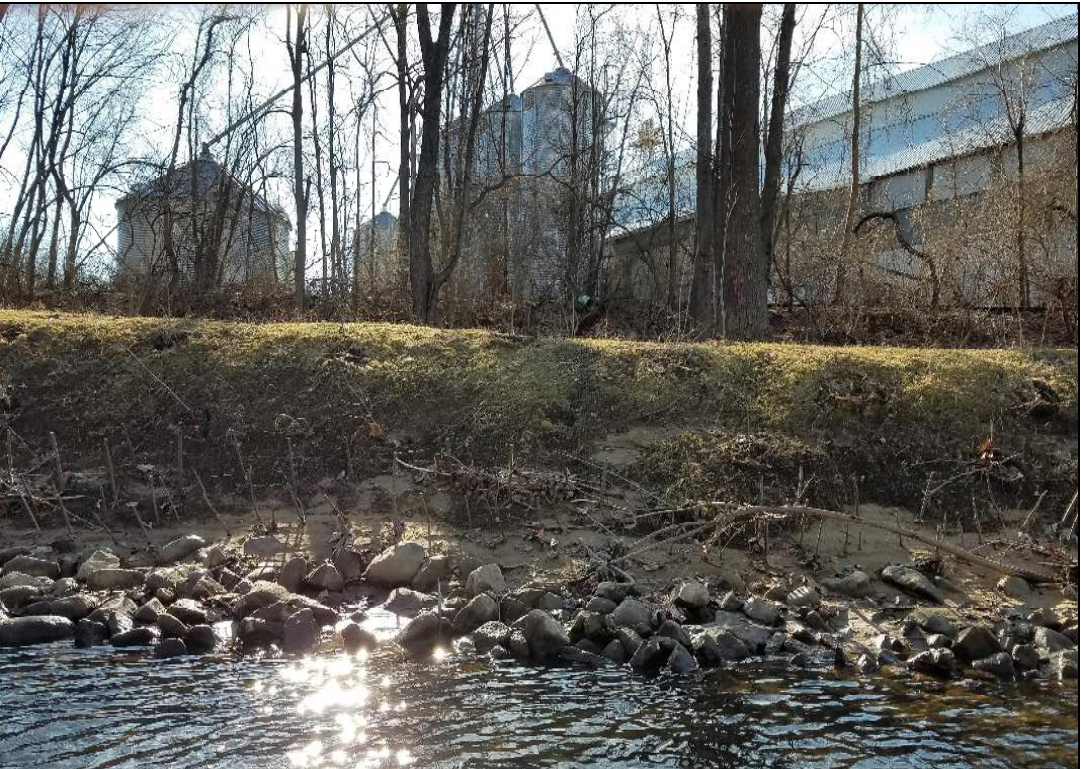
| <b>Description:</b><br><br>Station PCM13<br><br>~30 degree bank angle;<br>installed rock toe intact;<br>grasses establishing at<br>top of bank; erosion<br>fabric exposed from<br>mid-bank towards the<br>rock toe; sand<br>deposition occurring<br>above rock toe. | | |

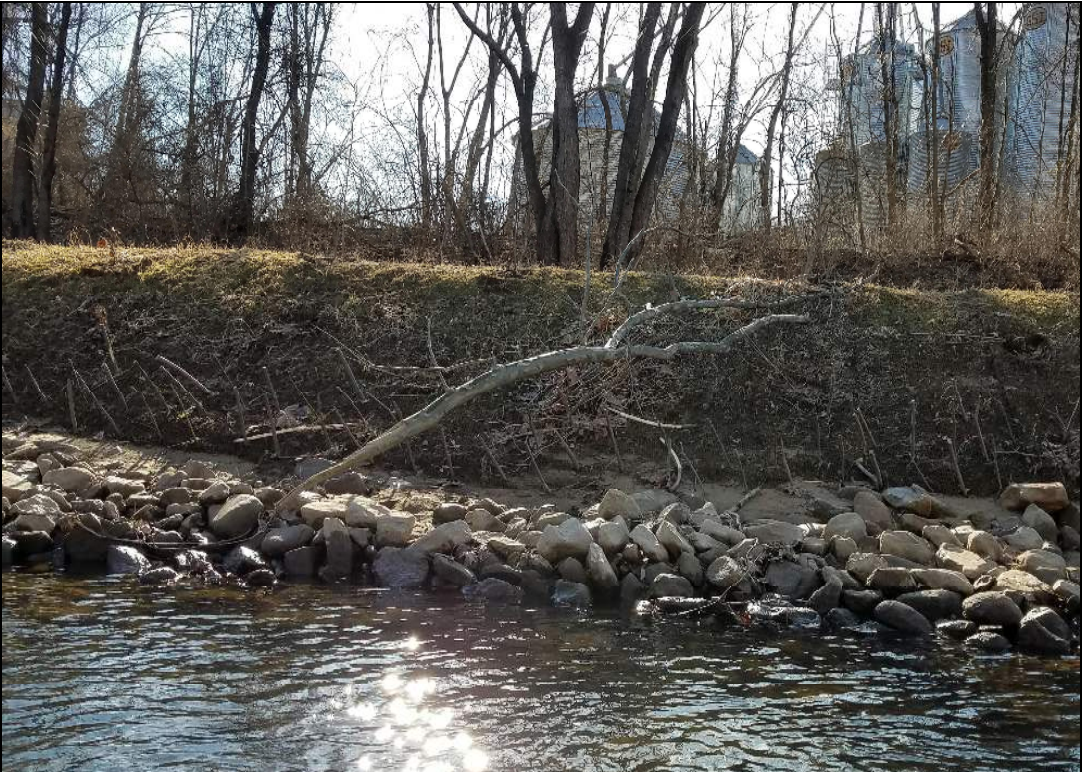
| <b>Description:</b><br><br>Station PCM14<br><br>~30 degree bank angle; installed rock toe intact; grasses establishing at top of bank; erosion fabric exposed from mid-bank towards the rock toe (~50% exposed); sand deposition occurring above rock toe. | | |

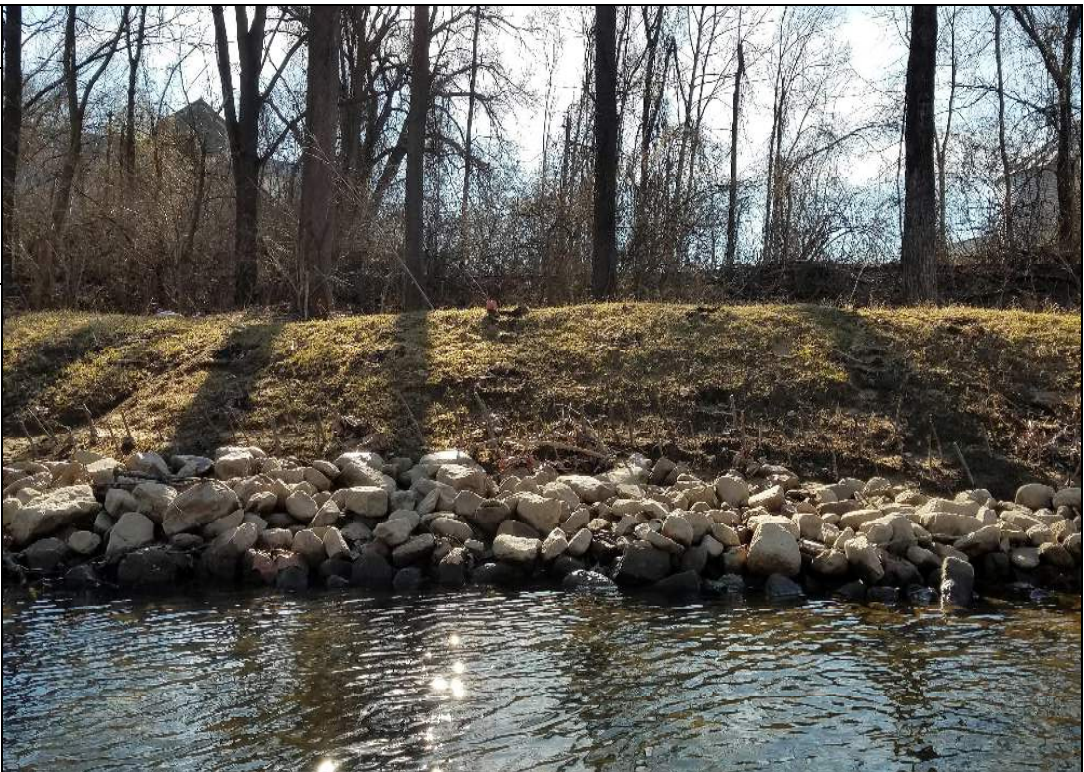
| <b>Description:</b><br><br>Station PCM16<br><br>~30 degree bank angle;<br>installed rock toe intact;<br>grasses establishing at<br>top of bank; erosion<br>fabric exposed from<br>mid-bank towards the<br>rock toe (~50%<br>exposed); sand<br>deposition occurring<br>above rock toe. | | |

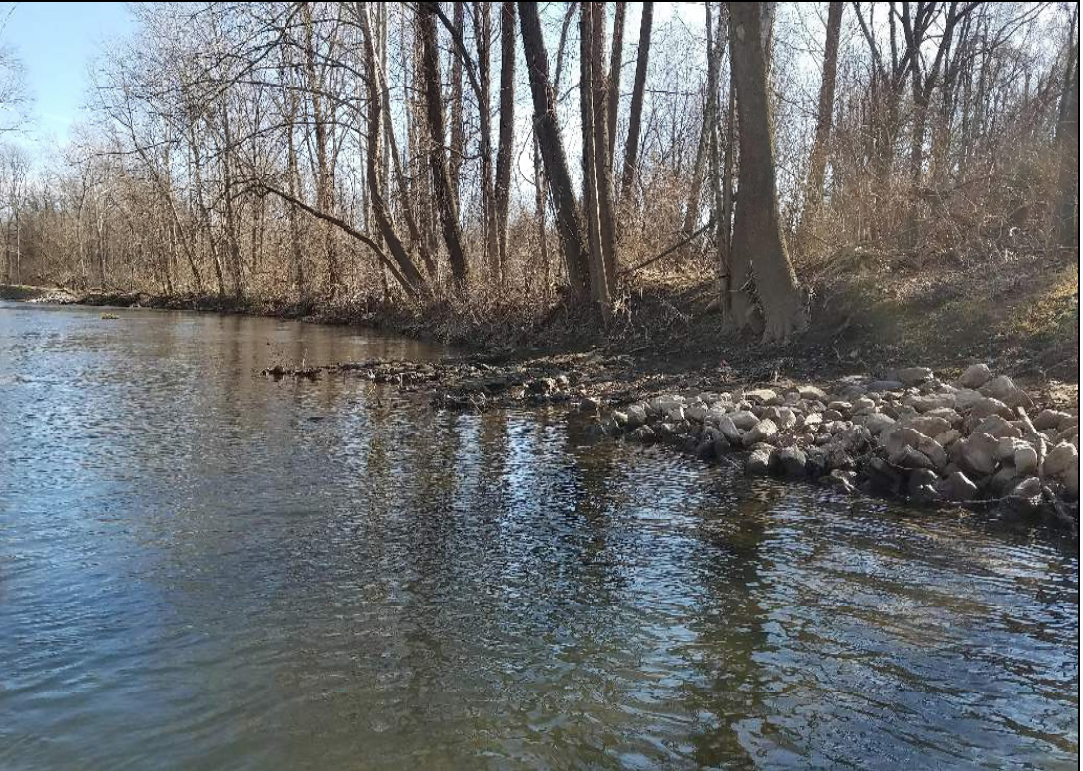
| <b>Description:</b><br><br>Station PCM16<br><br>Downstream view of PCM16 showing the end of the first remediated section. | | | |

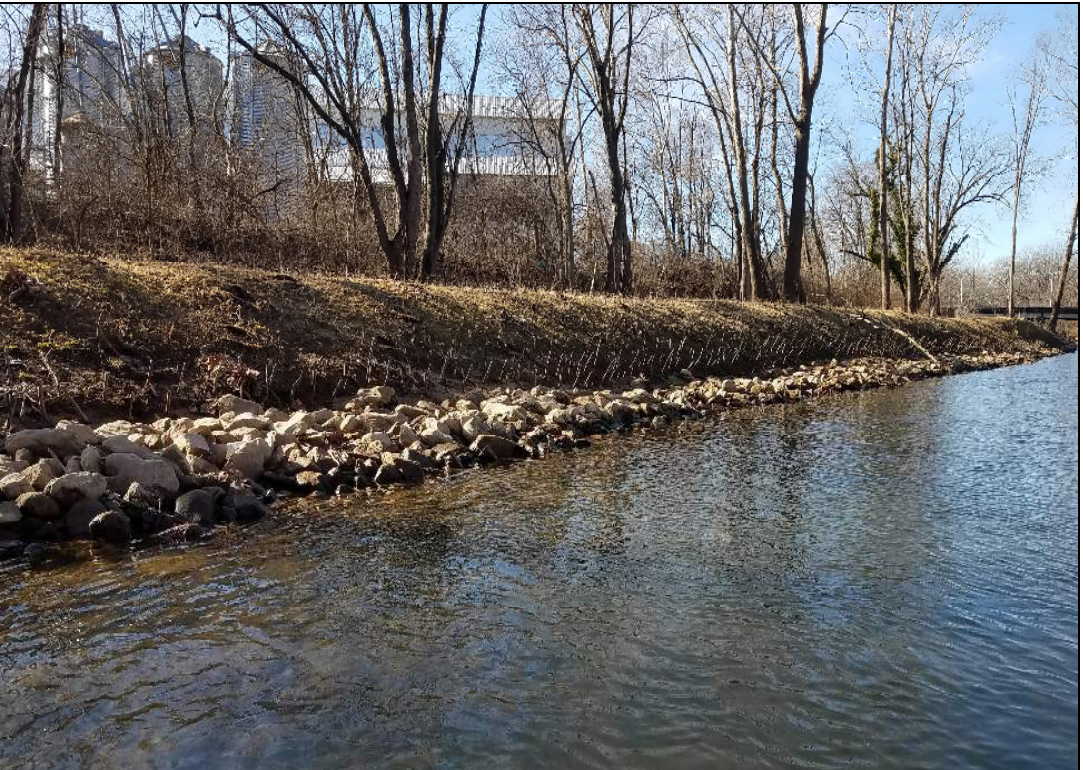
| <b>Description:</b><br><br>Station PCM16<br><br>Upstream view of PCM16; live stakes and rock toe intact. | | |

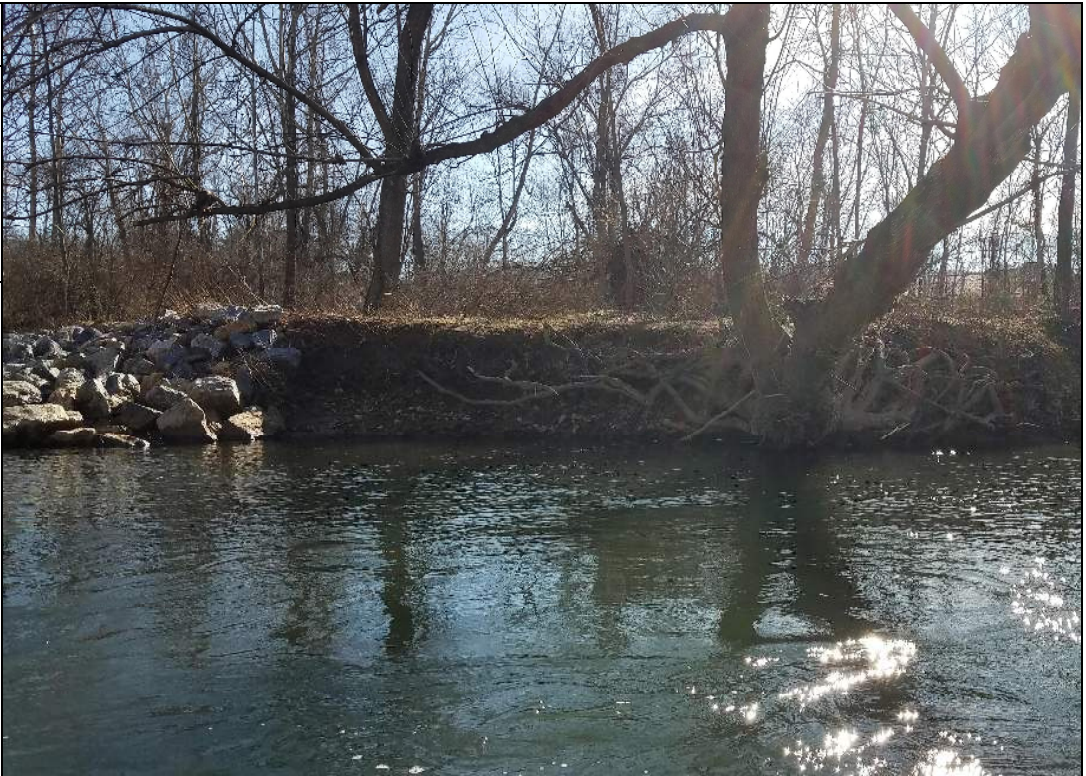
| <b>Description:</b><br>Station PCM18<br><br>~40 degree bank angle(non-remediated 80); upstream of remediation exposed roots of large at risk tree are present, evidence of heavy scour around roots; no scour present along rock toe of remediation. | | |

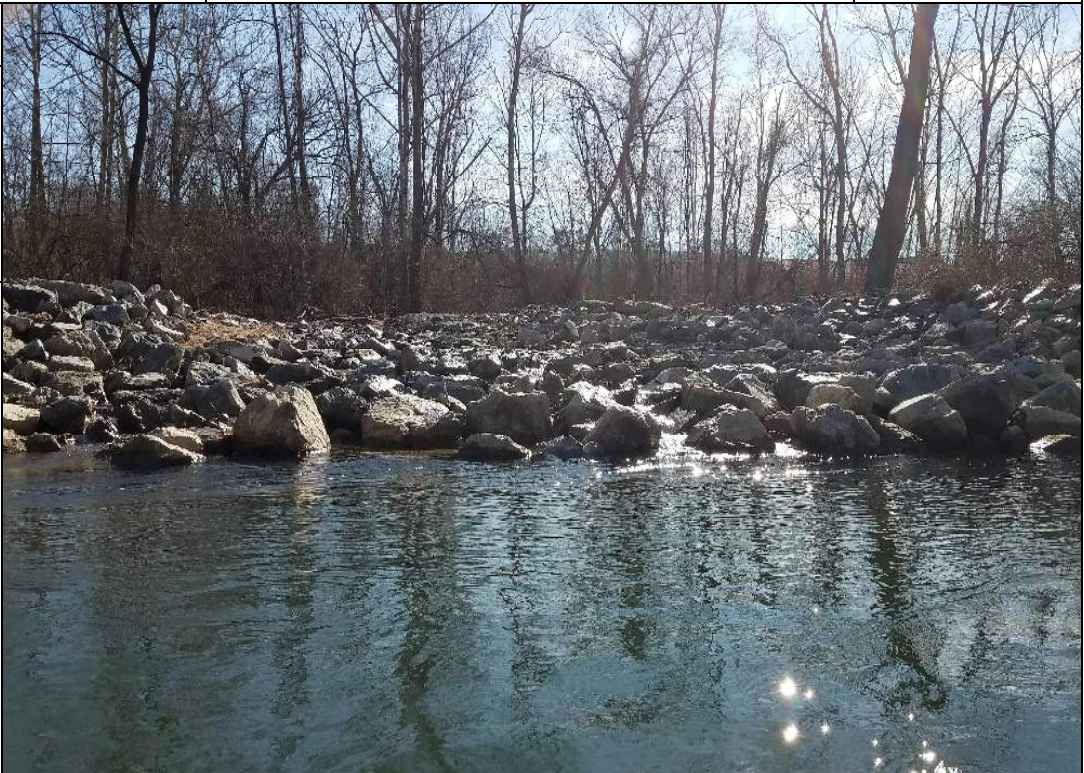
| <b>Description:</b><br><br>Station PCM19<br><br>~20 degree bank angle; rip rap fortified tributary channel; no exposed roots; no at risk trees; no fabric or geocell installed; no live stakes or trees planted. | | | |

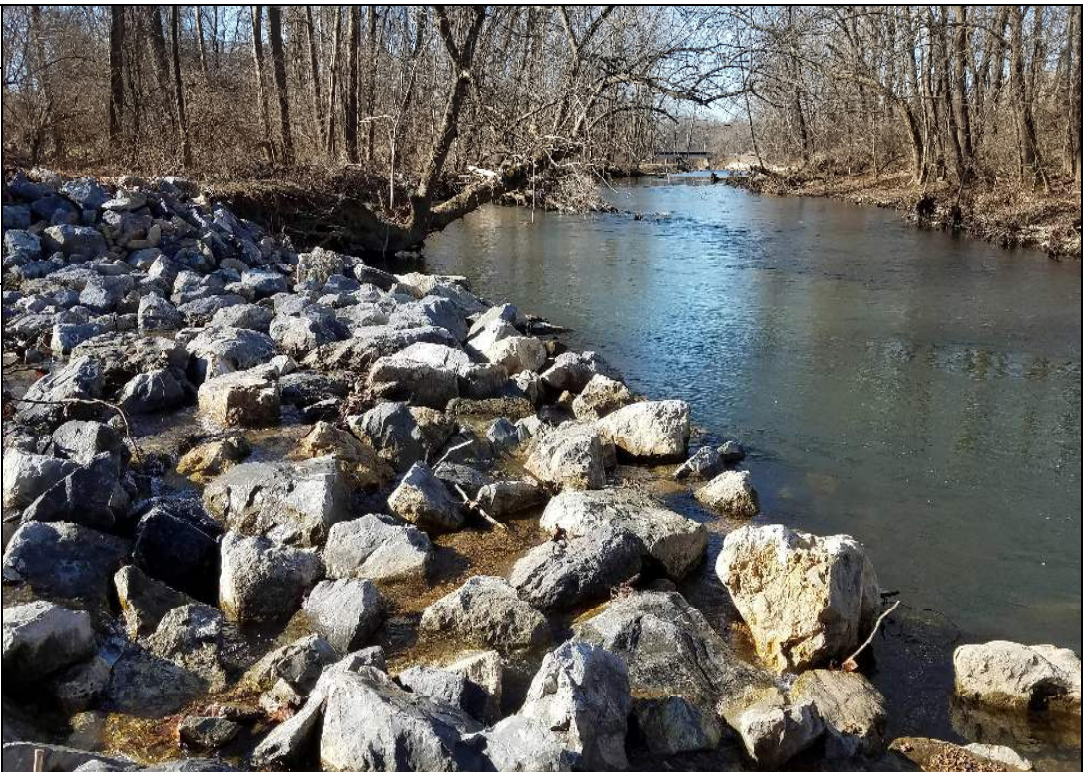
| <b>Description:</b><br><br>Station PCM19<br><br>View of the confluence of Steel Run and South River; installed rip rap intact. | | |

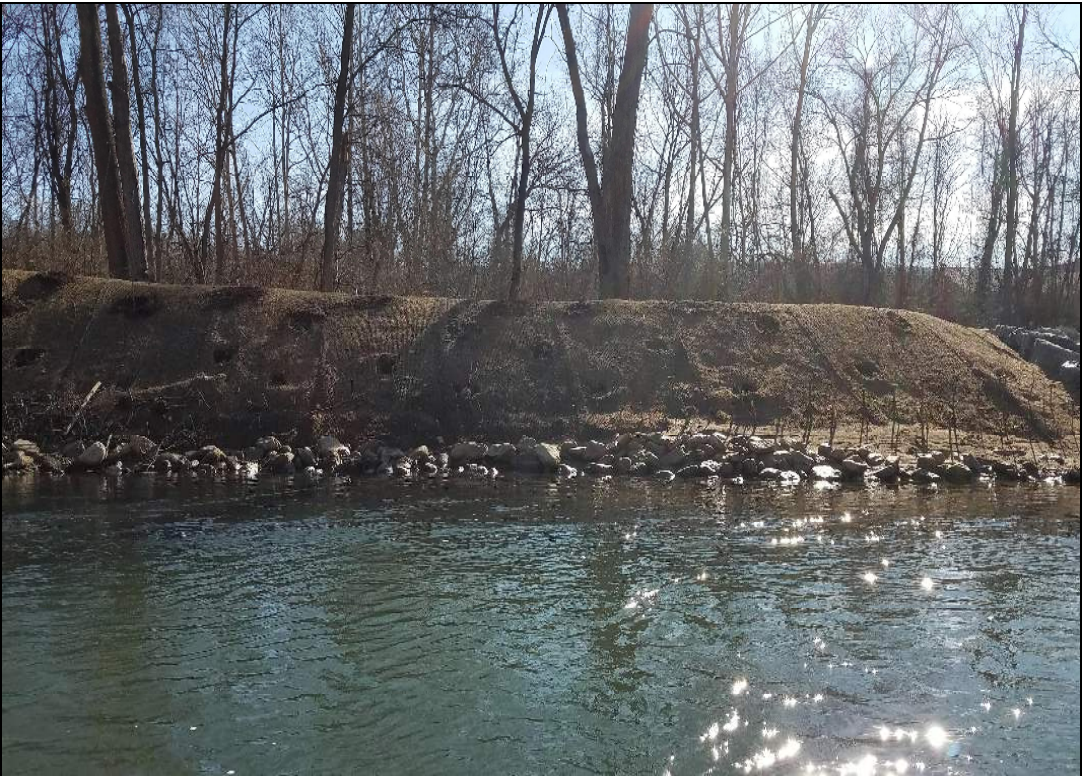
| <b>Description:</b><br><br>Station PCM20<br><br>~50 degree bank angle; no exposed roots; no at risk trees; live stakes planted on lower bank above rock toe; saplings planted throughout rest of bank; fabric is torn and scour present where mid bank planted container stock has washed away. | | |

Comments: Empty holes where planted stock was lost during high flow events will be backfilled with planting substrate and have erosion control fabric repair. Dormant live stakes (4') or similar will be installed to replace lost container stock. Monitor upstream end of BMA for signs of wear from foot traffic.

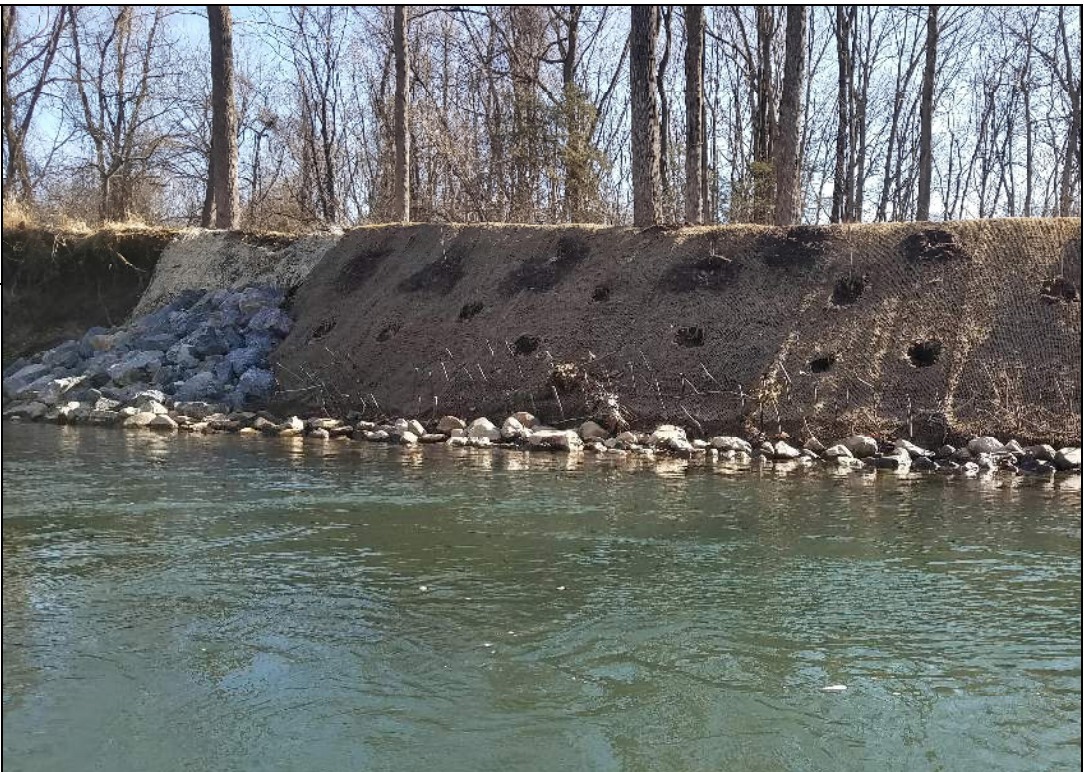
| <b>Description:</b><br><br>Station PCM22<br><br>Downstream view of PCM 21 showing end of BMA; no exposed roots; no at risk trees; live stakes planted on lower bank above rock toe; saplings planted throughout rest of bank; installed rock toe intact. | | |

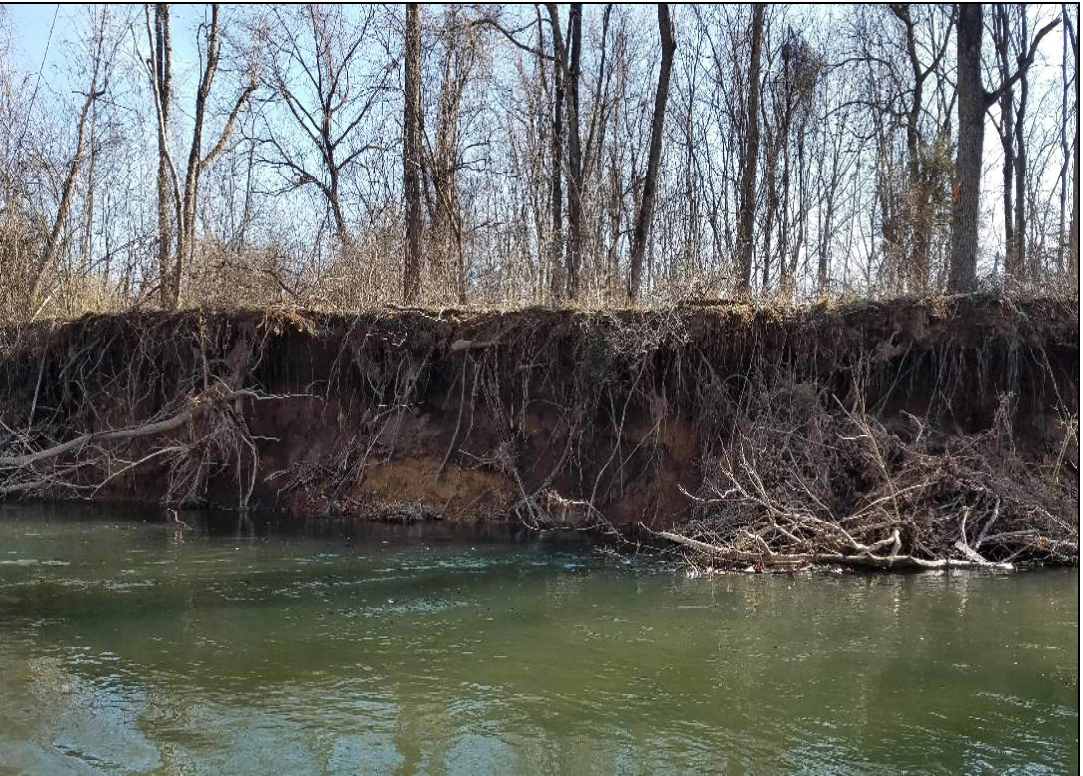
| <b>Description:</b><br><br>Station PCM23<br><br>~90 degree bank angle;<br>heavy erosion present downstream of remediated BMA;<br>severe root exposure and high density of at risk trees due to undercut bank. | | |
