# Integration of Remediation, Restoration and Revitalization Objectives: A Case Study on the Mercury-Impacted South River, Virginia

Cameron Dixon (AECOM, Boston, MA, USA) | Ryan Davis (Anchor QEA, Seattle, WA, USA) | Nancy Grosso and Mike Liberati (E.I. du Pont de Nemours and Company, Wilmington, DE, USA) | Dwayne Jones (City of Waynesboro, Waynesboro, VA, USA)

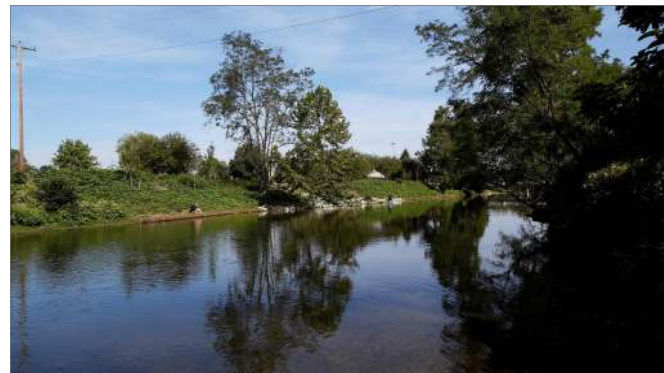
Figure 4. Post-Remediation Constitution Park Recreational Use

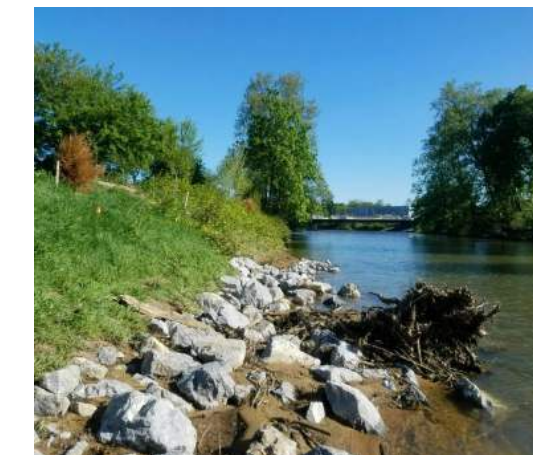
Figure 7. Six-months after completion at Constitution Park
