# Outreach Learnings What's Next

SRST Meeting  
4/19/17

### Constitution Park Riverbank Remediation Complete

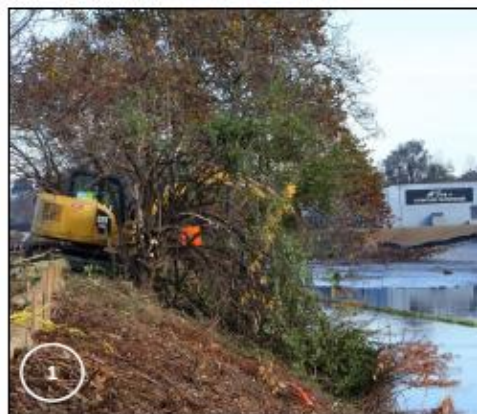
The remediation of the riverbank at Constitution Park was completed in February 2017. This riverbank was identified to be remediated for two reasons: the soil contains elevated concentrations of mercury, and the soil is eroding into the South River. The riverbanks at Constitution Park are the first of several to be remediated with the objective of significantly decreasing the erosion of mercury into river. The majority of the identified riverbanks will be capped. The soil in areas with the highest levels of mercury will be excavated and disposed of properly prior to capping. This newsletter highlights the activities that were involved in completing the remediation at Constitution Park.

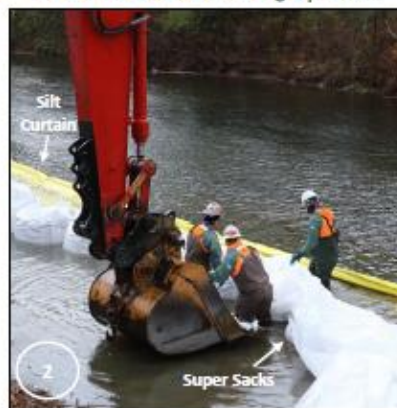
Site access was controlled with temporary fencing. A silt-retaining curtain was installed in the river, and vegetation was removed. Healthy trees were left in place.

Heavy fabric bags called super sacks were filled with clean soil and used to create a temporary dam around the planned excavation area. The area behind the dam was pumped dry.

An approximately 75-foot-long section of riverbank with the highest mercury levels was excavated. The excavated soil was transported and disposed of at a permitted landfill.
